From: [Rosenberg, Julie \(BOA\)](#)
To: [Longaway, Alec \(BOA\)](#); [Mejia, Xiomara \(BOA\)](#)
Cc: [BoardofAppeals \(PAB\)](#)
Subject: FW: Code interpretation of SFBC section 106A.1 (Appeal No. 23-046 @ 1331-1333 Church ST.)
Date: Monday, January 8, 2024 4:13:05 PM

In particular, the question is whether this code section requires that two permits be obtained for the exterior stair repair at 1331-1333 Church Street. Building permit application # 202306291194 was issued to the property owner of 1331-1333 Church. The owners of the adjacent property (1325-1327 Church Street), assert that there are some fasteners that penetrate their property line wall. As such, they believe that a second permit for the repairs is required to be issued under their address. Other than the fasteners (and I am uncertain as to the number of fasteners), the stair structure is on the 1331-1333 Church Street side of the property line. The stairs serve only 1331-1333 Church Street.

FIRE EGRESS STAIRS REPAIR

The substance or effect of the decision or order appealed from is the **ISSUANCE** on September 19, 2023 to Ken Chin, of an Alteration Permit (repair the damaged framing in-kind in the fire egress stai

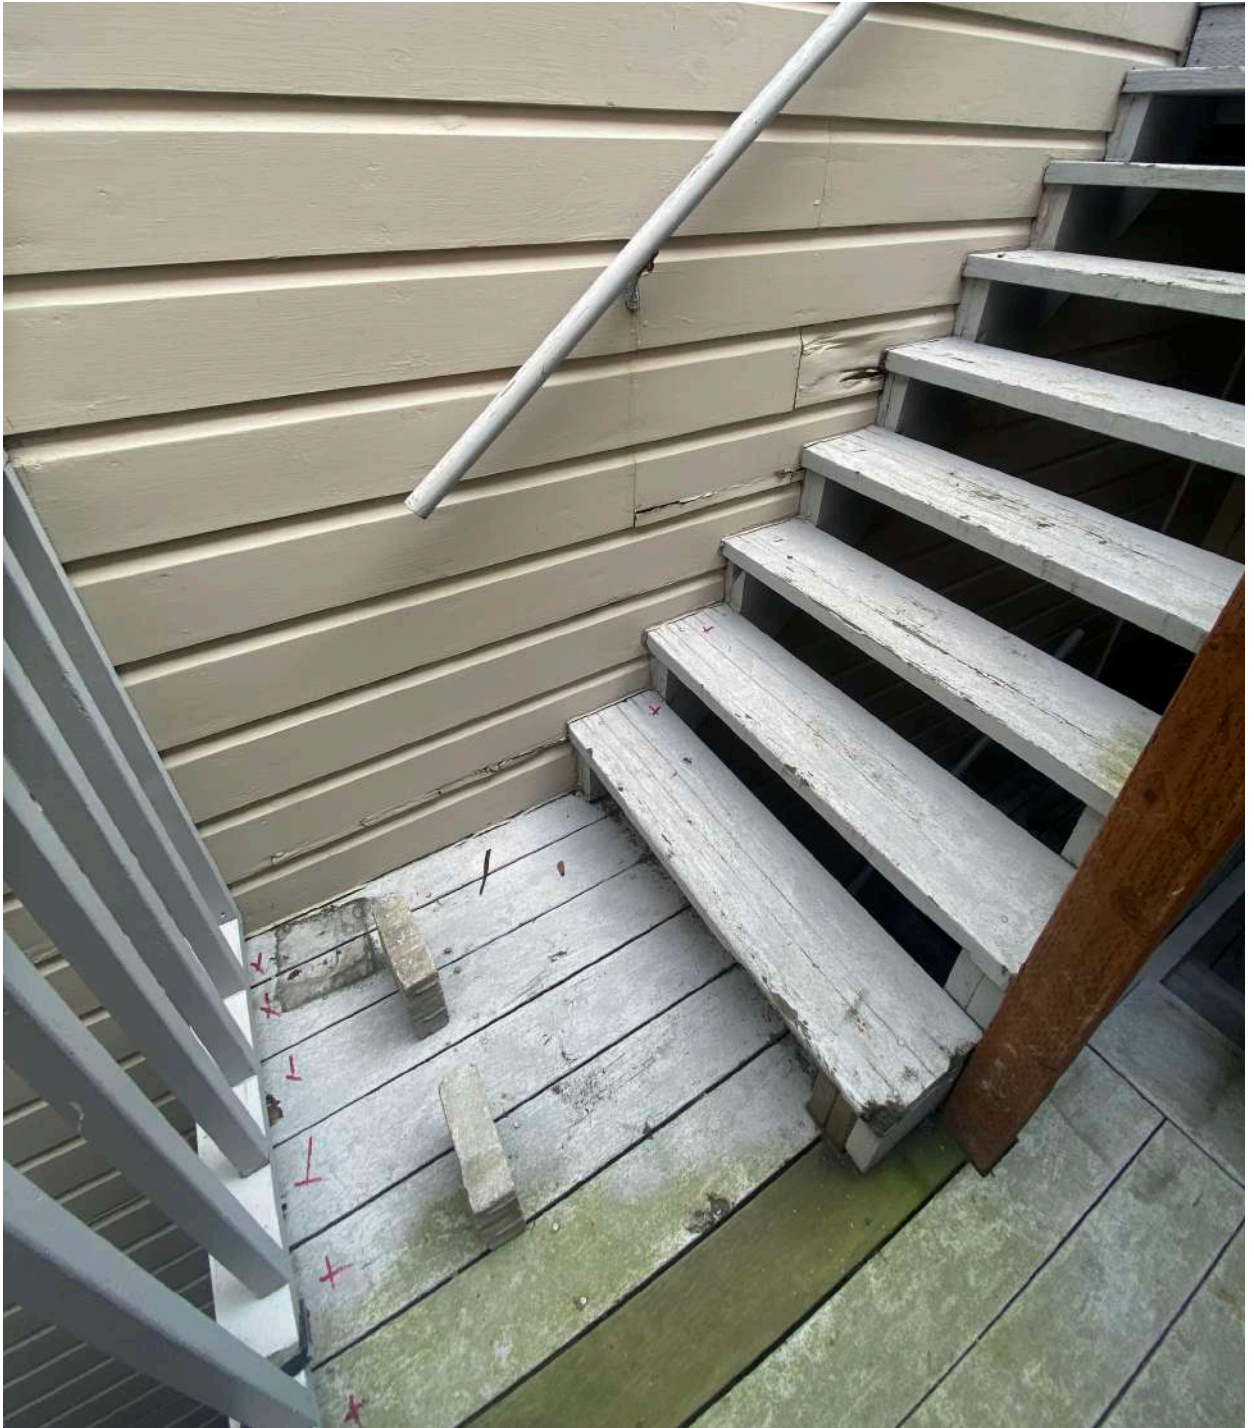
1331-1333 Church St Staircase is affixed to 1325-1327 Church St wall. Dry rot is found on 1325-1327 Church St Siding and 1331-1333 Church St Staircase.

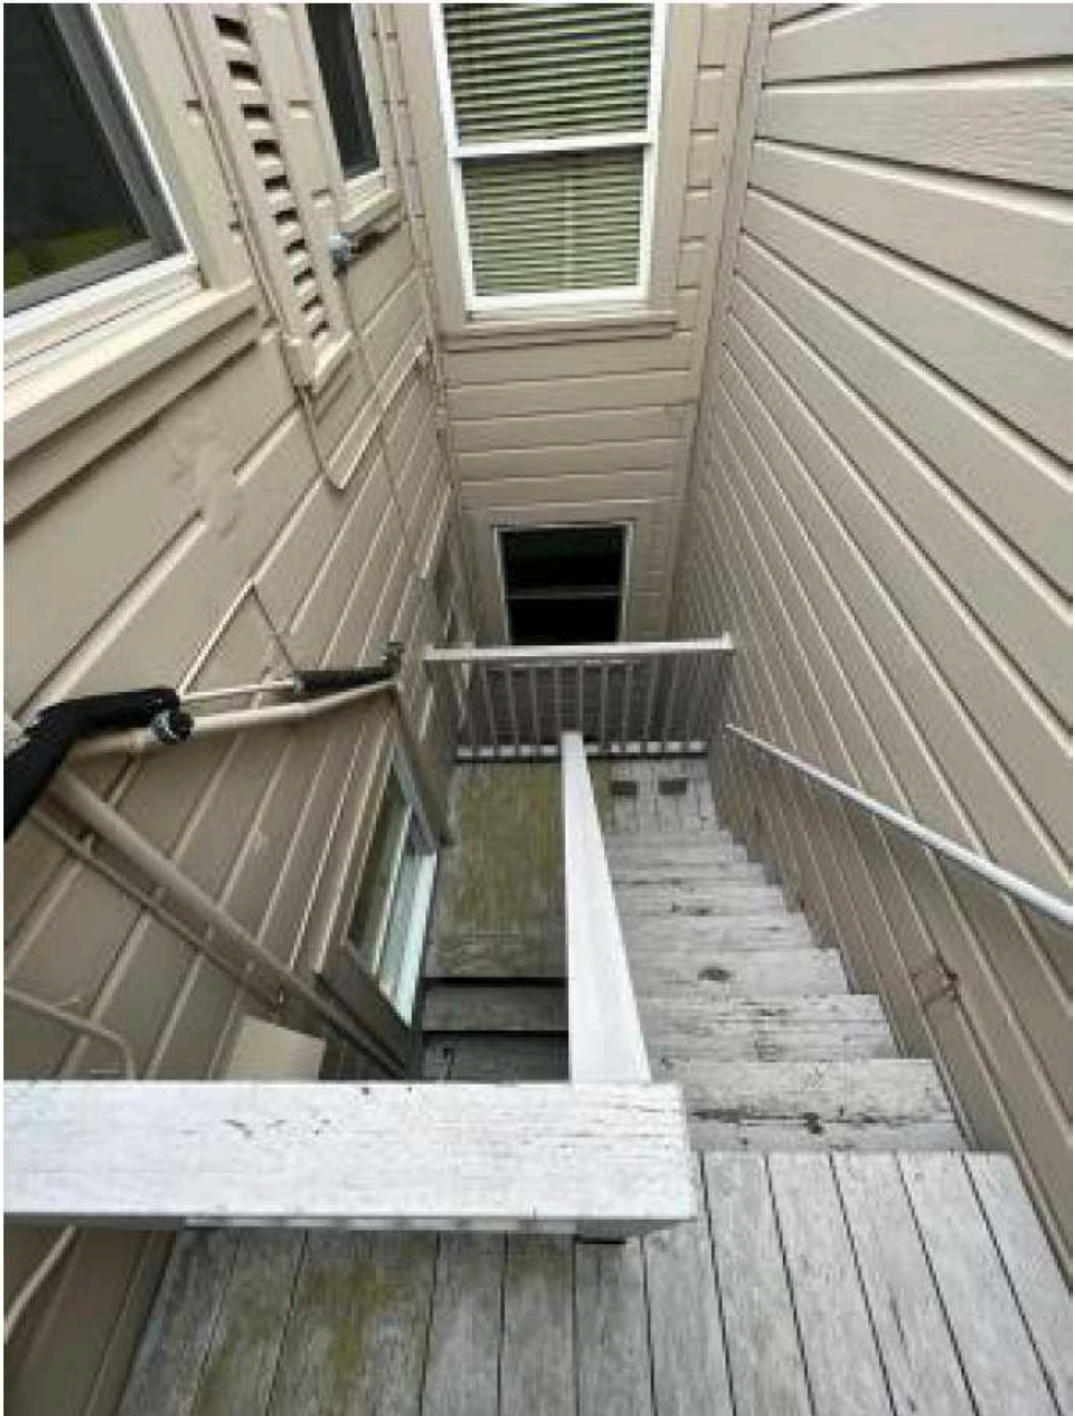
1331-1333 Church St staircase is affixed to 1325-1327 Church St and to 1331-1333 Church St walls on both sides of the lightwell.

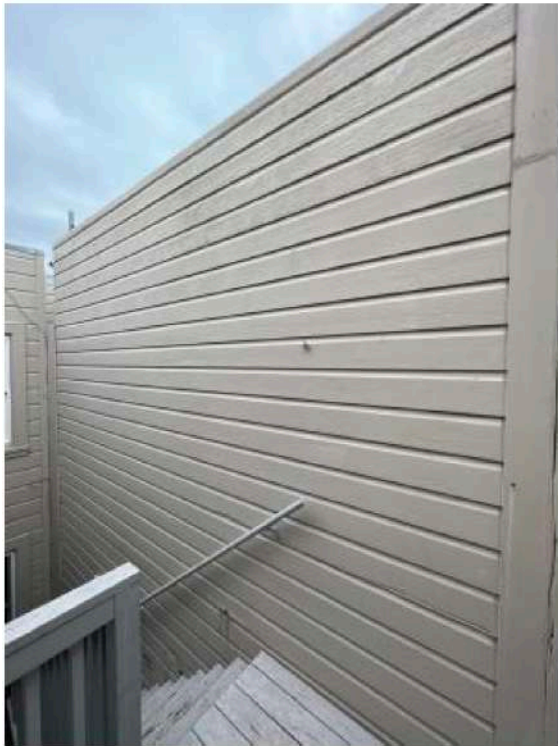
**Dwelling/Exterior/Stairwell - 18-
Overview**

Neighbor's siding - no obvious dry rot to the upper boards.

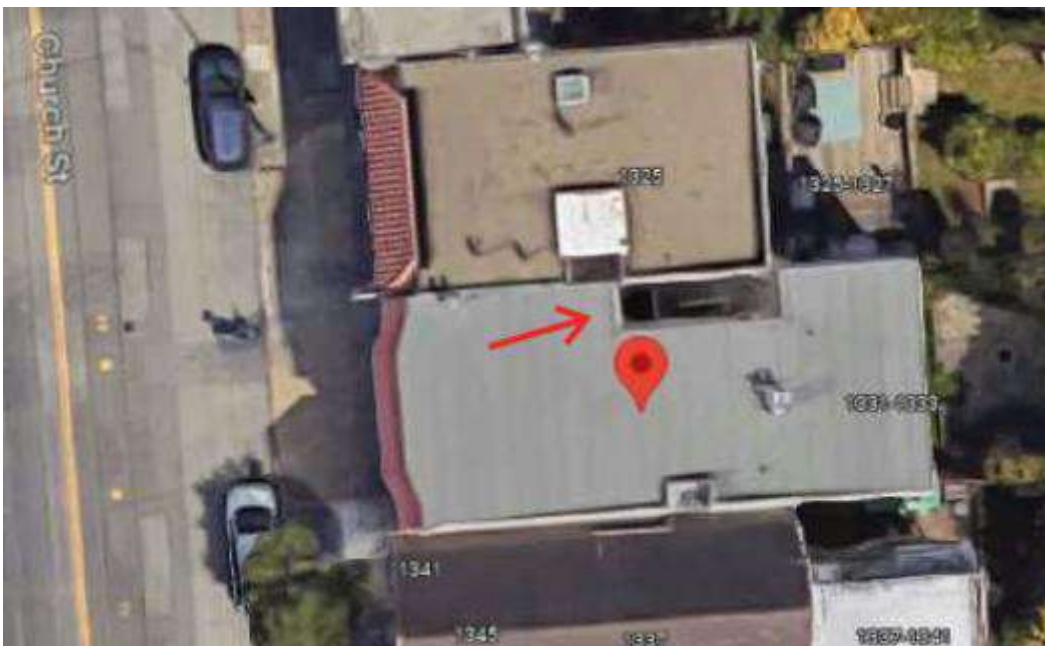
Dwelling/Risk - 2

1. Advanced dry rot to neighbor's siding in contact with Insured's stairs that has no dry rot or little dry rot.
2. Advanced dry rot on neighbor's siding where there is no contact with Insured's stairs.
3. Water damage to neighbor's siding from active interior leak.

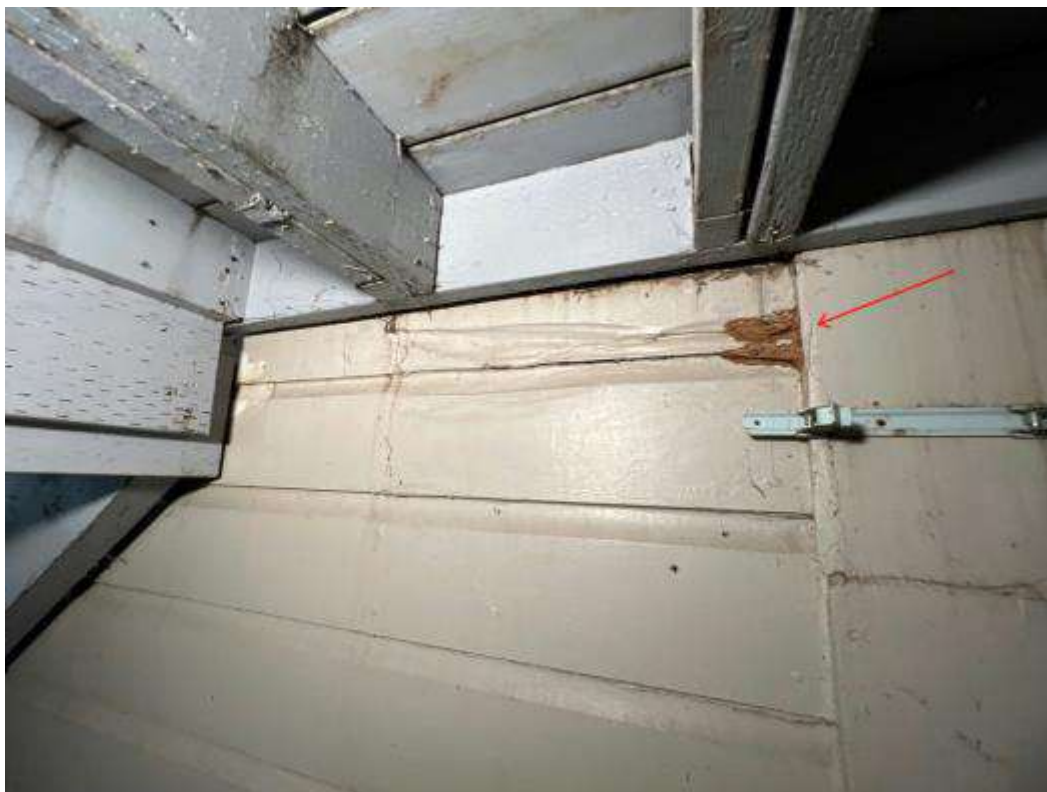
1325 Church St - 22

Note: the joist is pressure treated compared to most of the other stair's framing indicating it was probably replaced when the previous owner replaced the dry rotted section of stairs before selling the property to the Insured.

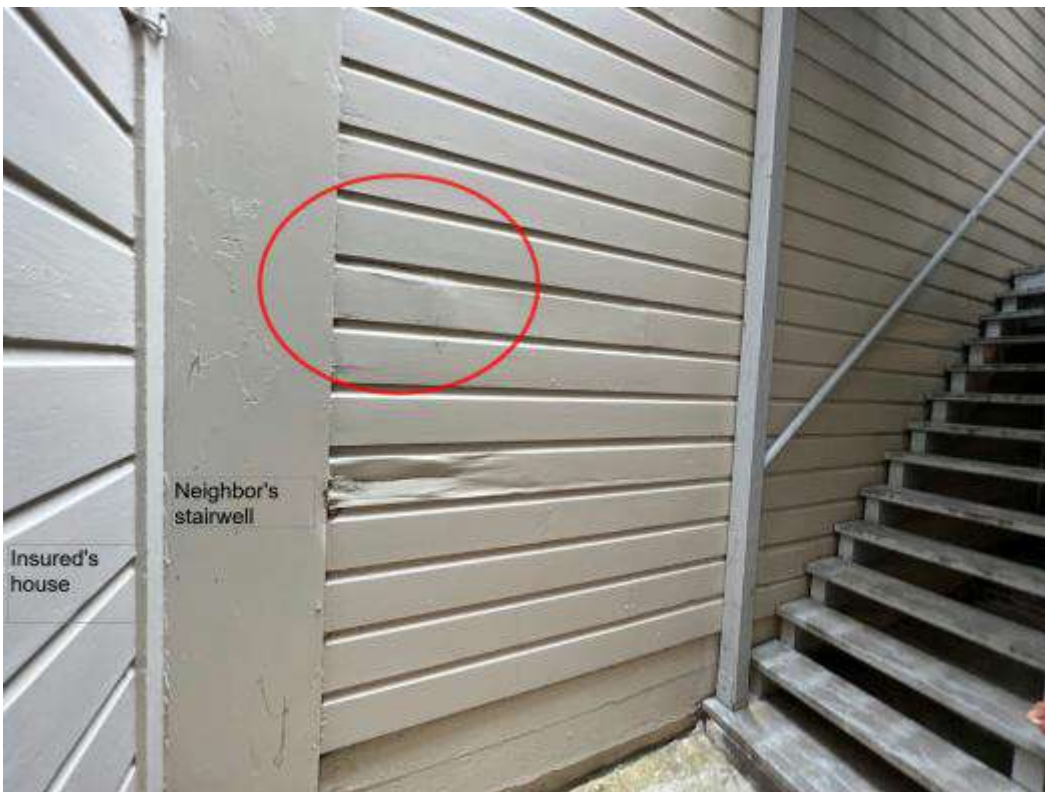
1325 Church St - 24

Dry rot on the neighbor's siding at least 3 feet from the Insured's stairs.

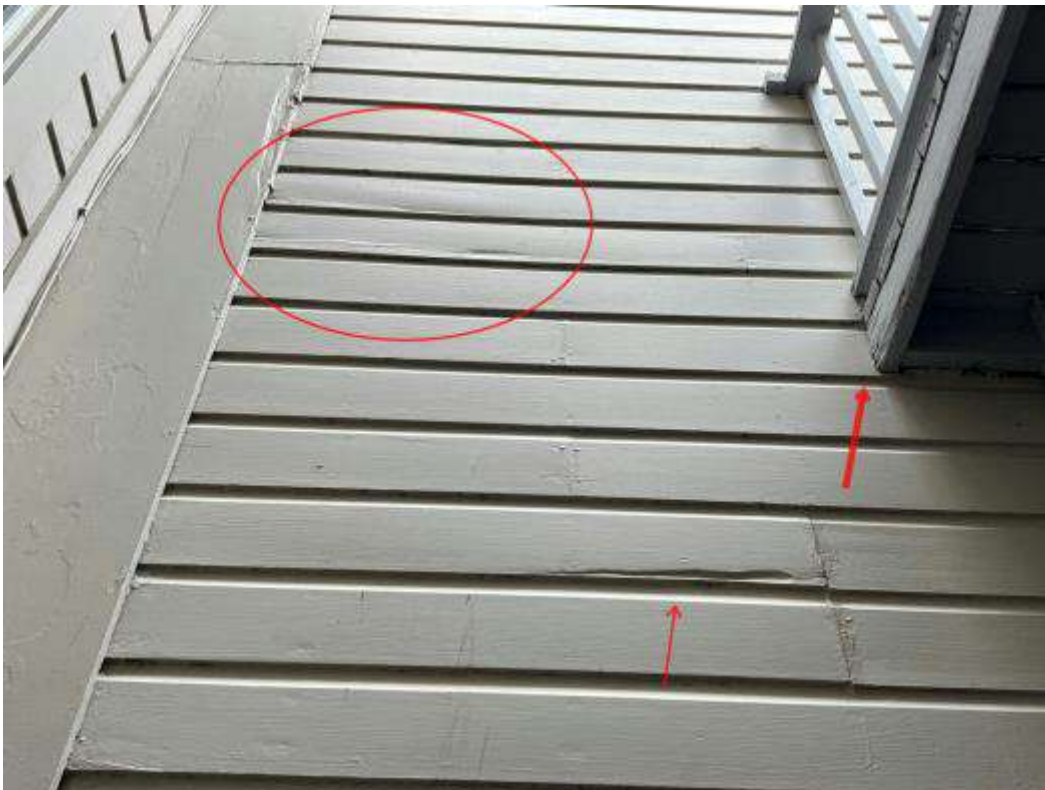
1325 Church St - 26

Dry rot on the neighbor's siding at least 2 feet away from the Insured's stairs.

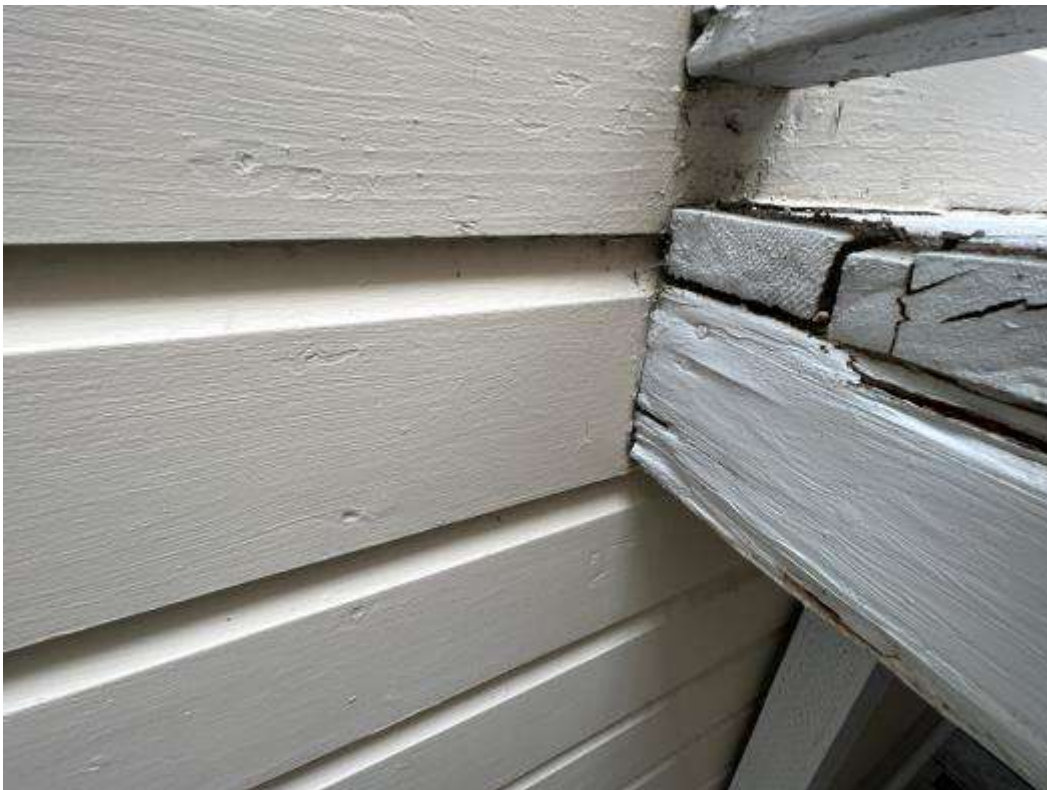
1325 Church St - 28

Dry rot to 2x6 joist for 2nd landing but no dry rot to neighbor's siding.

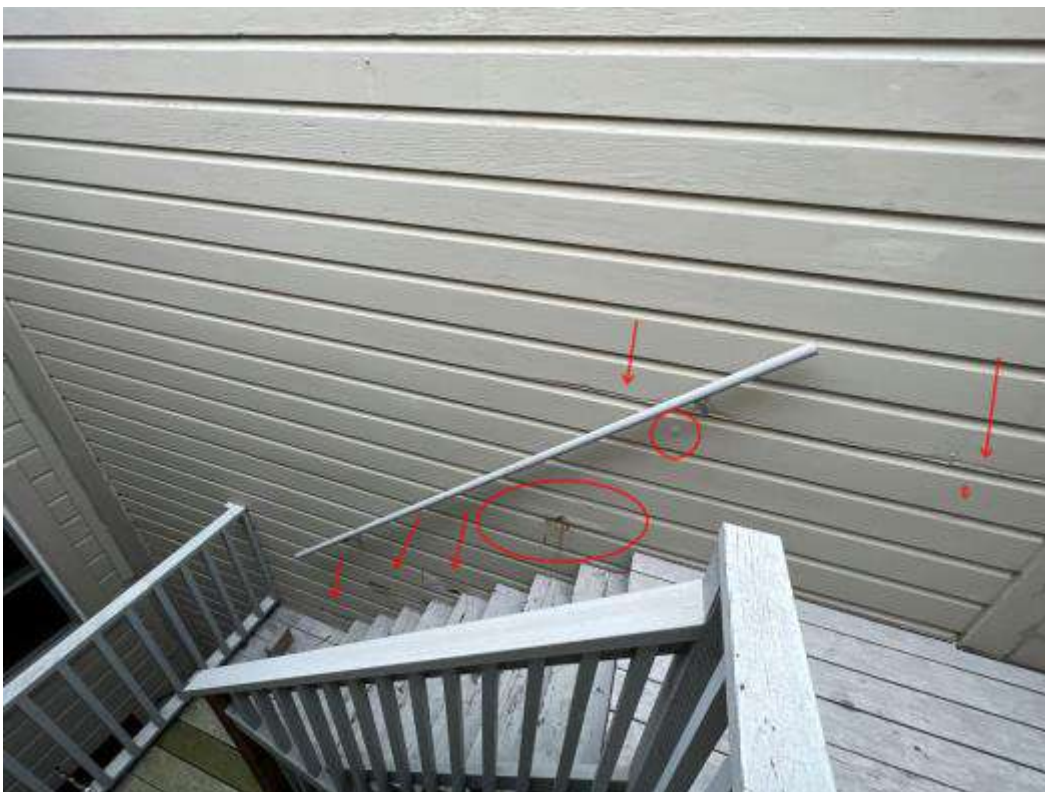
1325 Church St - 30

Relatively advanced dry rot on the neighbor's siding next to the treads of the stairs between the 2nd and 3rd landing with little, if any, dry rot to the butt end of the treads and stringer where they contact the neighbor's siding.

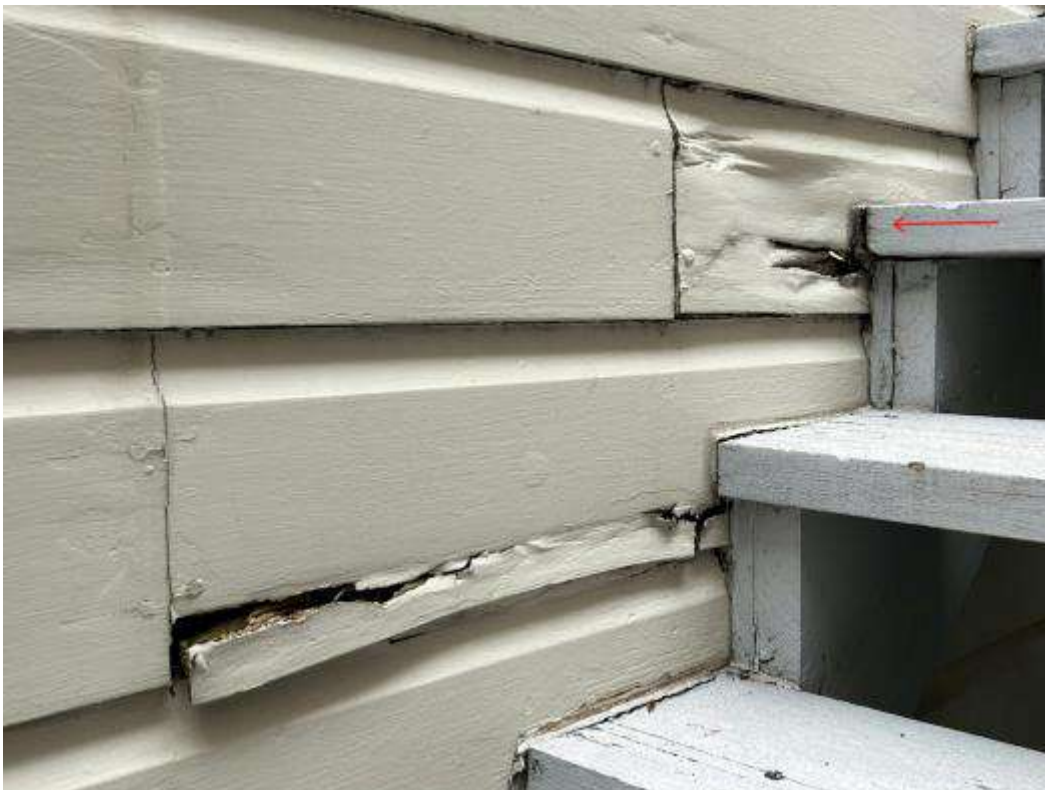
1325 Church St - 32

Relatively advanced dry rot on the neighbor's siding with little, if any, dry rot to the butt end of the treads.

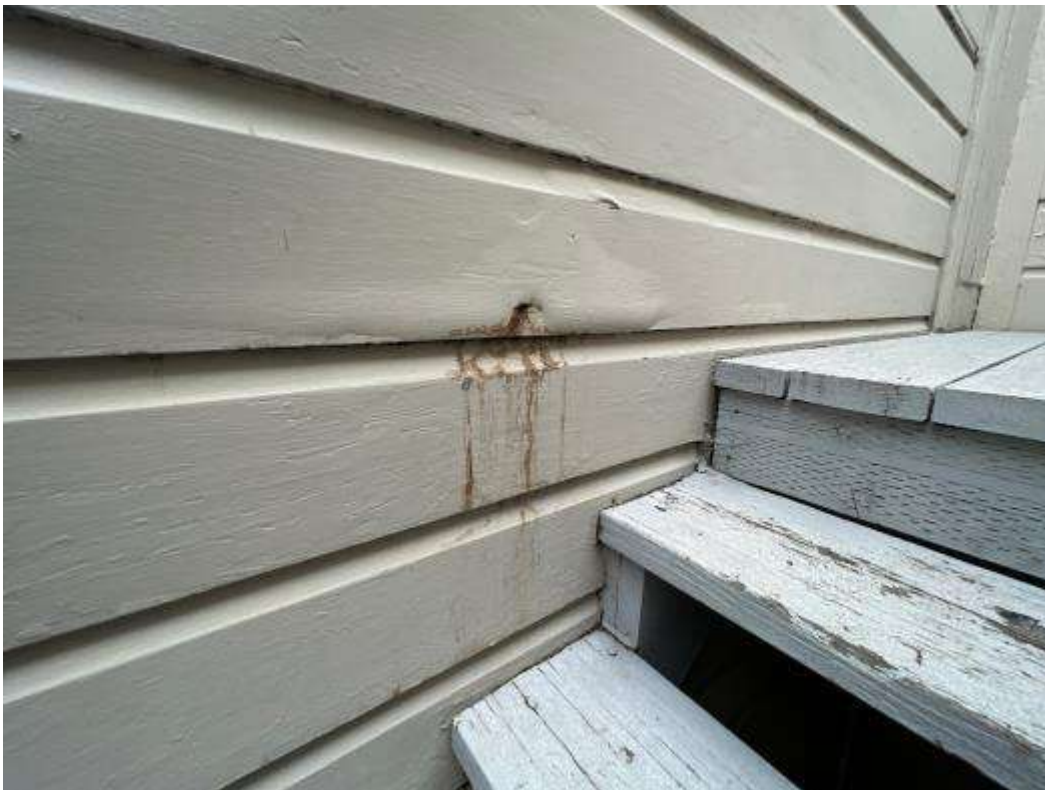
1325 Church St - 34

Water damage to neighbor's siding from interior leak.

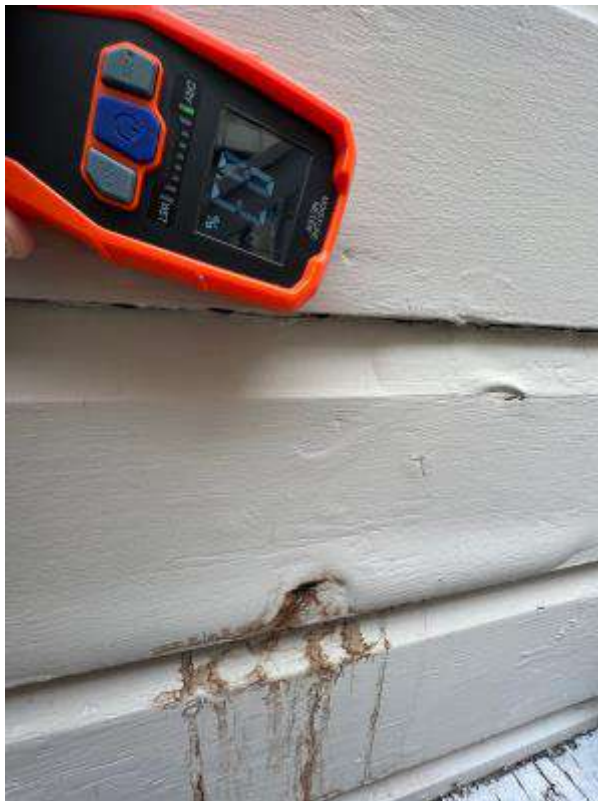
1325 Church St - 36

Wood is wet. Moisture reading is over limits.

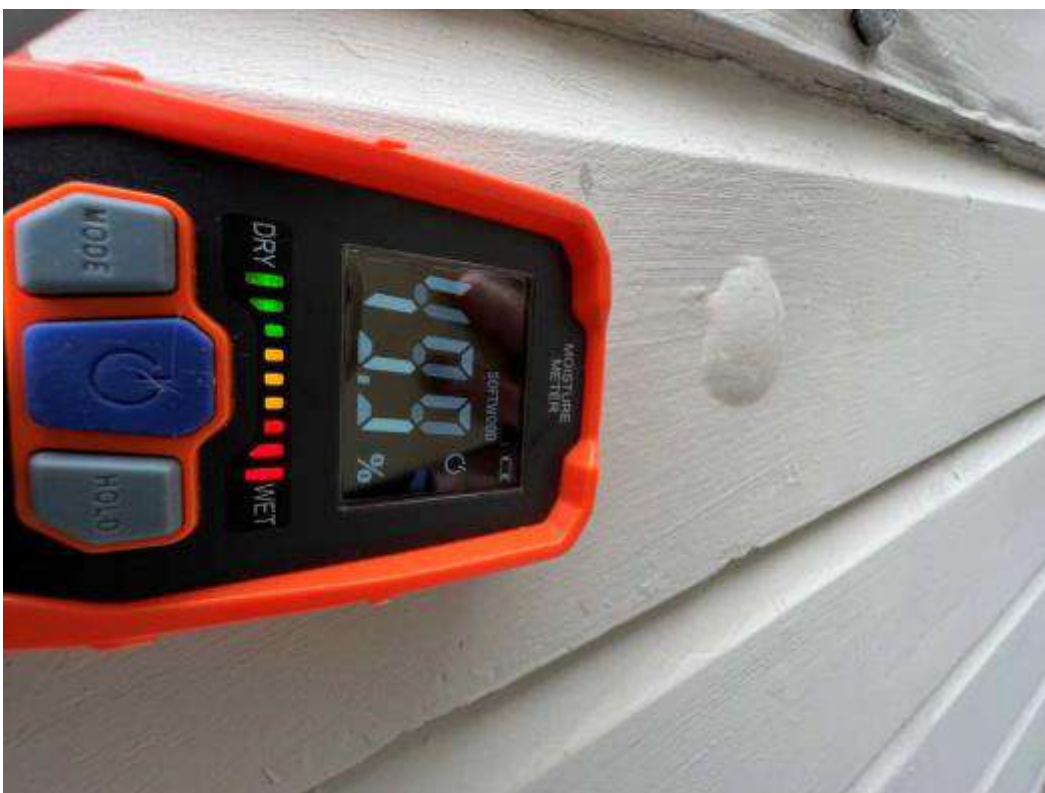
1325 Church St - 42

Areas circled in red had high moisture readings. The rest of the area in the photo was dry.

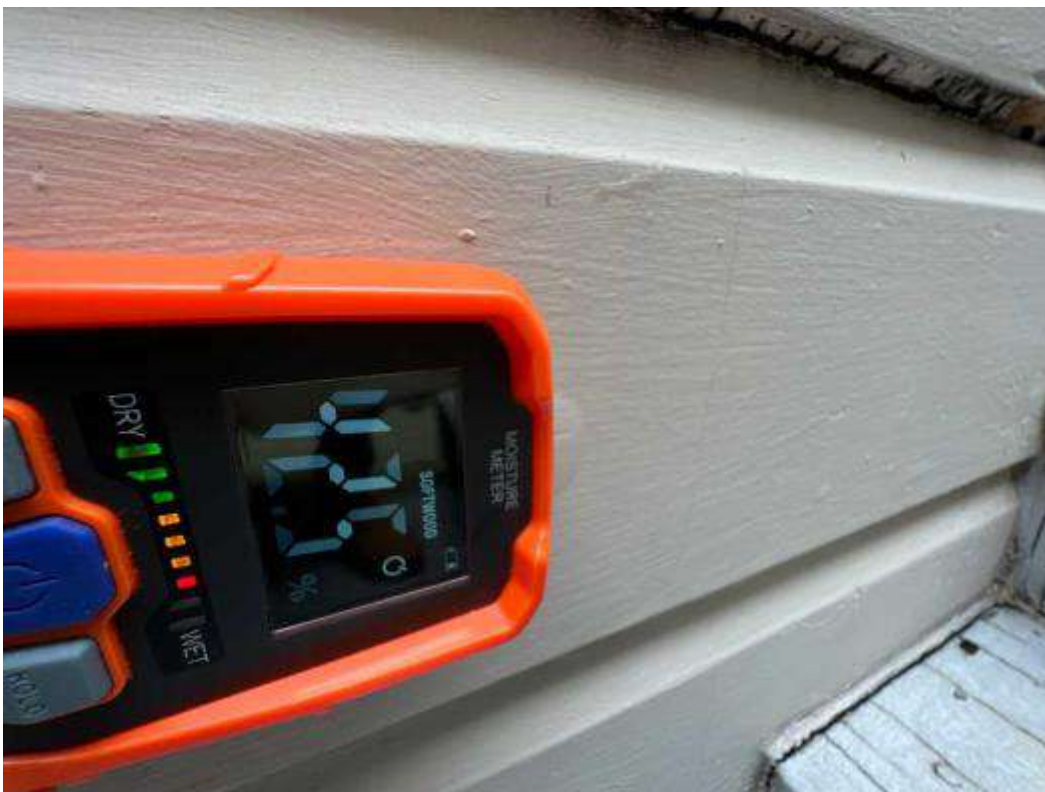
1325 Church St - 44

Wood is wet just below the advanced dry rot but dry in the rest of the photo.
