BOARD OF APPEALS, CITY & COUNTY OF SAN FRANCISCO

Appeal No. **23-046**

NOTICE OF APPEAL

PRELIMINARY STATEMENT FOR APPEAL NO. 23-046

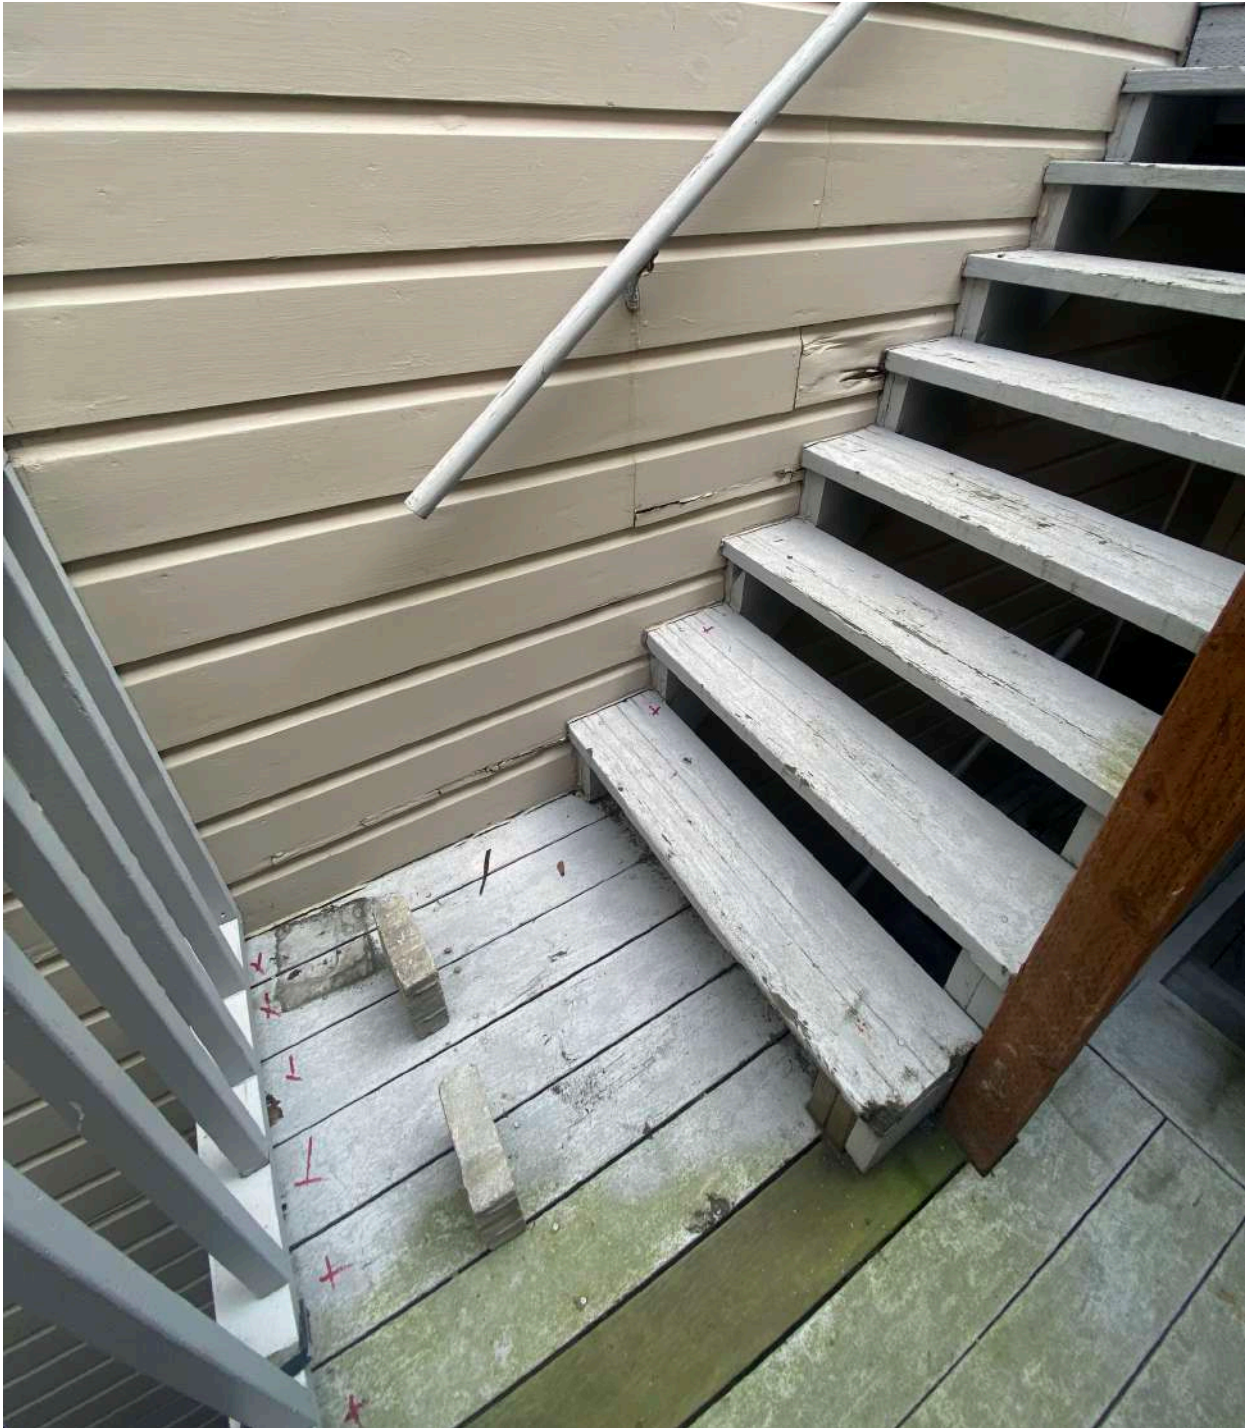
1331-1333 Church St Staircase is affixed to 1325-1327 Church St wall. Dry rot is found on 1325-1327 Church St Siding and 1331-1333 Church St Staircase.

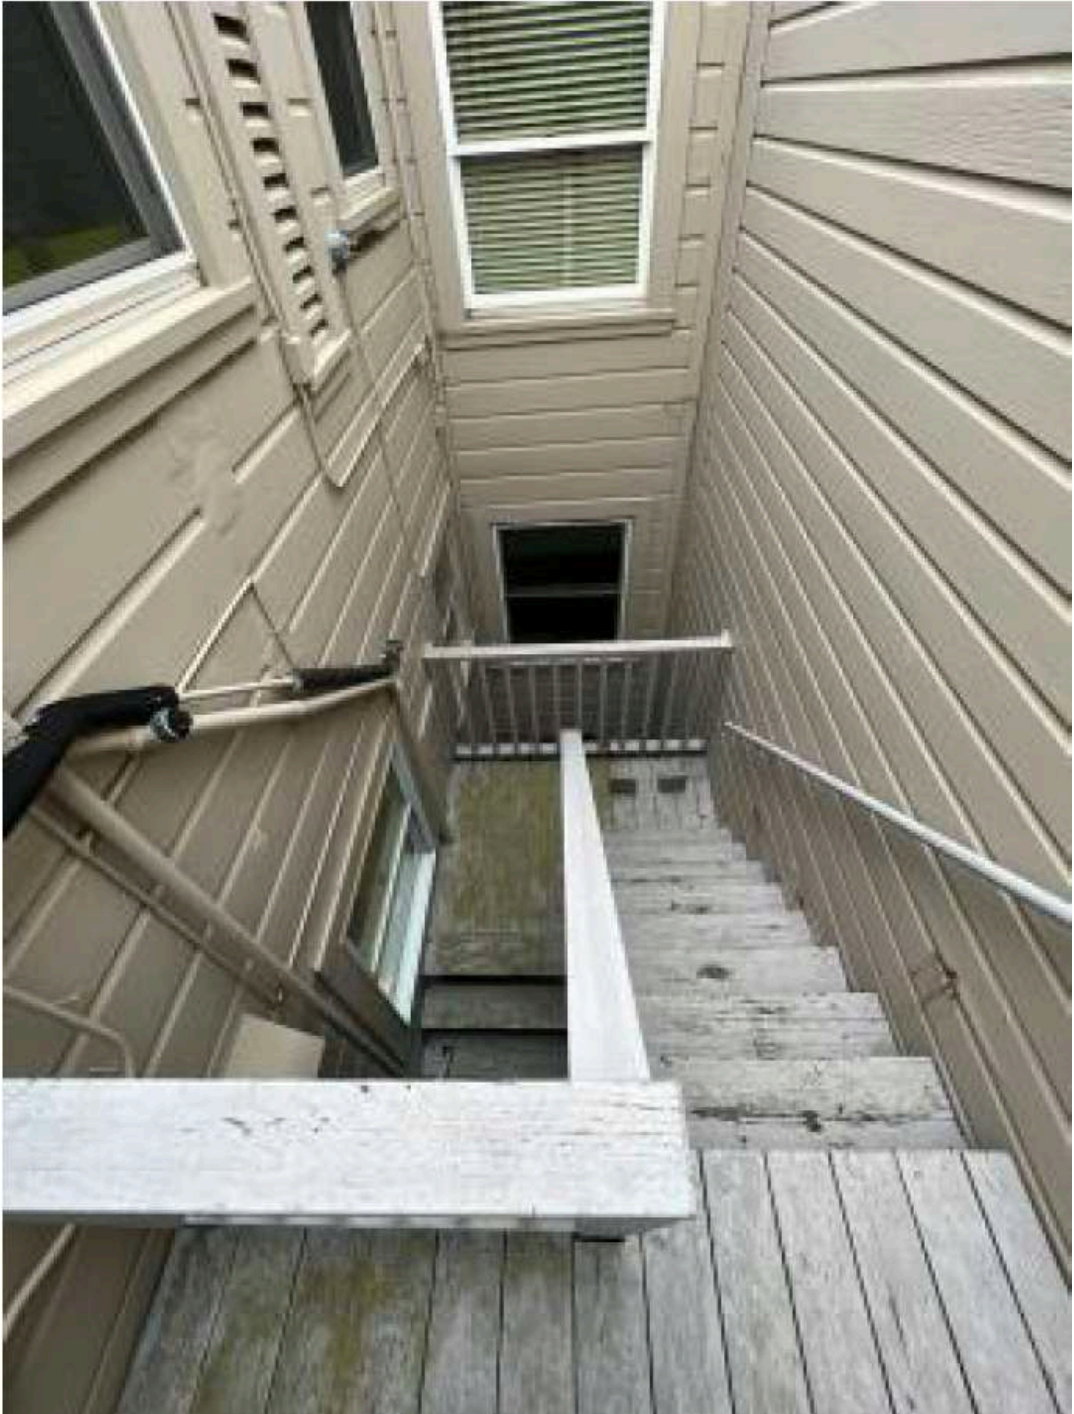
1331-1333 Church St staircase is affixed to 1325-1327 Church St and to 1331-1333 Church St walls on both sides of the lightwell.

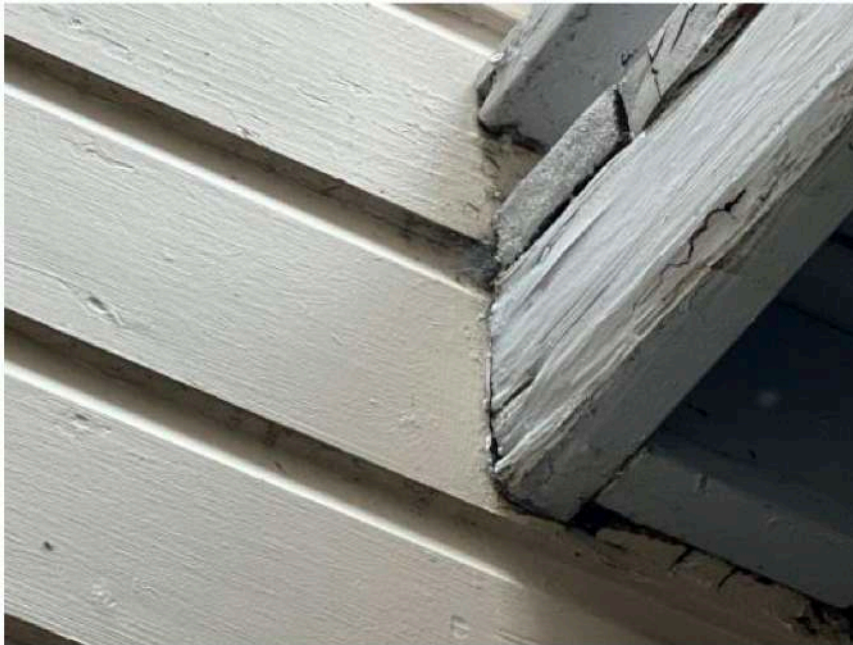
1325 Church St - 29

Dry rot to 2x6 joist for 2nd landing but
no dry rot to neighbor's siding.

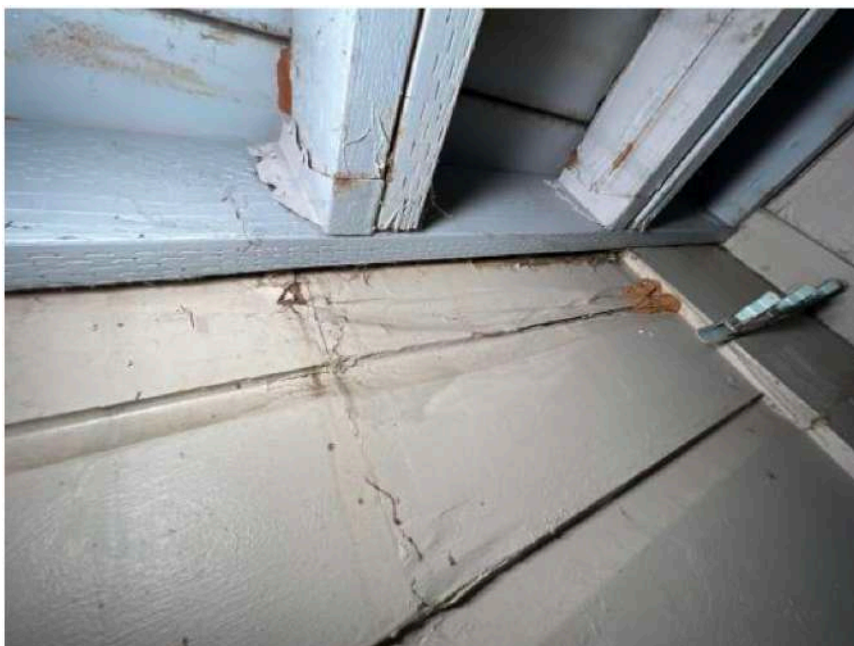
1325 Church St - 23

Dry rot and signs of termites on neighbor's siding.

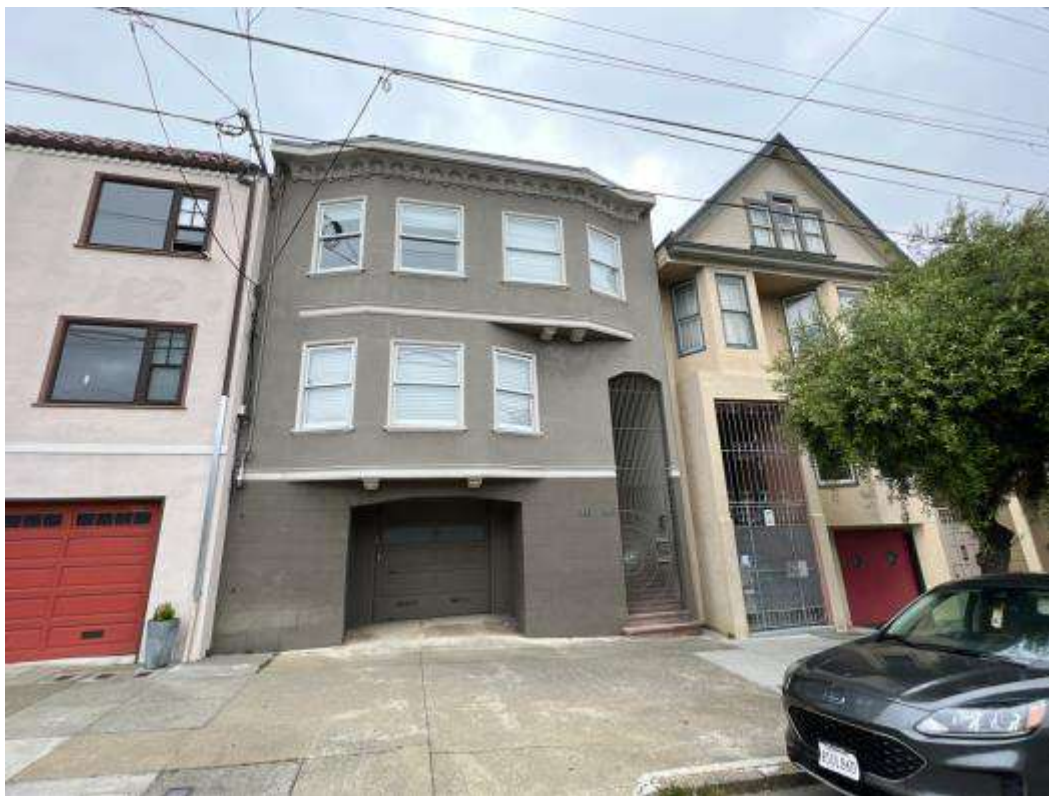
Dwelling/Risk - 1

1. Advanced dry rot to neighbor's siding in contact with Insured's stairs that has no dry rot or little dry rot.
2. Advanced dry rot on neighbor's siding where there is no contact with Insured's stairs.
3. Water damage to neighbor's siding from active interior leak.

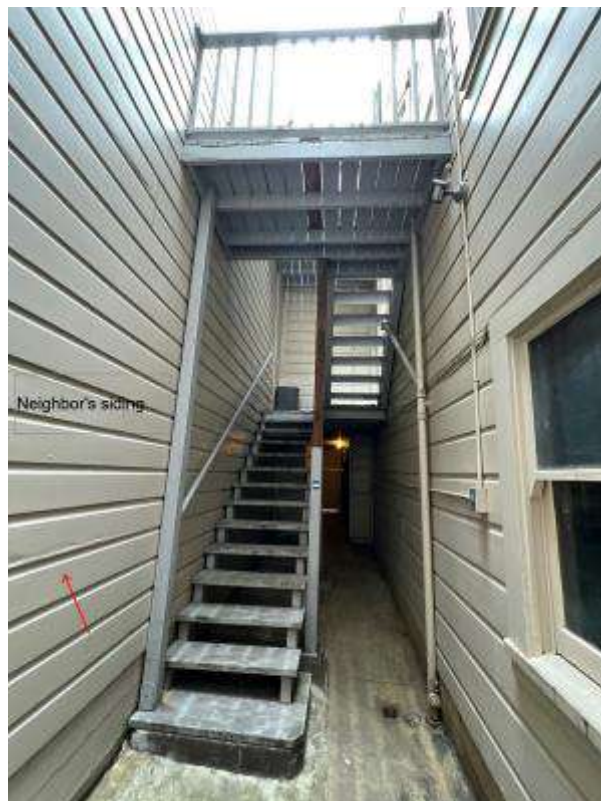
Dwelling/Exterior/Stairwell - 6-Overview

Dry rot on neighbor's siding.

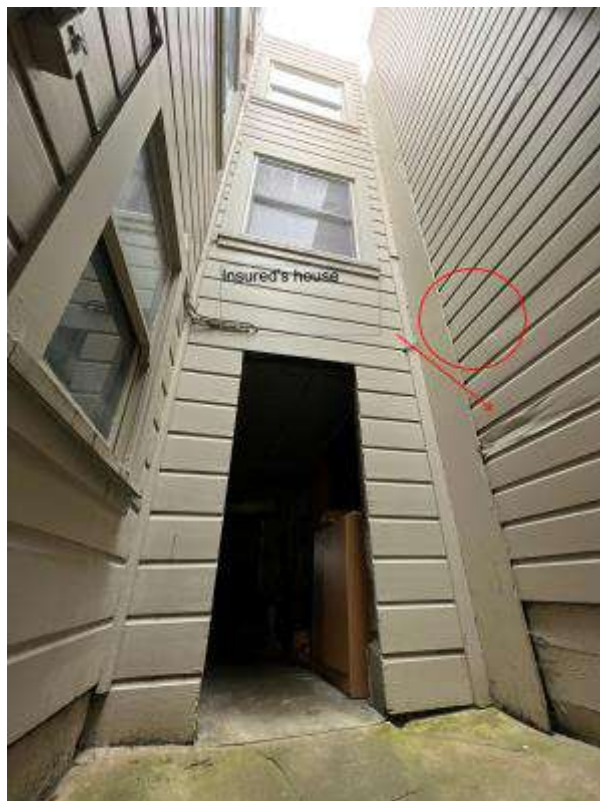
Dwelling/Exterior/Stairwell - 8- Overview

Neighbor's siding in left of photo.
No dry rot on Insured's siding.

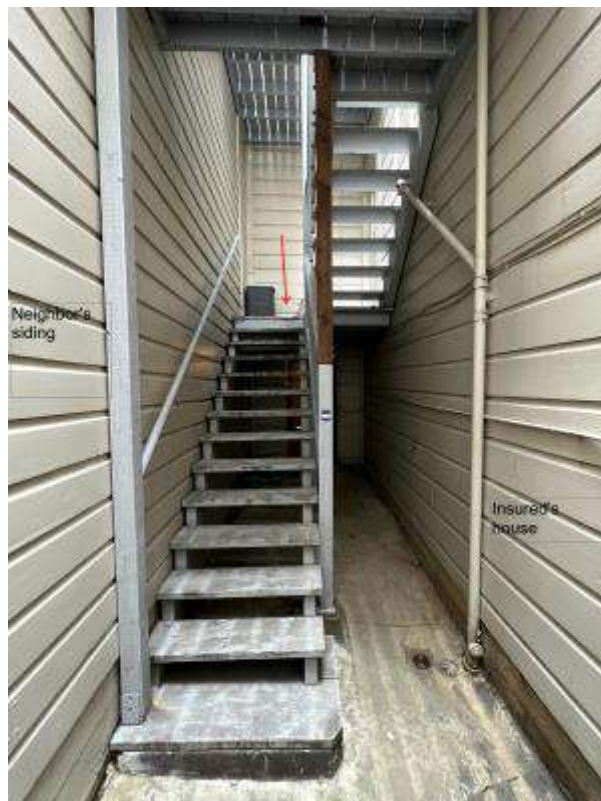
Dwelling/Exterior/Stairwell - 10- Overview

Dry rot on Insured's 1st landing.

No dry rot on neighbor's siding.

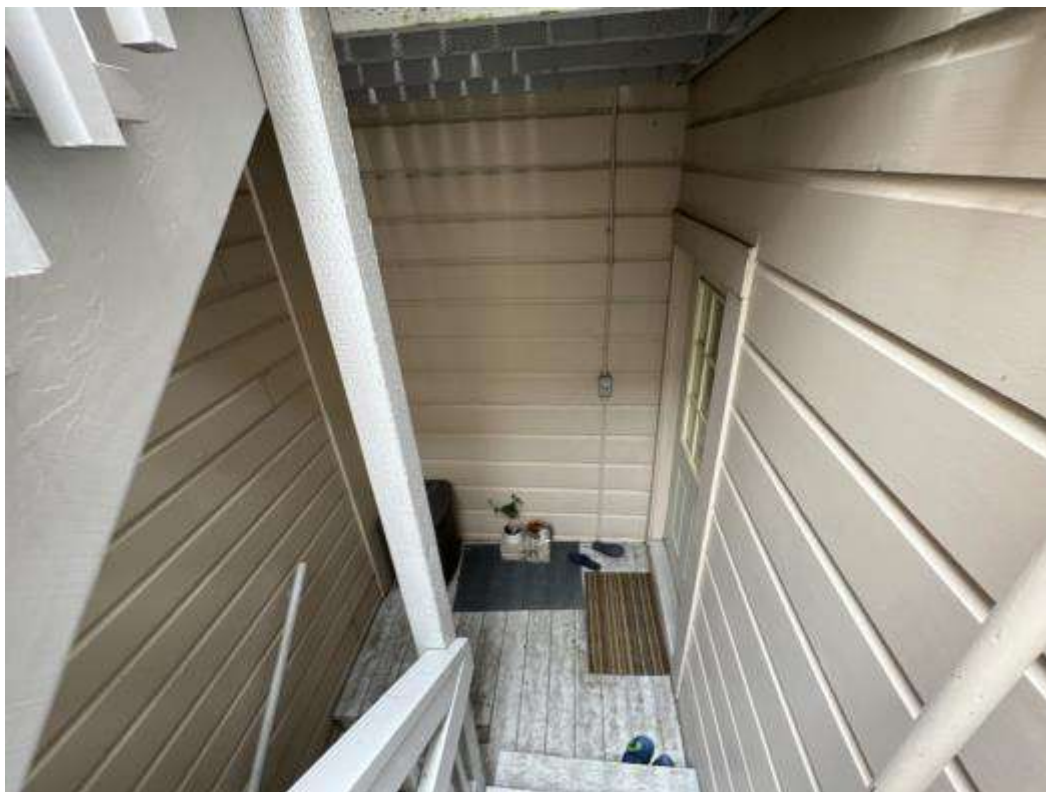
Dwelling/Exterior/Stairwell - 12- Overview

Overview of 2nd landing.

Arrow points to dry rot on neighbor's siding in next photo.

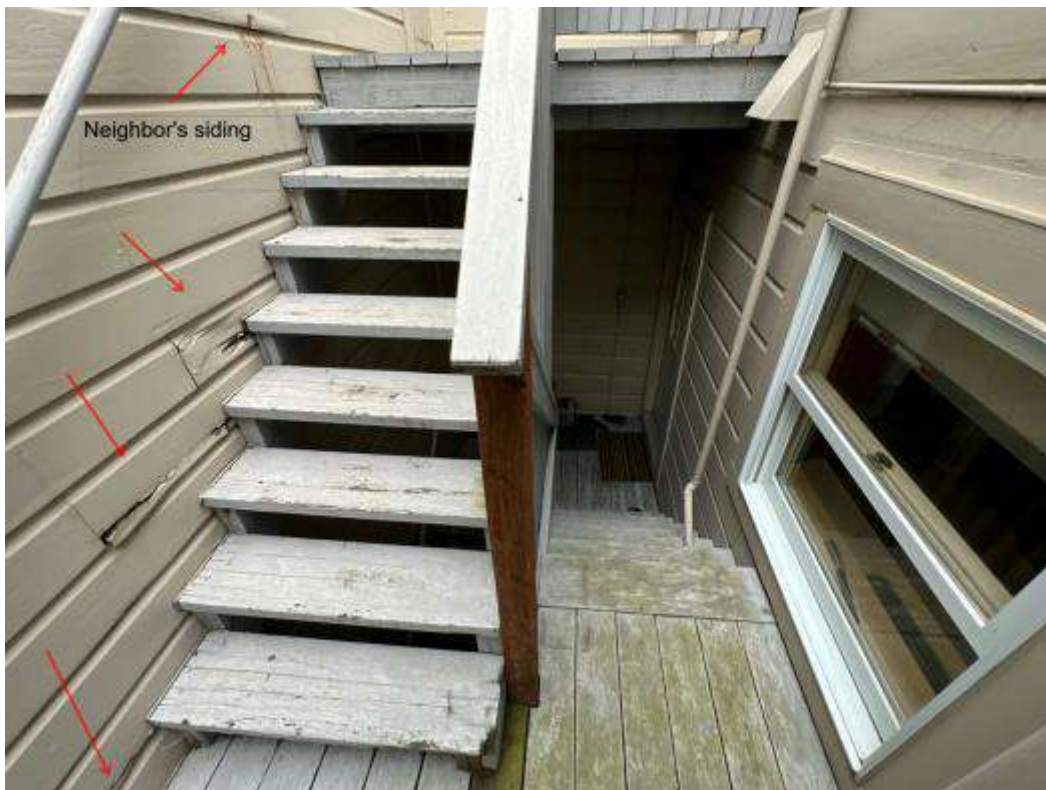
Dwelling/Exterior/Stairwell - 14- Overview

Water damage to neighbor's siding
circled in red.

Arrows point to dry rot.

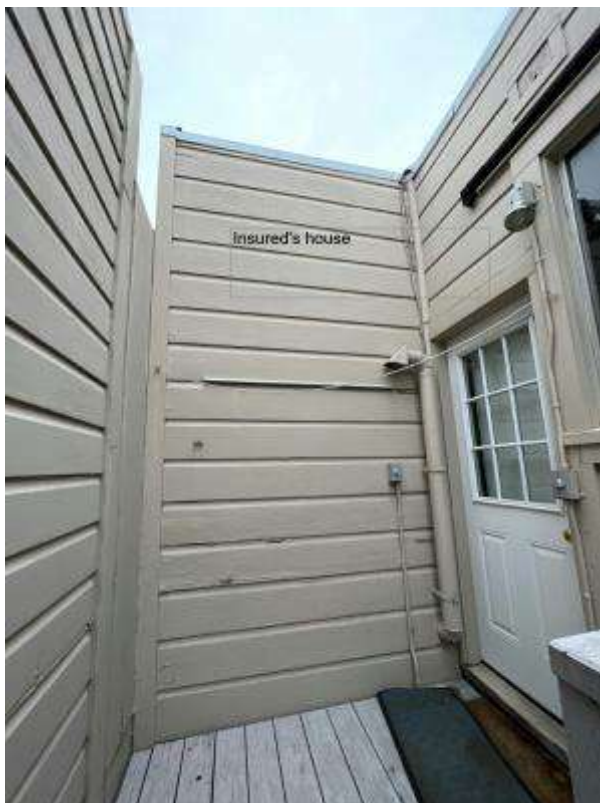
Dwelling/Exterior/Stairwell - 16- Overview

Insured's house - no damage - no dry rot.

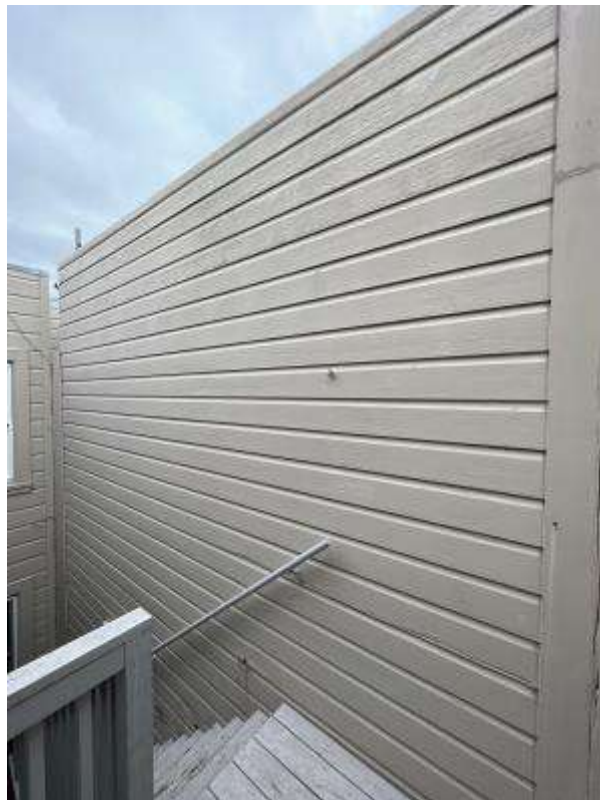
Dwelling/Exterior/Stairwell - 18- Overview

Dry rot and termites (arrow) on neighbor's siding.

No visible dry rot on the 2x6 joist for Insured's 1st landing.

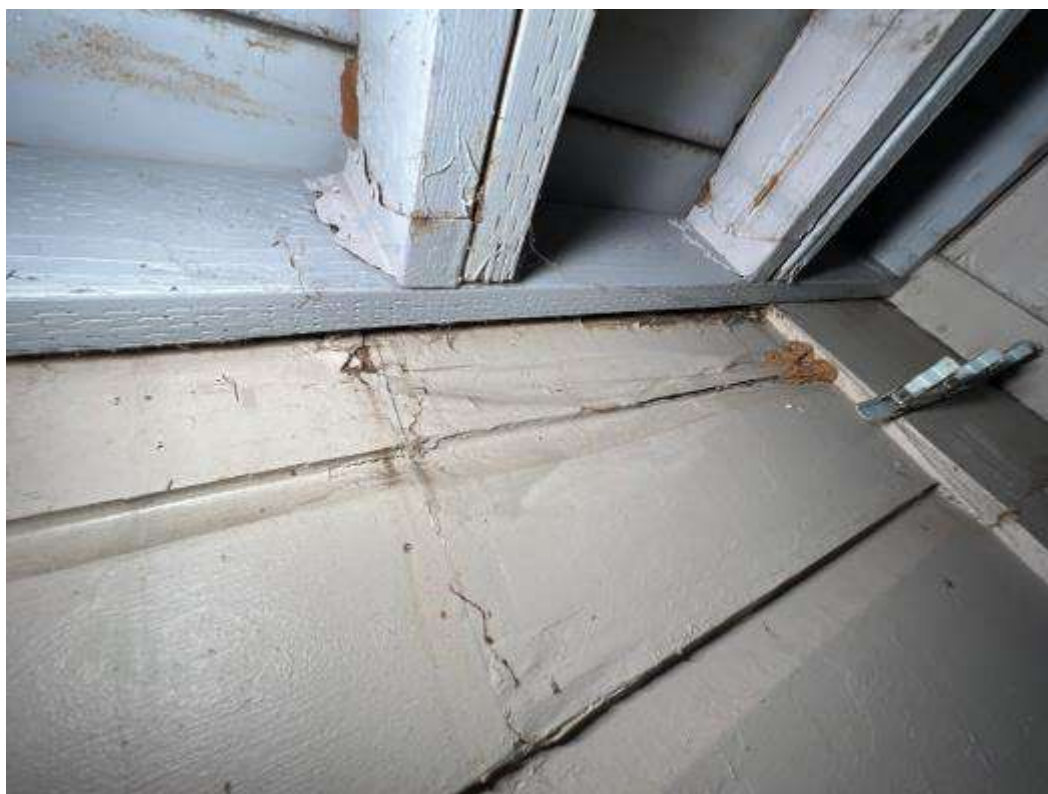
1325 Church St - 23

No visible dry rot on 2x6 joist for Insured's 1st landing.

Note: the joist is pressure treated compared to most of the other stair's framing indicating it was probably replaced when the previous owner replaced the dry rotted section of stairs before selling the property to the Insured.

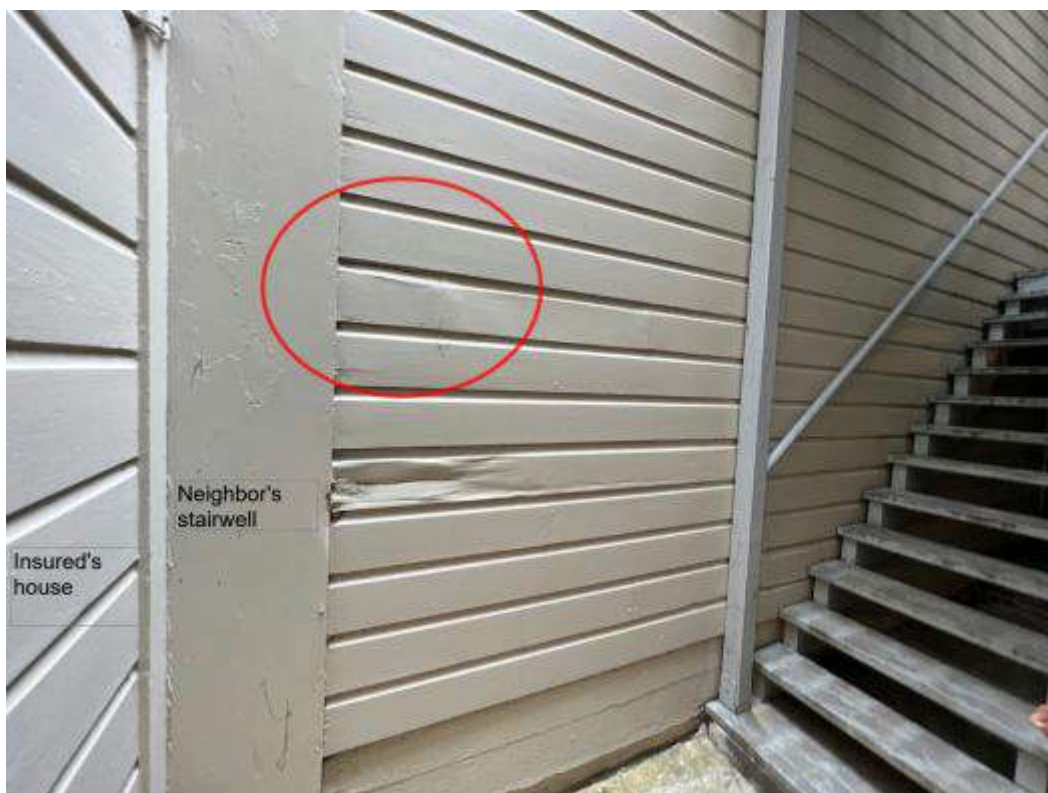
1325 Church St - 24

Dry rot on the neighbor's siding at least 3 feet from the Insured's stairs.

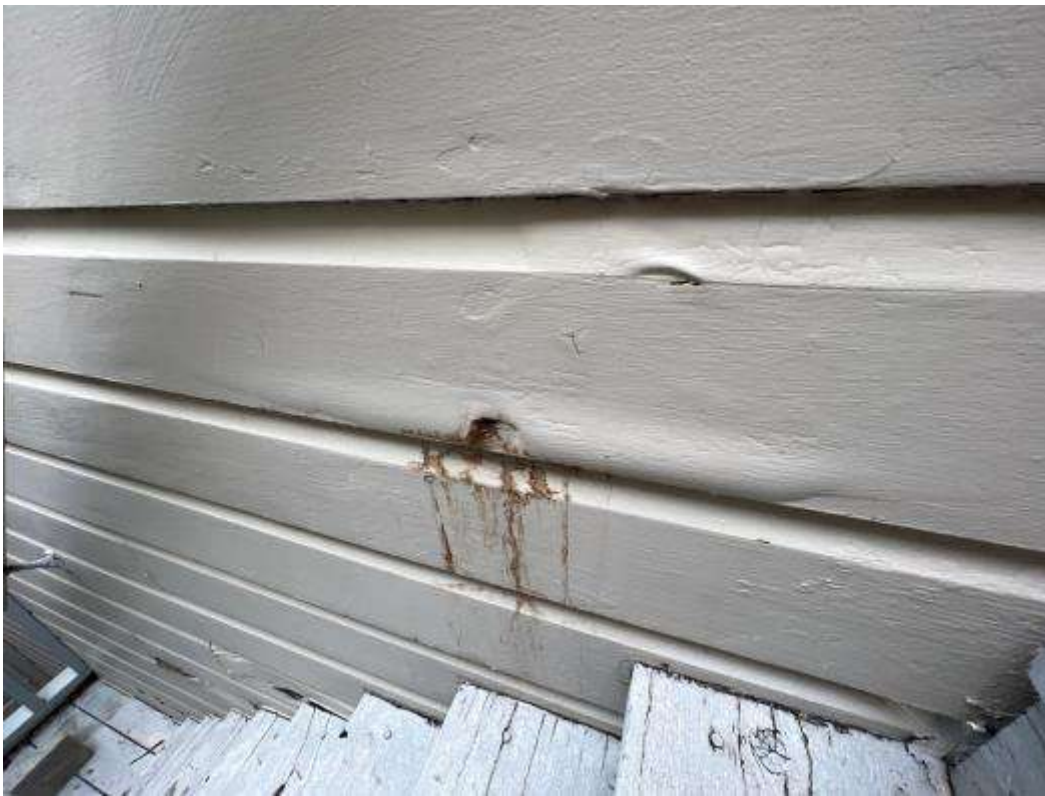
1325 Church St - 35

Water damage to neighbor's siding from interior leak.

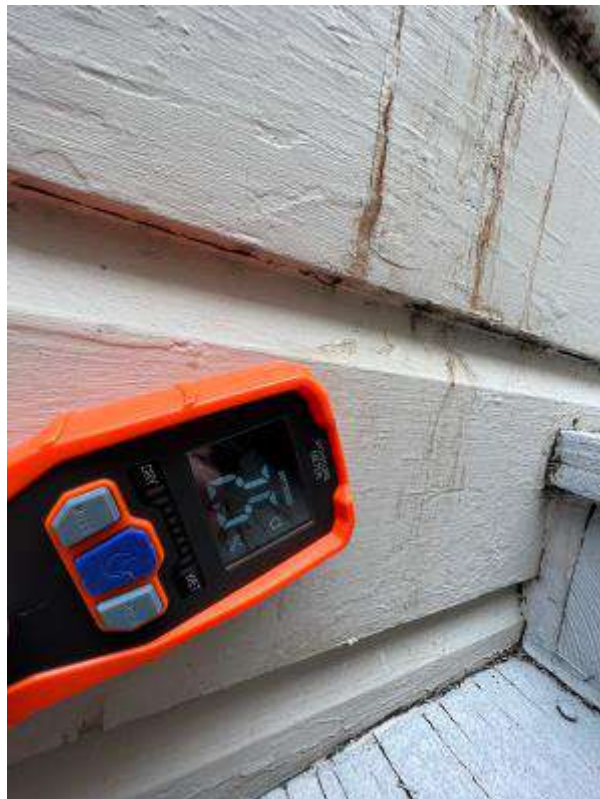
1325 Church St - 38

Arrow points to the bottom of the board above bubble, which has several feet of what appears to be old dry rot that was painted over at some point.

It appears the hardware was detached before the board was painted.

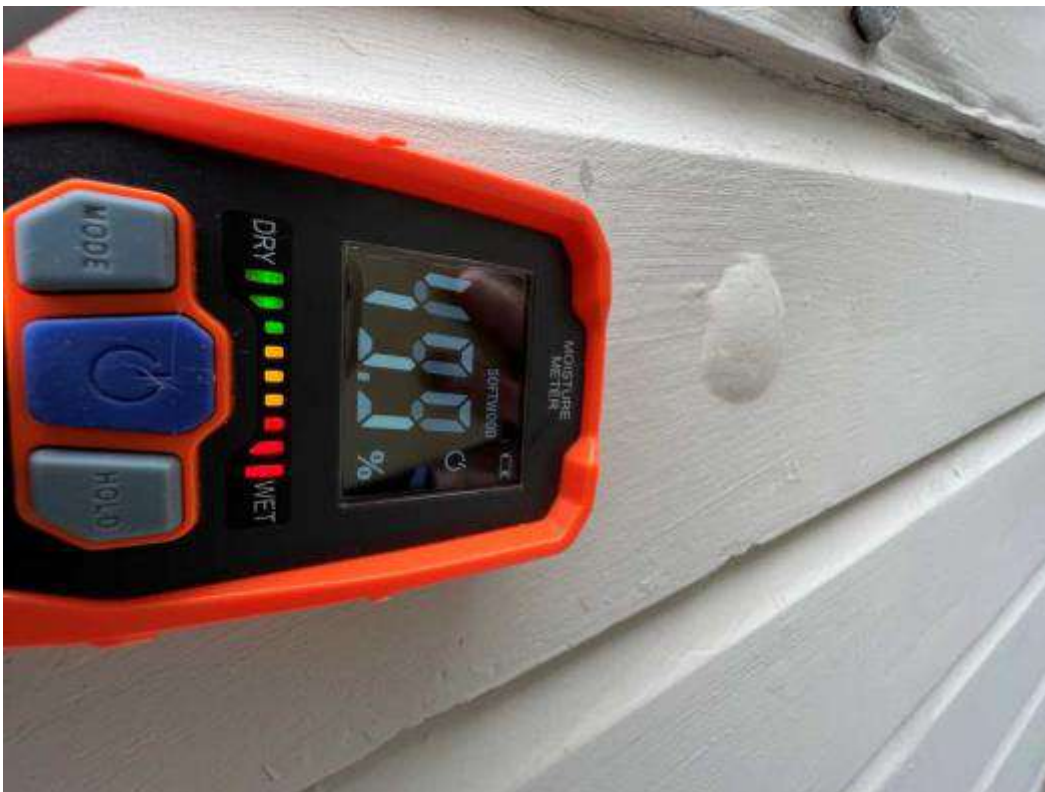
1325 Church St - 42

Areas circled in red had high moisture readings. The rest of the area in the photo was dry.

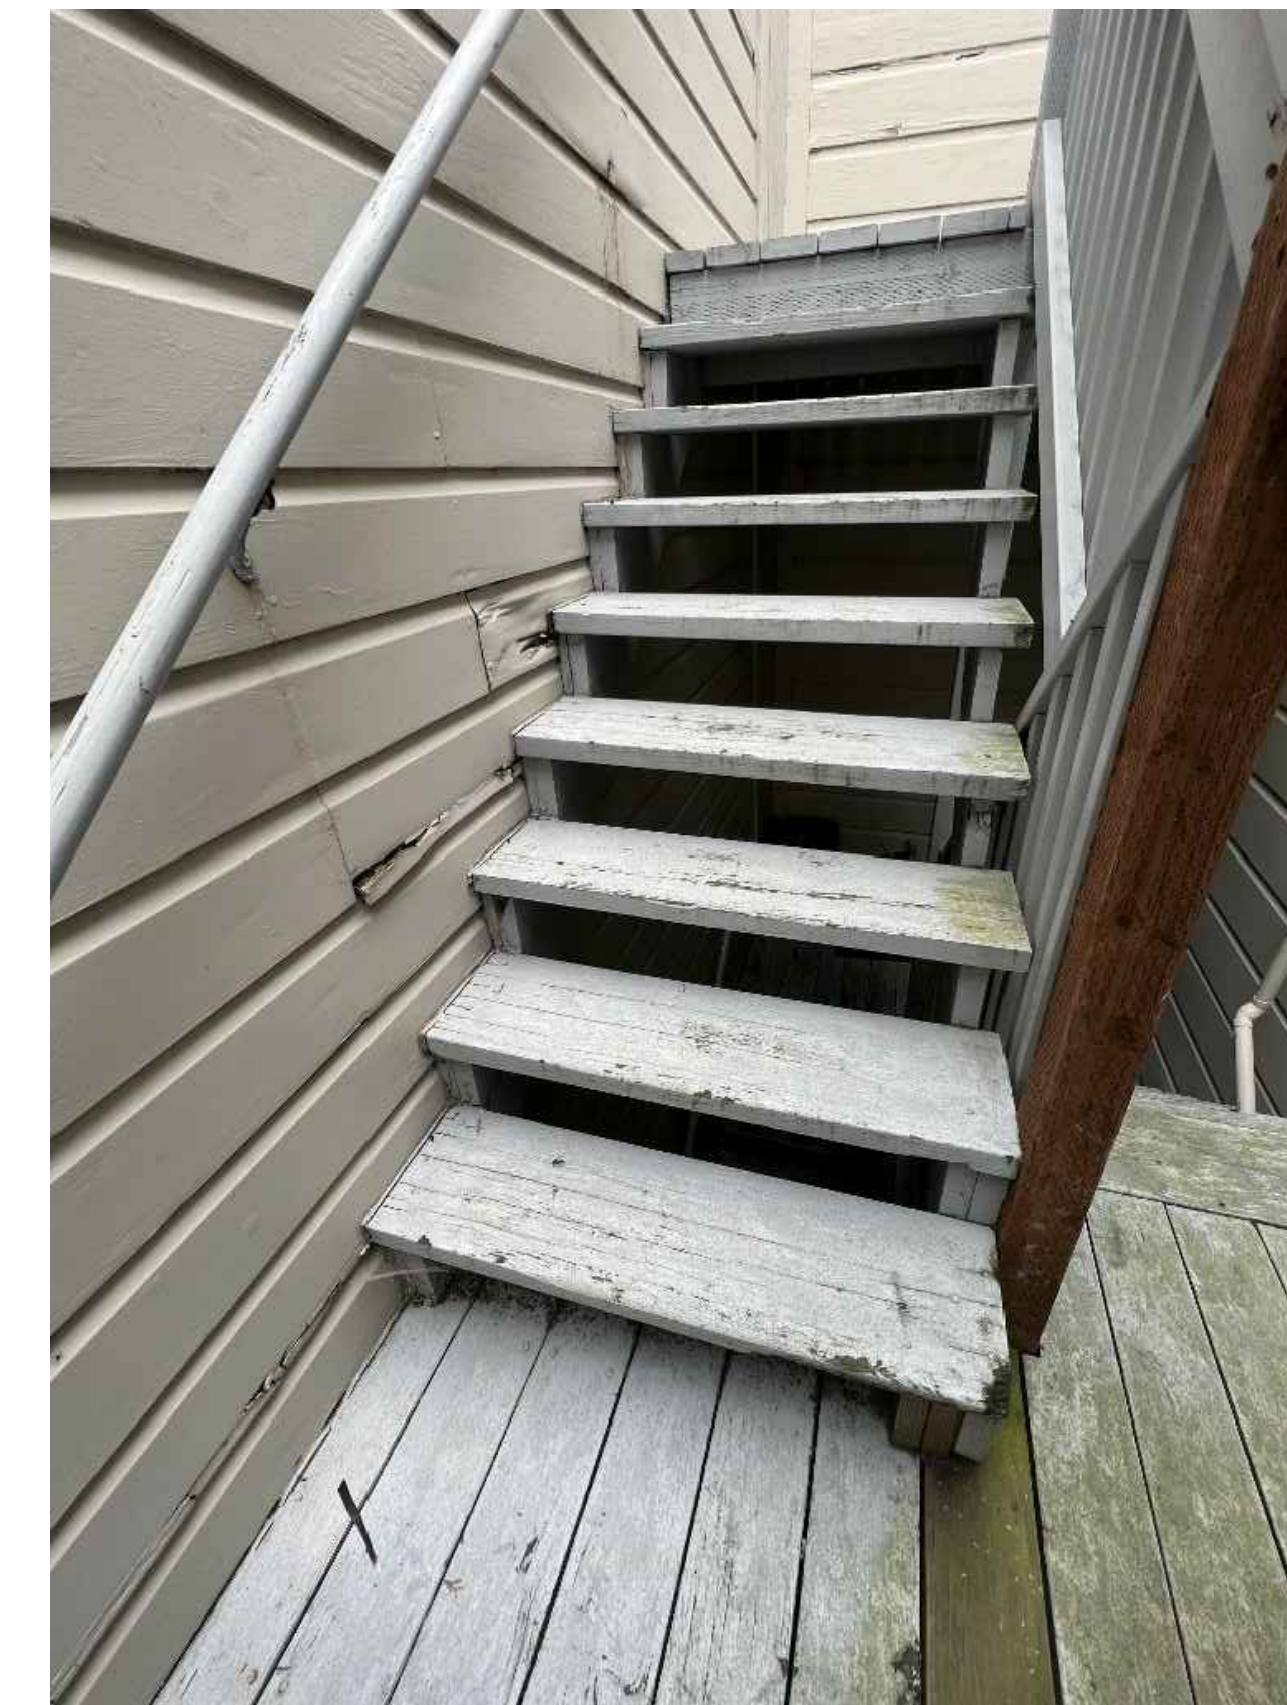
6 (E) TREADS TO BE REPLACED IN KIND
