Subject: 301 Mission Retrofit Monitoring Report 007: Results as of June 17, 2021

This memorandum summarizes results from the monitoring plan implemented at the 301 Mission property. Instrumentation to monitor the structure prior to, during and after the retrofit was installed in January 2021, including piezometers and extensometers. Settlement markers installed in April 2009 and January 2017, survey prisms mounted on the exterior of the structure in December 2016, and crack gauges installed in April 2009 have also been monitored.

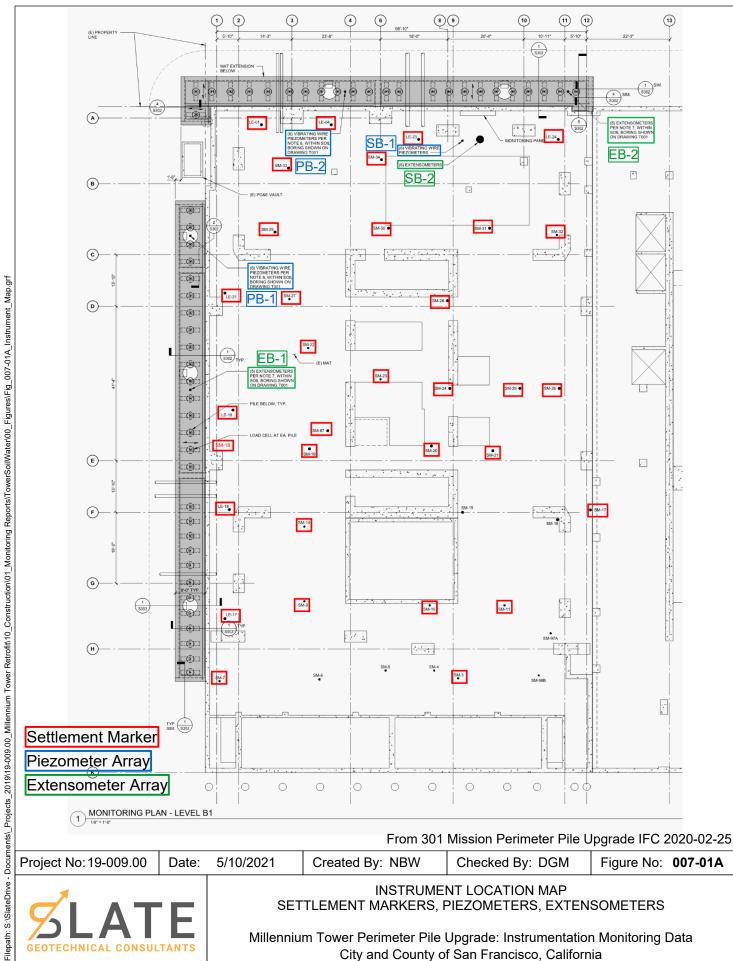
Created By: NBW Checked By: DGM Figure No: **007-01A**

Figure 01 presents the instrument locations as referenced in later figures.

Figure 01A – Instrument Location Map: Settlement Markers, Piezometers, Extensometers

INSTRUMENT LOCATION MAP SETTLEMENT MARKERS, PIEZOMETERS, EXTENSOMETERS

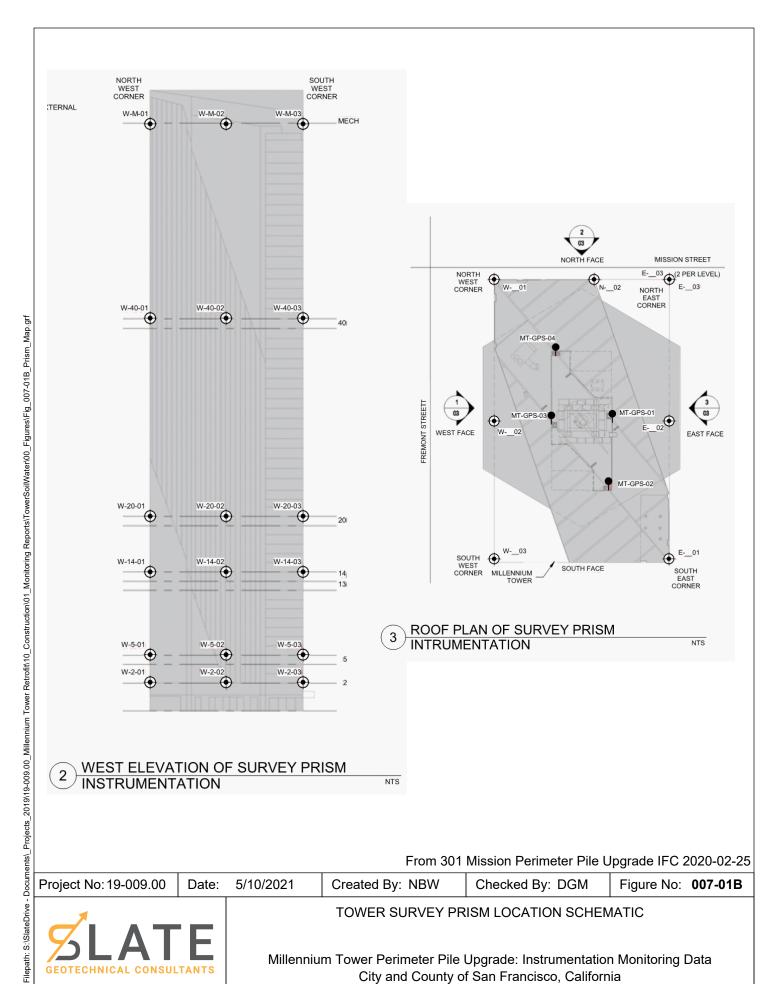
Project No: 19-009.00 5/10/2021 Date: Created By: NBW Checked By: DGM Figure No: **007-01B**

Figure 01B – Tower Survey Prism Location Schematic

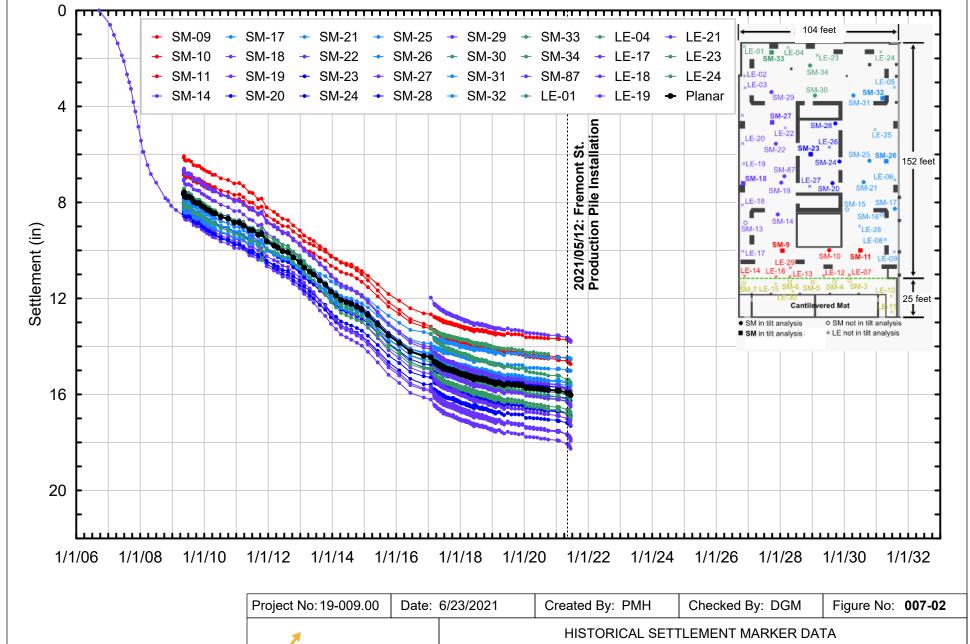
Figure 02 – Historical Settlement Marker Data

Figure 02 presents the historical settlement data interpreted from settlement markers installed on the B-1 Level of 301 Mission Tower. In addition, data from surveys performed during the retrofit are included. Figure 03 presents differential settlement data since the start of production pile installation (May 12, 2021; baseline readings on May 10, 2021) through June 14, 2021. Figure 04 presents current differential settlement contours (in inches) on June 14, 2021.

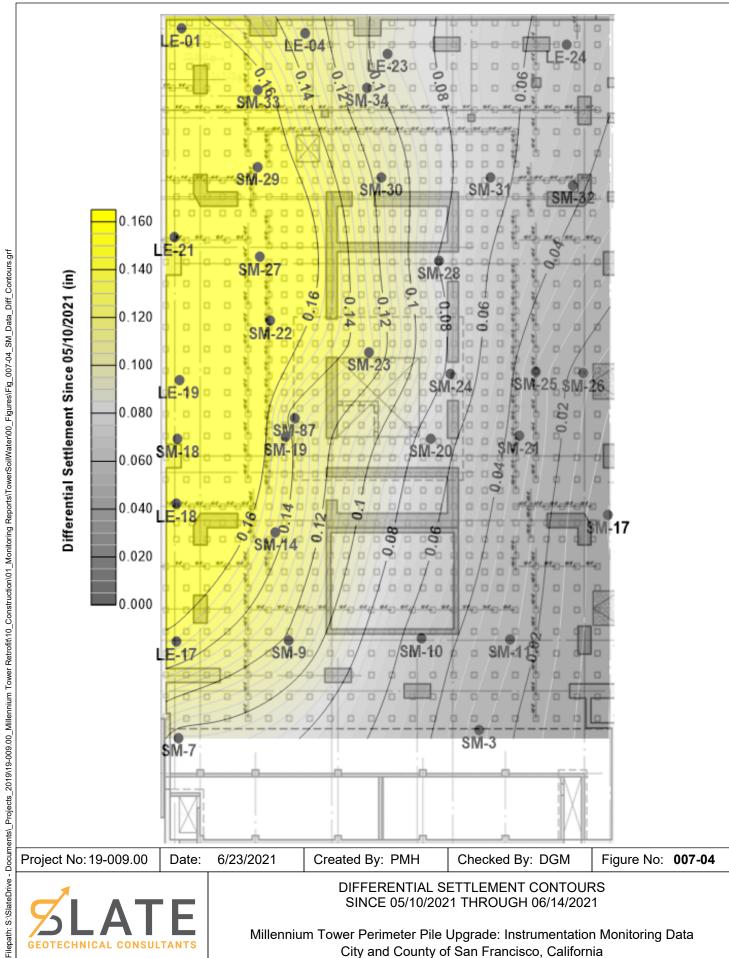
Figure 04 – Differential Settlement Contours since 05/10/2021 through 06/14/2021

DIFFERENTIAL SETTLEMENT CONTOURS SINCE 05/10/2021 THROUGH 06/14/2021

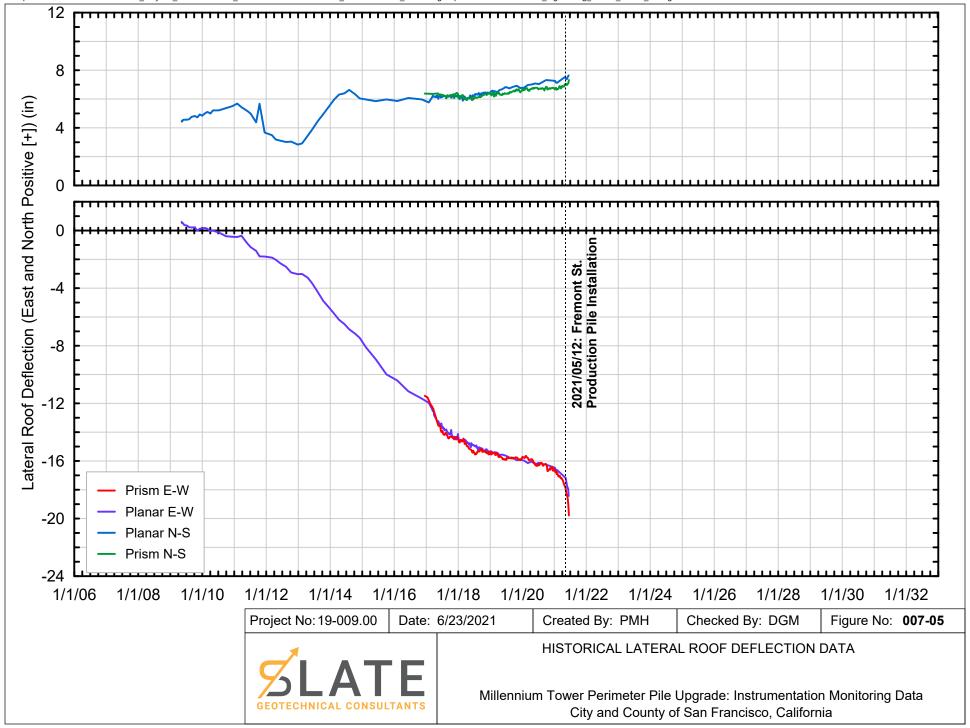
Figure 05 – Historical Lateral Roof Deflection Data

Figure 05 presents historical lateral roof deflections in the project north-south and project east-west directions interpreted from survey prisms mounted on the exterior of the Tower, from InSAR data, and from a planar fit of the settlement marker data. In addition, data from survey performed during the retrofit are included. Figure 06 presents differential lateral roof deflection data from a planar fit of the settlement marker data and from survey prisms mounted on the exterior of the Tower since the start of production pile installation (May 12, 2021; baseline readings on May 10 and 13, 2021, respectively) through June 17, 2021.
