Date: July 26, 2021 Project Number: 19-009

Subject: 301 Mission Retrofit Monitoring Report 012: Results as of July 23, 2021

Millennium Tower Perimeter Pile Upgrade: Instrumentation Monitoring Data City and County of San Francisco, California

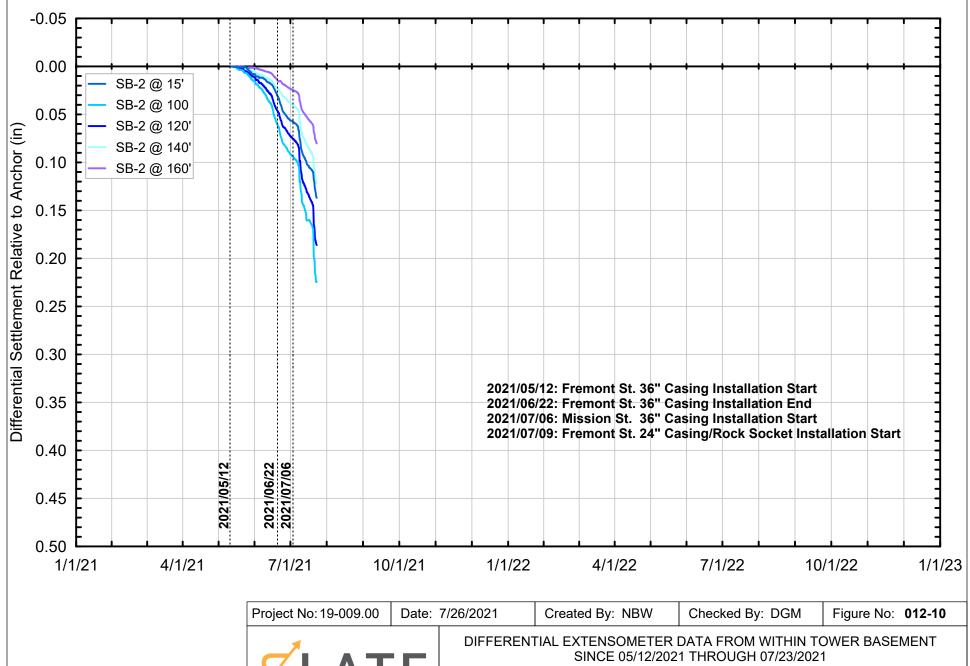
Figure 10 presents extensometer data from within the Tower basement since the start of production pile installation (May 12, 2021) through July 23, 2021. Figure 11 presents extensometer data from Fremont Street since the start of production pile installation (May 12, 2021) through July 23, 2021. Figure 12 presents extensometer data from Mission Street since the start of production pile installation (May 12, 2021) through July 23, 2021.
