Project Number: 19-009

Subject: 301 Mission Retrofit Supplemental Monitoring Report 065: Results as of August 2, 2022

Millennium Tower Perimeter Pile Upgrade: Instrumentation Monitoring Data
City and County of San Francisco, California

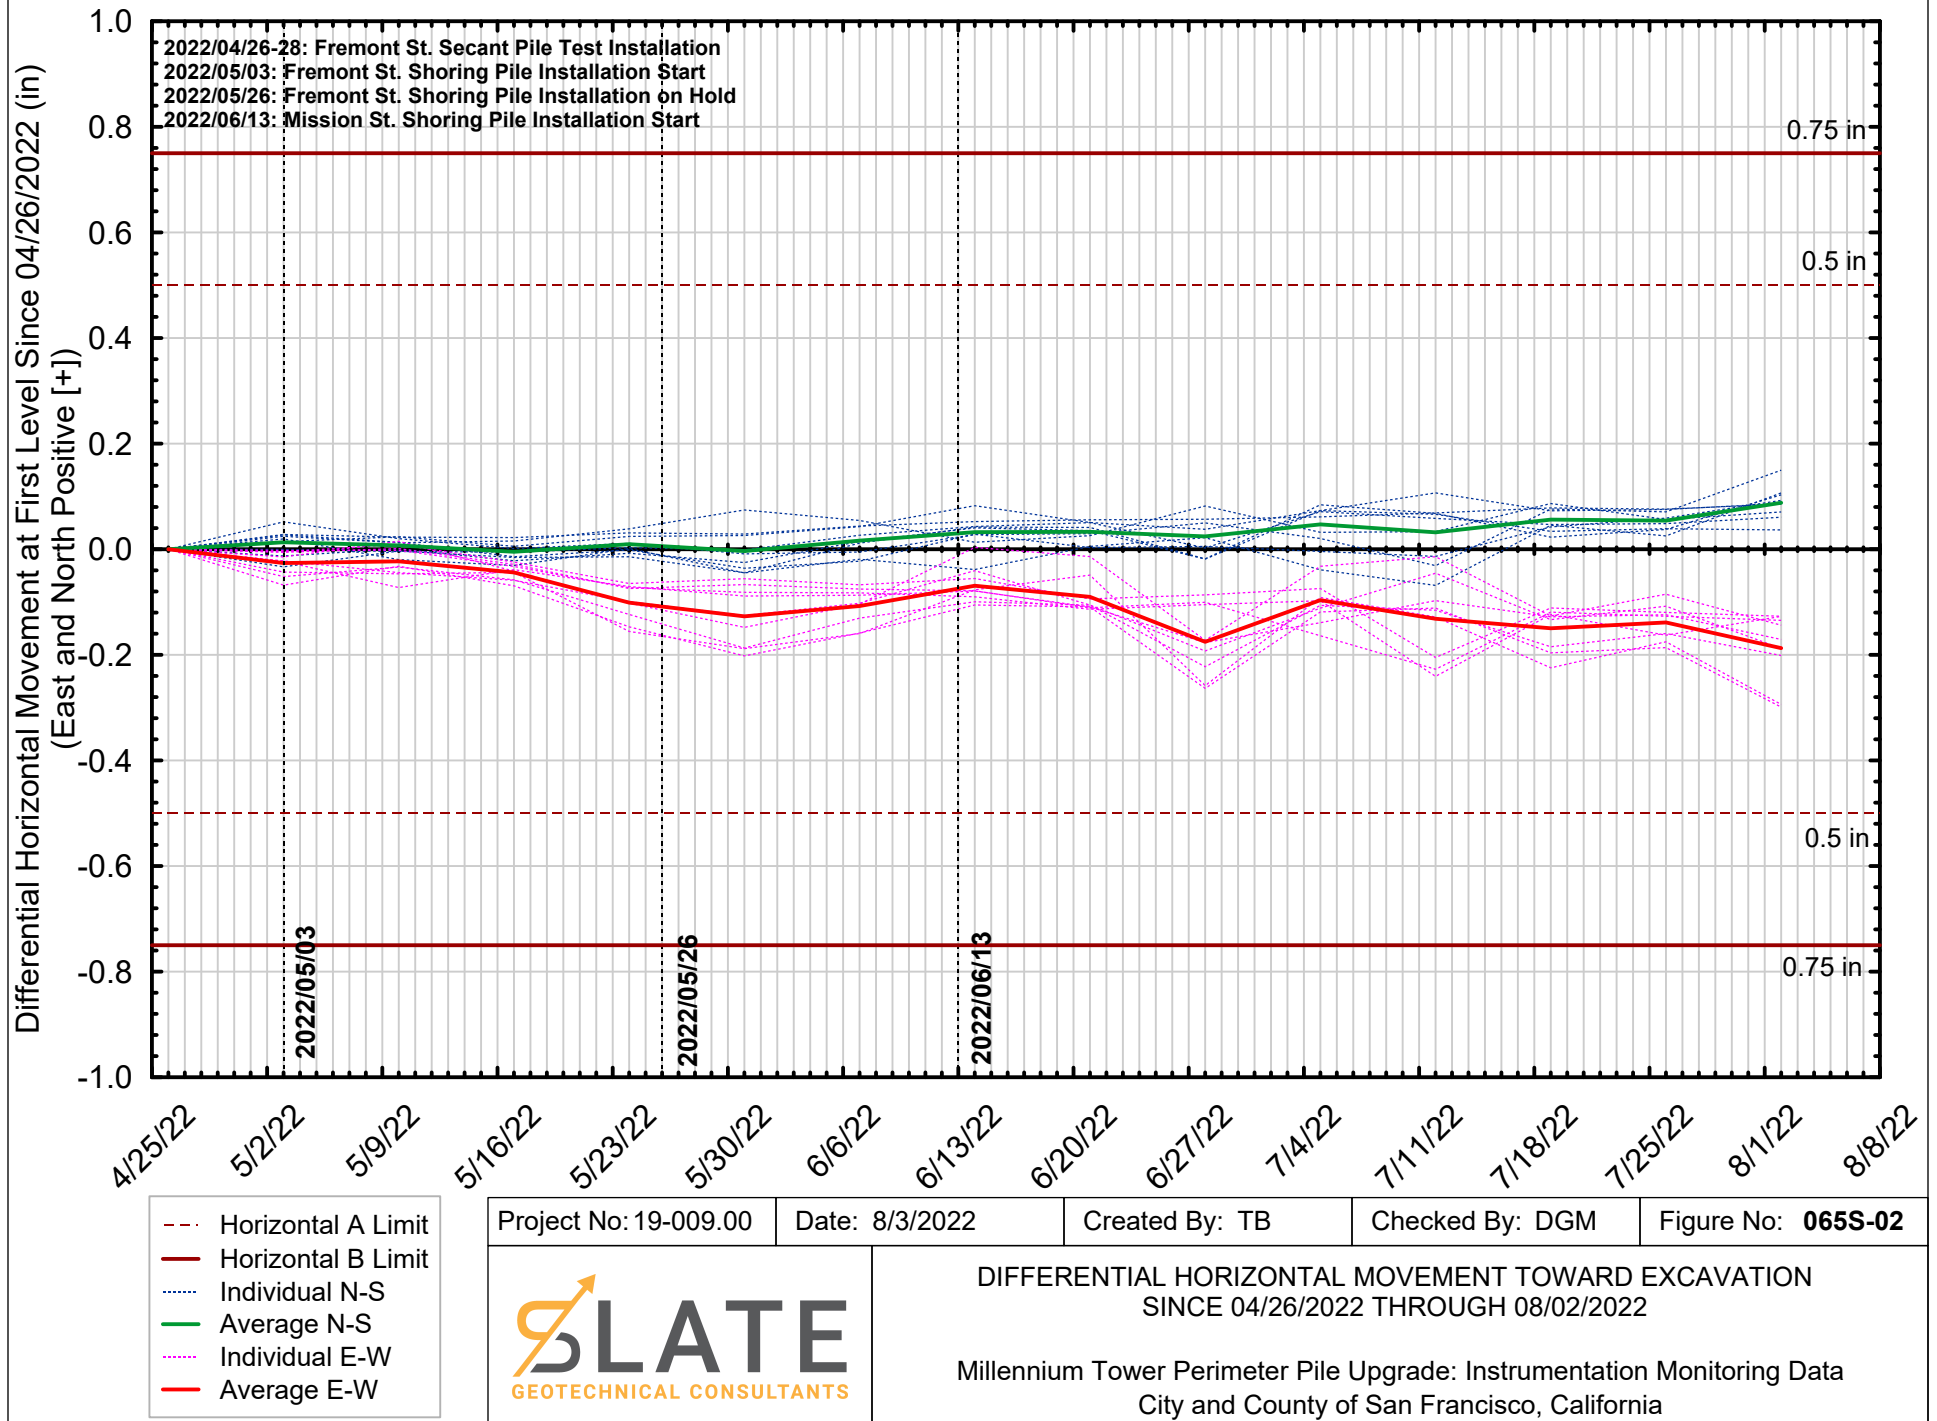
Figure S-02 – Differential Horizontal Movement Toward Excavation Since 04/26/2022 through 08/02/2022

Figure S-02 presents the differential horizontal movement toward the excavation at survey prisms installed at approximately one floor level above grade on the exterior of the building, as well as the average in each of the project north-south and east-west direction, since April 26, 2022, through August 2, 2022. Limits established in the aforementioned letter are included for reference.

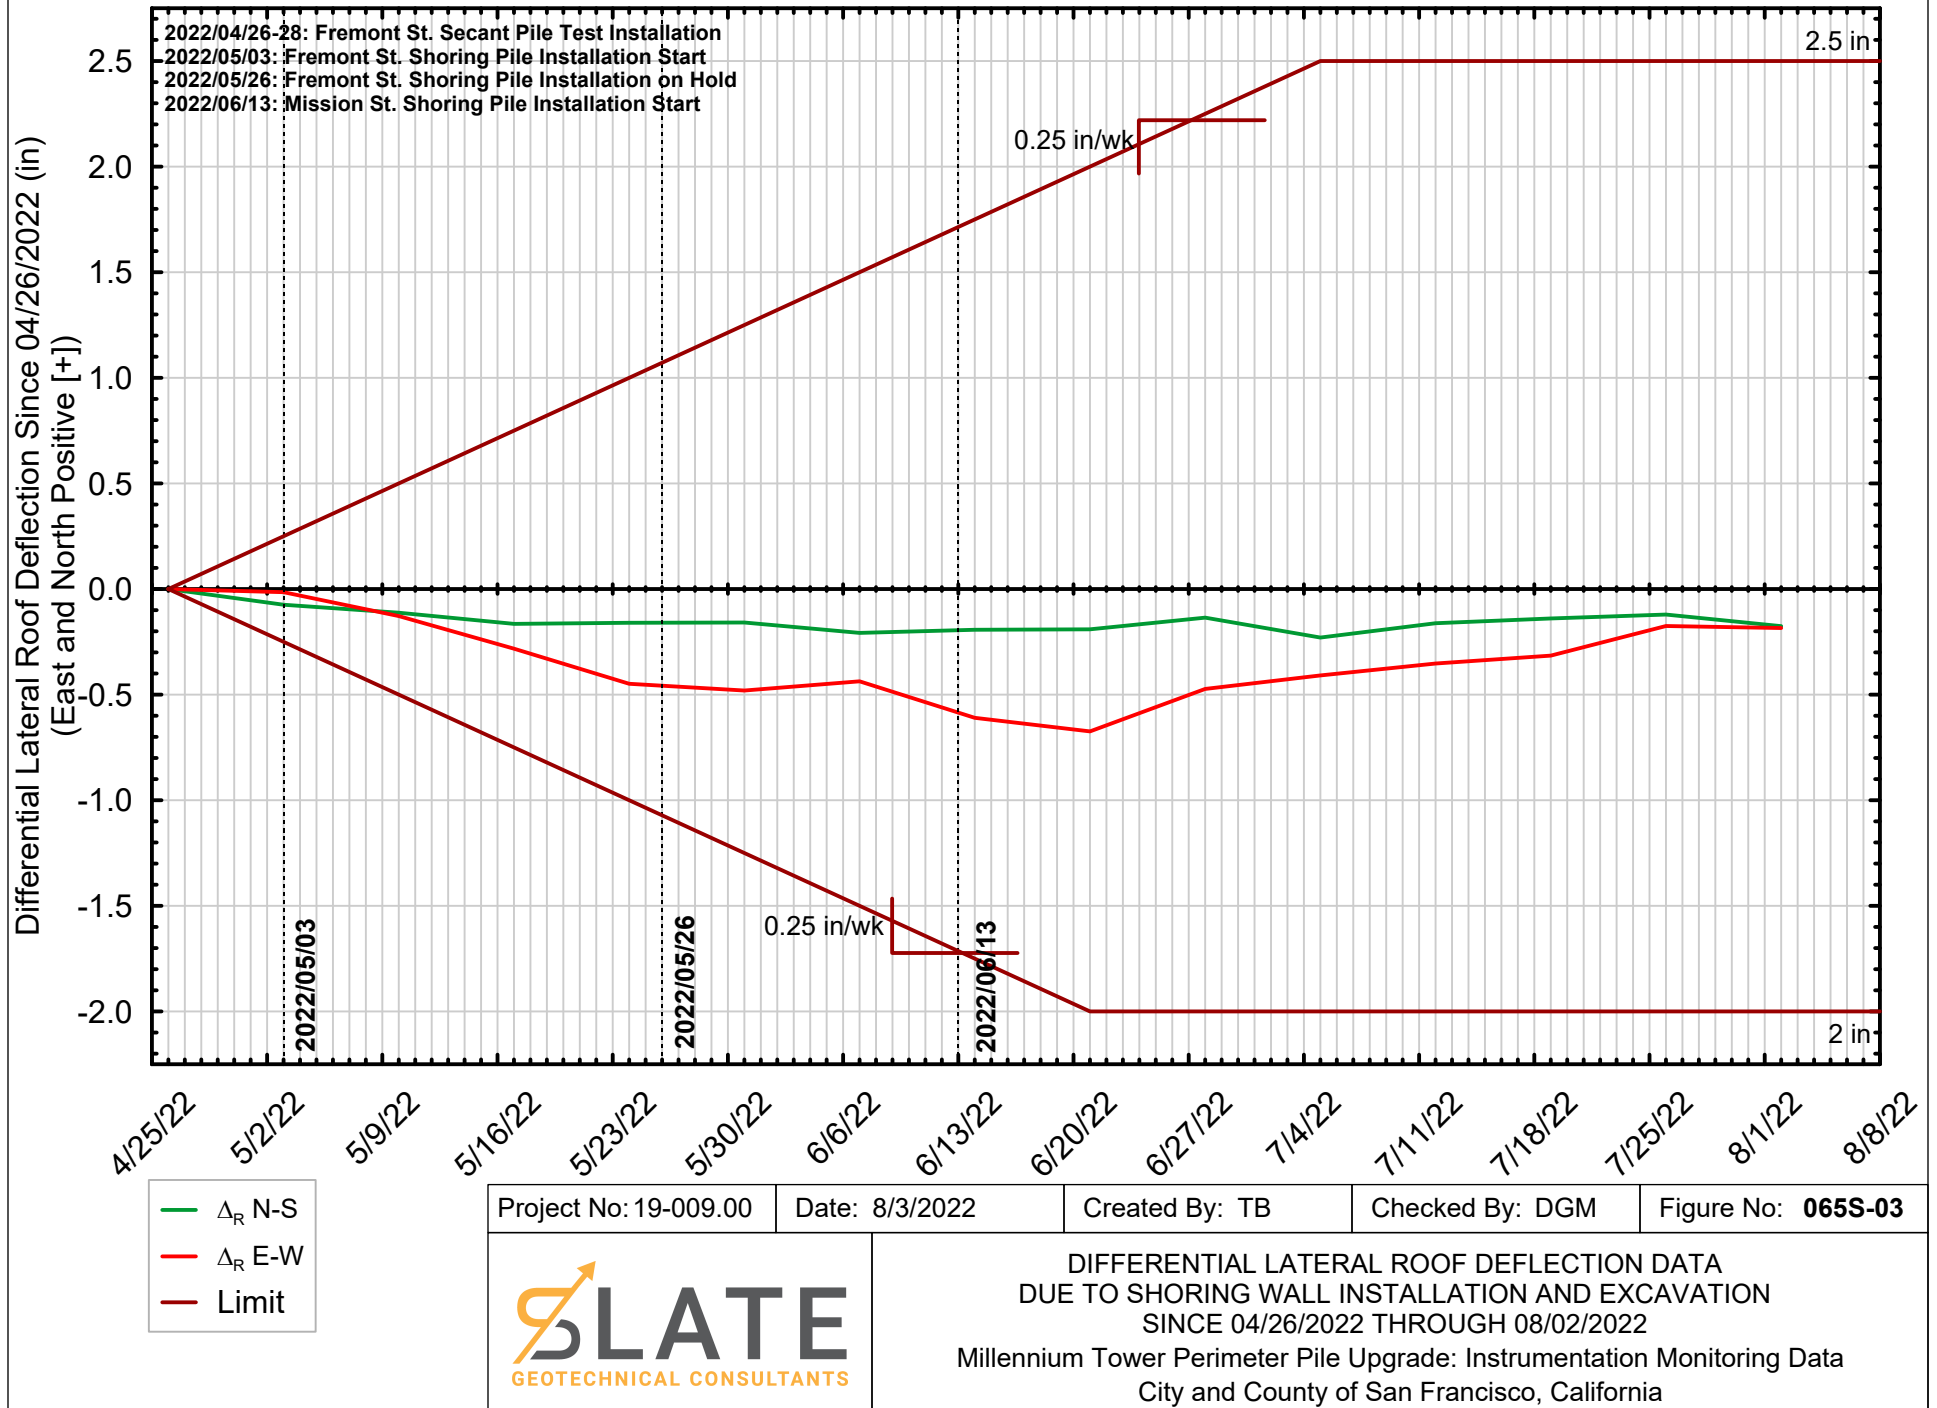
Figure S-03 – Differential Lateral Roof Deflection Data due to Shoring Wall Installation and Excavation since 04/26/2022 through 08/02/2022

Figure S-03 presents differential lateral roof deflection data due to shoring wall installation and excavation since April 26, 2022, through August 2, 2022. Limits established in the aforementioned letter are included for reference. Note that differential lateral roof deflection due to shoring wall installation and excavation is calculated following the aforementioned letter as:

$$\Delta_R = \Delta_{R-prism} - \Delta_H - \alpha T$$

where: Δ_R is the computed differential lateral roof deflection due to shoring wall installation and excavation;
 $\Delta_{R-prism}$ is the differential lateral roof deflection obtained from prism data;
 Δ_H is the average differential horizontal movement "at-grade";
 α is the weekly lateral roof deflection rate (computed as described below); and,
 T is the number of weeks since initiation of shoring wall installation or excavation.

The time frame over which α is computed changes depending on the phase of the work, as specified in the aforementioned letter. For the construction phase during which the shoring wall is installed (currently ongoing), α is computed from the two months of monitoring conducted immediately prior to the shoring wall installation (i.e., monitoring data from February 22, 2022, through April 25, 2022). During the excavation phase (to occur in the future), α will be readjusted to reflect the recorded lateral roof deflection rate in the two months immediately preceding the start of excavation (dates to be determined).

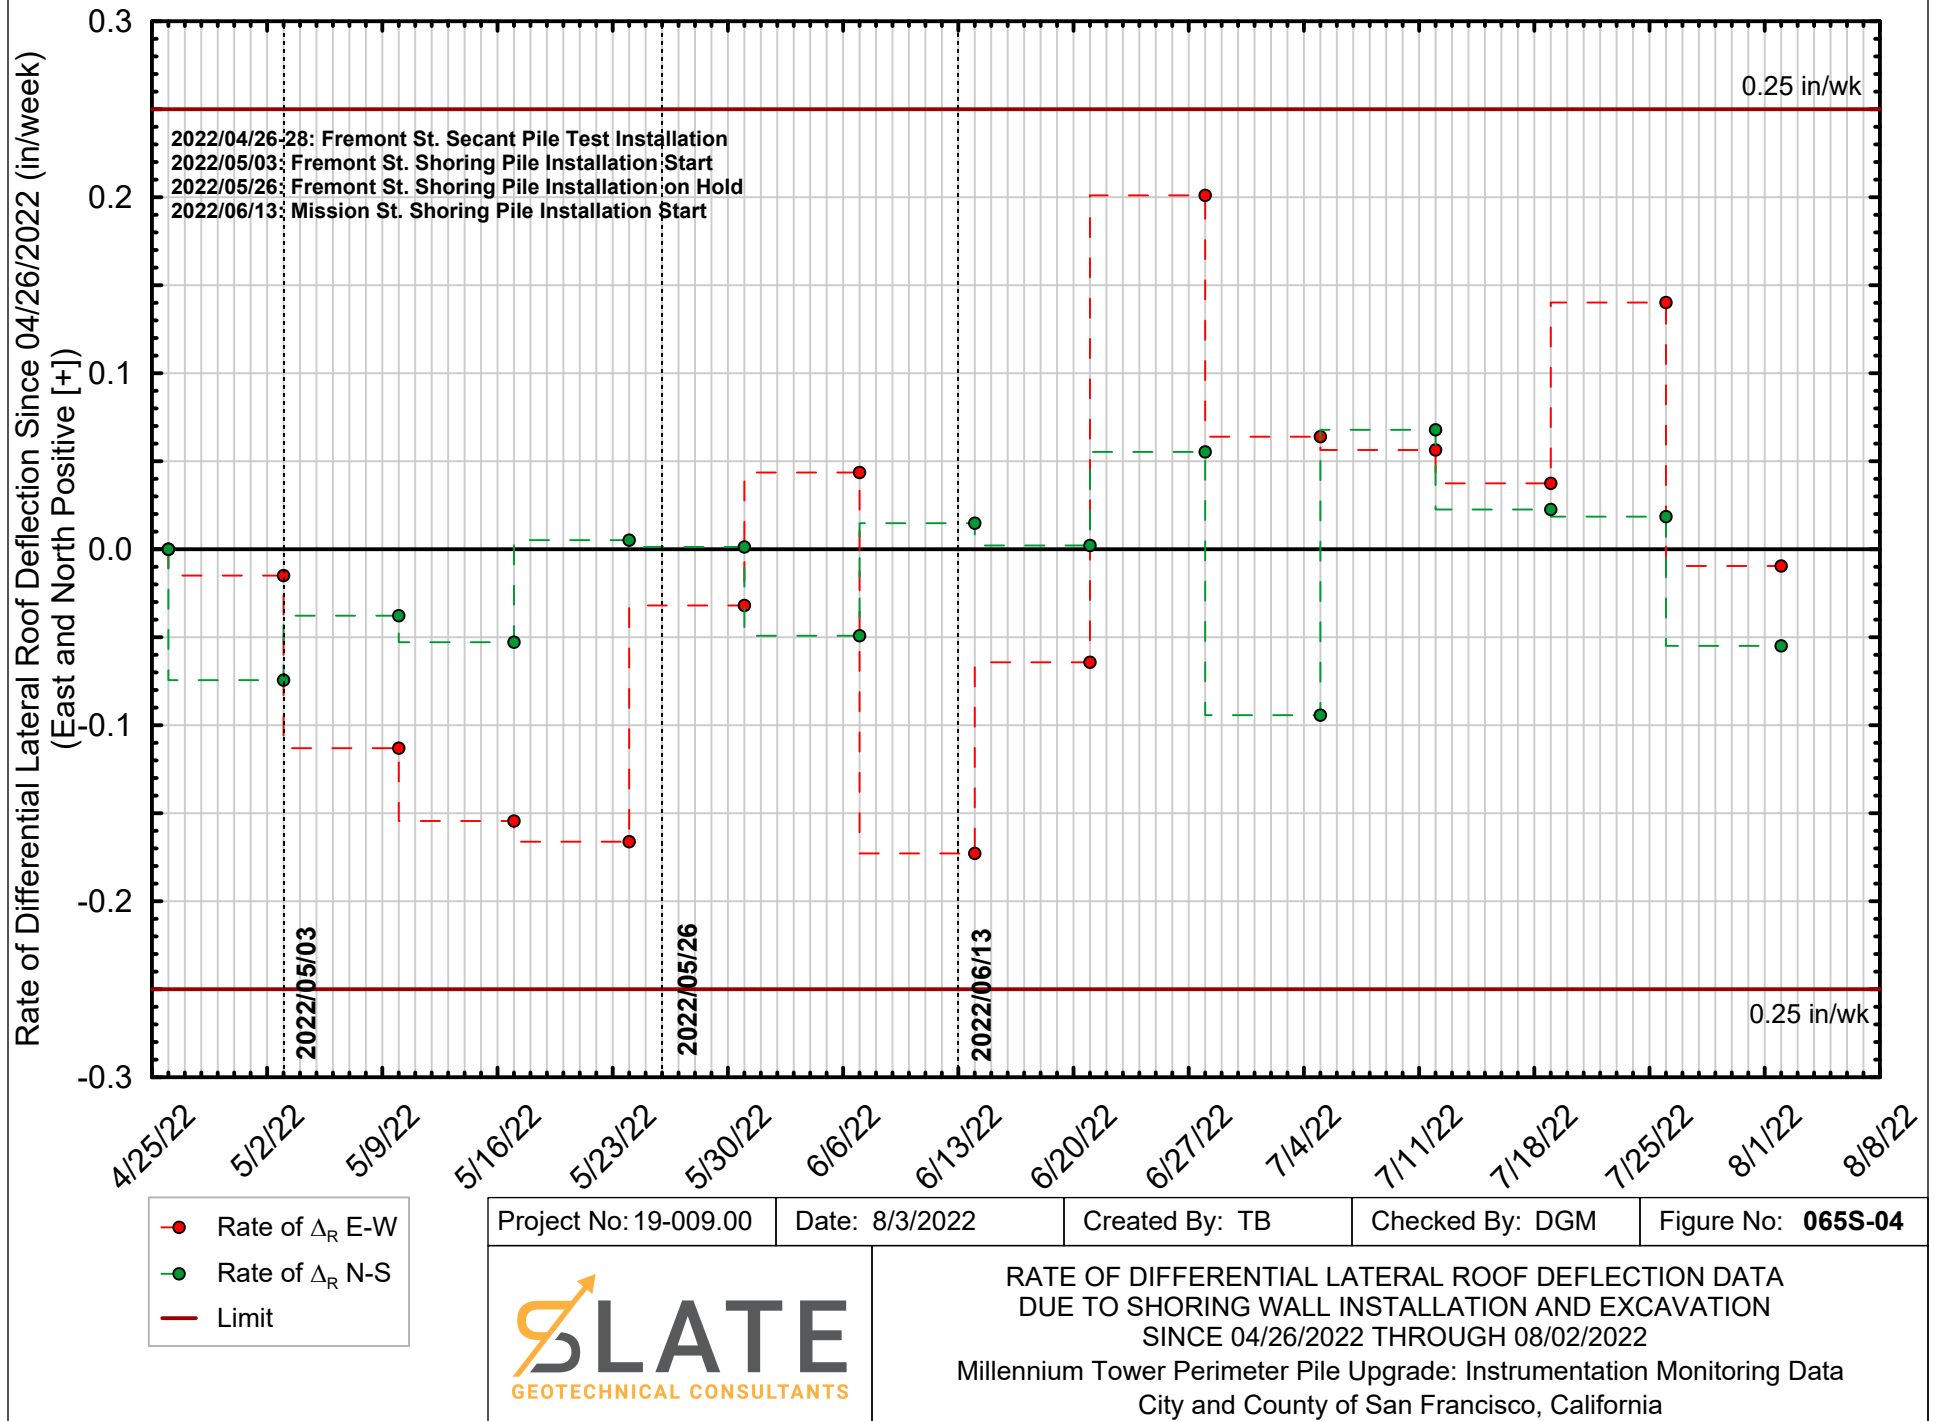
Figure S-04 – Rate of Differential Lateral Roof Deflection Data due to Shoring Wall Installation and Excavation since 04/26/2022 through 08/02/2022

Figure S-04 presents rates of differential lateral roof deflection data due to shoring wall installation and excavation since April 26, 2022, through August 2, 2022. Limits established in the aforementioned letter are included for reference. Note that the rates are calculated as:

$$\frac{d\Delta_R}{dT} \approx \frac{\Delta_{R,t} - \Delta_{R,t-1}}{T_t - T_{t-1}}$$

where: t is an index representing the current instance in time; and
 $t - 1$ is an index representing the previous instance in time.
