Date: June 15, 2022

Project Number: 19-009

Subject: 301 Mission Retrofit Supplemental Monitoring Report 058S: Results as of June 14, 2022

Millennium Tower Perimeter Pile Upgrade: Instrumentation Monitoring Data
City and County of San Francisco, California

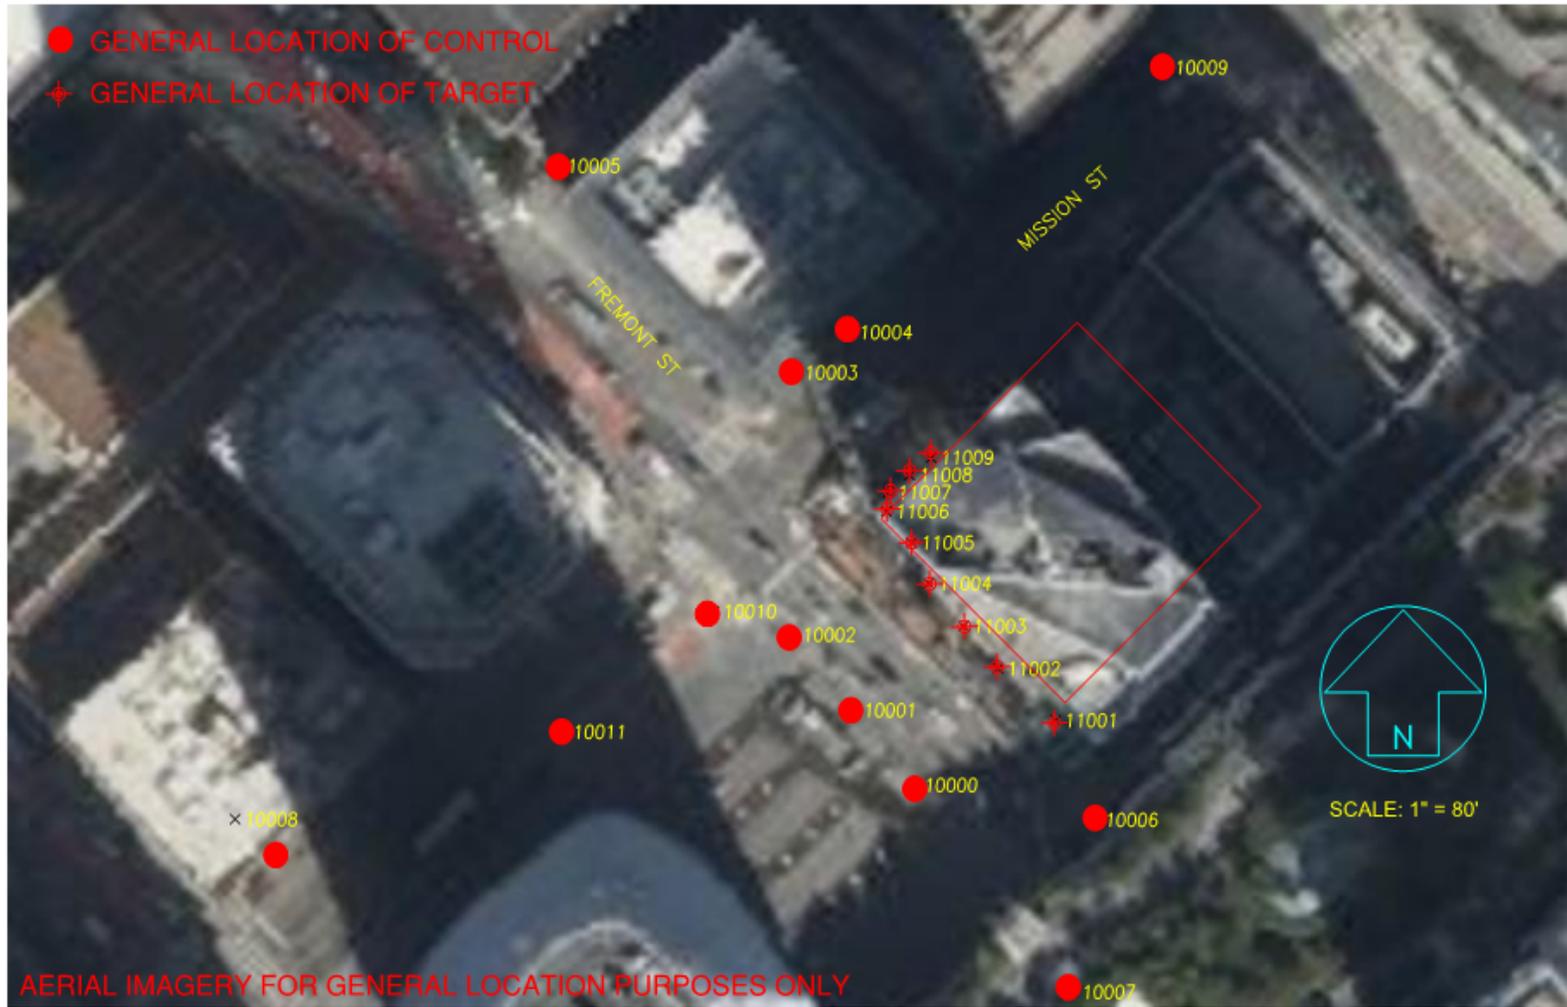
Project No: 19-009.00	Date: 5/3/2022	Created By: NBW	Checked By: DGM	Figure No: 058S-01
-----------------------	----------------	-----------------	-----------------	---------------------------

Figure S-01 presents the locations of the survey prisms (including both control and target prisms) as referenced in later figures.

INSTRUMENT LOCATION MAP
HORIZONTAL SURVEY CONTROL AND TARGET POINTS AT FIRST LEVEL
