Project Number: 19-009

Subject: 301 Mission Retrofit Supplemental Monitoring Report 069: Results as of September 7, 2022

Millennium Tower Perimeter Pile Upgrade: Instrumentation Monitoring Data
City and County of San Francisco, California

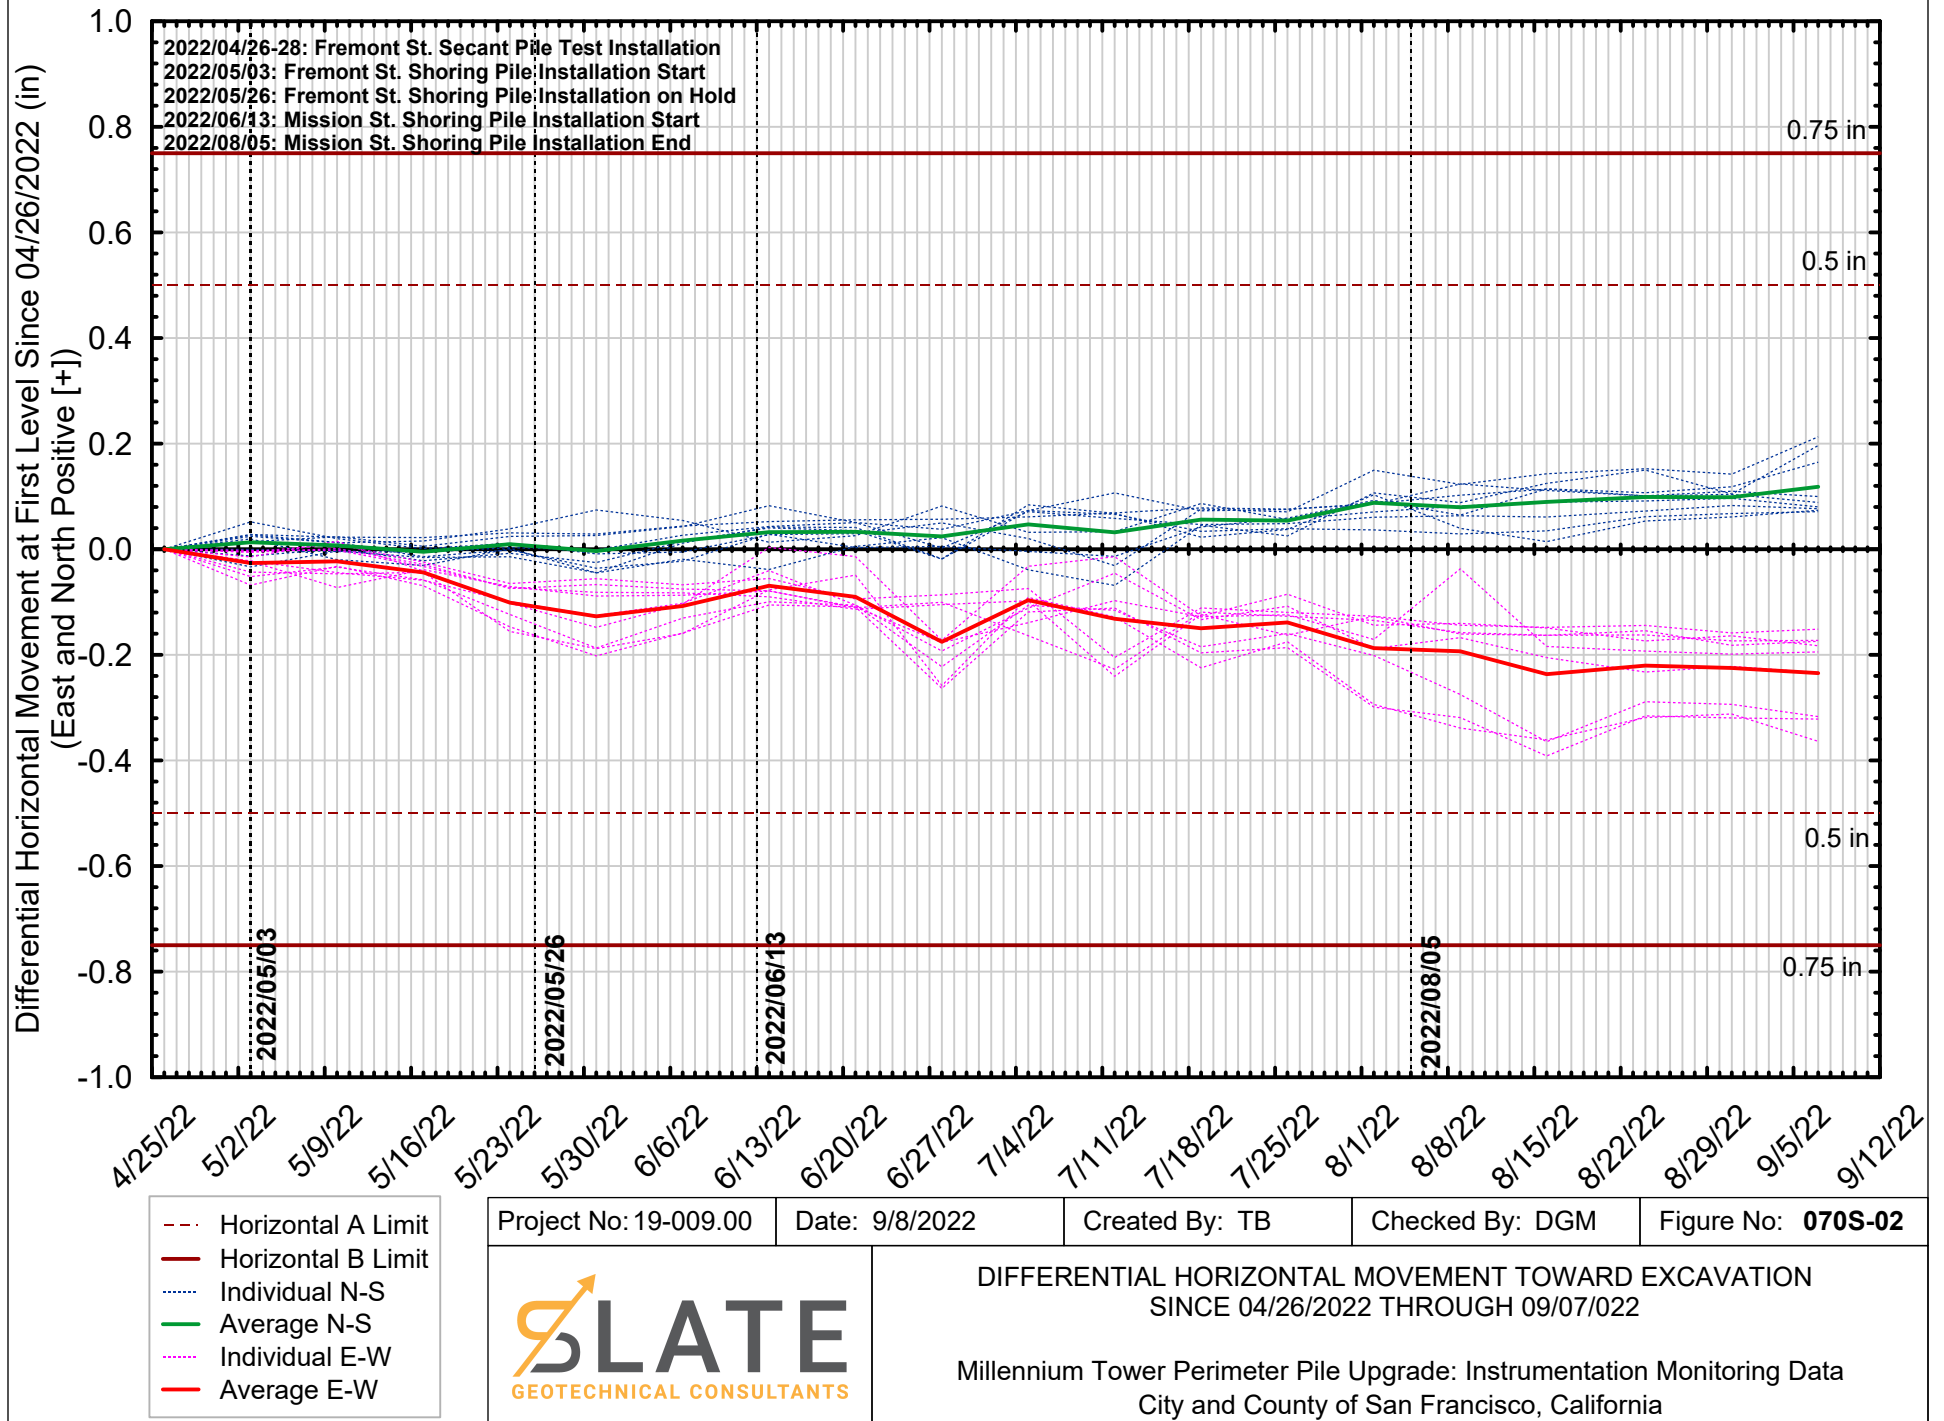
Figure S-02 – Differential Horizontal Movement Toward Excavation Since 04/26/2022 through 09/07/2022

Figure S-02 presents the differential horizontal movement toward the excavation at survey prisms installed at approximately one floor level above grade on the exterior of the building, as well as the average in each of the project north-south and east-west direction, since April 26, 2022, through September 7, 2022. Limits established in the aforementioned letter are included for reference.

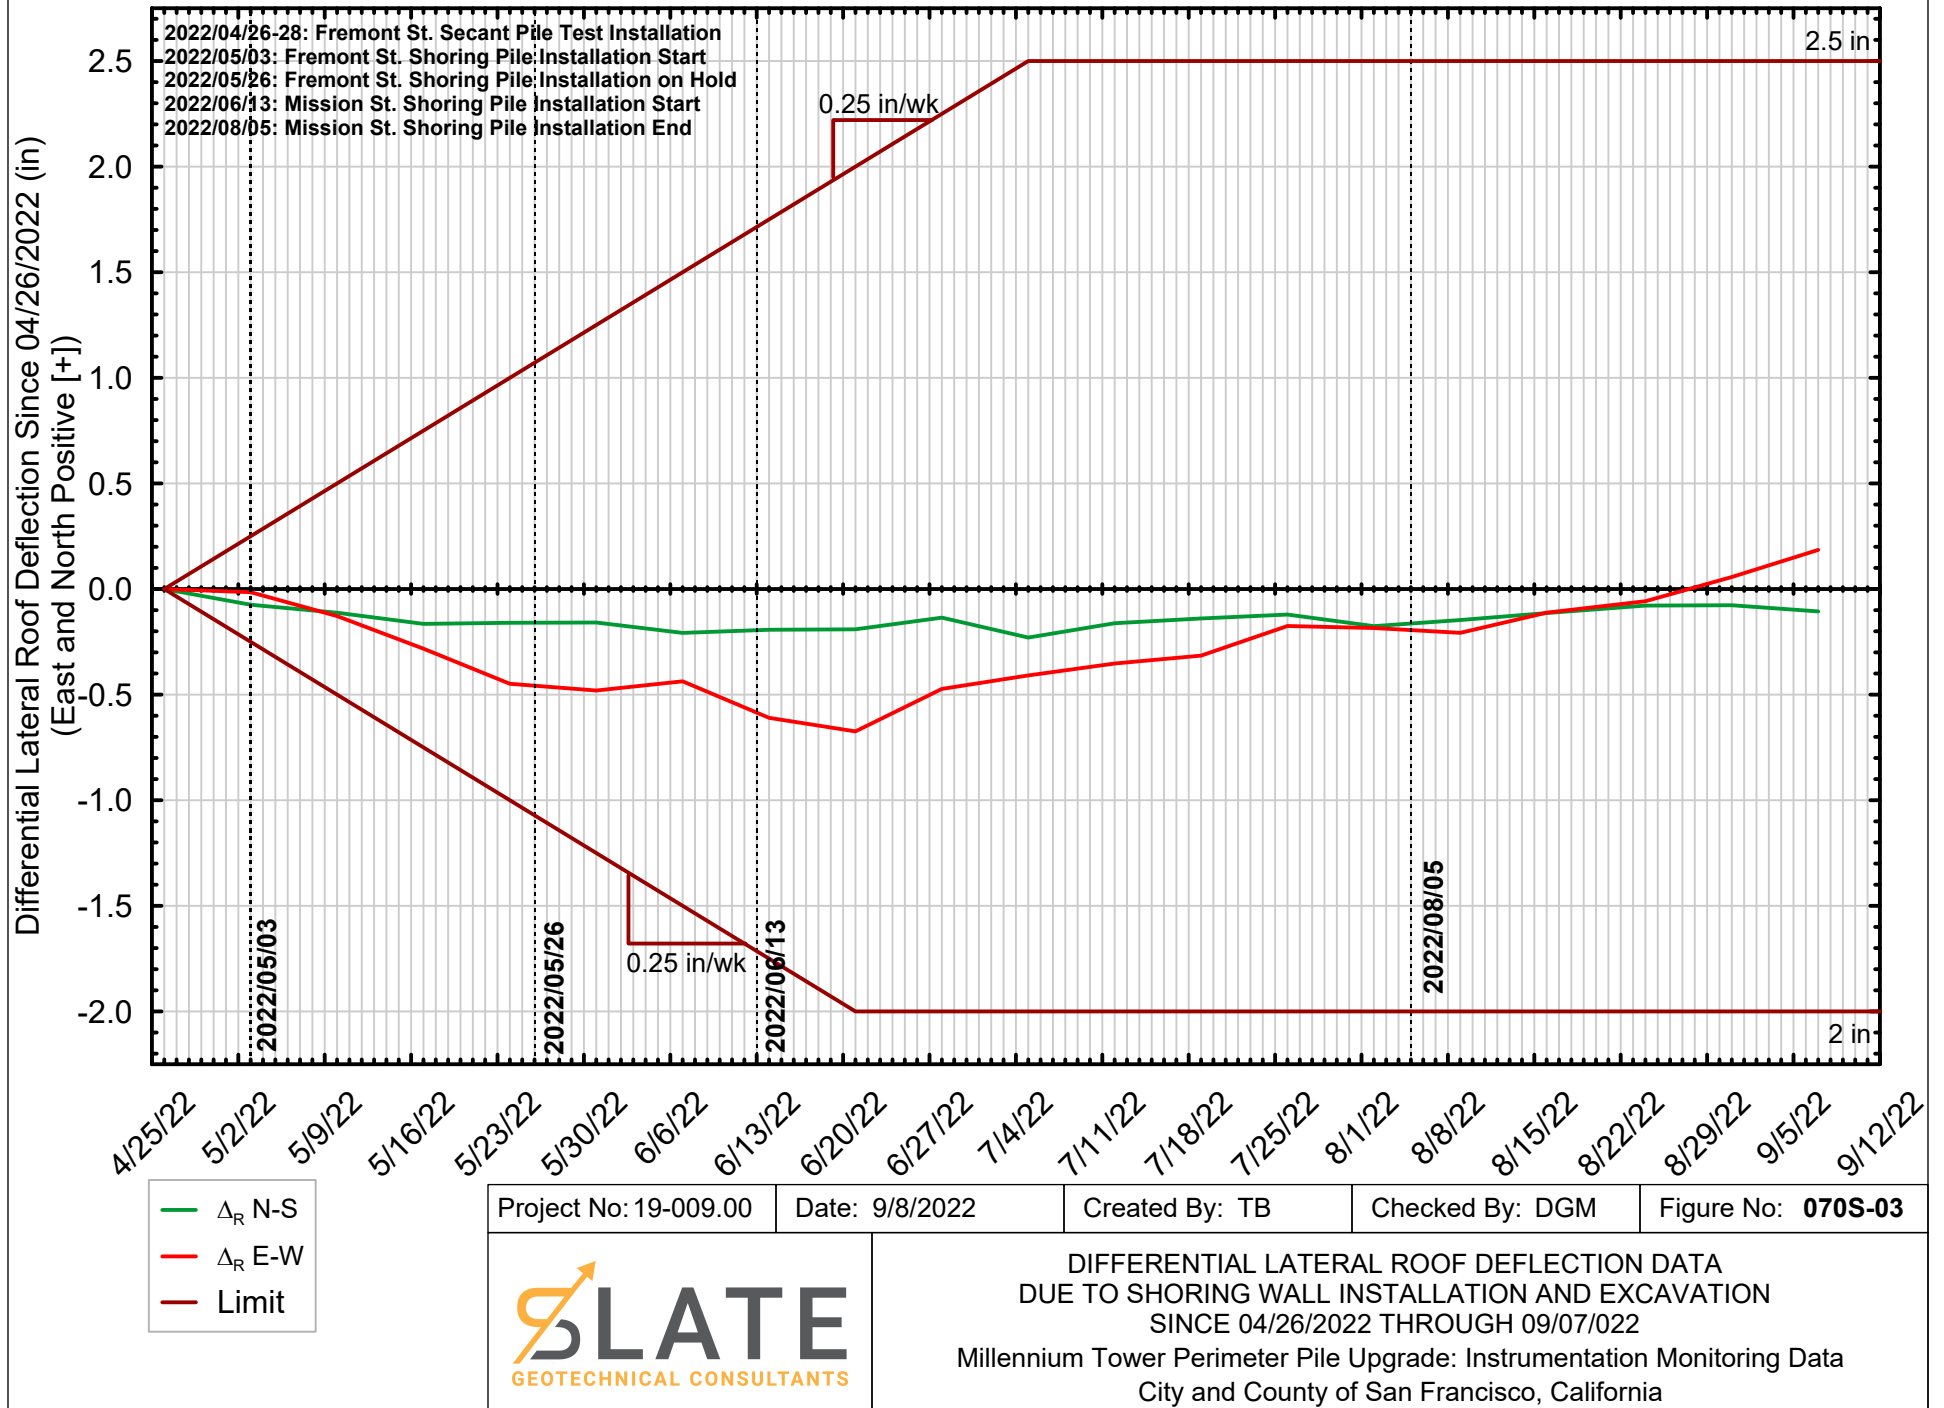
Figure S-03 – Differential Lateral Roof Deflection Data due to Shoring Wall Installation and Excavation since 04/26/2022 through 09/07/2022

Figure S-03 presents differential lateral roof deflection data due to shoring wall installation and excavation since April 26, 2022, through September 7, 2022. Limits established in the aforementioned letter are included for reference. Note that differential lateral roof deflection due to shoring wall installation and excavation is calculated following the aforementioned letter as:

$$\Delta_R = \Delta_{R-prism} - \Delta_H - \alpha T$$

where: Δ_R is the computed differential lateral roof deflection due to shoring wall installation and excavation;
 $\Delta_{R-prism}$ is the differential lateral roof deflection obtained from prism data;
 Δ_H is the average differential horizontal movement "at-grade";
 α is the weekly lateral roof deflection rate (computed as described below); and,
 T is the number of weeks since initiation of shoring wall installation or excavation.

The time frame over which α is computed changes depending on the phase of the work, as specified in the aforementioned letter. For the construction phase during which the shoring wall is installed (currently ongoing), α is computed from the two months of monitoring conducted immediately prior to the shoring wall installation (i.e., monitoring data from February 22, 2022, through April 25, 2022). During the excavation phase (to occur in the future), α will be readjusted to reflect the recorded lateral roof deflection rate in the two months immediately preceding the start of excavation (dates to be determined).

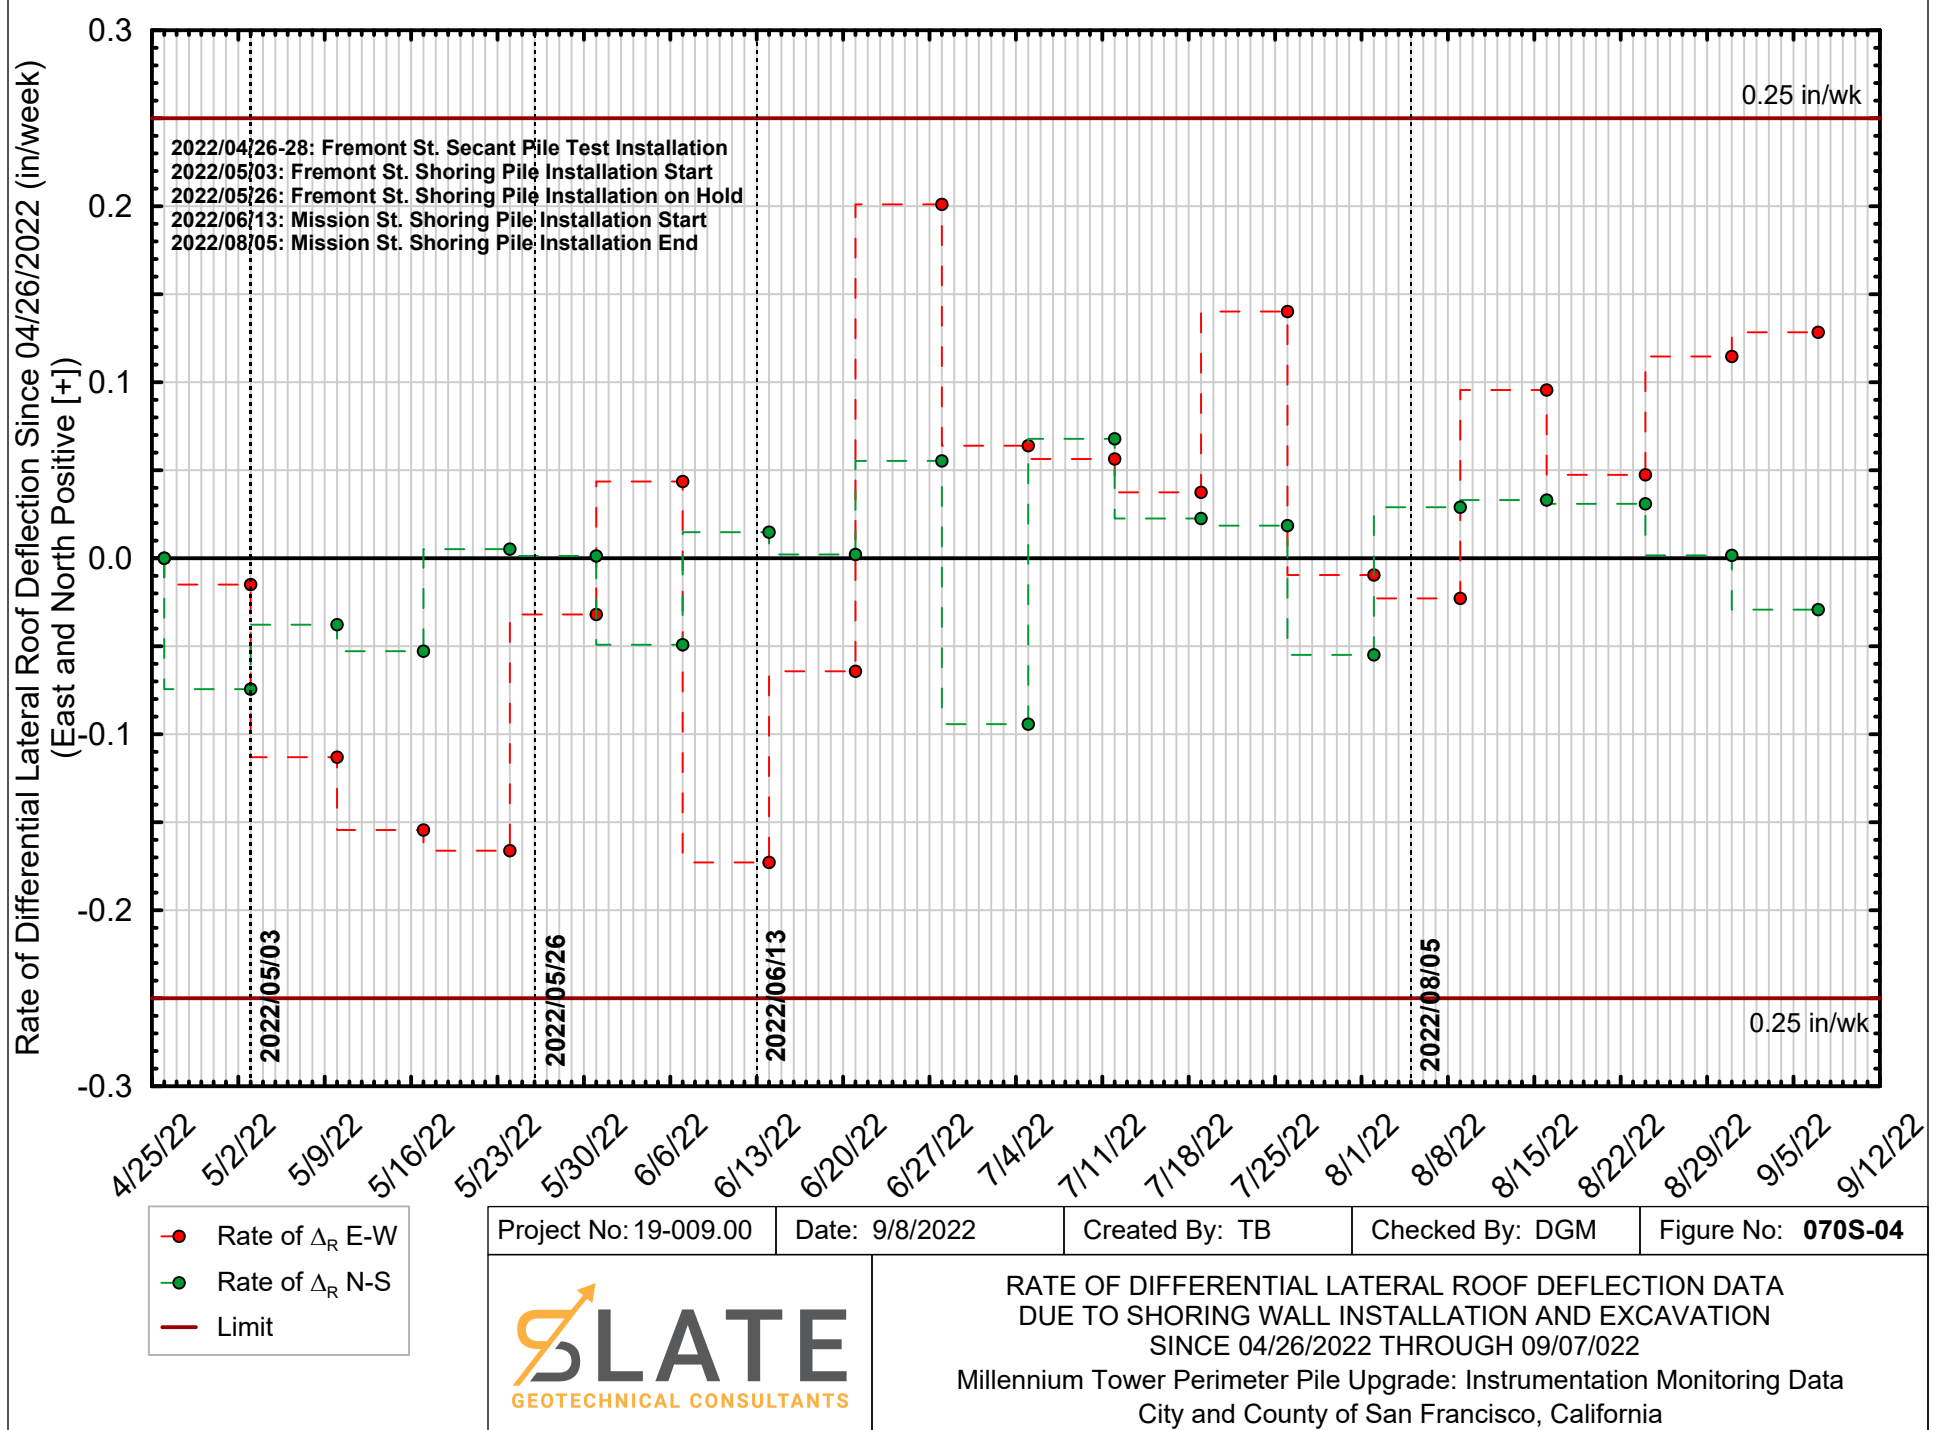
Figure S-04 – Rate of Differential Lateral Roof Deflection Data due to Shoring Wall Installation and Excavation since 04/26/2022 through 09/07/2022

Figure S-04 presents rates of differential lateral roof deflection data due to shoring wall installation and excavation since April 26, 2022, through September 7, 2022. Limits established in the aforementioned letter are included for reference. Note that the rates are calculated as:

$$\frac{d\Delta_R}{dT} \approx \frac{\Delta_{R,t} - \Delta_{R,t-1}}{T_t - T_{t-1}}$$

where: t is an index representing the current instance in time; and
 $t - 1$ is an index representing the previous instance in time.
