Project Number: 19-009

Subject: 301 Mission Retrofit Supplemental Monitoring Report 079: Results as of November 10, 2022

Millennium Tower Perimeter Pile Upgrade: Instrumentation Monitoring Data  
City and County of San Francisco, California

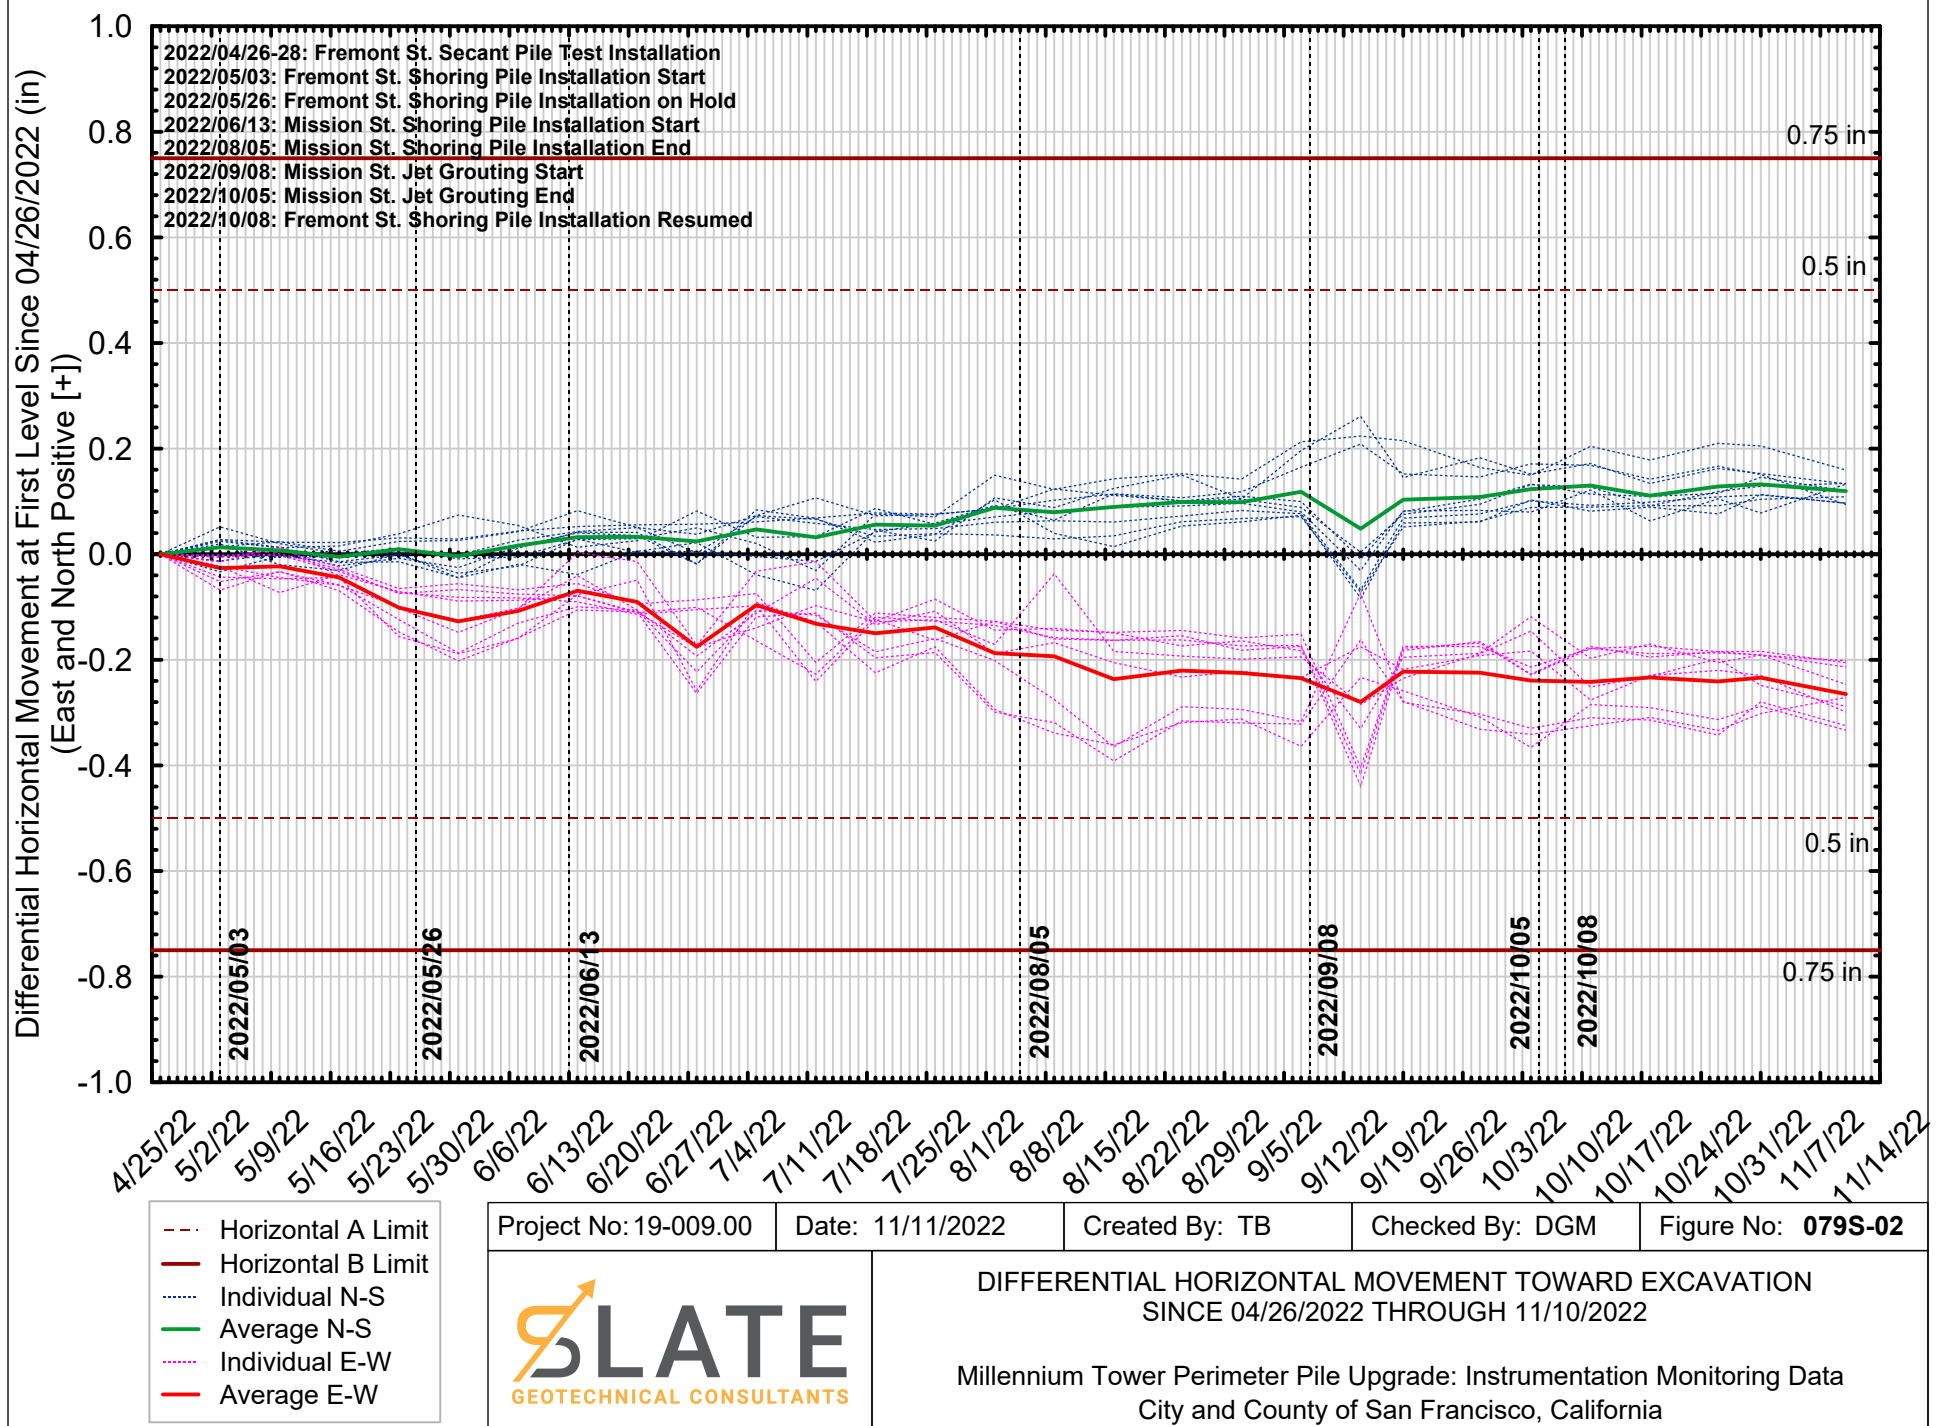
Figure S-02 – Differential Horizontal Movement Toward Excavation Since 04/26/2022 through 11/10/2022

Figure S-02 presents the differential horizontal movement toward the excavation at survey prisms installed at approximately one floor level above grade on the exterior of the building, as well as the average in each of the project north-south and east-west direction, since April 26, 2022, through November 10, 2022. Limits established in the aforementioned letter are included for reference.

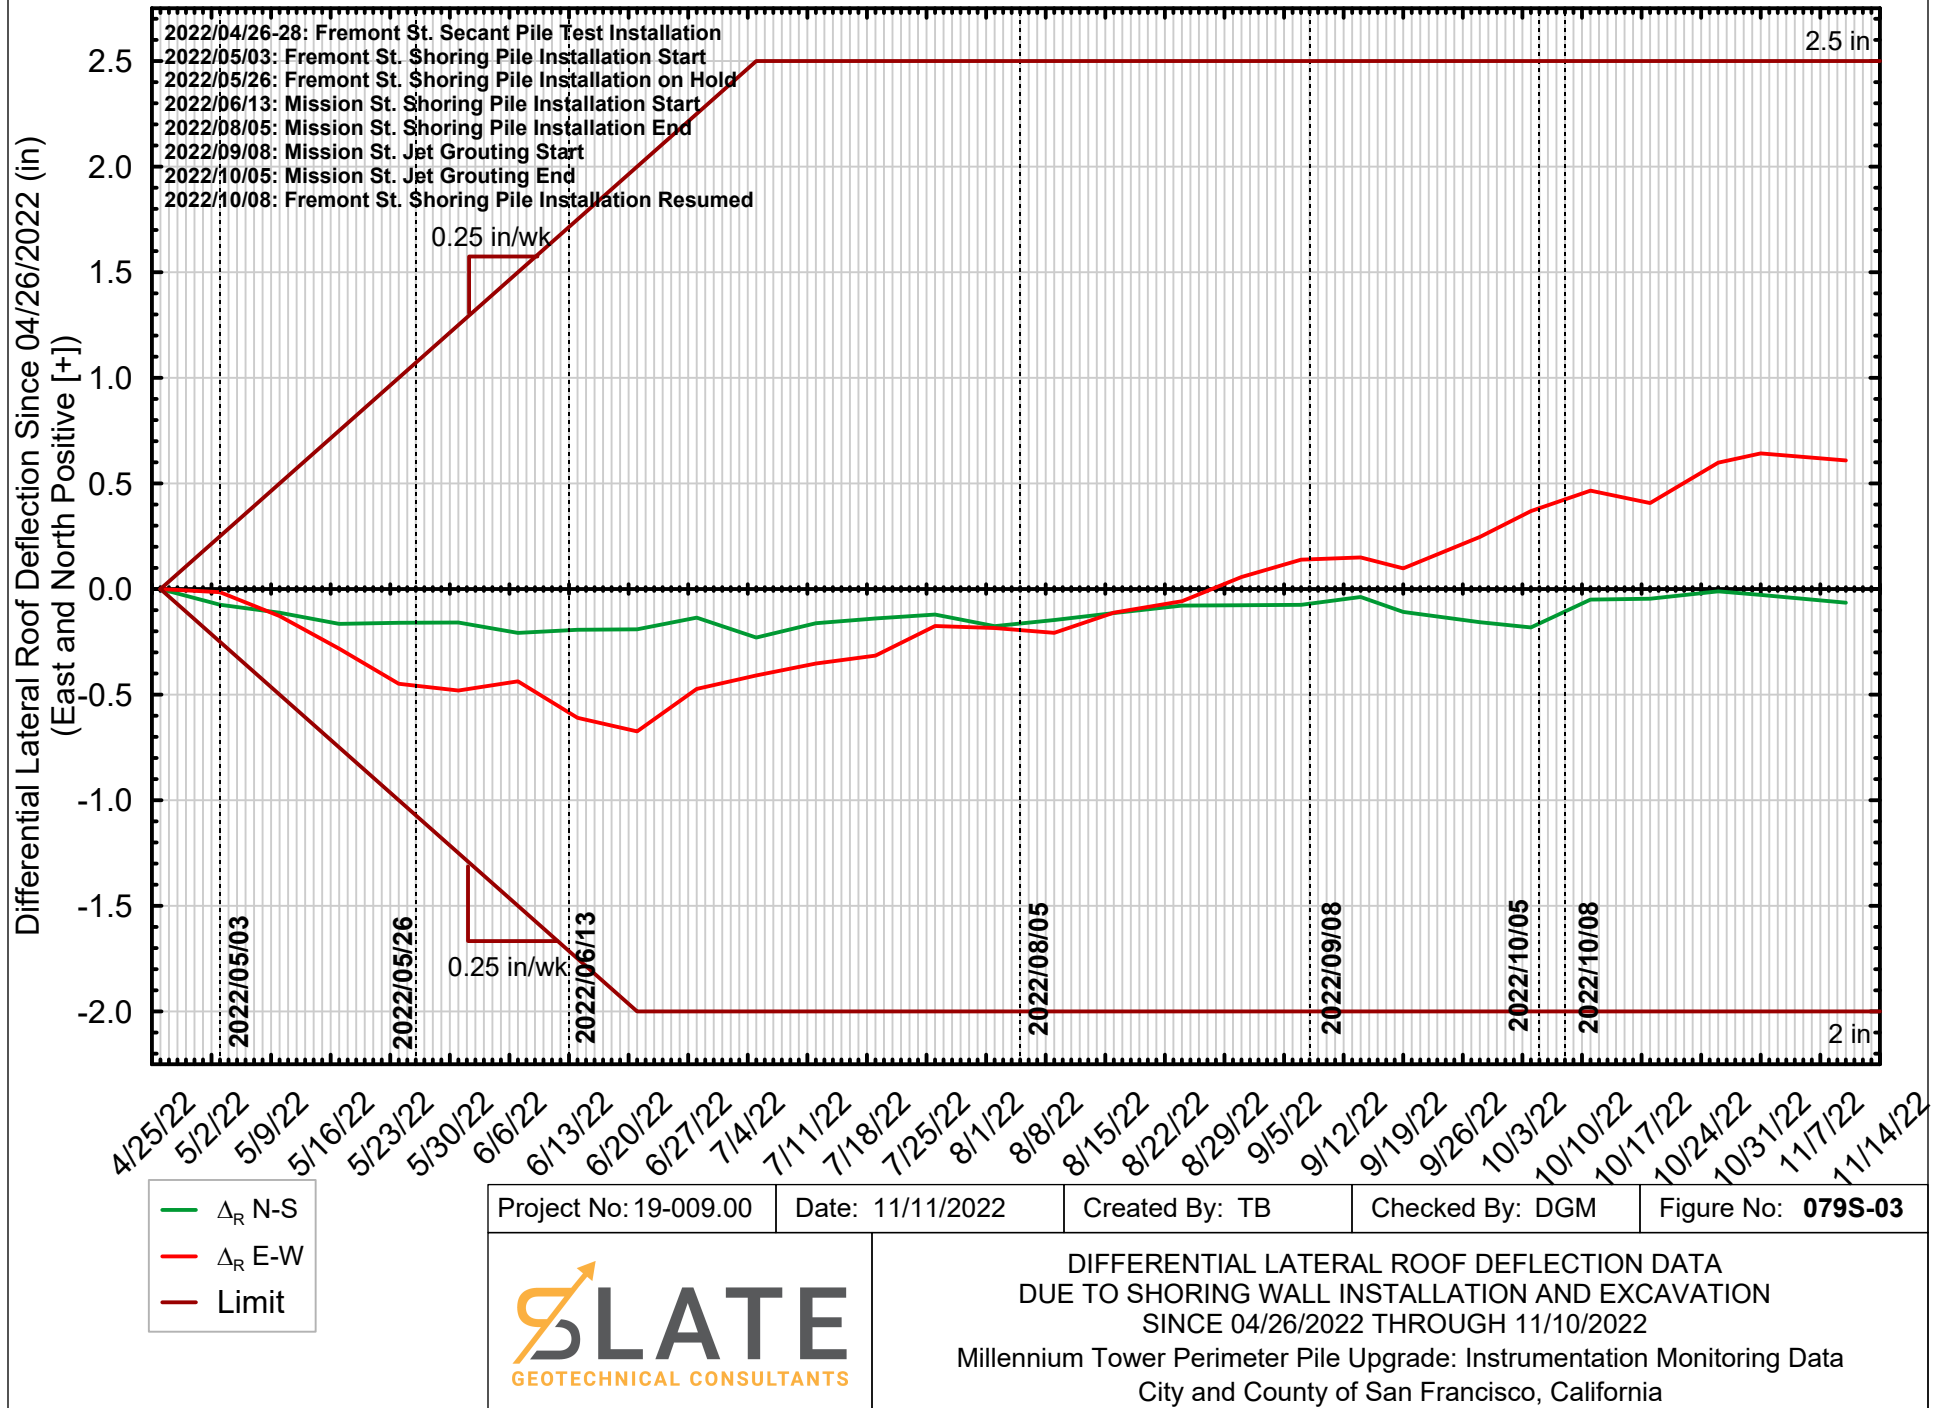
Figure S-03 – Differential Lateral Roof Deflection Data due to Shoring Wall Installation and Excavation since 04/26/2022 through 11/10/2022

Figure S-03 presents differential lateral roof deflection data due to shoring wall installation and excavation since April 26, 2022, through November 10, 2022. Limits established in the aforementioned letter are included for reference. Note that differential lateral roof deflection due to shoring wall installation and excavation is calculated following the aforementioned letter as:

$$\Delta_R = \Delta_{R-prism} - \Delta_H - \alpha T$$

where:  $\Delta_R$  is the computed differential lateral roof deflection due to shoring wall installation and excavation;  
 $\Delta_{R-prism}$  is the differential lateral roof deflection obtained from prism data;  
 $\Delta_H$  is the average differential horizontal movement "at-grade";  
 $\alpha$  is the weekly lateral roof deflection rate (computed as described below); and,  
 $T$  is the number of weeks since initiation of shoring wall installation or excavation.

The time frame over which  $\alpha$  is computed changes depending on the phase of the work, as specified in the aforementioned letter. For the construction phase during which the shoring wall is installed (currently ongoing),  $\alpha$  is computed from the two months of monitoring conducted immediately prior to the shoring wall installation (i.e., monitoring data from February 22, 2022, through April 25, 2022). During the excavation phase (to occur in the future),  $\alpha$  will be readjusted to reflect the recorded lateral roof deflection rate in the two months immediately preceding the start of excavation (dates to be determined).

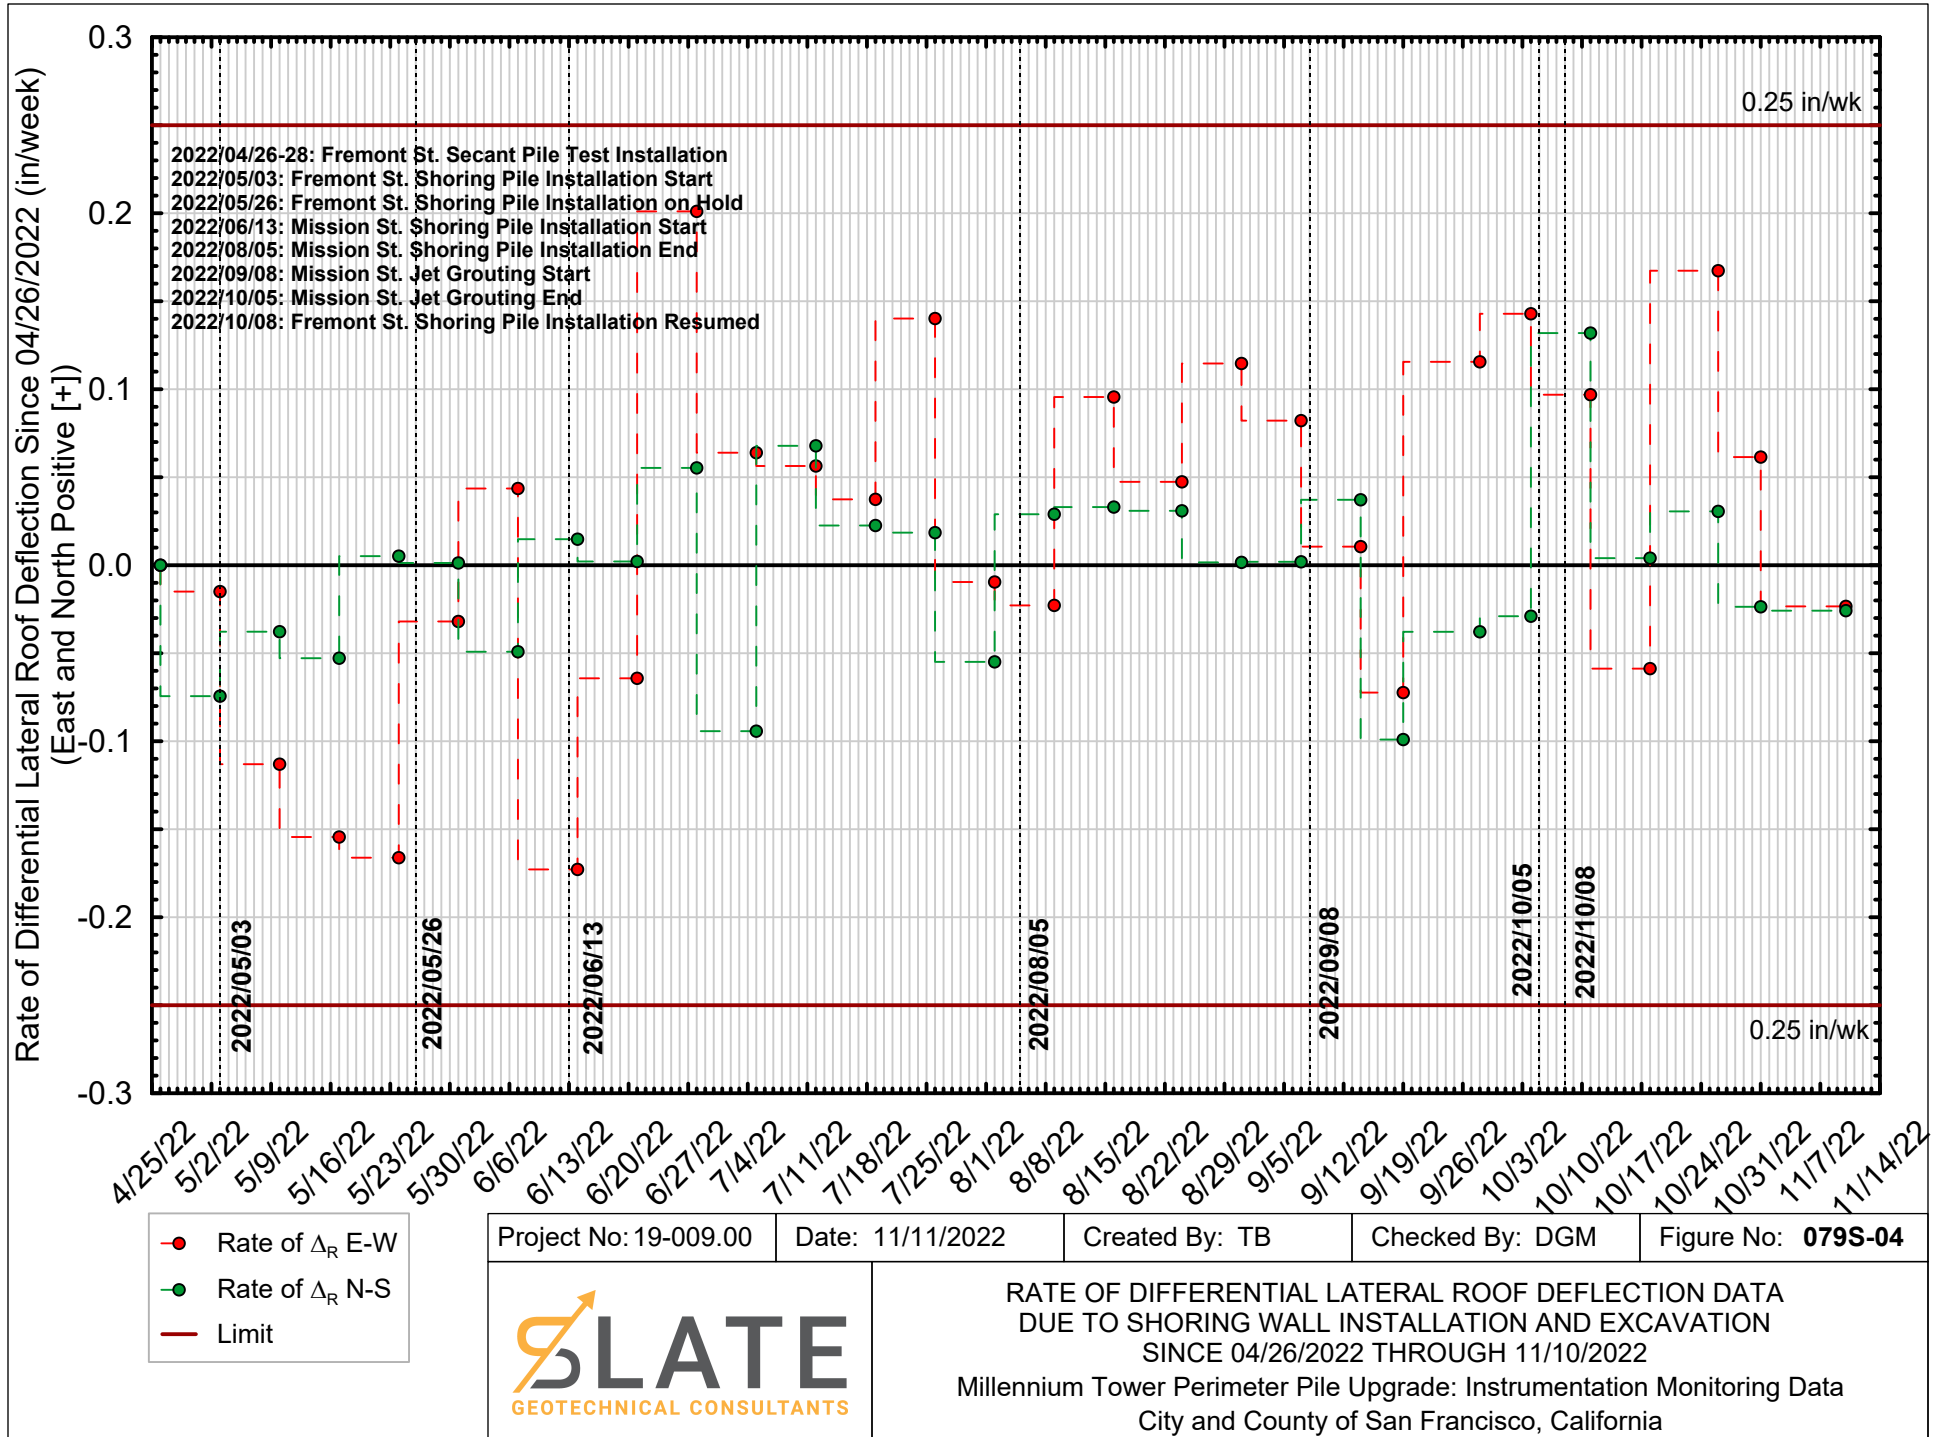
Figure S-04 – Rate of Differential Lateral Roof Deflection Data due to Shoring Wall Installation and Excavation since 04/26/2022 through 11/10/2022

Figure S-04 presents rates of differential lateral roof deflection data due to shoring wall installation and excavation since April 26, 2022, through November 10, 2022. Limits established in the aforementioned letter are included for reference. Note that the rates are calculated as:

$$\frac{d\Delta_R}{dT} \approx \frac{\Delta_{R,t} - \Delta_{R,t-1}}{T_t - T_{t-1}}$$

where:  $t$  is an index representing the current instance in time; and  
 $t - 1$  is an index representing the previous instance in time.
