Project Number: 19-009

Subject: 301 Mission Retrofit Supplemental Monitoring Report 080: Results as of November 16, 2022

Millennium Tower Perimeter Pile Upgrade: Instrumentation Monitoring Data
City and County of San Francisco, California

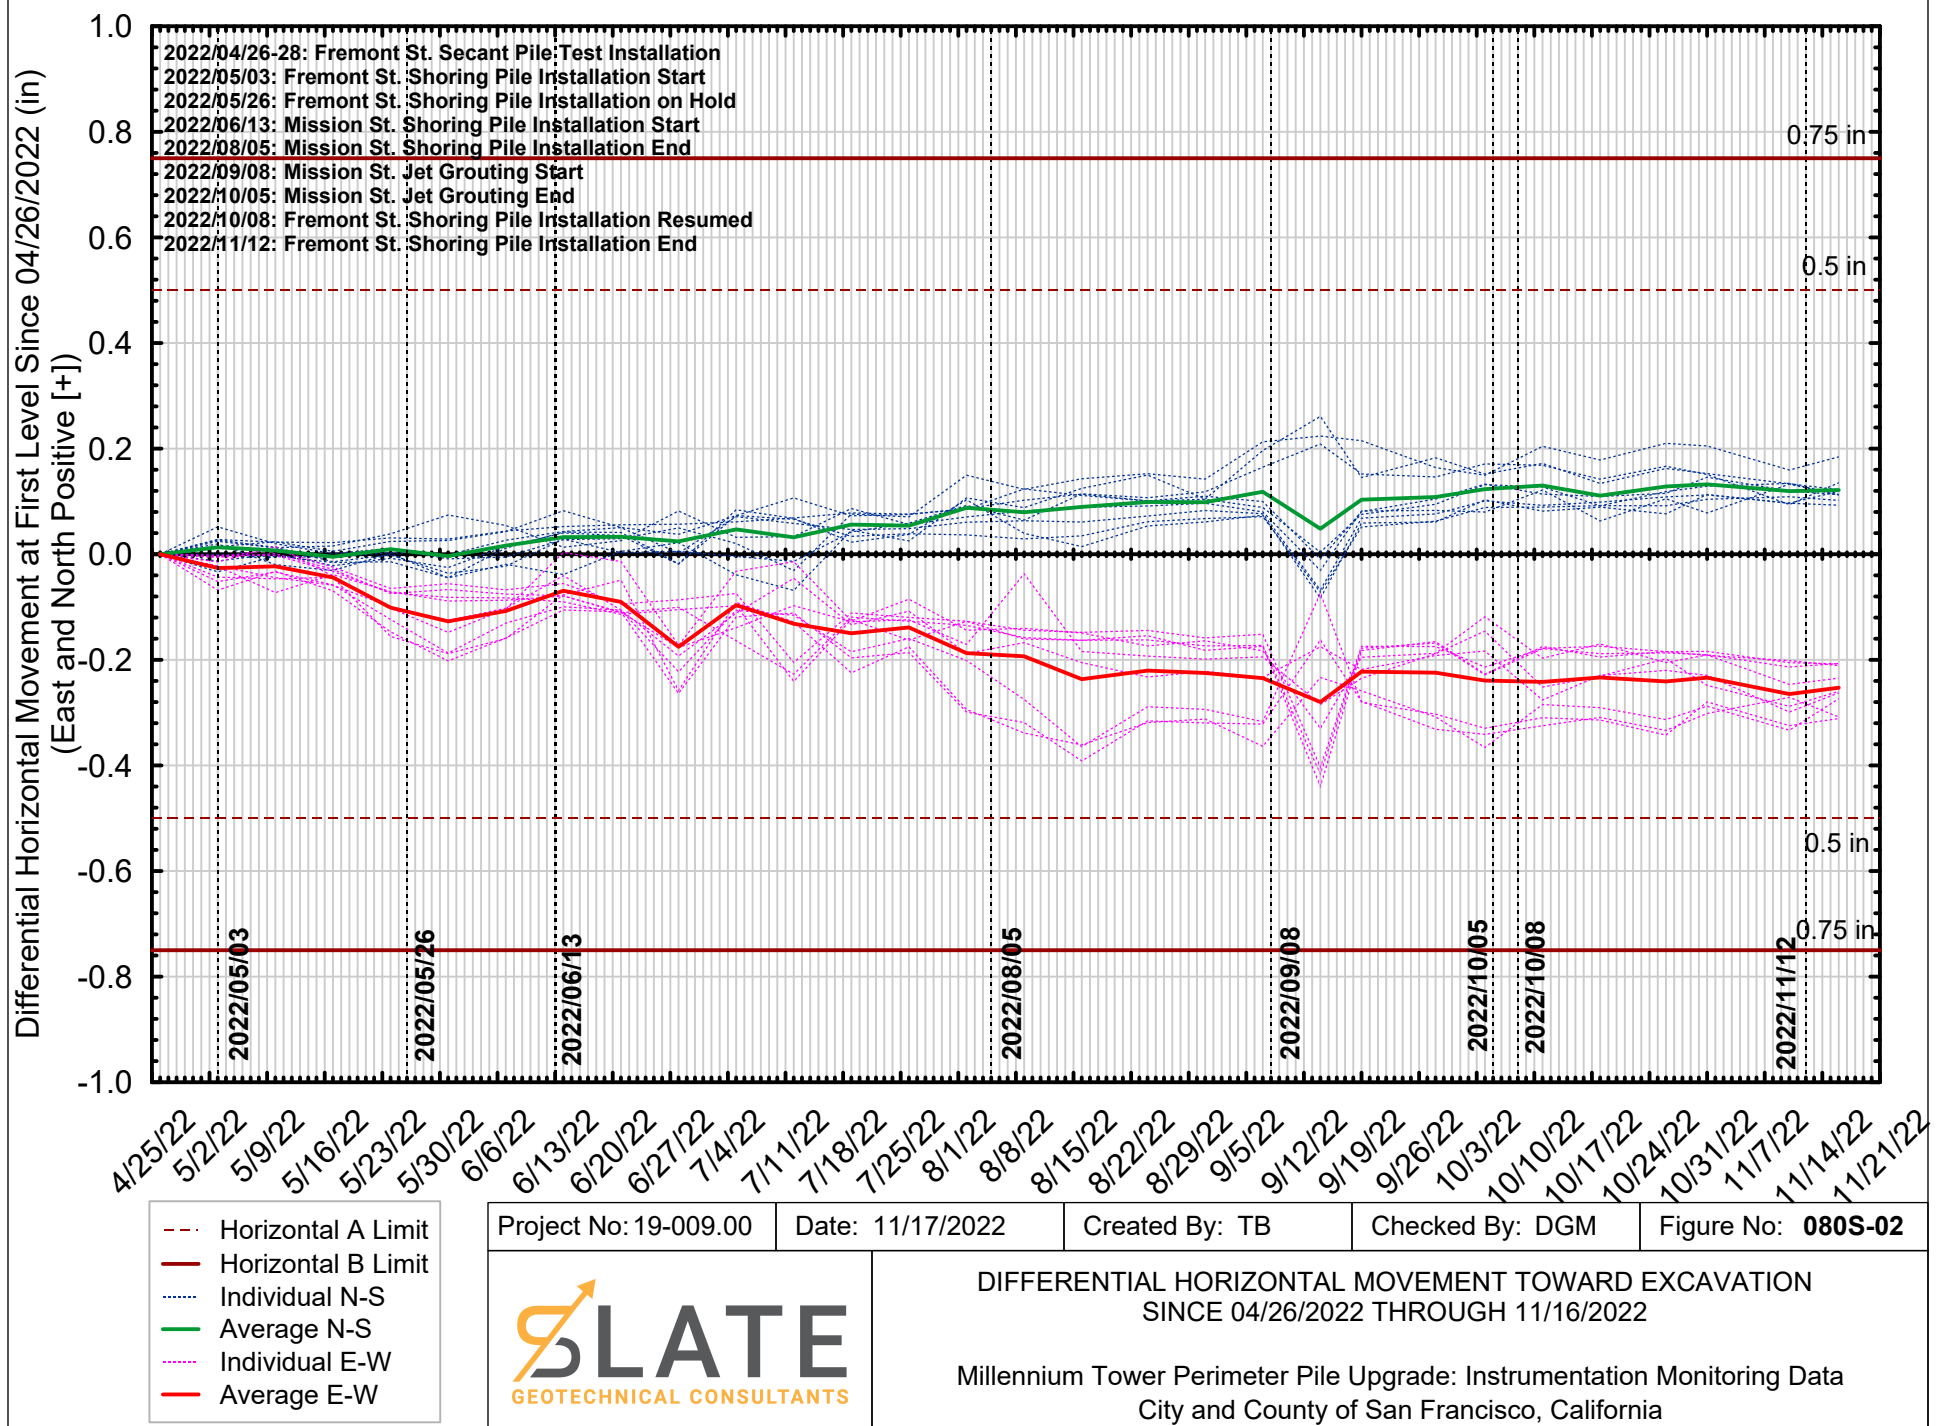
Figure S-02 – Differential Horizontal Movement Toward Excavation Since 04/26/2022 through 11/16/2022

Figure S-02 presents the differential horizontal movement toward the excavation at survey prisms installed at approximately one floor level above grade on the exterior of the building, as well as the average in each of the project north-south and east-west direction, since April 26, 2022, through November 16, 2022. Limits established in the aforementioned letter are included for reference.

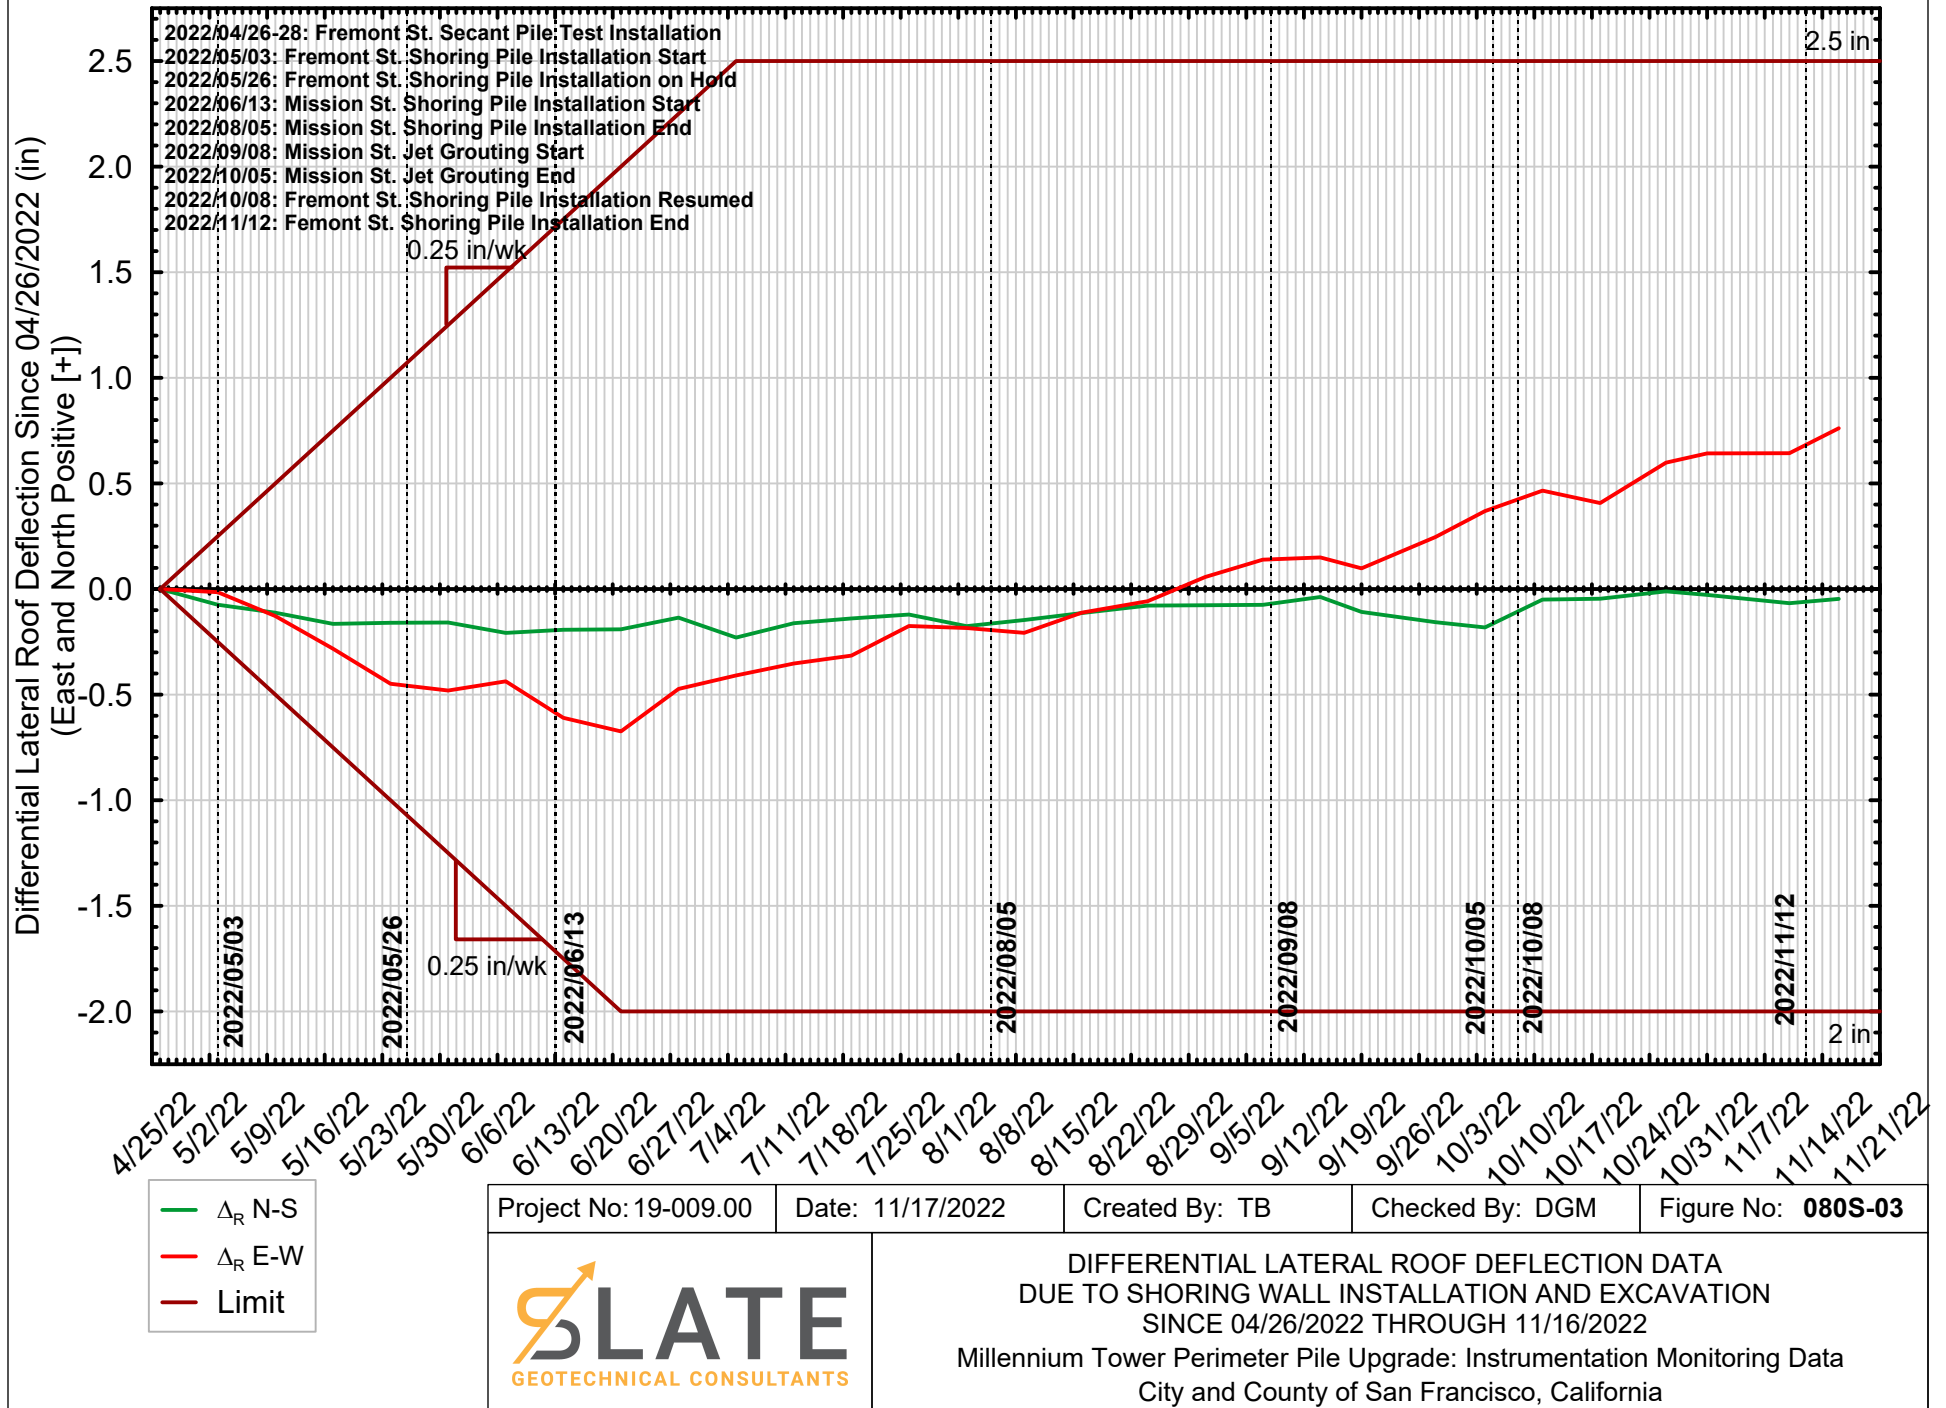
Figure S-03 – Differential Lateral Roof Deflection Data due to Shoring Wall Installation and Excavation since 04/26/2022 through 11/16/2022

Figure S-03 presents differential lateral roof deflection data due to shoring wall installation and excavation since April 26, 2022, through November 16, 2022. Limits established in the aforementioned letter are included for reference. Note that differential lateral roof deflection due to shoring wall installation and excavation is calculated following the aforementioned letter as:

where: Δ_R is the computed differential lateral roof deflection due to shoring wall installation and excavation;
 $\Delta_{R-prism}$ is the differential lateral roof deflection obtained from prism data;
 Δ_H is the average differential horizontal movement "at-grade";
 α is the weekly lateral roof deflection rate (computed as described below); and,
 T is the number of weeks since initiation of shoring wall installation or excavation.

The time frame over which α is computed changes depending on the phase of the work, as specified in the aforementioned letter. For the construction phase during which the shoring wall is installed (currently ongoing), α is computed from the two months of monitoring conducted immediately prior to the shoring wall installation (i.e., monitoring data from February 22, 2022, through April 25, 2022). During the excavation phase (to occur in the future), α will be readjusted to reflect the recorded lateral roof deflection rate in the two months immediately preceding the start of excavation (dates to be determined).

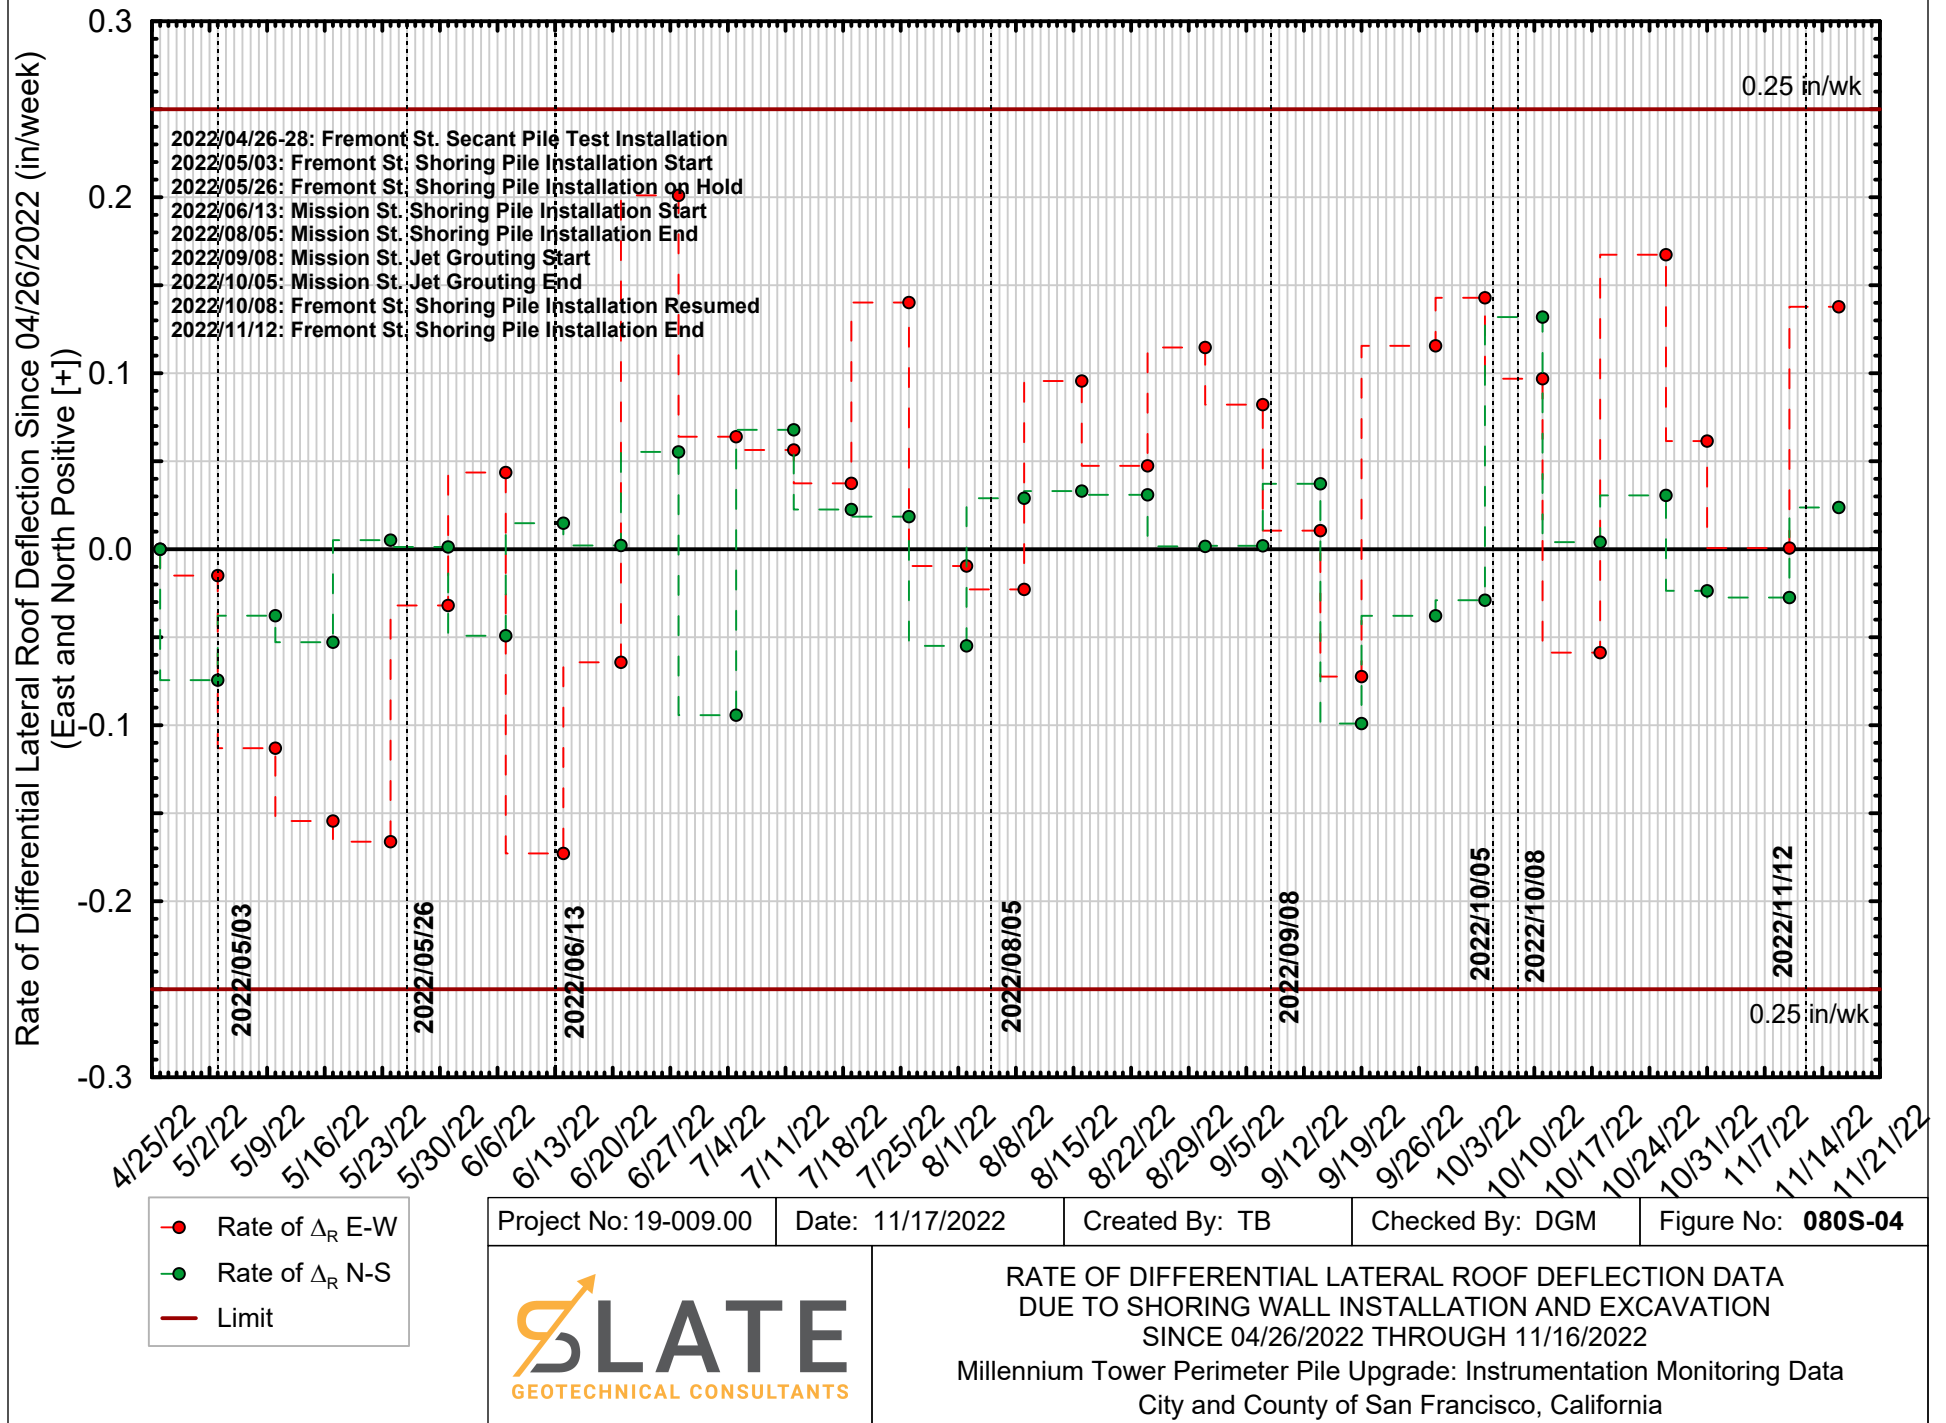
Figure S-04 – Rate of Differential Lateral Roof Deflection Data due to Shoring Wall Installation and Excavation since 04/26/2022 through 11/16/2022

Figure S-04 presents rates of differential lateral roof deflection data due to shoring wall installation and excavation since April 26, 2022, through November 16, 2022. Limits established in the aforementioned letter are included for reference. Note that the rates are calculated as:

where: t is an index representing the current instance in time; and
 $t - 1$ is an index representing the previous instance in time.
