Date: June 07, 2021
Project Number: 19-009
Subject: 301 Mission Retrofit Monitoring Report 005: Results as of June 04, 2021

Millennium Tower Perimeter Pile Upgrade: Instrumentation Monitoring Data
City and County of San Francisco, California

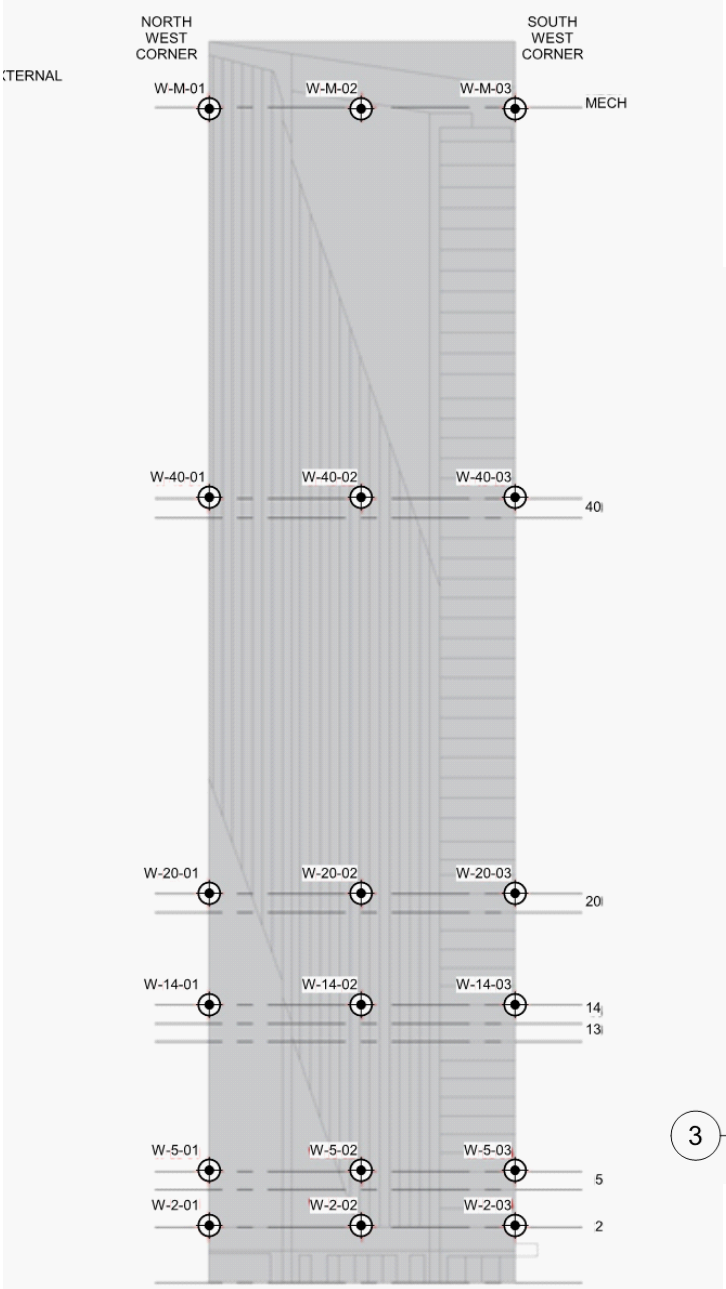
Project No: 19-009.00	Date: 5/10/2021	Created By: NBW	Checked By: DGM	Figure No: **005-01A**

INSTRUMENT LOCATION MAP
SETTLEMENT MARKERS, PIEZOMETERS, EXTENSOMETERS

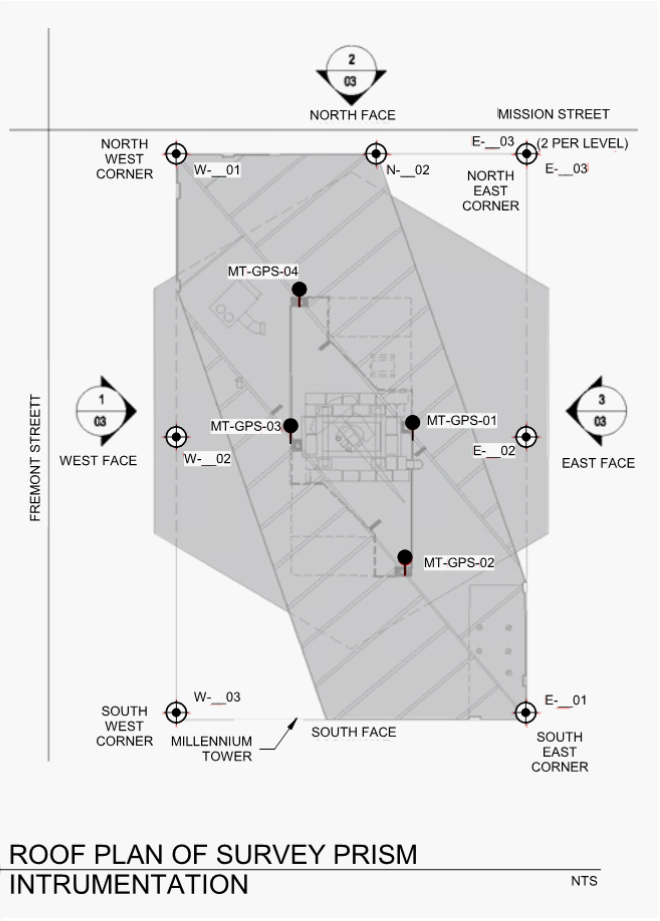
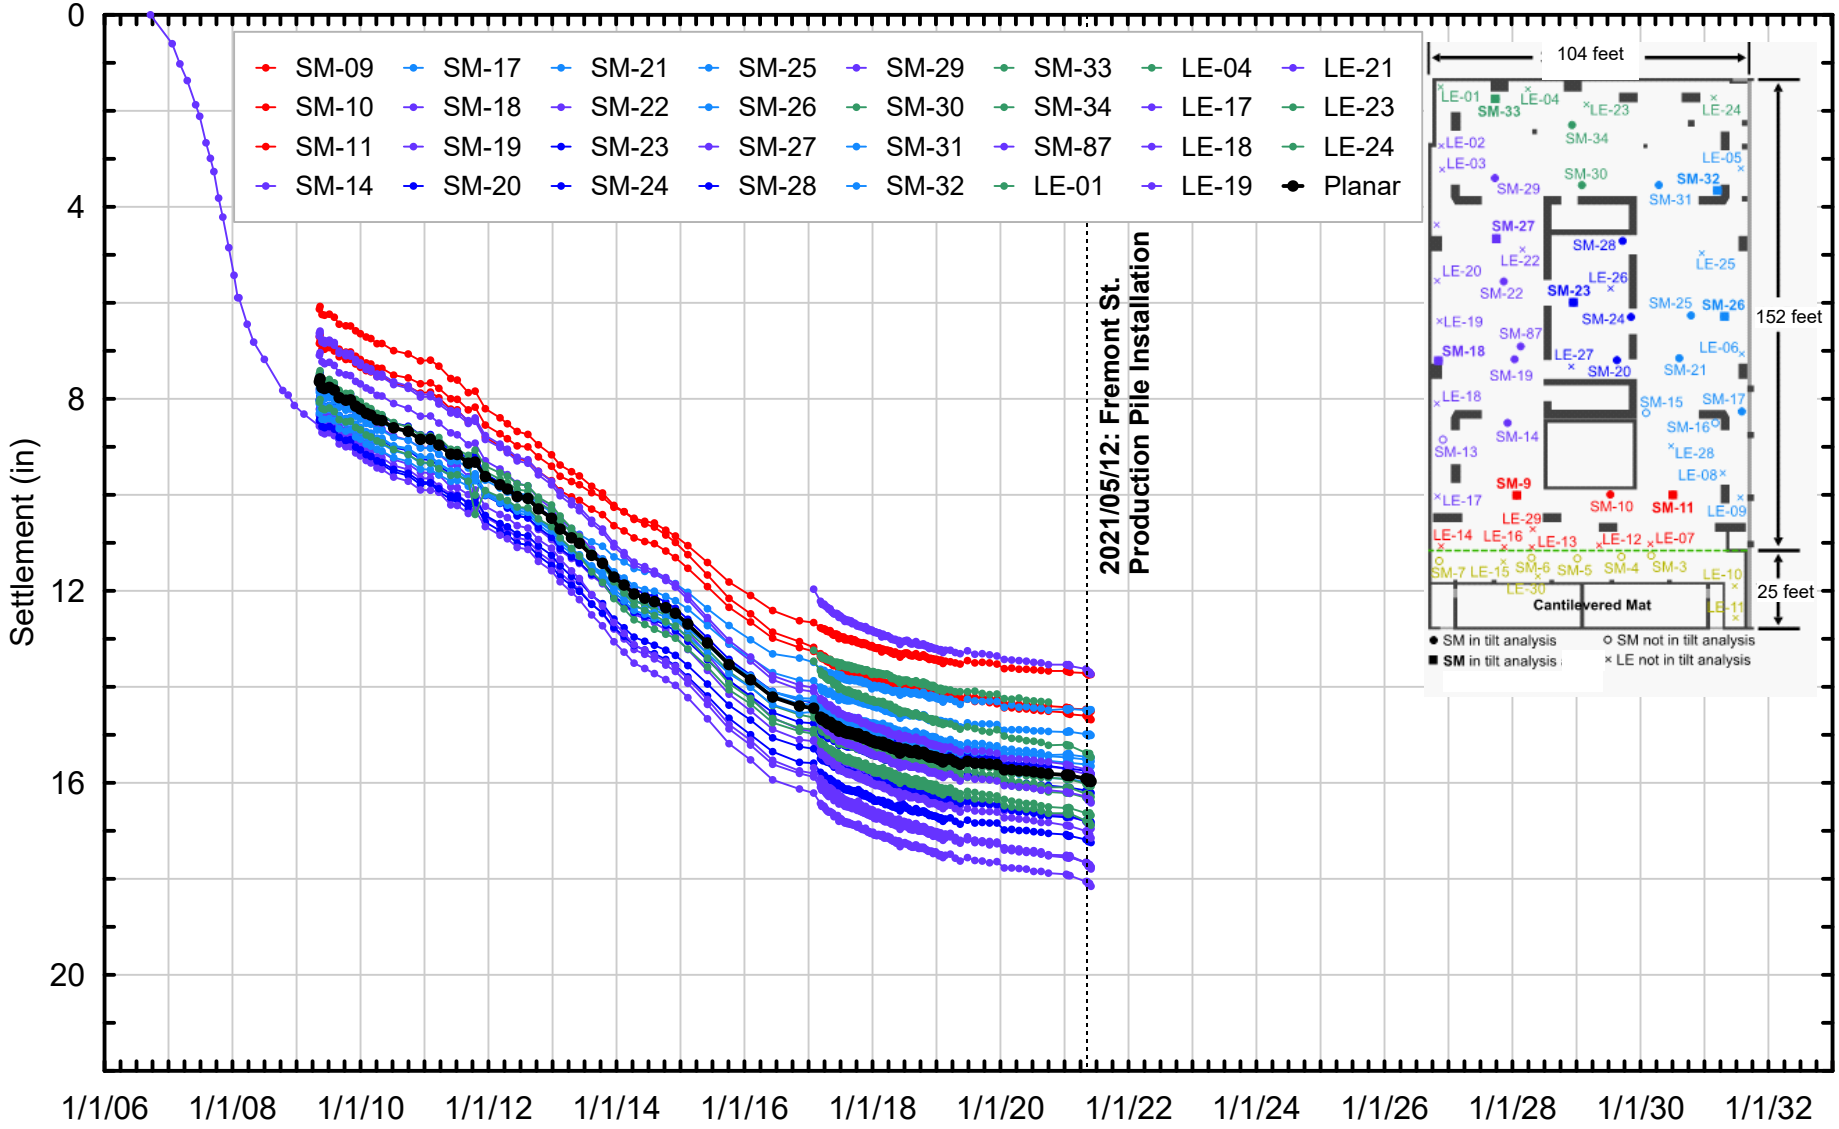
Project No: 19-009.00	Date: 5/10/2021	Created By: NBW	Checked By: DGM	Figure No: **005-01B**

TOWER SURVEY PRISM LOCATION SCHEMATIC

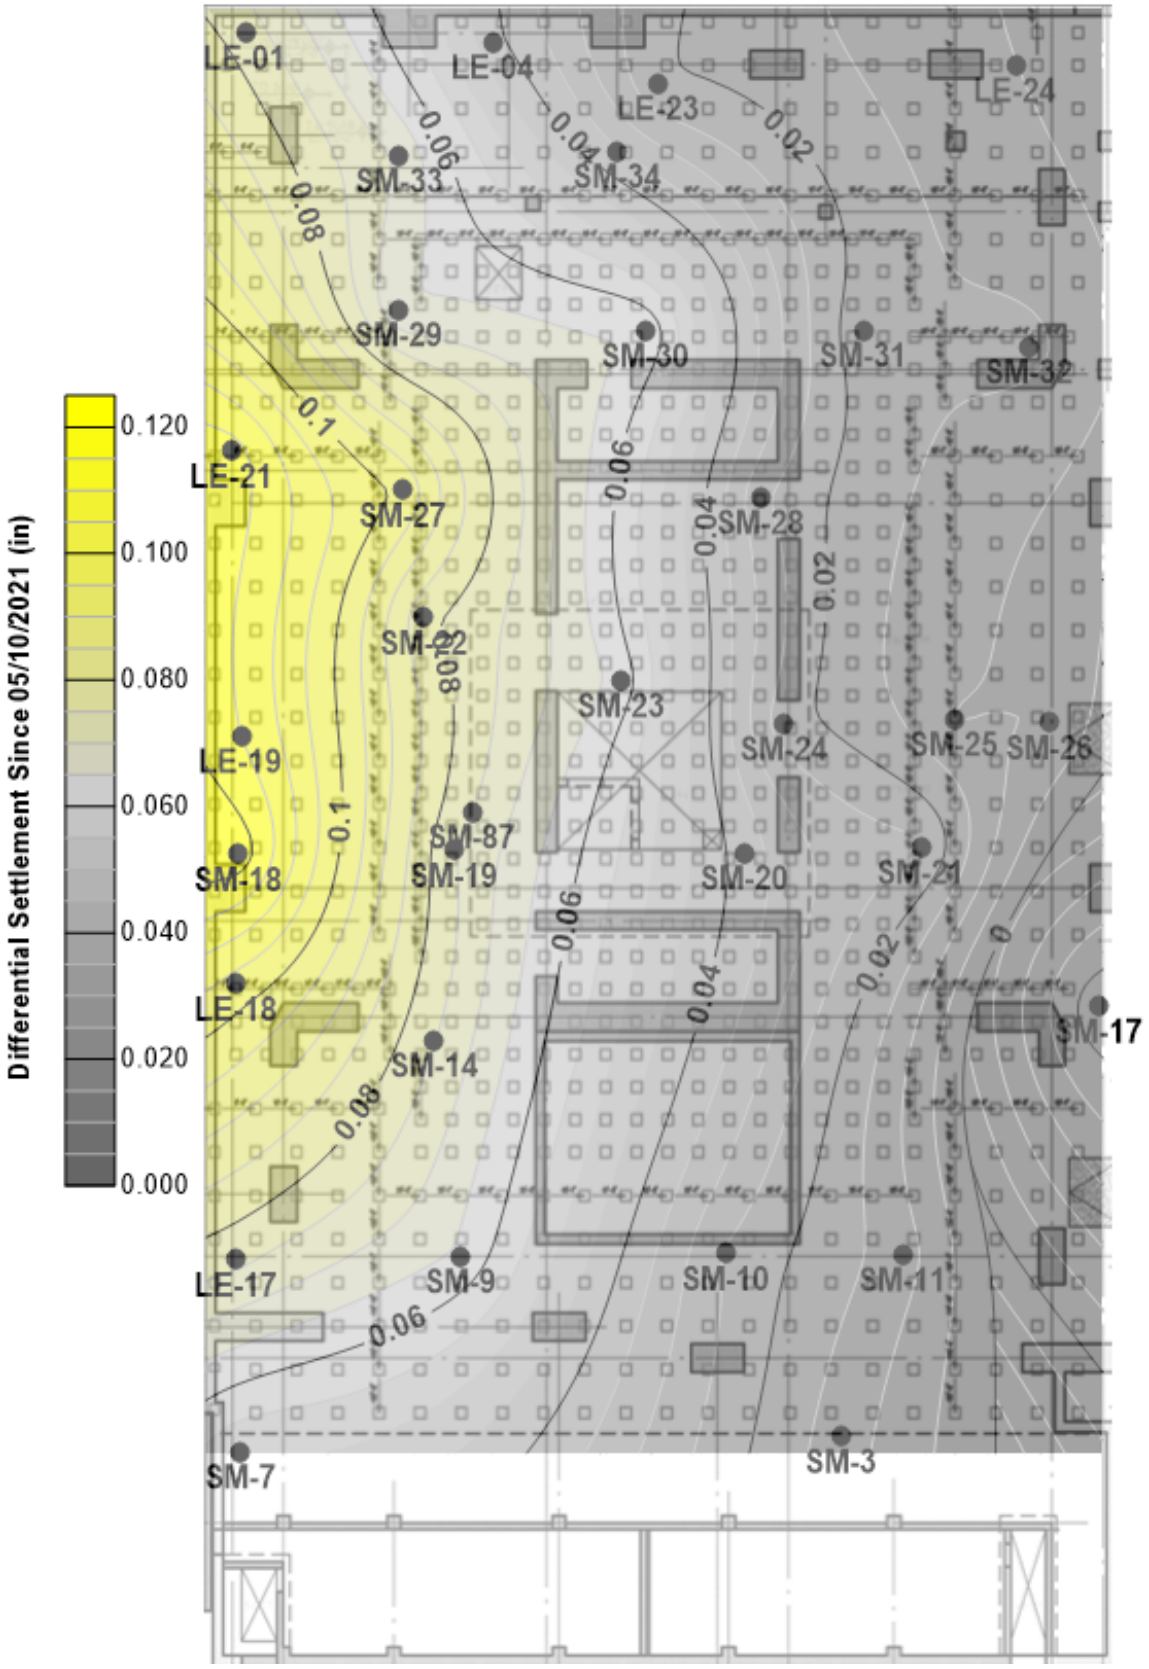
Project No: 19-009.00	Date: 6/7/2021	Created By: NBW	Checked By: DGM	Figure No: **005-03**

DIFFERENTIAL SETTLEMENT MARKER DATA
SINCE 05/10/2021 THROUGH 06/01/2021
