SLATE
GEOTECHNICAL CONSULTANTS

Date: November 23, 2022
Project Number: 19-009
Subject: 301 Mission Retrofit Monitoring Report 081: Results as of November 22, 2022

Millennium Tower Perimeter Pile Upgrade: Instrumentation Monitoring Data
City and County of San Francisco, California

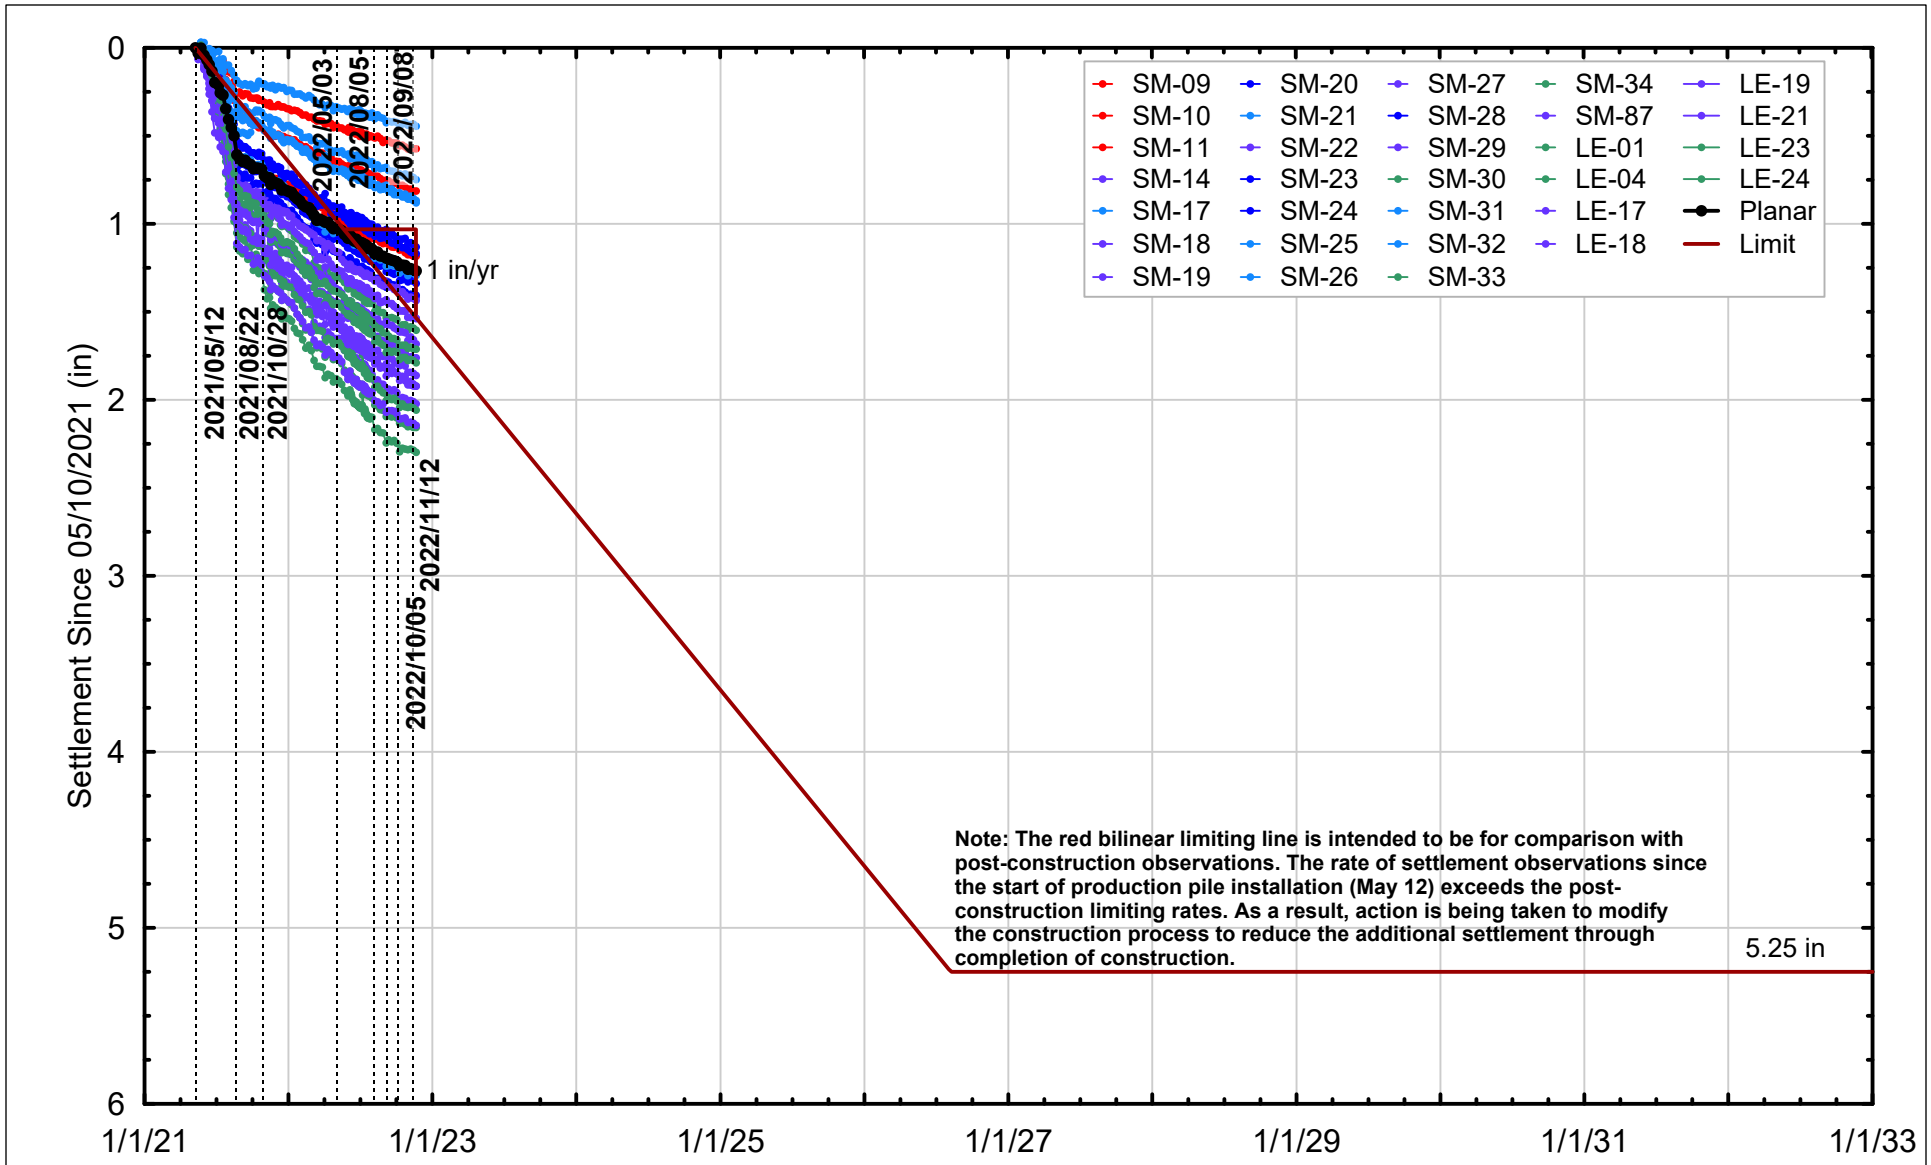
HISTORICAL SETTLEMENT MARKER DATA

Figure 02 presents the historical settlement data interpreted from settlement markers installed on the B-1 Level of 301 Mission Tower. In addition, data from surveys performed during the retrofit are included. Figure 03A presents settlement data since the start of production pile installation (May 12, 2021; baseline readings on May 10, 2021) through November 21, 2022. Figure 03B presents settlement data since January 11, 2021, through November 21, 2022. Figure 04 presents current settlement contours (in inches) on November 21, 2022.

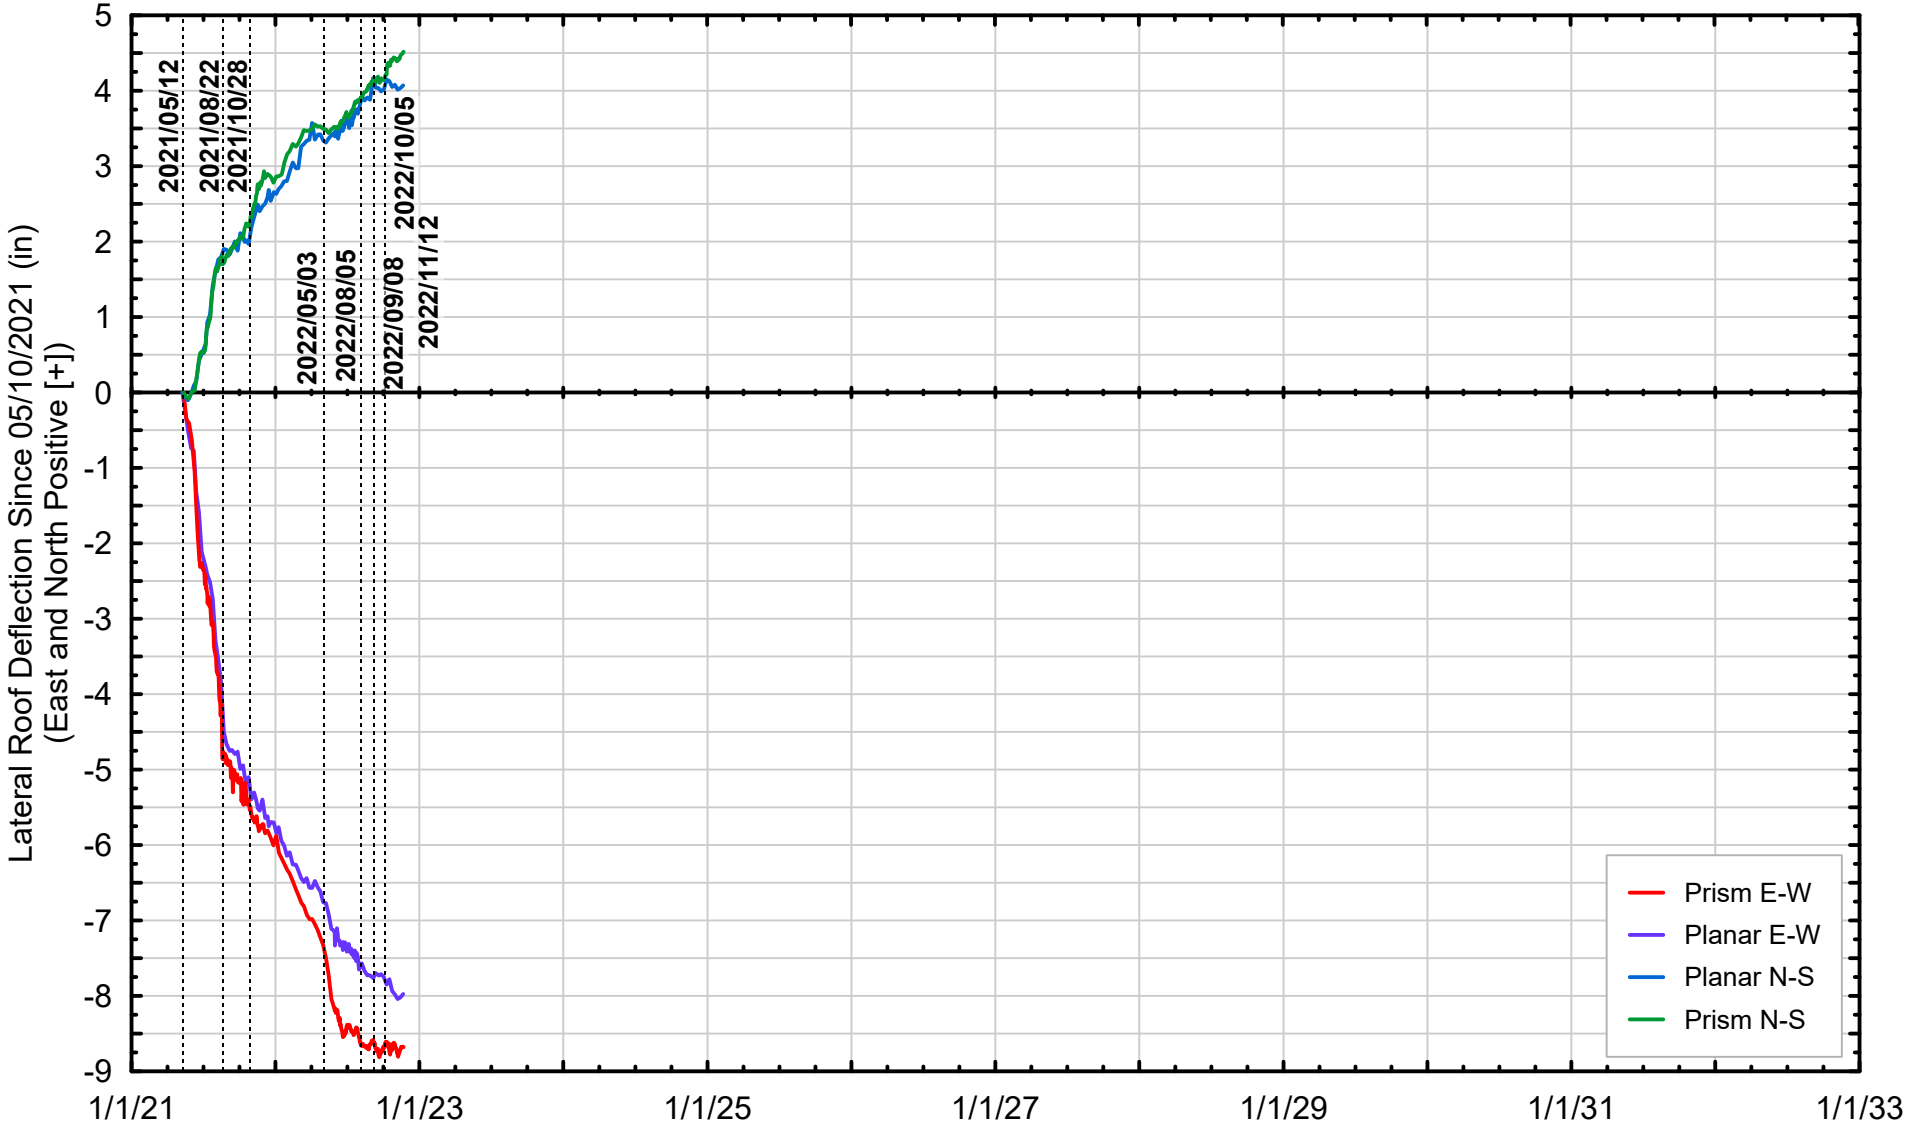
HISTORICAL LATERAL ROOF DEFLECTION DATA

Figure 05 presents historical lateral roof deflections in the project north-south and project east-west directions interpreted from survey prisms mounted on the exterior of the Tower, from InSAR data, and from a planar fit of the settlement marker data. In addition, data from surveys performed during the retrofit are included. Figure 06A presents lateral roof deflection data from a planar fit of the settlement marker data and from survey prisms mounted on the exterior of the Tower since the start of production pile installation (May 12, 2021; baseline readings on May 10 and 13, 2021, respectively) through November 22, 2022. Figure 06B presents lateral roof deflection data from a planar fit of the settlement marker data and from survey prisms mounted on the exterior of the Tower since January 11, 2021, through November 22, 2022.

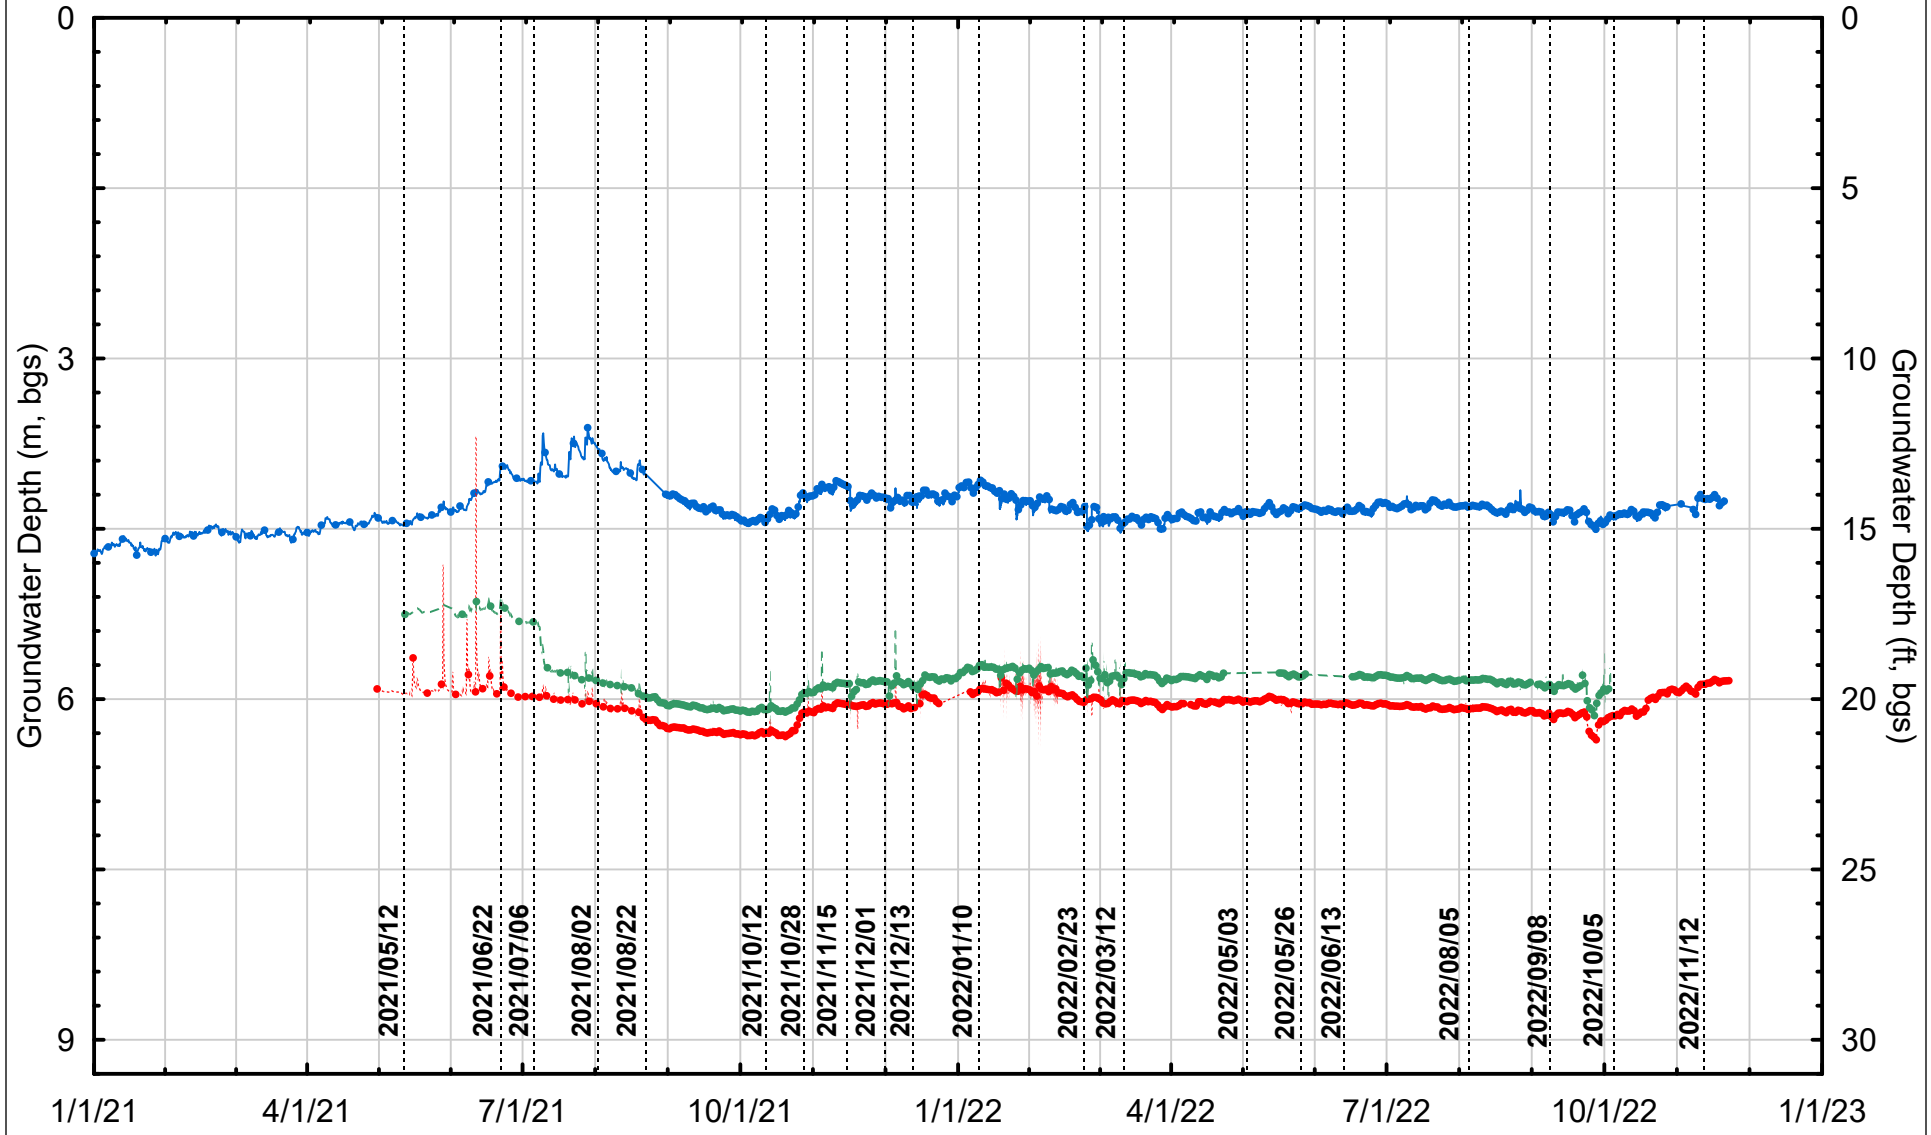
GROUNDWATER ELEVATION MEASUREMENTS IN MARINE AND COLMA SAND
SINCE 01/01/2021 THROUGH 11/22/2022

Figure 07 presents the historical groundwater elevation interpreted from piezometer readings at locations near 301 Mission. In addition, data from piezometers installed to monitor groundwater elevation during the retrofit are included. Figures 08 and 09 present groundwater elevation interpreted from piezometer readings

in the Marine/Colma Sand and the Old Bay Clay, respectively, for the time period prior to the start of production pile installation (January 1, 2021) through November 22, 2022.

Note that the Mission Street piezometer, PB-2, has been offline since October 3, 2022. Mission Street extensometer, EB-2, has been offline since November 11, 2022; work to correct this is ongoing. Please contact us if you have any comments or questions, or if you would like to discuss the results presented in this memorandum.

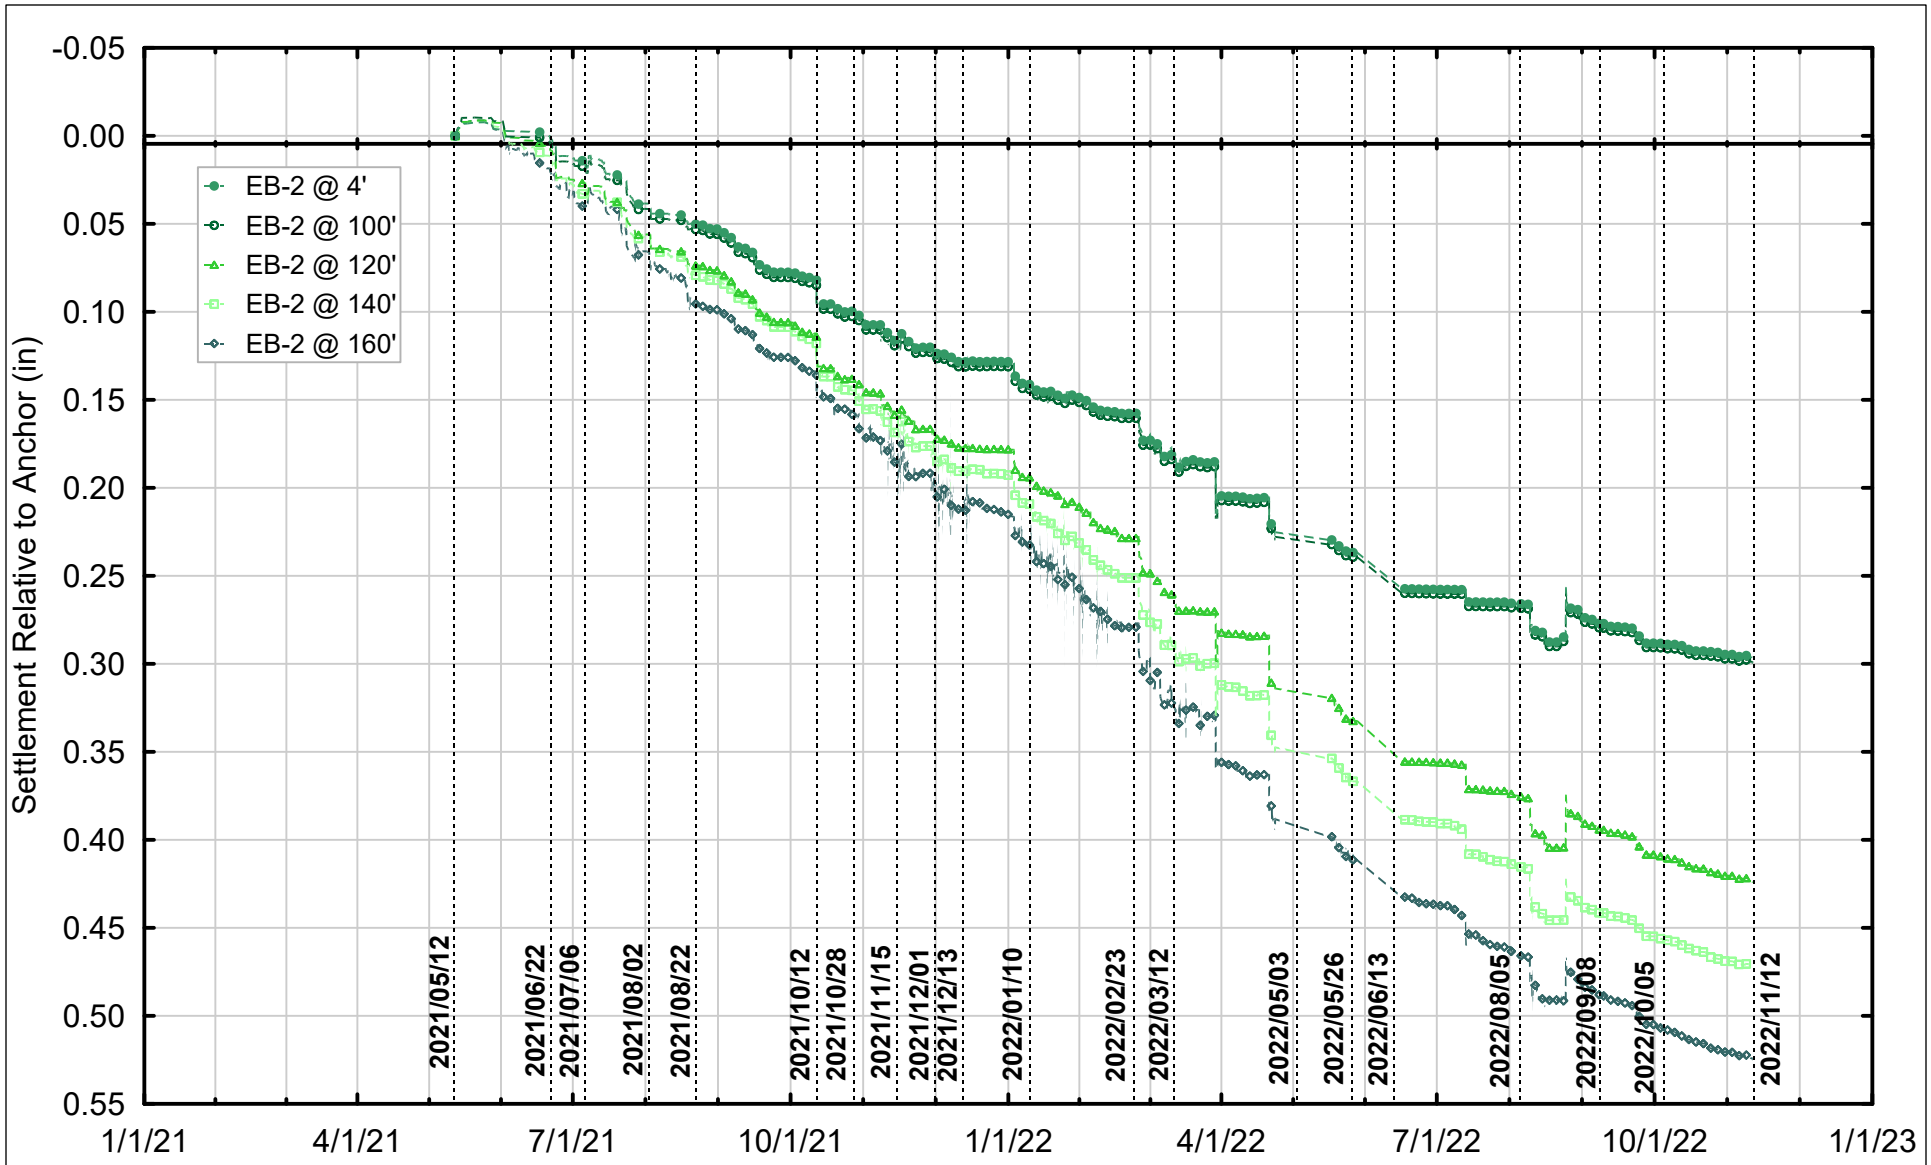
EXTENSOMETER DATA FROM MISSION STREET
SINCE 01/01/2021 THROUGH 11/11/2022

Figure 10 presents extensometer data from within the Tower basement since the start of production pile installation (May 12, 2021) through November 21, 2022. Figure 11 presents extensometer data from Fremont Street since the start of production pile installation (May 12, 2021) through November 21, 2022. Figure 12 presents extensometer data from Mission Street since the start of production pile installation (May 12, 2021) through November 11, 2022.
