Project Number: 19-009

Subject: 301 Mission Retrofit Monitoring Report 019: Results as of September 14, 2021

Millennium Tower Perimeter Pile Upgrade: Instrumentation Monitoring Data  
City and County of San Francisco, California

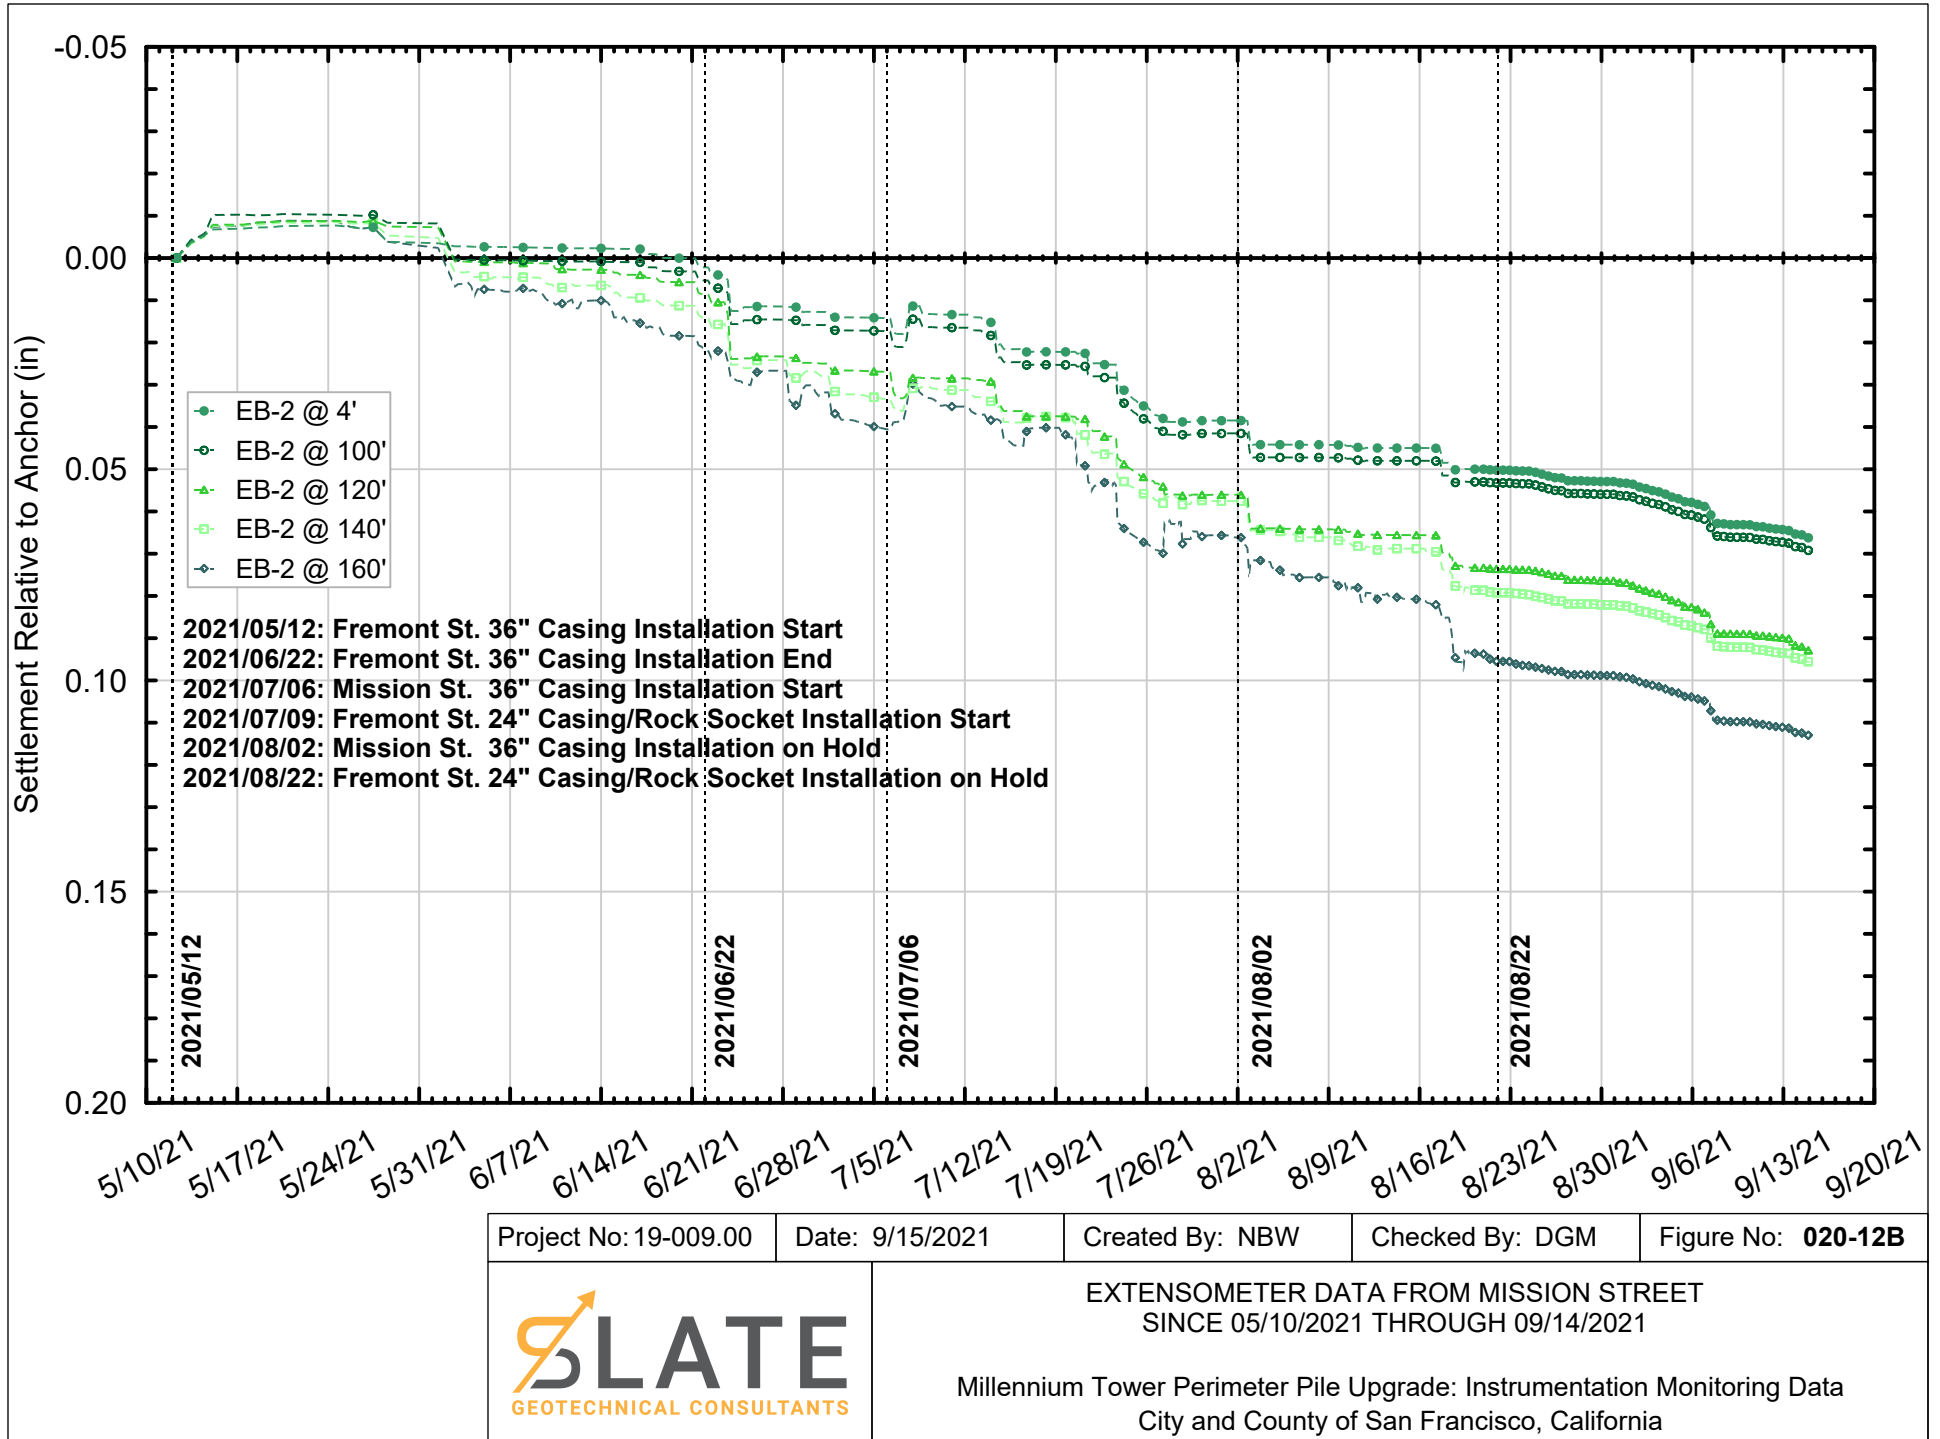
- Figure 12B – Extensometer Data from Mission Street since 05/10/2021 through 09/14/2021
