Subject: 301 Mission Retrofit Monitoring Report 023: Results as of October 5, 2021

This memorandum summarizes results from the monitoring plan implemented at the 301 Mission property. Instrumentation to monitor the structure prior to, during and after the retrofit was installed in January 2021, including piezometers and extensometers. Settlement markers installed in April 2009 and January 2017, survey prisms mounted on the exterior of the structure in December 2016, and crack gauges installed in April 2009 have also been monitored. This memorandum is for review only. It only contains ongoing monitoring information. This memorandum does not contain recommendations based upon the ongoing monitoring information.

Millennium Tower Perimeter Pile Upgrade: Instrumentation Monitoring Data  
City and County of San Francisco, California

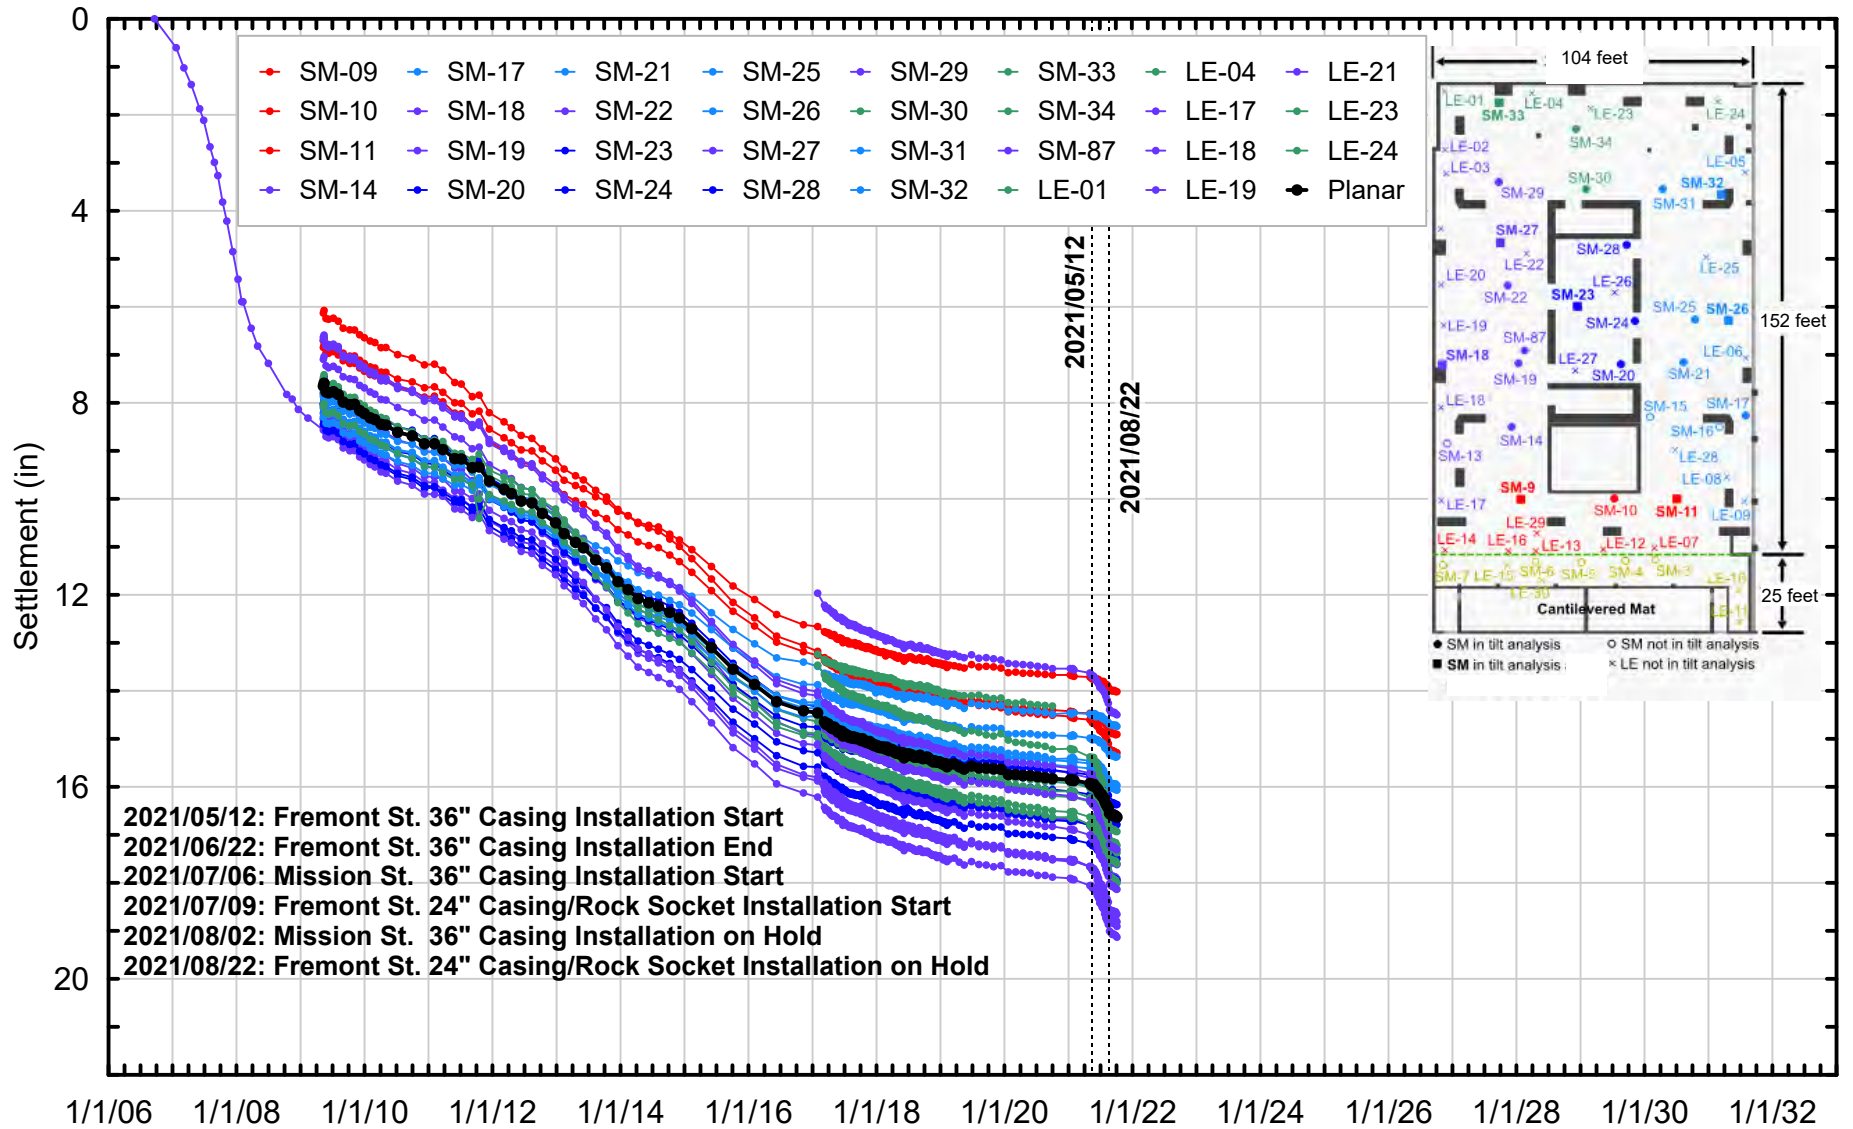
| Project No: 19-009.00 | Date: 10/6/2021 | Created By: NBW | Checked By: DGM | Figure No: <b>023-02</b> |

Figure 02 presents the historical settlement data interpreted from settlement markers installed on the B-1 Level of 301 Mission Tower. In addition, data from surveys performed during the retrofit are included. Figure 03A presents settlement data since the start of production pile installation (May 12, 2021; baseline readings on May 10, 2021) through October 4, 2021. Figure 03B presents settlement data since January 11, 2021, through October 4, 2021. Figure 04 presents current settlement contours (in inches) on October 4, 2021.

### HISTORICAL SETTLEMENT MARKER DATA

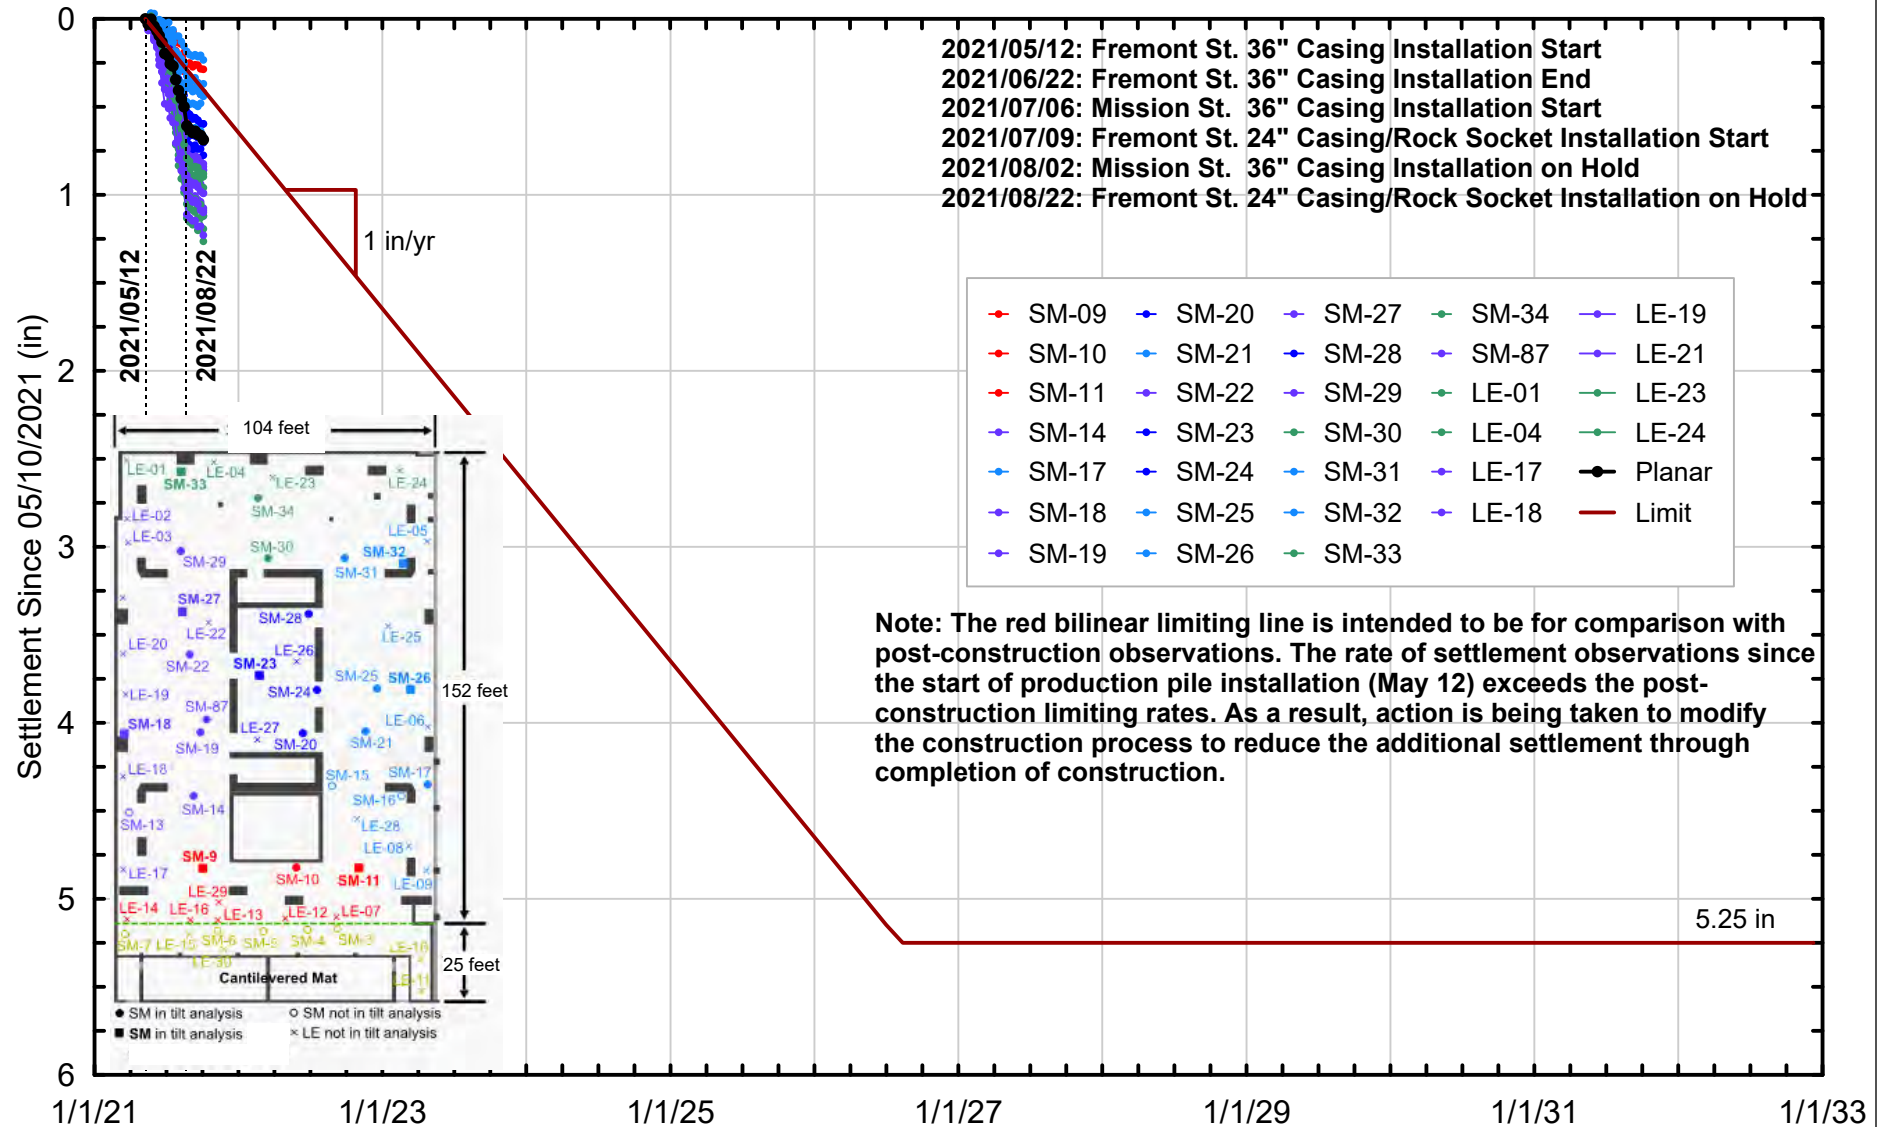
Project No: 19-009.00 Date: 10/6/2021 Created By: NBW Checked By: DGM Figure No: **023-03A**

SETTLEMENT MARKER DATA  
 SINCE 05/10/2021 THROUGH 10/04/2021

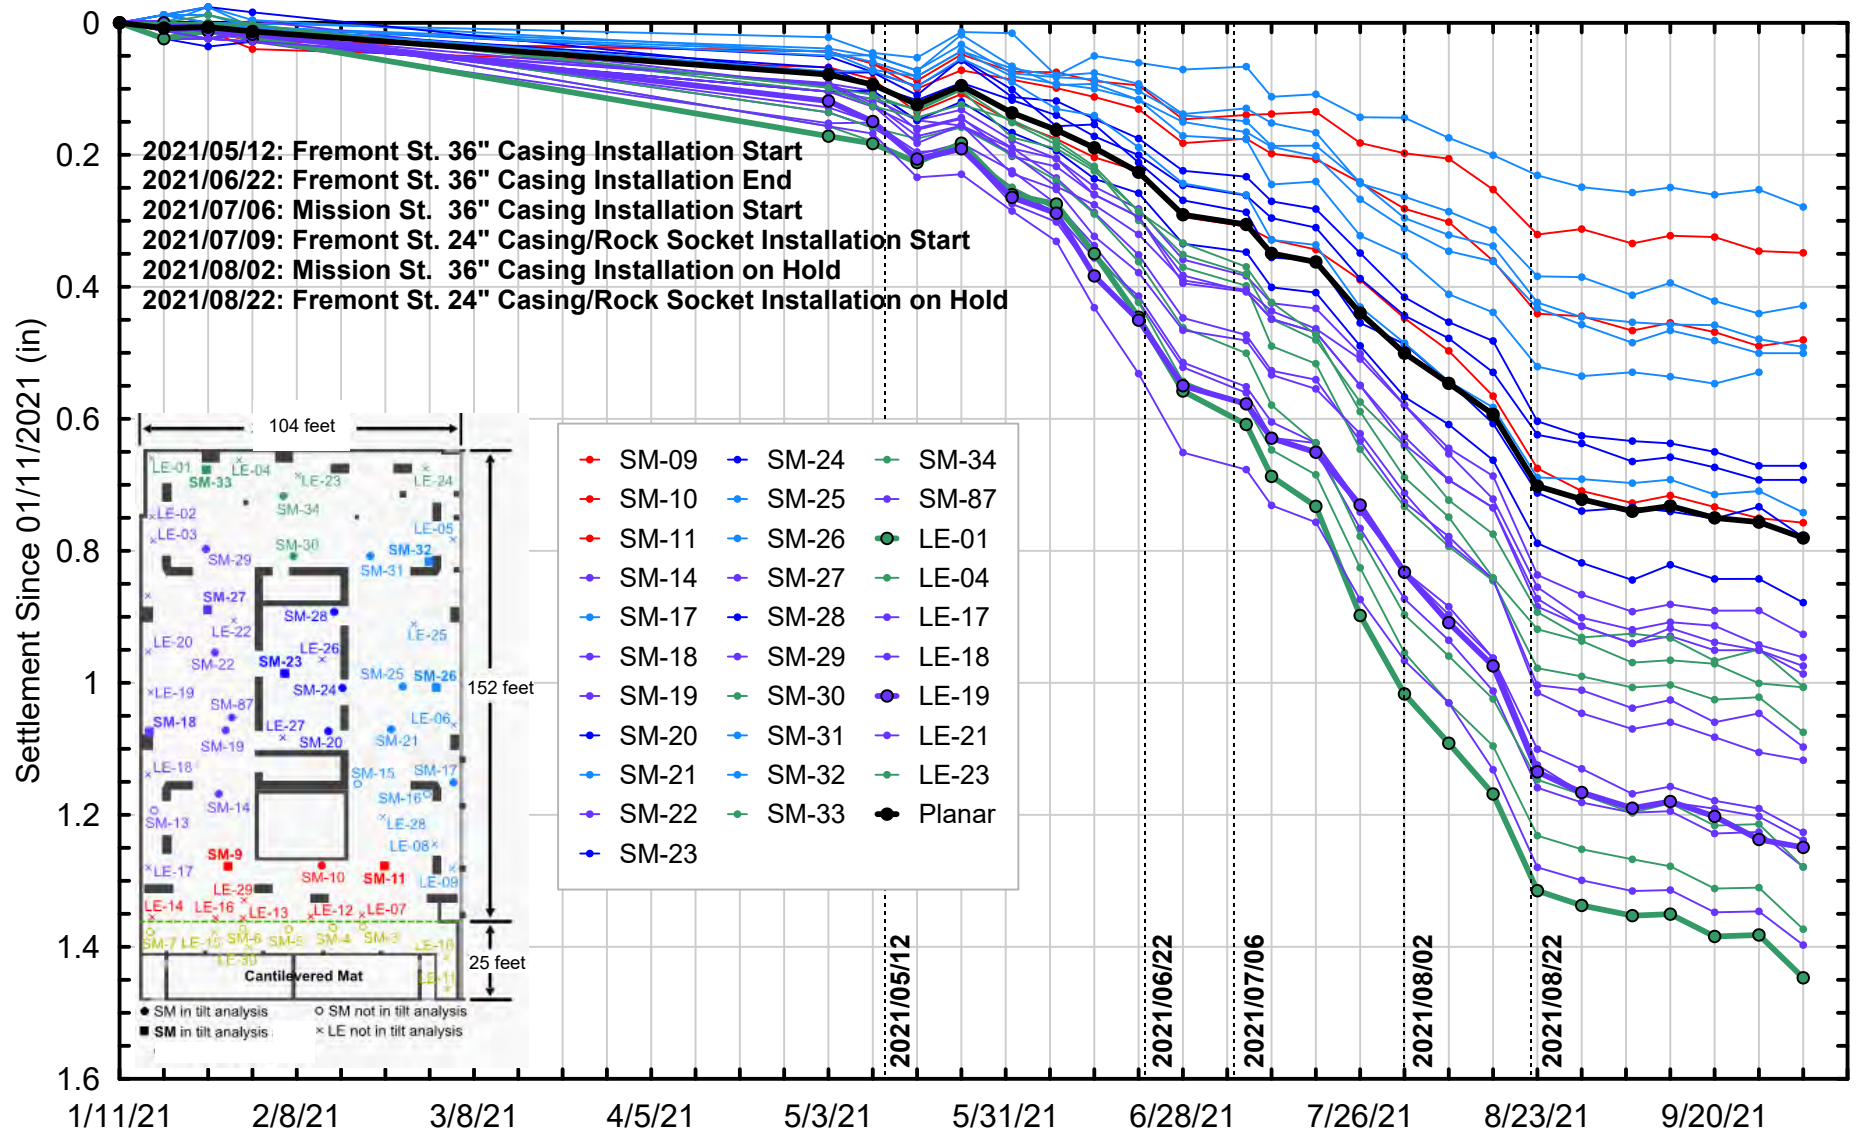
Figure No: **023-03B**

SETTLEMENT MARKER DATA  
 SINCE 01/11/2021 THROUGH 10/04/2021

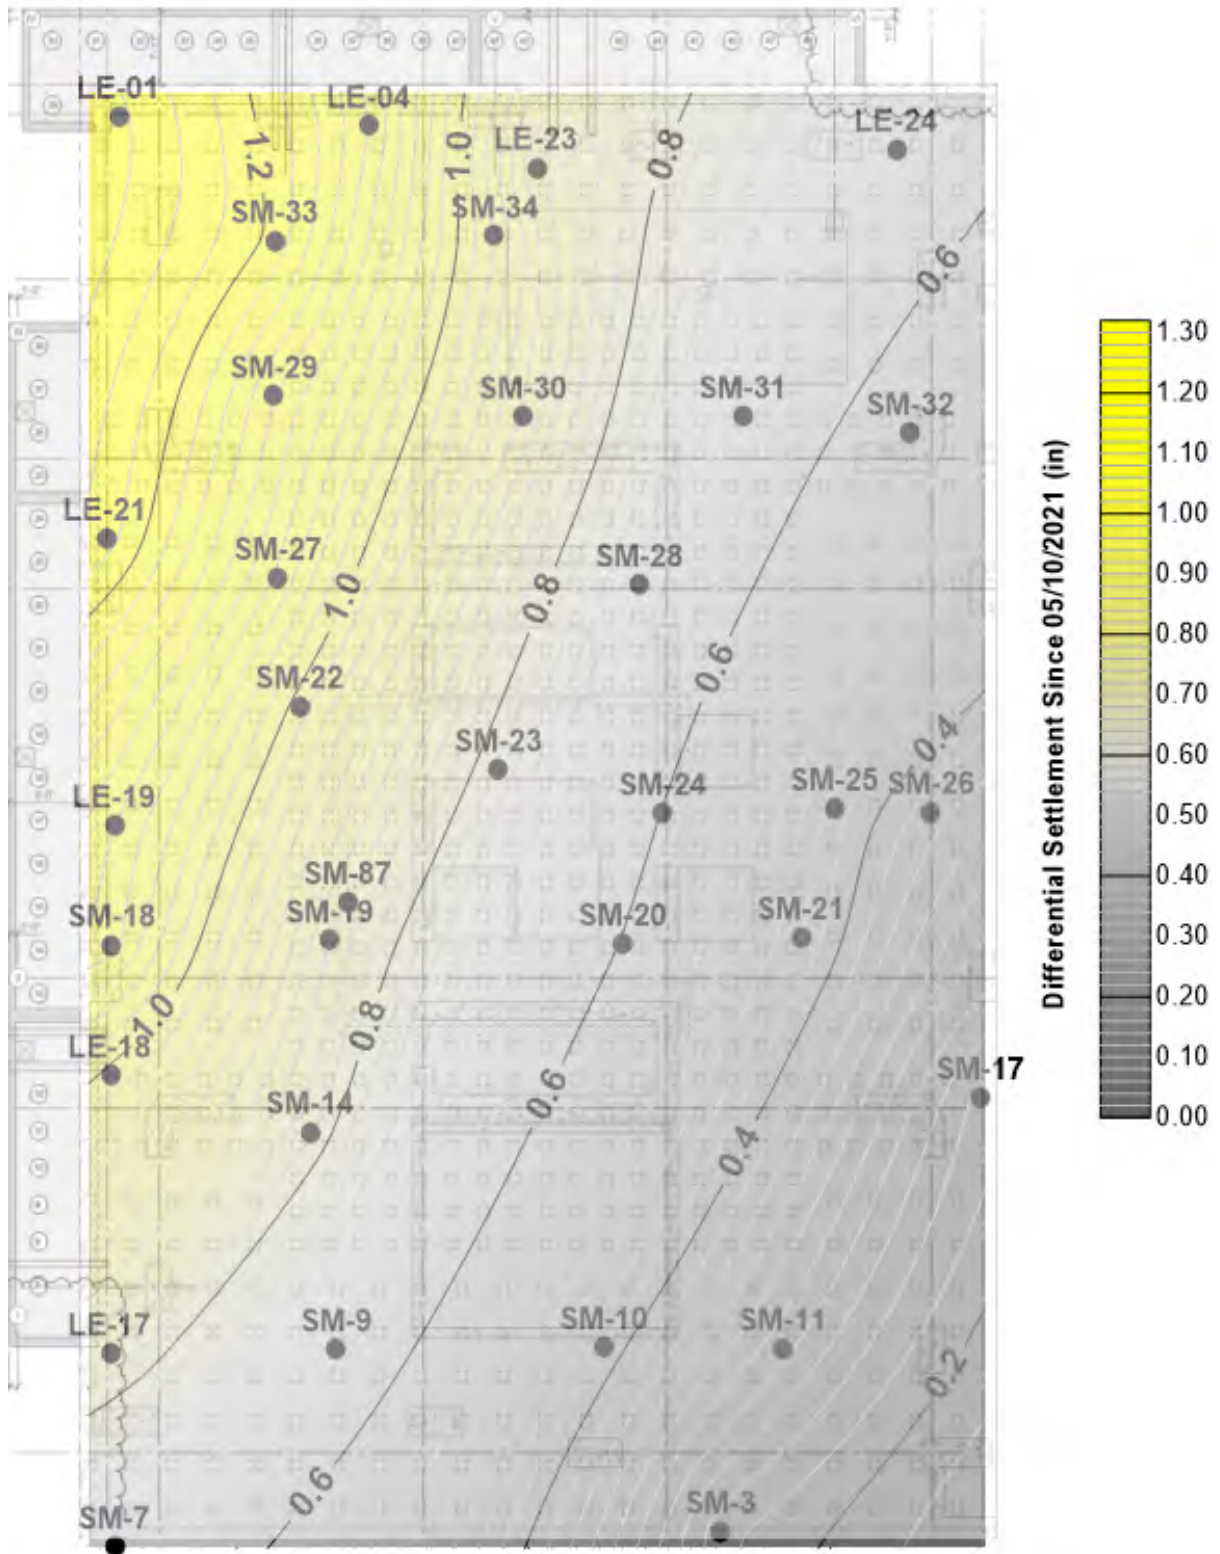
Figure No: **023-04**

SETTLEMENT CONTOURS  
SINCE 05/10/2021 THROUGH 10/04/2021

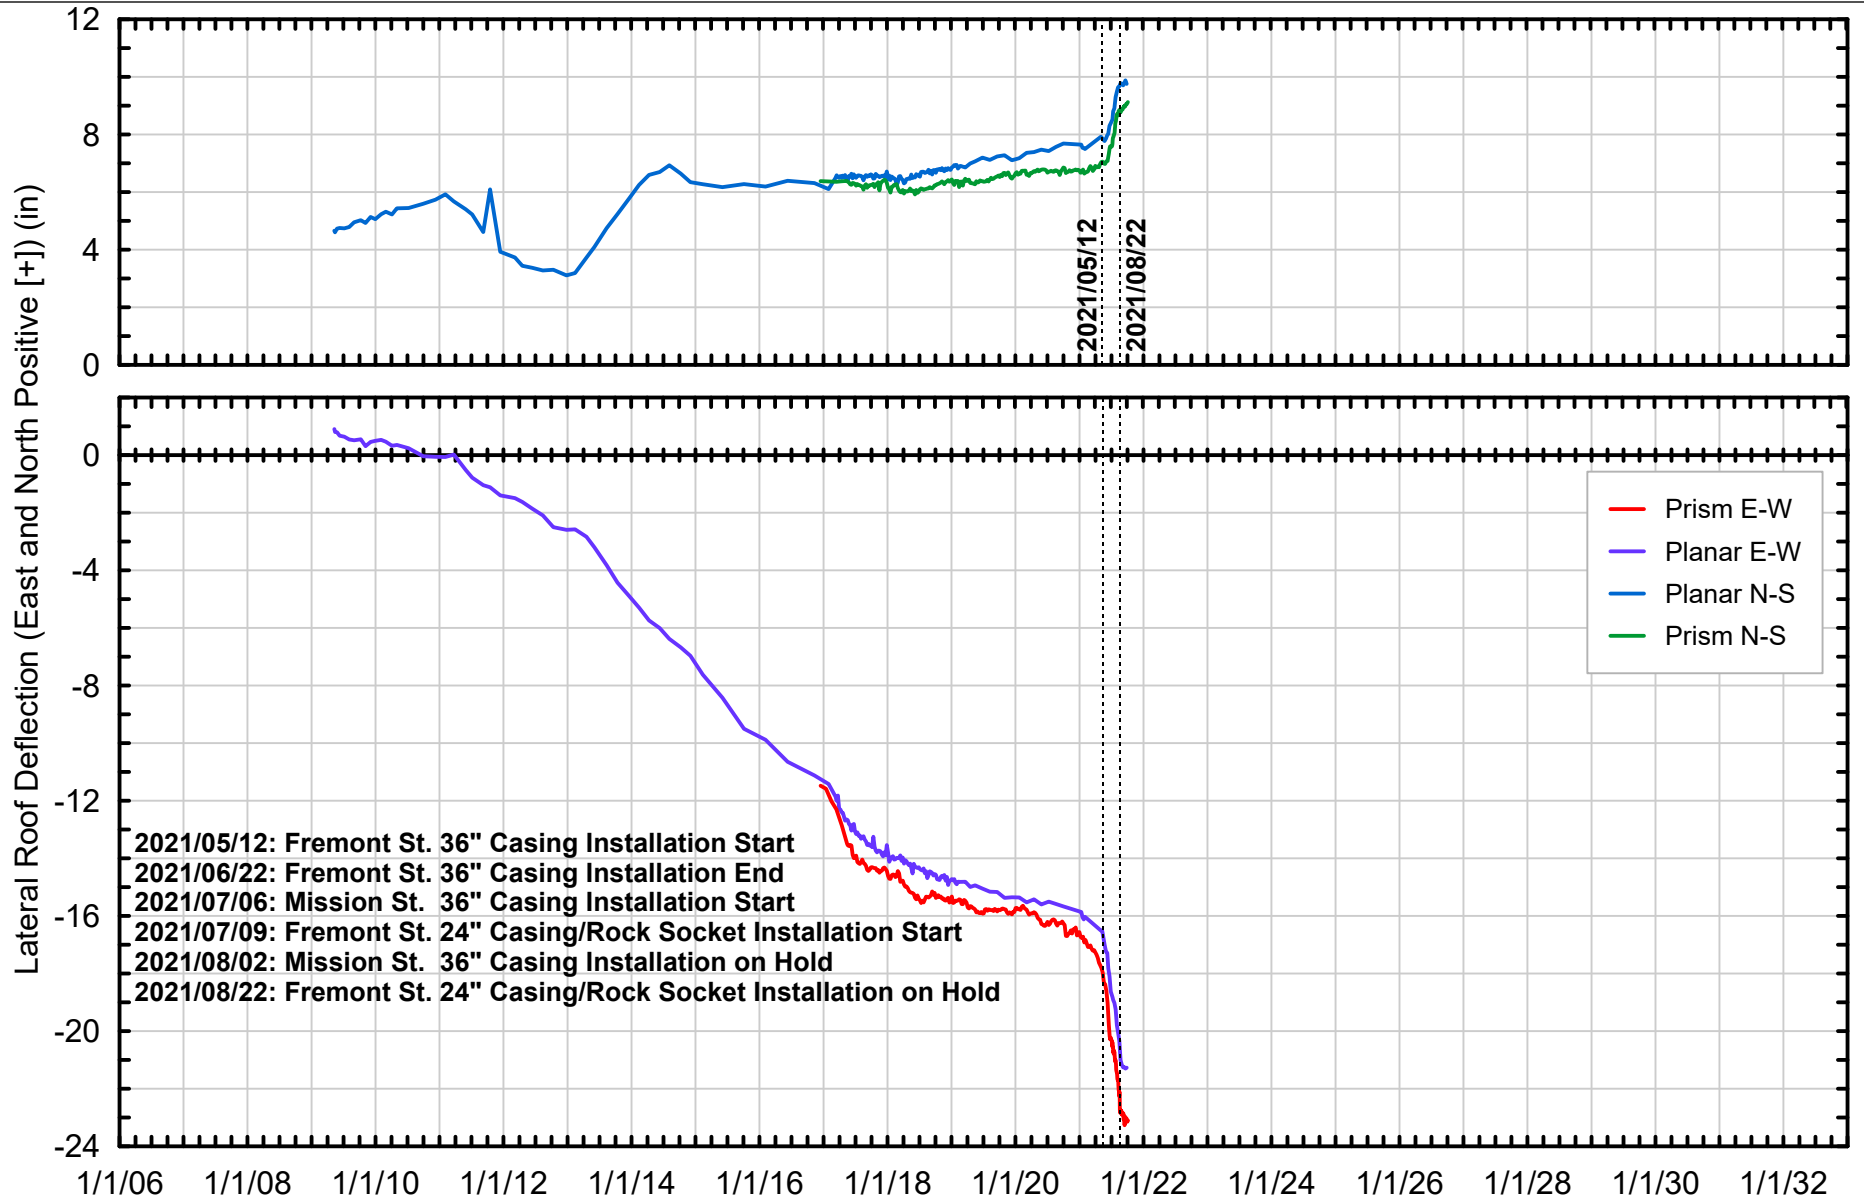
| Project No: 19-009.00 | Date: 10/6/2021 | Created By: NBW | Checked By: DGM | Figure No: <b>023-05</b> |

Figure 05 presents historical lateral roof deflections in the project north-south and project east-west directions interpreted from survey prisms mounted on the exterior of the Tower, from InSAR data, and from a planar fit of the settlement marker data. In addition, data from surveys performed during the retrofit are included. Figure 06A presents lateral roof deflection data from a planar fit of the settlement marker data and from survey prisms mounted on the exterior of the Tower since the start of production pile installation (May 12, 2021; baseline readings on May 10 and 13, 2021, respectively) through October 4, 2021. Figure 06B presents lateral roof deflection data from a planar fit of the settlement marker data and from survey prisms mounted on the exterior of the Tower since January 11, 2021, through October 4, 2021. Note that data from settlement marker SM-32 was not available as the marker was indicated in the latest survey to have been destroyed.

### HISTORICAL LATERAL ROOF DEFLECTION DATA

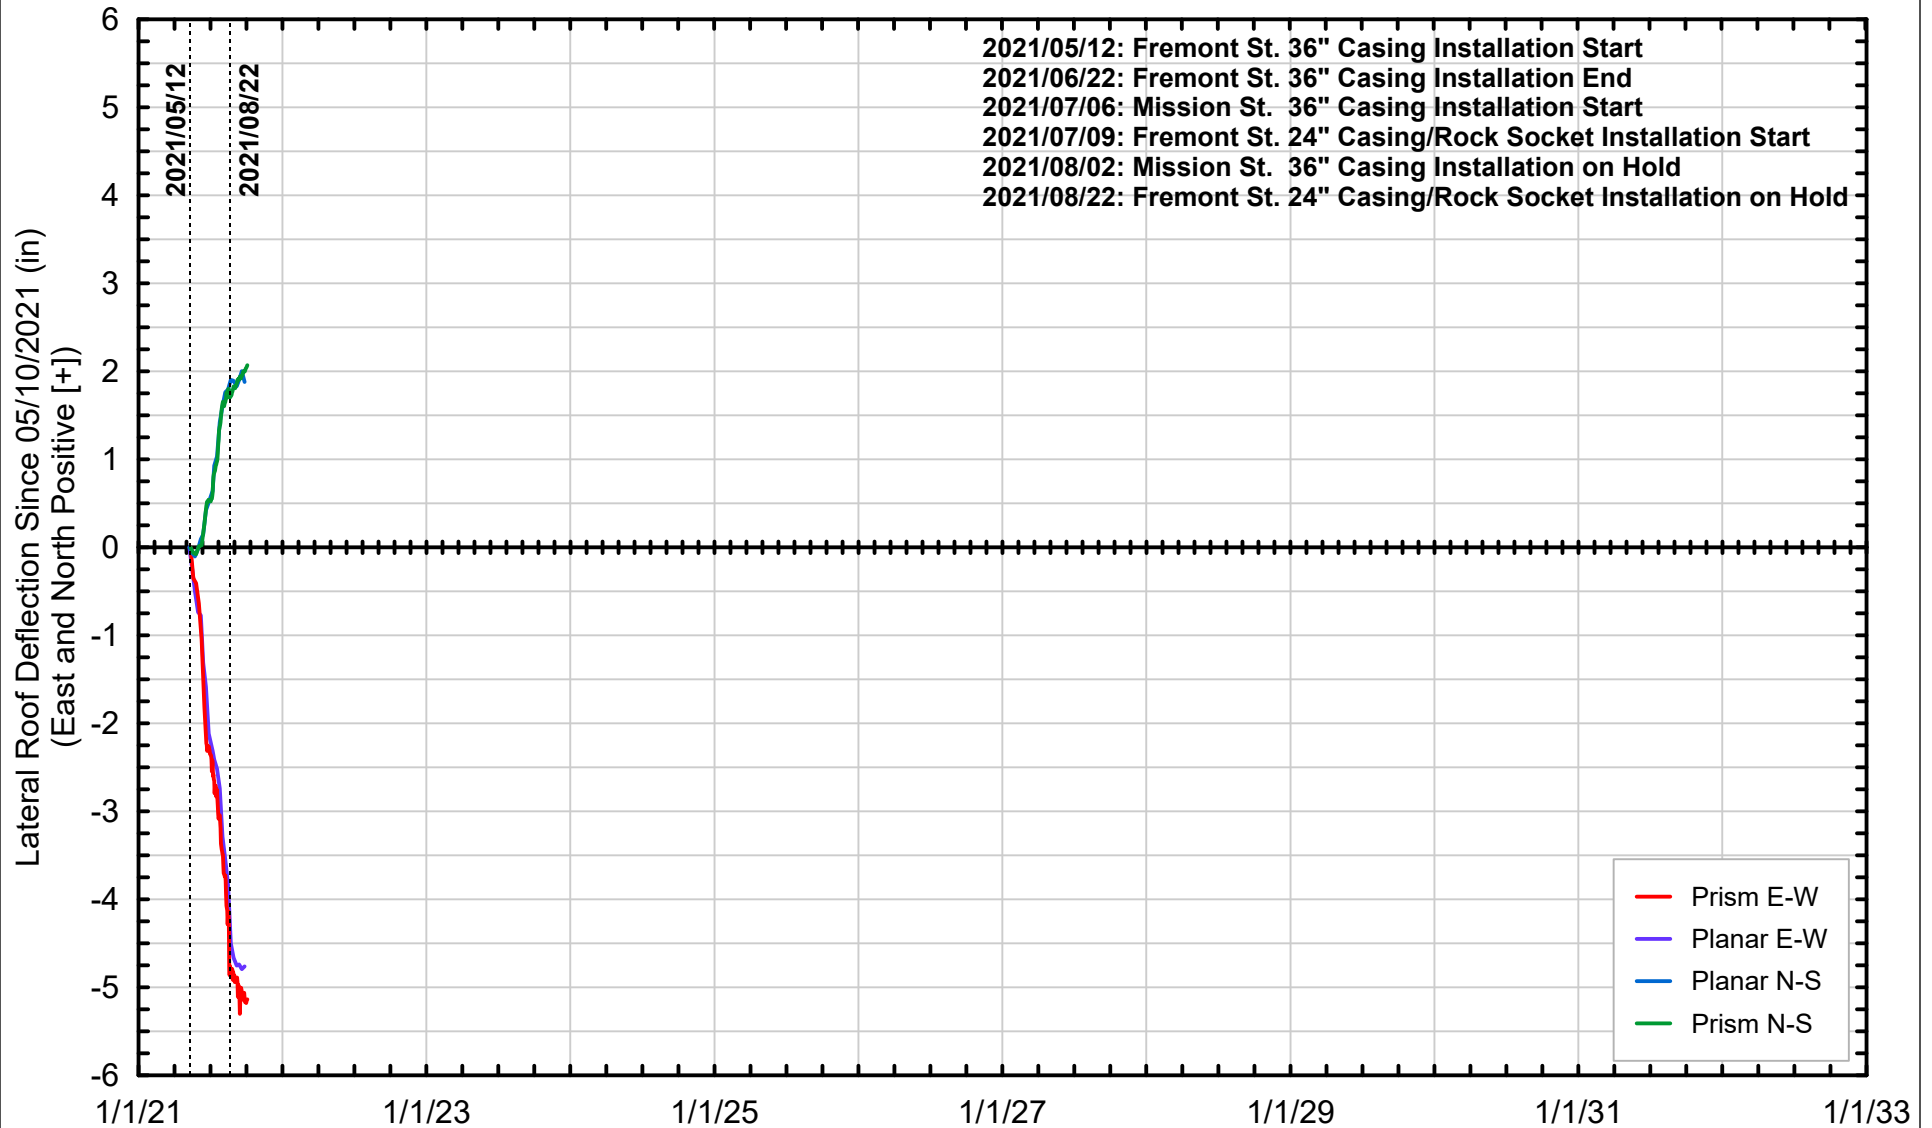
| Project No: 19-009.00 | Date: 10/6/2021 | Created By: NBW | Checked By: DGM | Figure No: <b>023-06A</b> |

LATERAL ROOF DEFLECTION DATA  
 SINCE 05/10/2021 THROUGH 10/04/2021

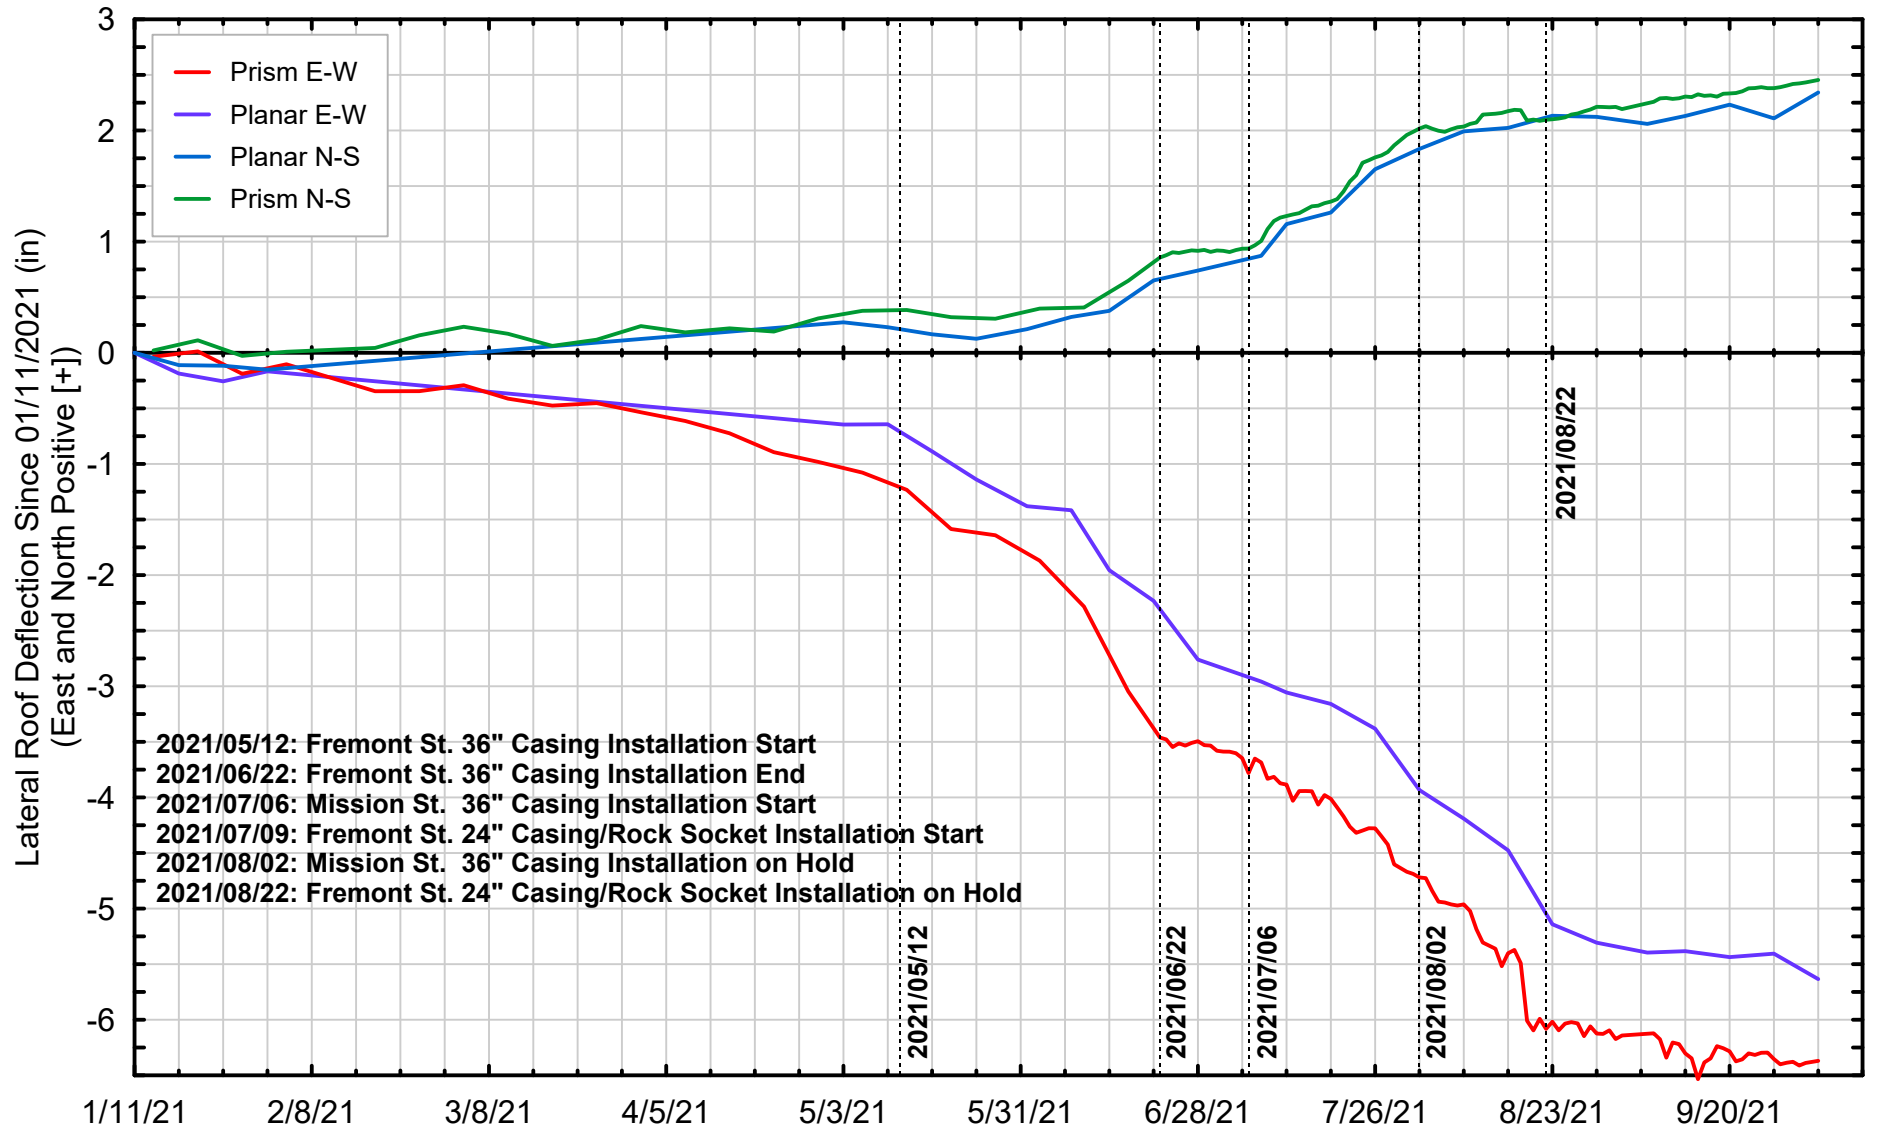
| Project No: 19-009.00 | Date: 10/6/2021 | Created By: NBW | Checked By: DGM | Figure No: <b>023-06B</b> |

LATERAL ROOF DEFLECTION DATA  
SINCE 01/11/2021 THROUGH 10/04/2021

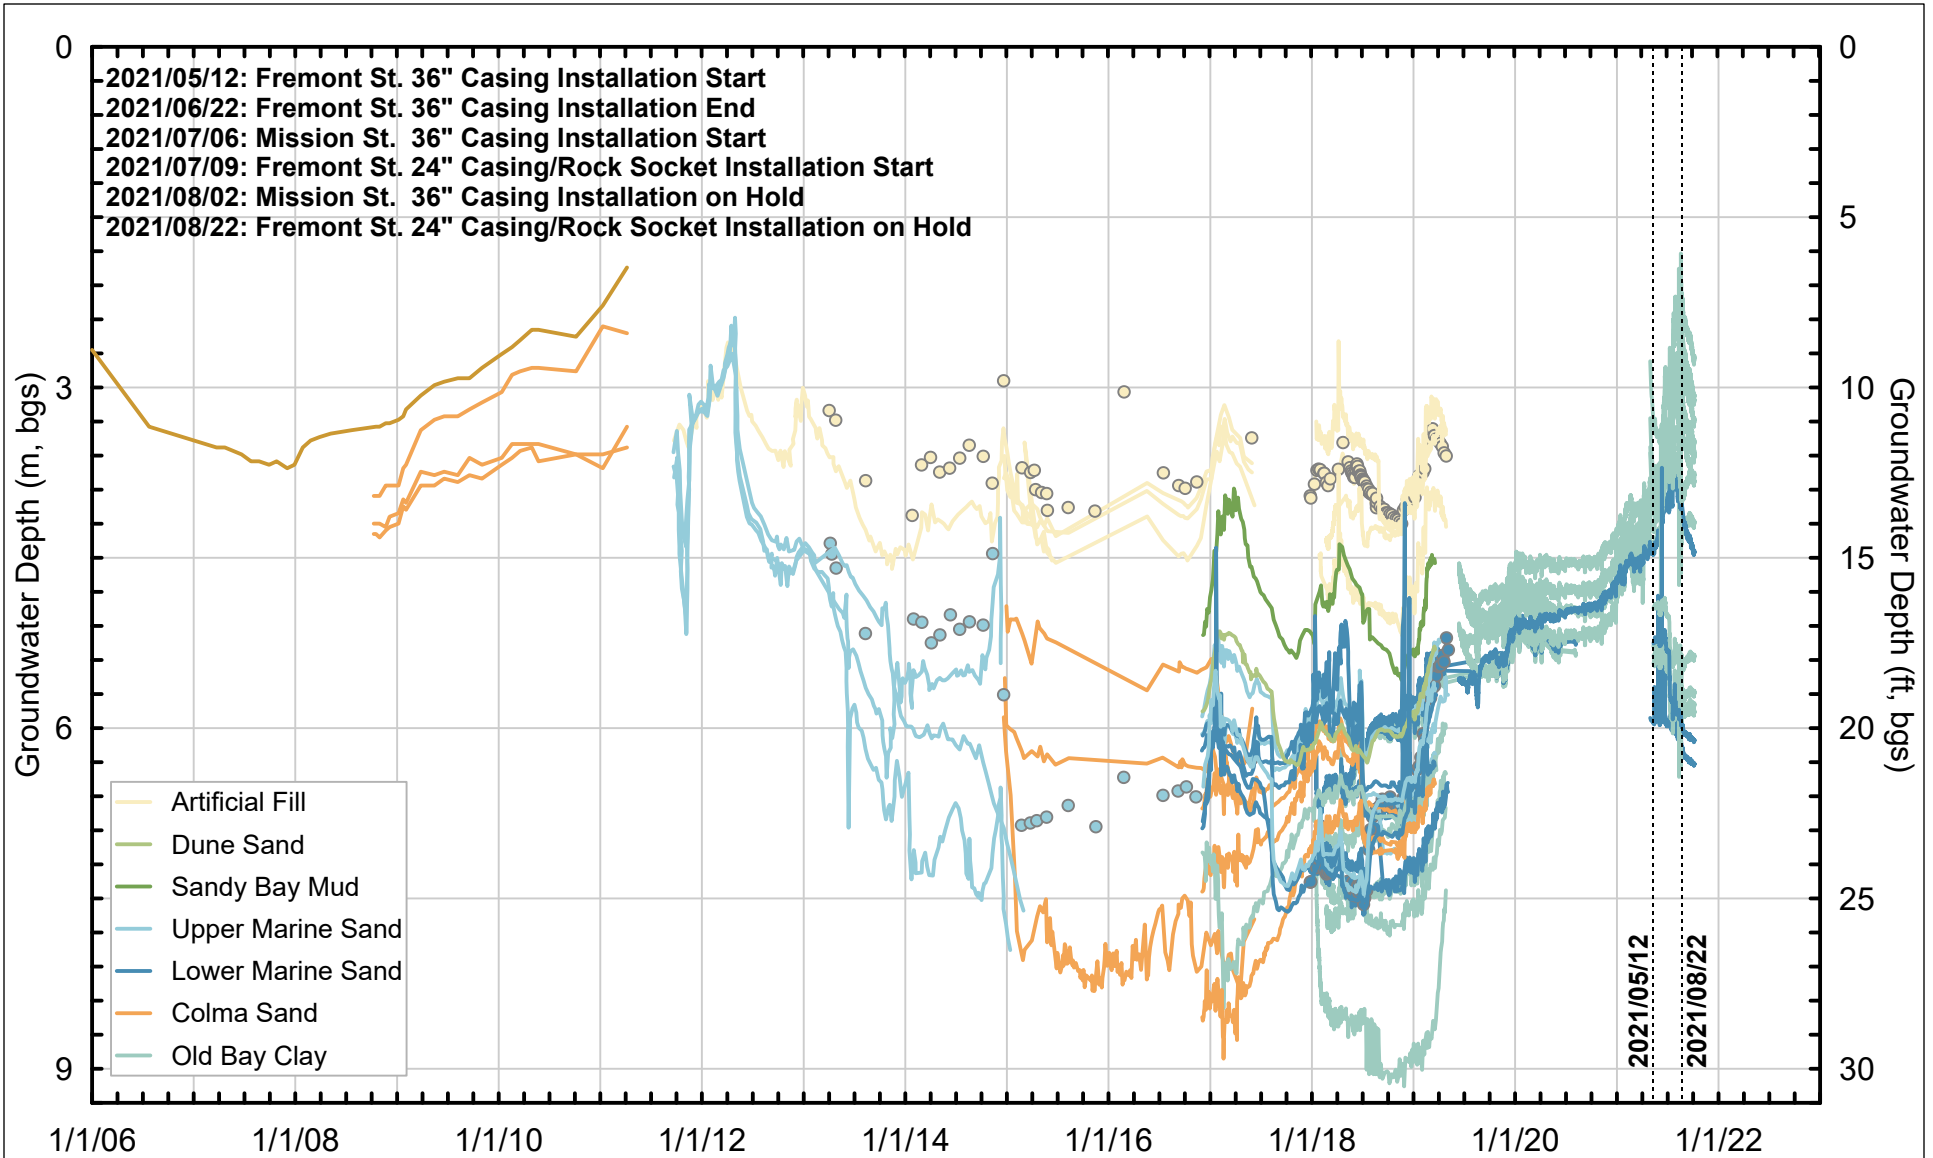
Figure 07 presents the historical groundwater elevation interpreted from piezometer readings at locations near 301 Mission. In addition, data from piezometers installed to monitor groundwater elevation during the retrofit are included. Figures 08 and 09 present groundwater elevation interpreted from piezometer readings in the Marine/Colma Sand and the Old Bay Clay, respectively, for the time period prior to the start of production pile installation (January 1, 2021) through October 5, 2021.

| | | HISTORICAL GROUNDWATER ELEVATION MEASUREMENTS<br>AT LOCATIONS NEAR 301 MISSION<br><br>Millennium Tower Perimeter Pile Upgrade: Instrumentation Monitoring Data<br>City and County of San Francisco, California | | |

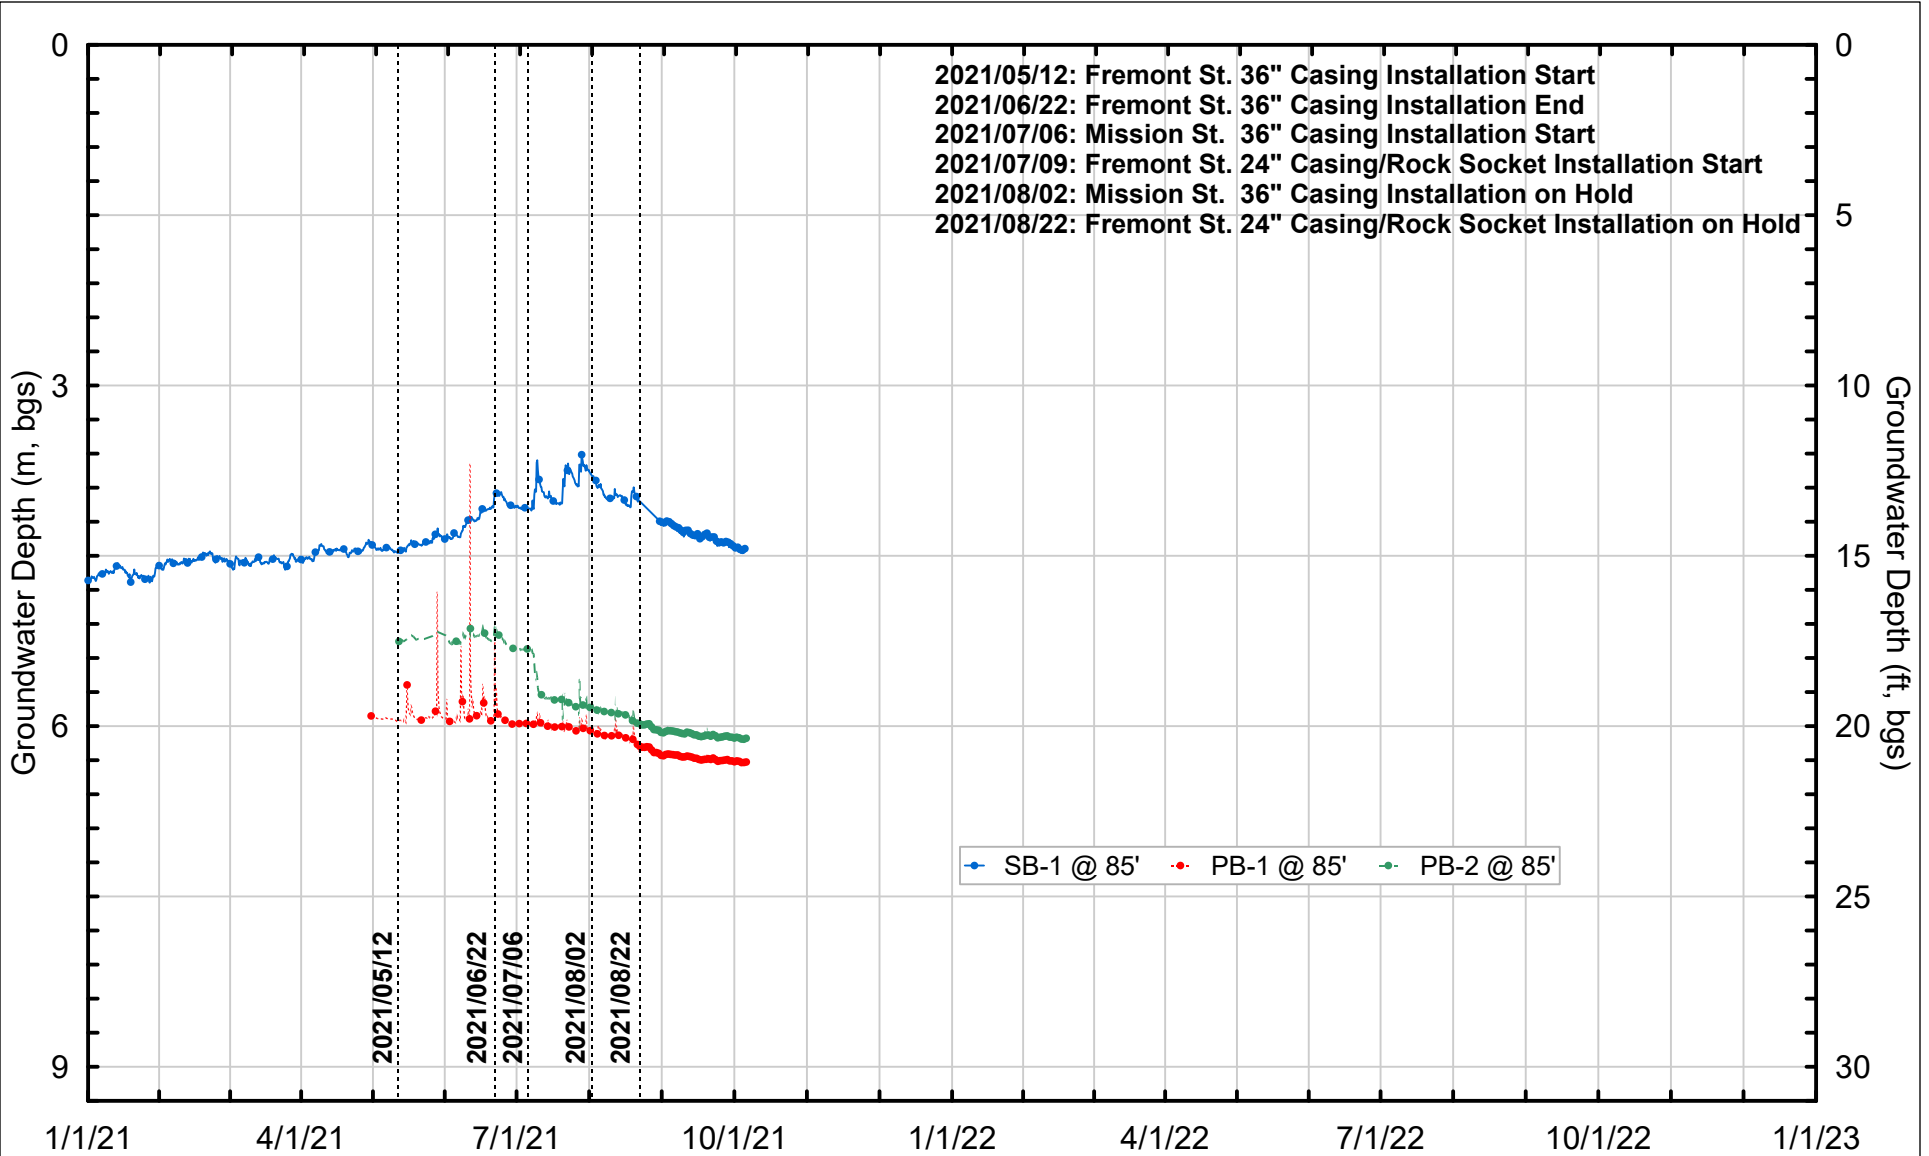
| | | GROUNDWATER ELEVATION MEASUREMENTS IN MARINE AND COLMA SAND<br>SINCE 01/01/2021 THROUGH 10/05/2021<br><br>Millennium Tower Perimeter Pile Upgrade: Instrumentation Monitoring Data<br>City and County of San Francisco, California | | |

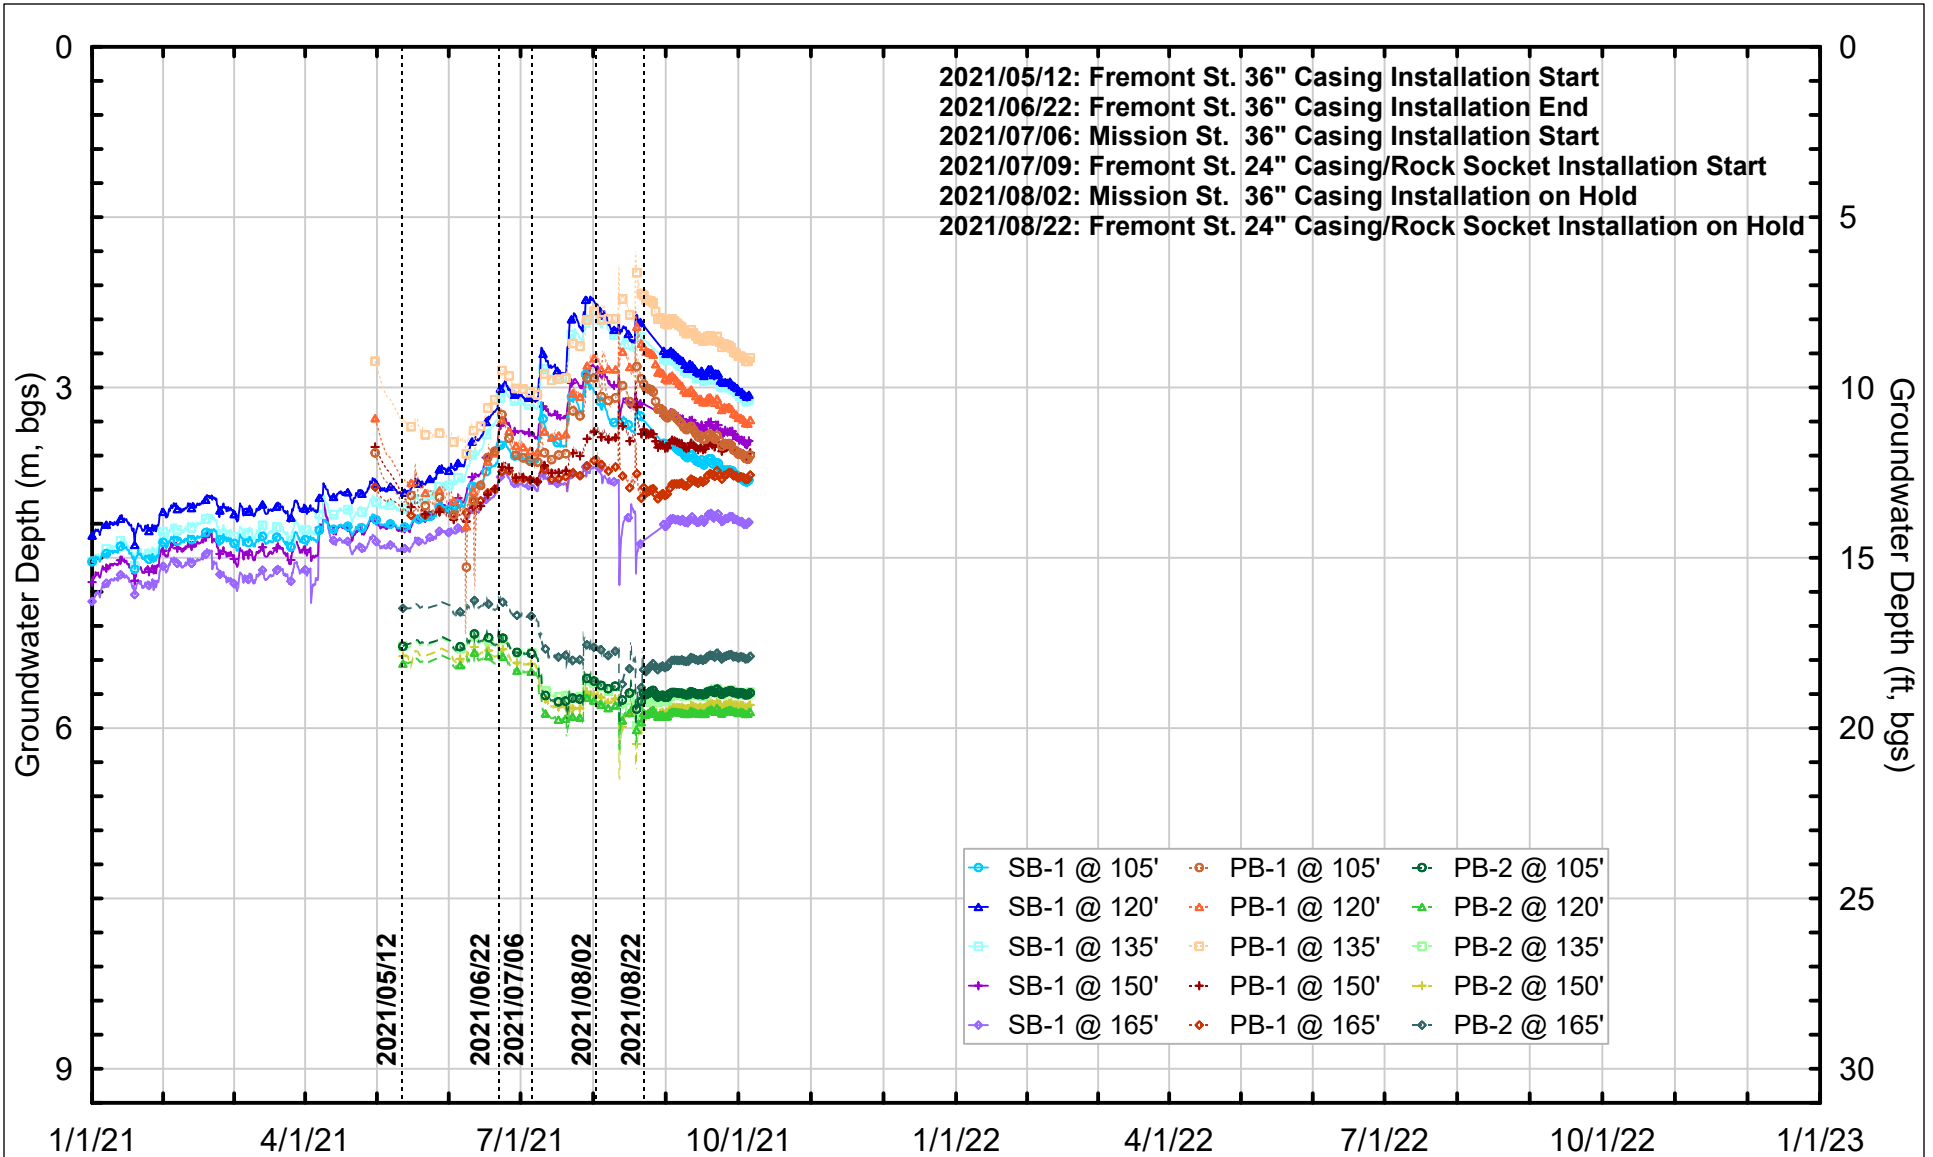
| | | <p>GROUNDWATER ELEVATION MEASUREMENTS IN OLD BAY CLAY<br/>SINCE 01/01/2021 THROUGH 10/05/2021</p> <p>Millennium Tower Perimeter Pile Upgrade: Instrumentation Monitoring Data<br/>City and County of San Francisco, California</p> | | |
