Subject: 301 Mission Retrofit Monitoring Report 023: Results as of October 5, 2021

This memorandum summarizes results from the monitoring plan implemented at the 301 Mission property. Instrumentation to monitor the structure prior to, during and after the retrofit was installed in January 2021, including piezometers and extensometers. Settlement markers installed in April 2009 and January 2017, survey prisms mounted on the exterior of the structure in December 2016, and crack gauges installed in April 2009 have also been monitored. This memorandum is for review only. It only contains ongoing monitoring information. This memorandum does not contain recommendations based upon the ongoing monitoring information.

Millennium Tower Perimeter Pile Upgrade: Instrumentation Monitoring Data  
City and County of San Francisco, California

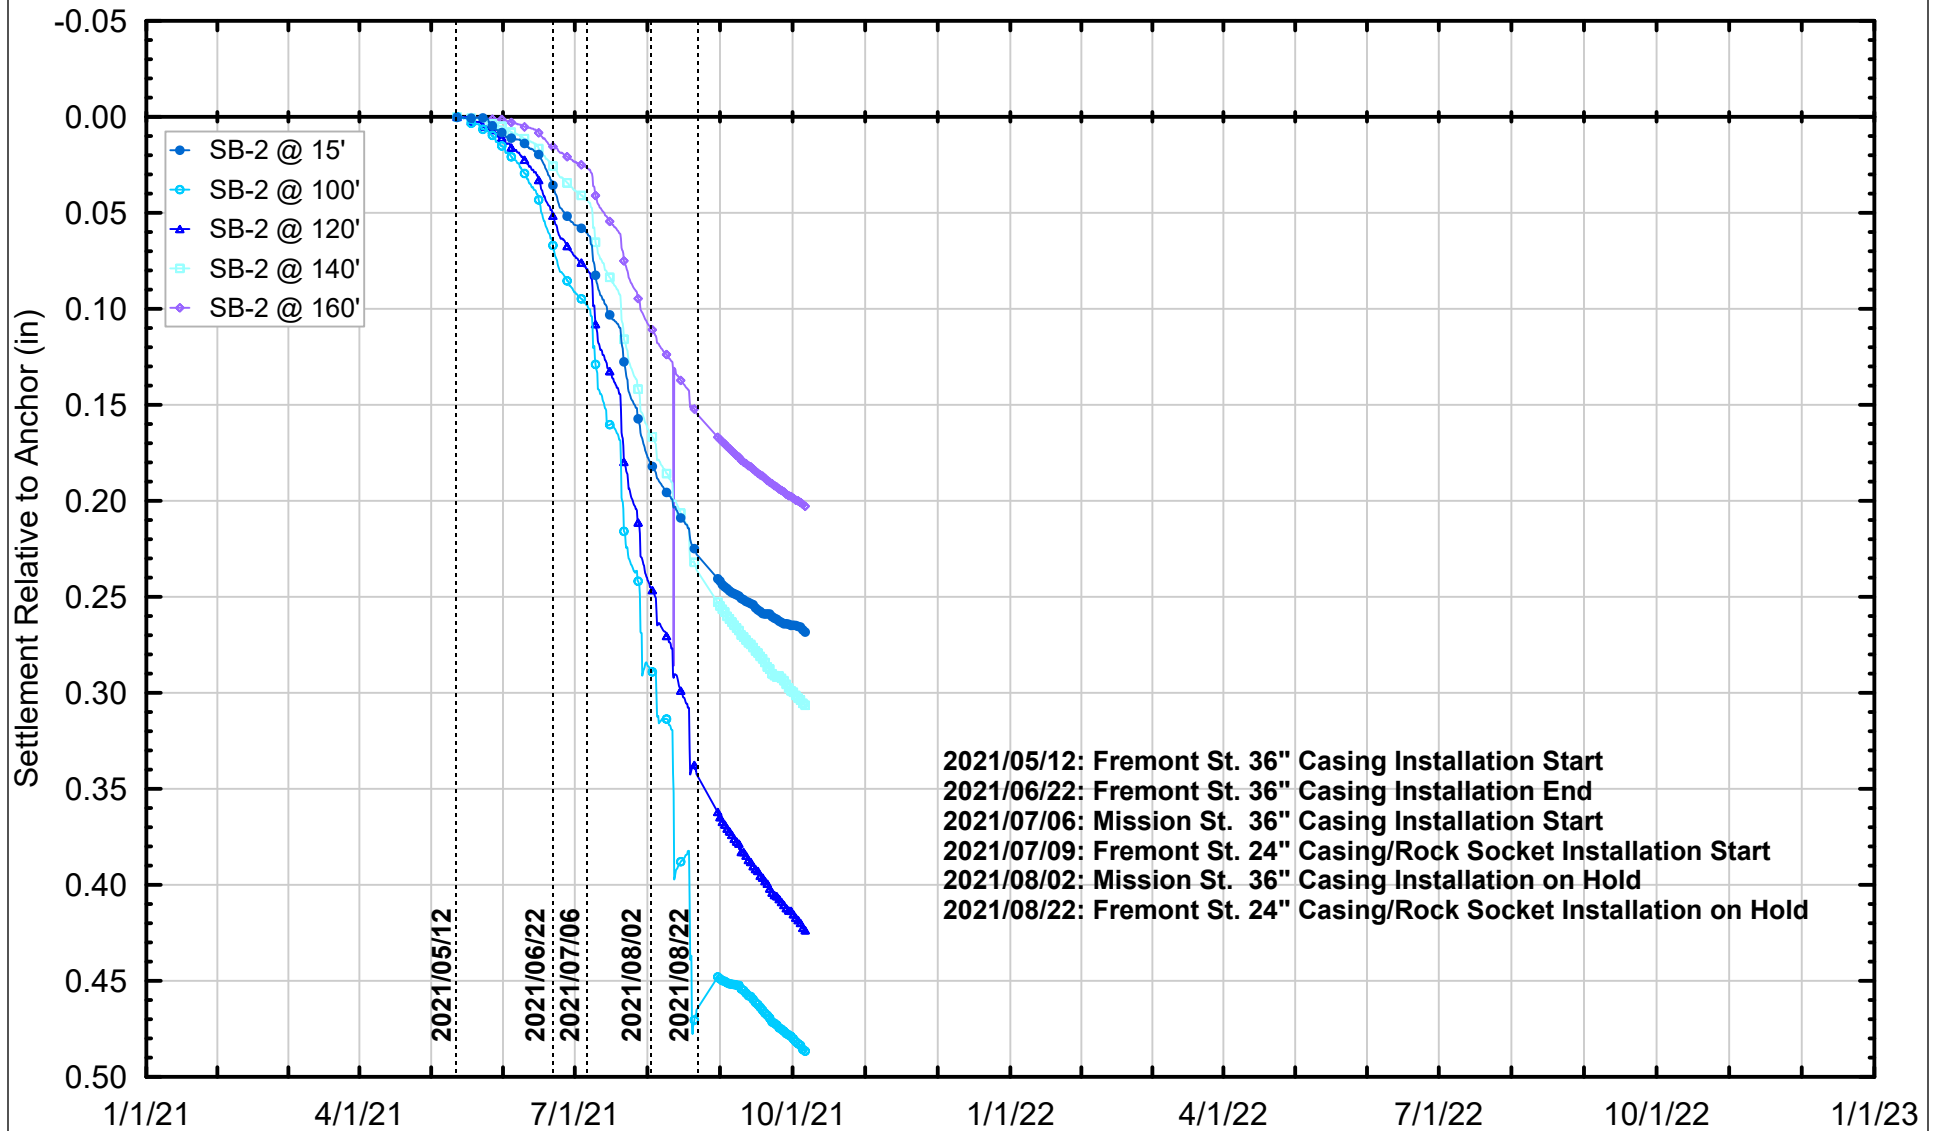
Figure 10 presents extensometer data from within the Tower basement since the start of production pile installation (May 12, 2021) through October 5, 2021. Figure 11 presents extensometer data from Fremont Street since the start of production pile installation (May 12, 2021) through October 5, 2021. Figure 12 presents extensometer data from Mission Street since the start of production pile installation (May 12, 2021) through October 5, 2021.

| | | <p>EXTENSOMETER DATA FROM WITHIN TOWER BASEMENT<br/>SINCE 01/01/2021 THROUGH 10/05/2021</p> <p>Millennium Tower Perimeter Pile Upgrade: Instrumentation Monitoring Data<br/>City and County of San Francisco, California</p> | | |

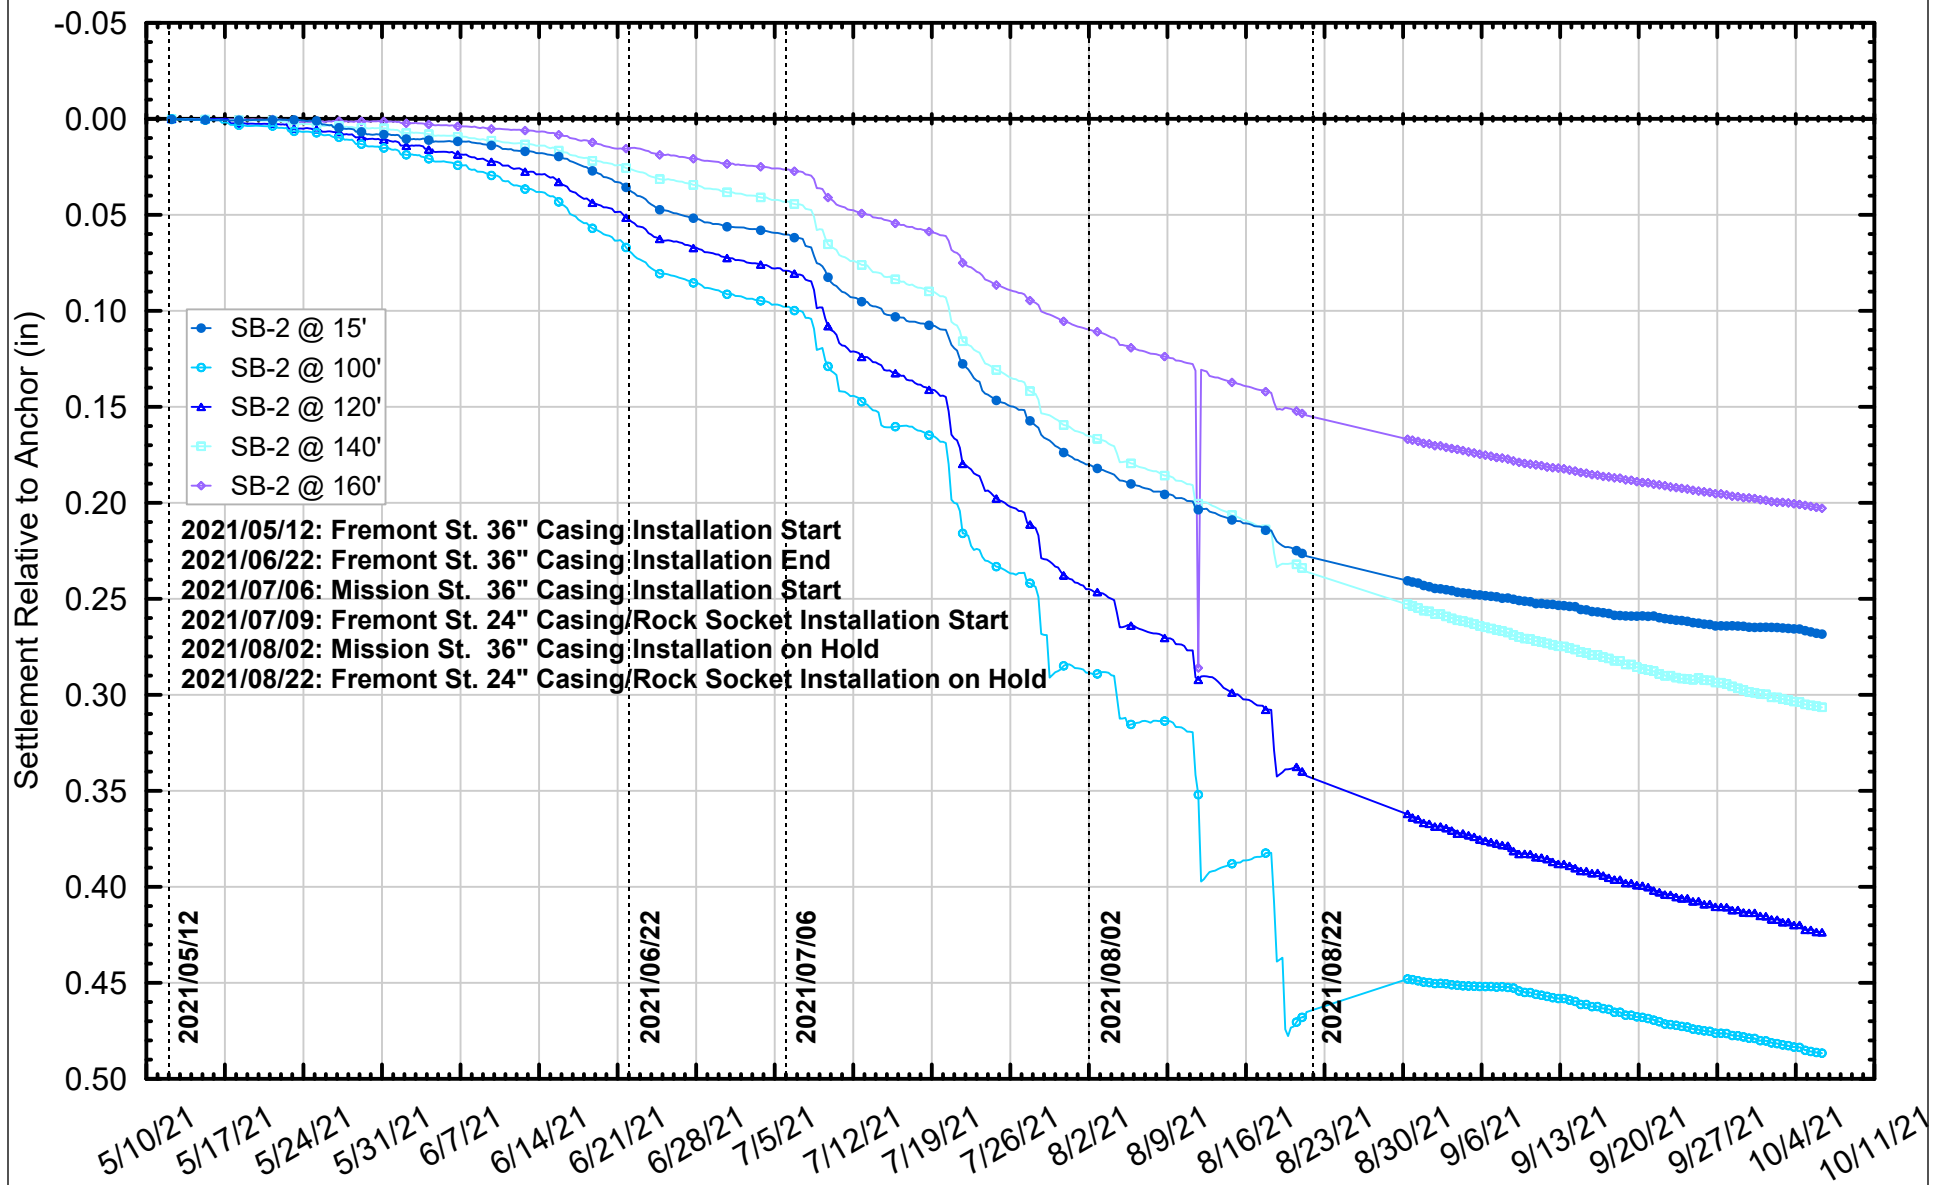
| Project No: 19-009.00 | Date: 10/6/2021 | Created By: NBW | Checked By: DGM | Figure No: <b>023-10B</b> |

EXTENSOMETER DATA FROM WITHIN TOWER BASEMENT  
SINCE 05/10/2021 THROUGH 10/05/2021

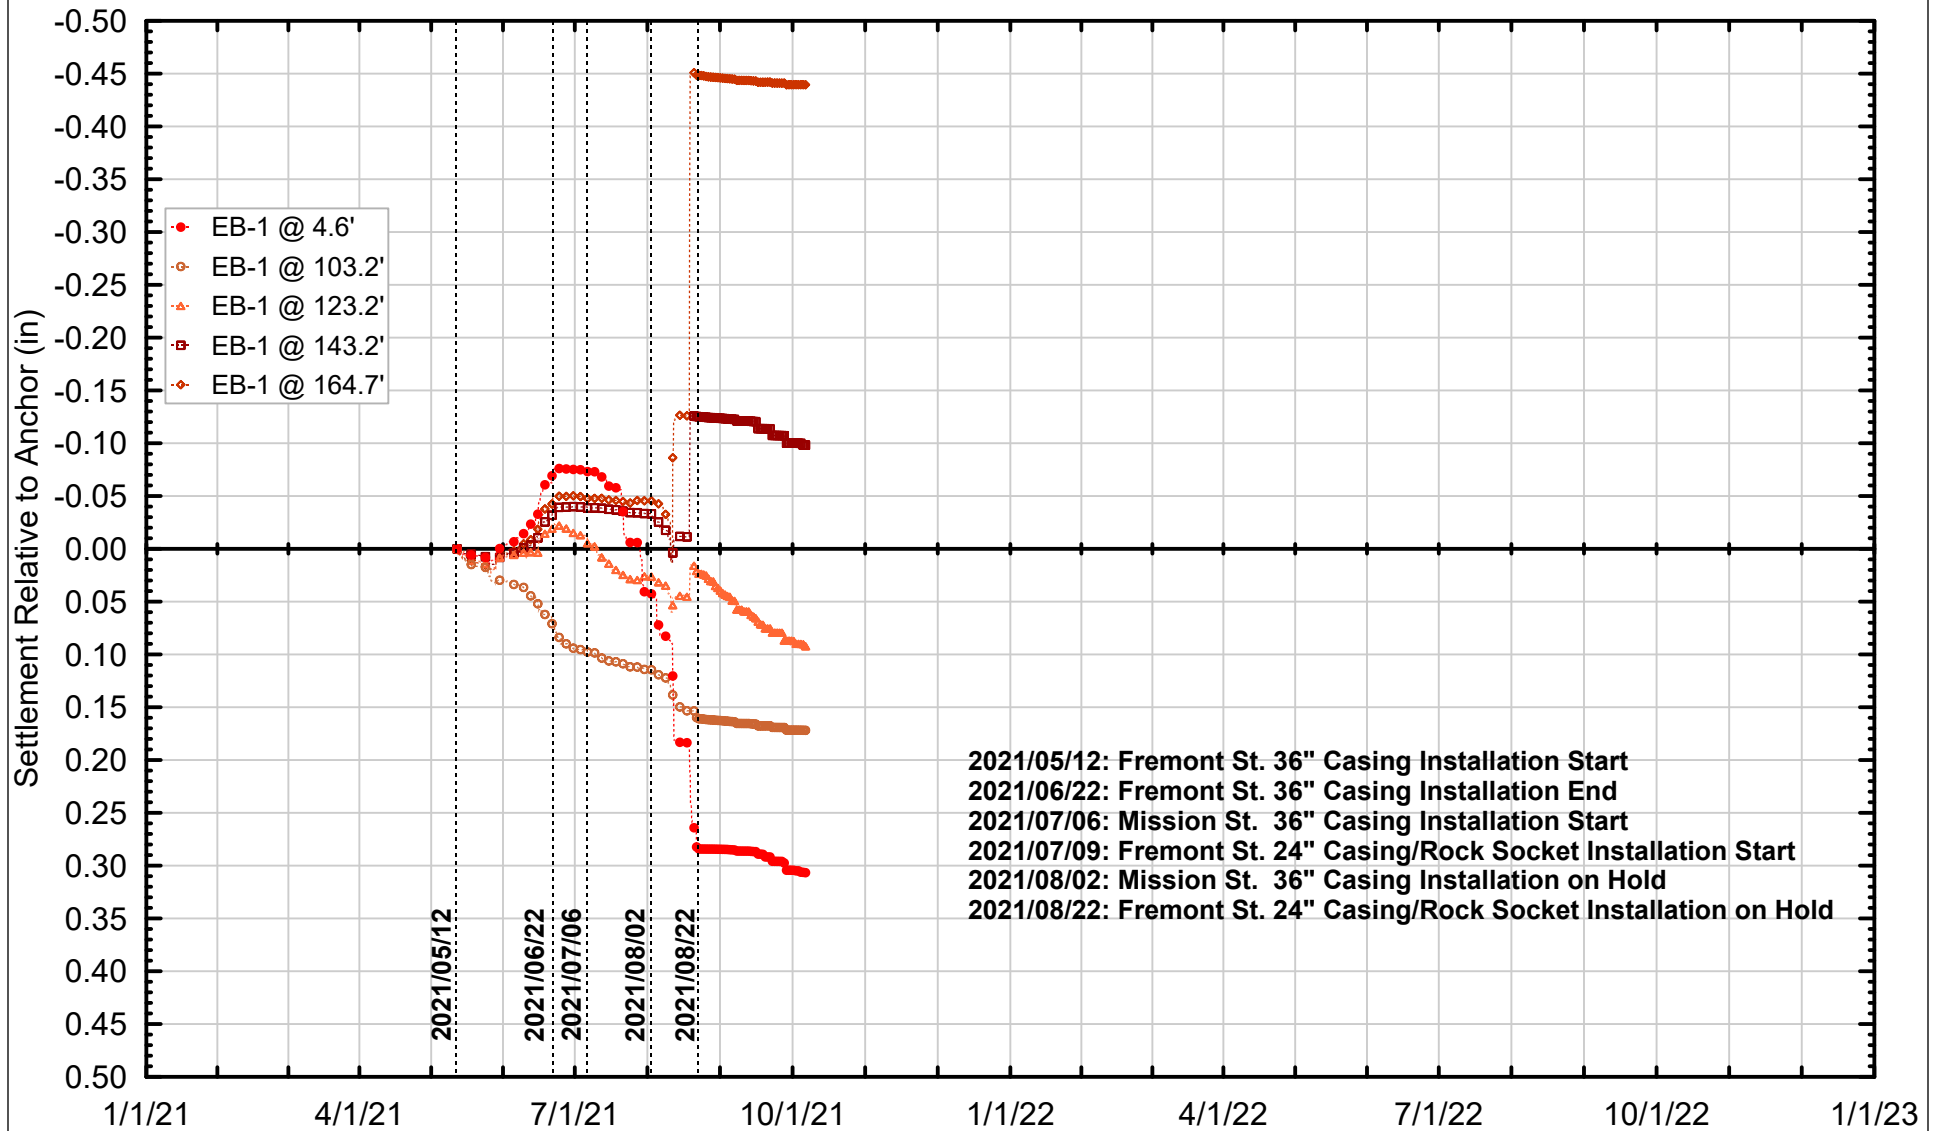
| | | <p>EXTENSOMETER DATA FROM FREMONT STREET<br/>SINCE 01/01/2021 THROUGH 10/05/2021</p> <p>Millennium Tower Perimeter Pile Upgrade: Instrumentation Monitoring Data<br/>City and County of San Francisco, California</p> | | |

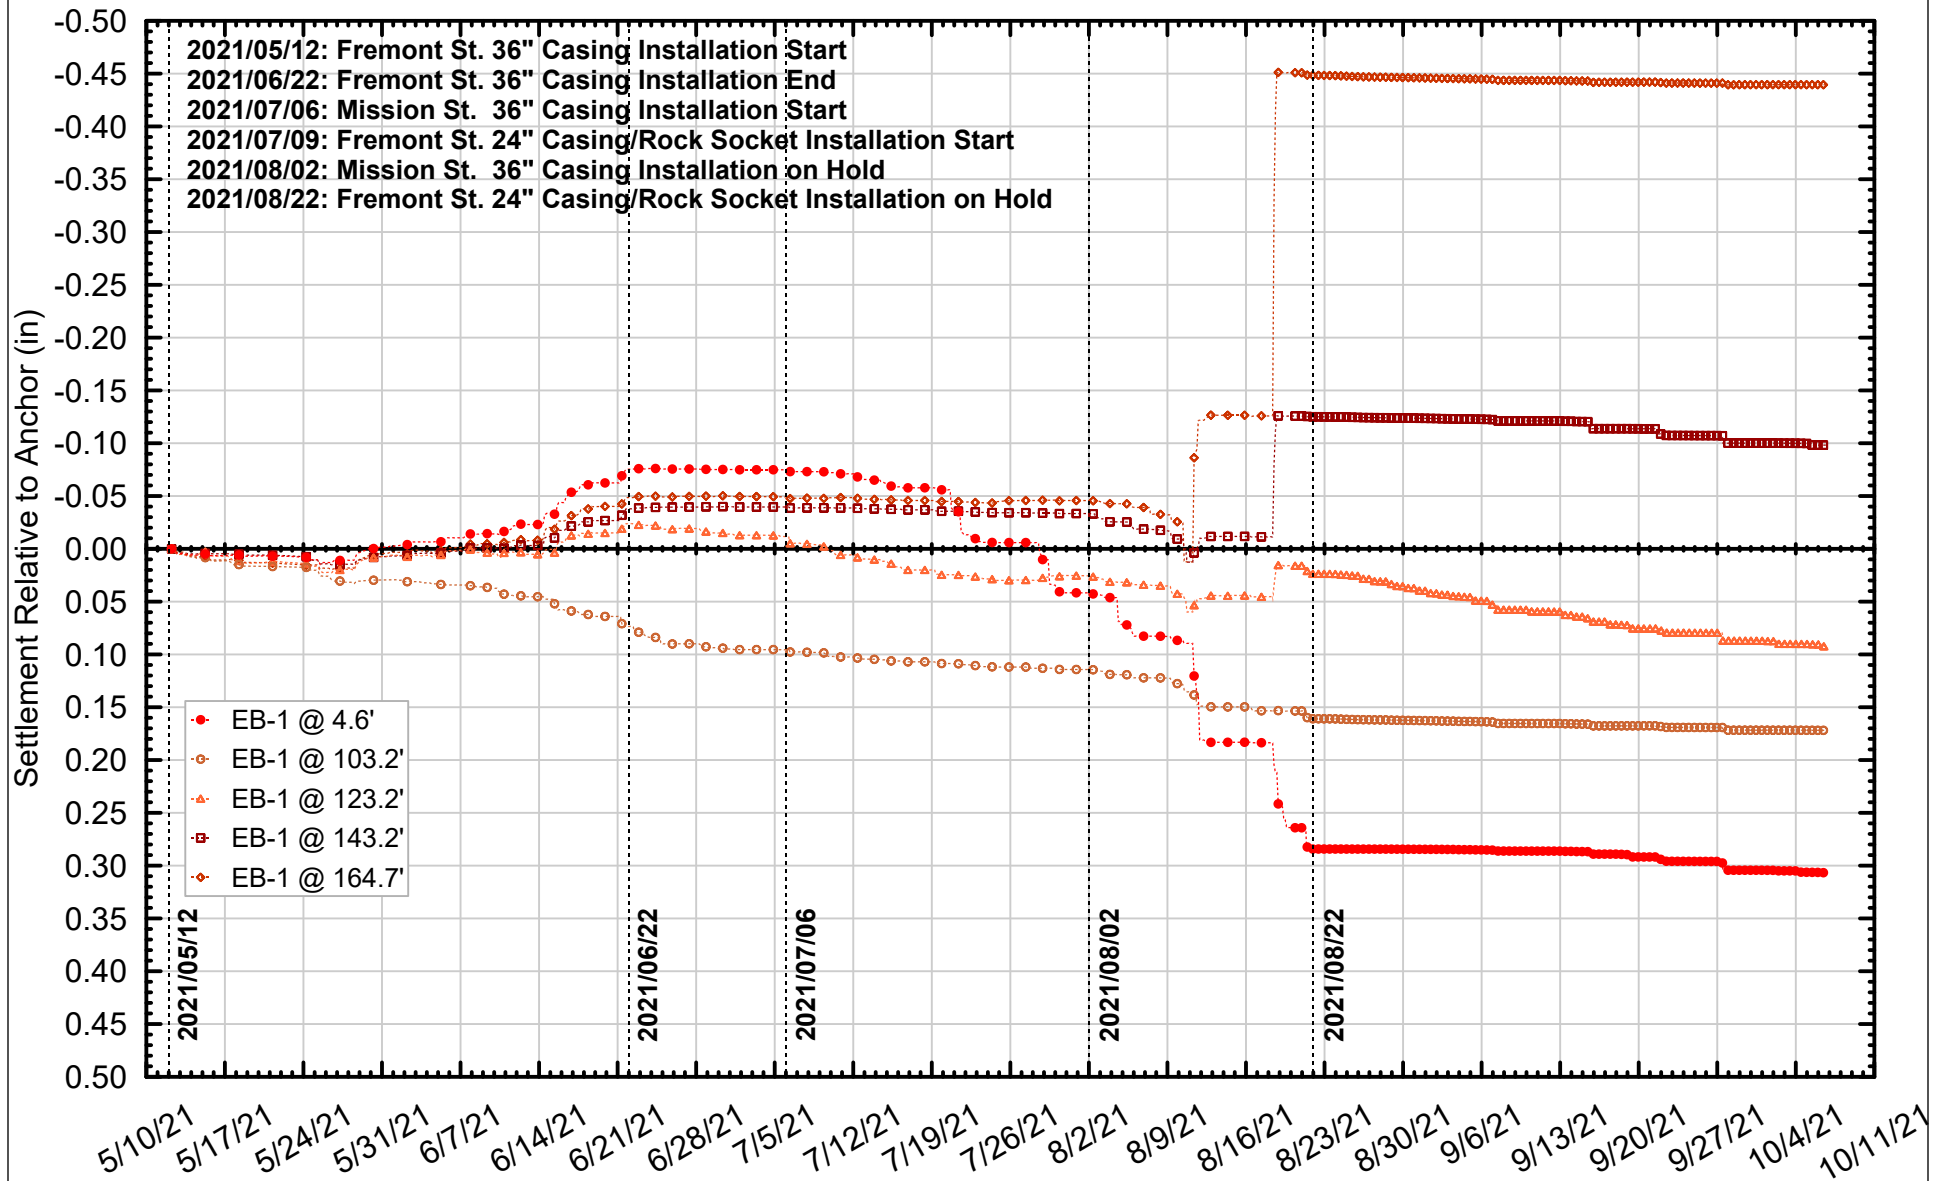
| Project No: 19-009.00 | Date: 10/6/2021 | Created By: NBW | Checked By: DGM | Figure No: <b>023-11B</b> |

EXTENSOMETER DATA FROM FREMONT STREET  
 SINCE 05/10/2021 THROUGH 10/05/2021

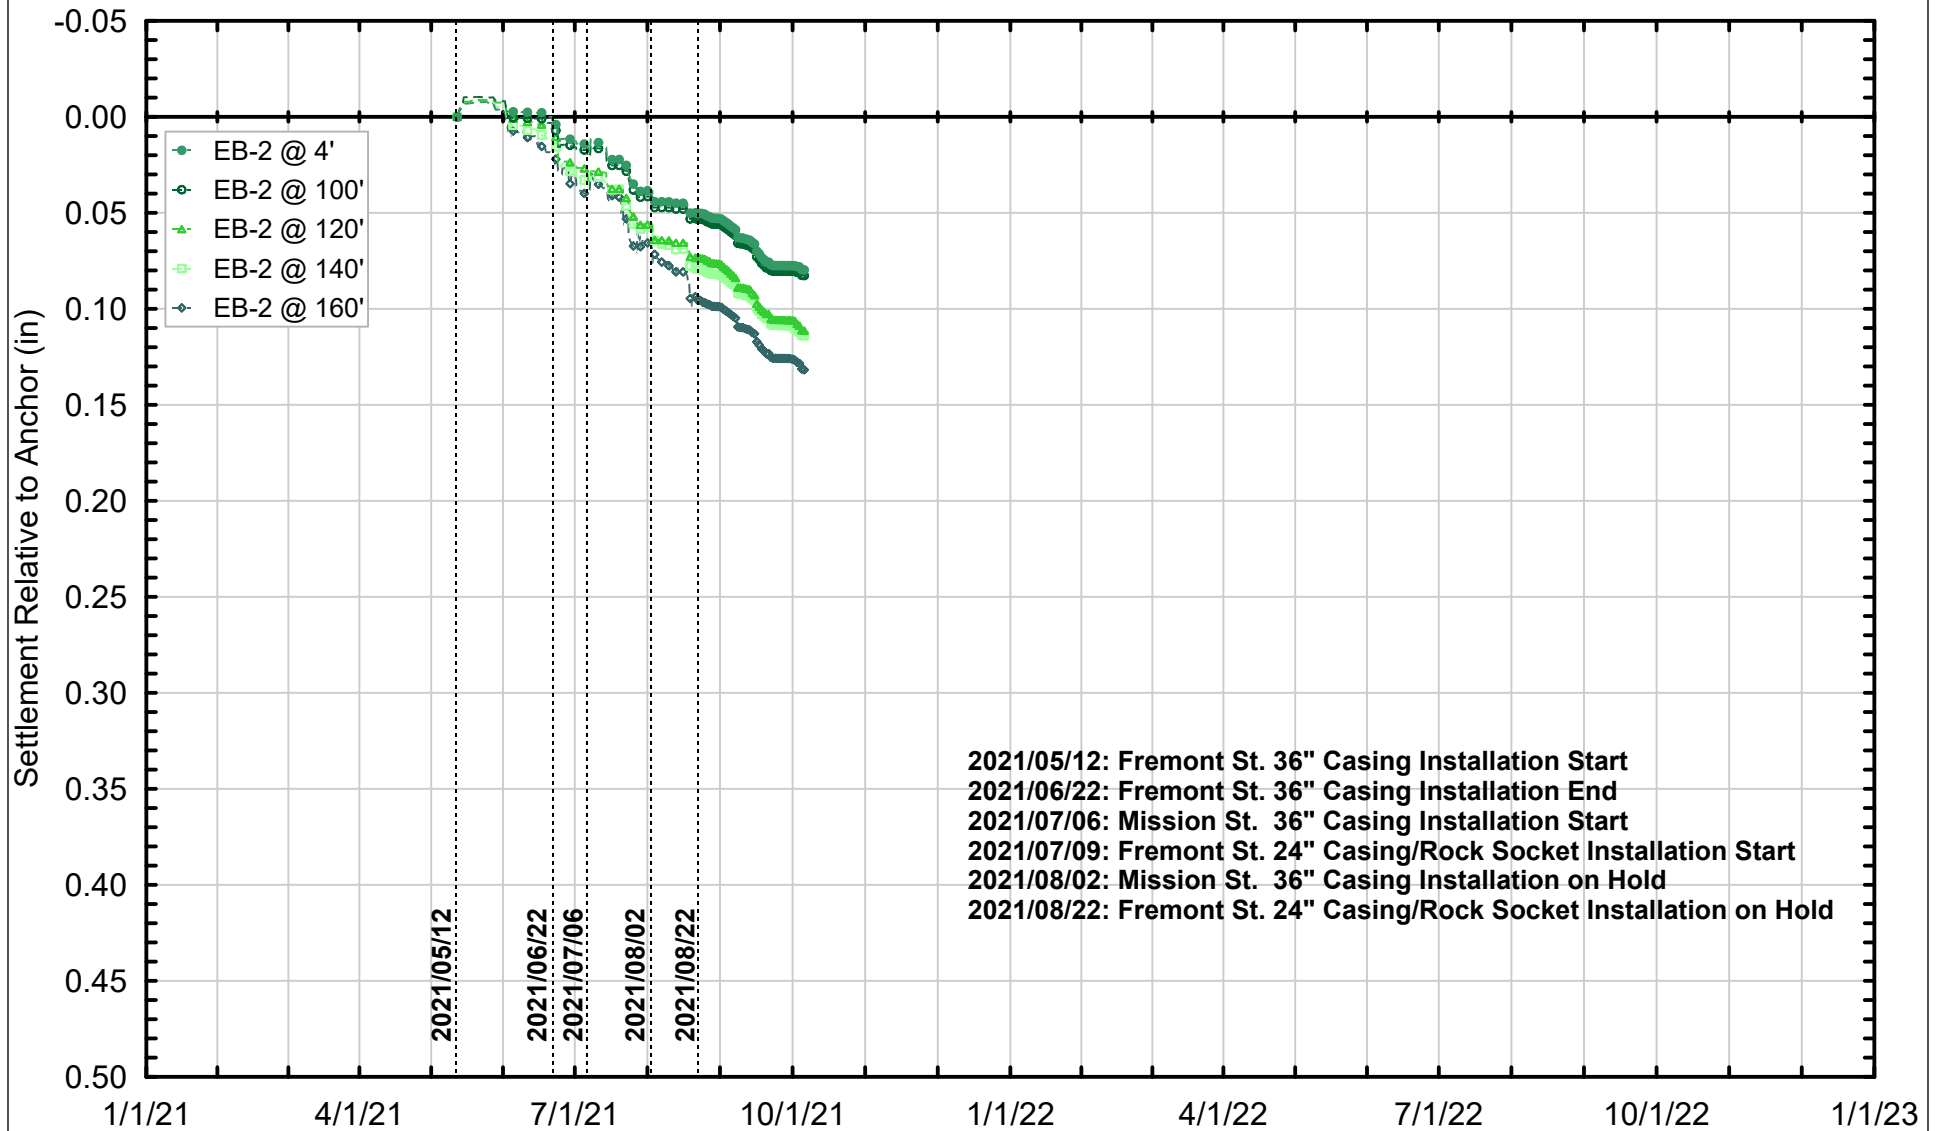
| | | <p>EXTENSOMETER DATA FROM MISSION STREET<br/>SINCE 01/01/2021 THROUGH 10/05/2021</p> <p>Millennium Tower Perimeter Pile Upgrade: Instrumentation Monitoring Data<br/>City and County of San Francisco, California</p> | | |
