Subject: 301 Mission Retrofit Monitoring Report 036: Results as of January 10, 2022

| Millennium Tower Perimeter Pile Upgrade: Instrumentation Monitoring Data<br>City and County of San Francisco, California | | | |

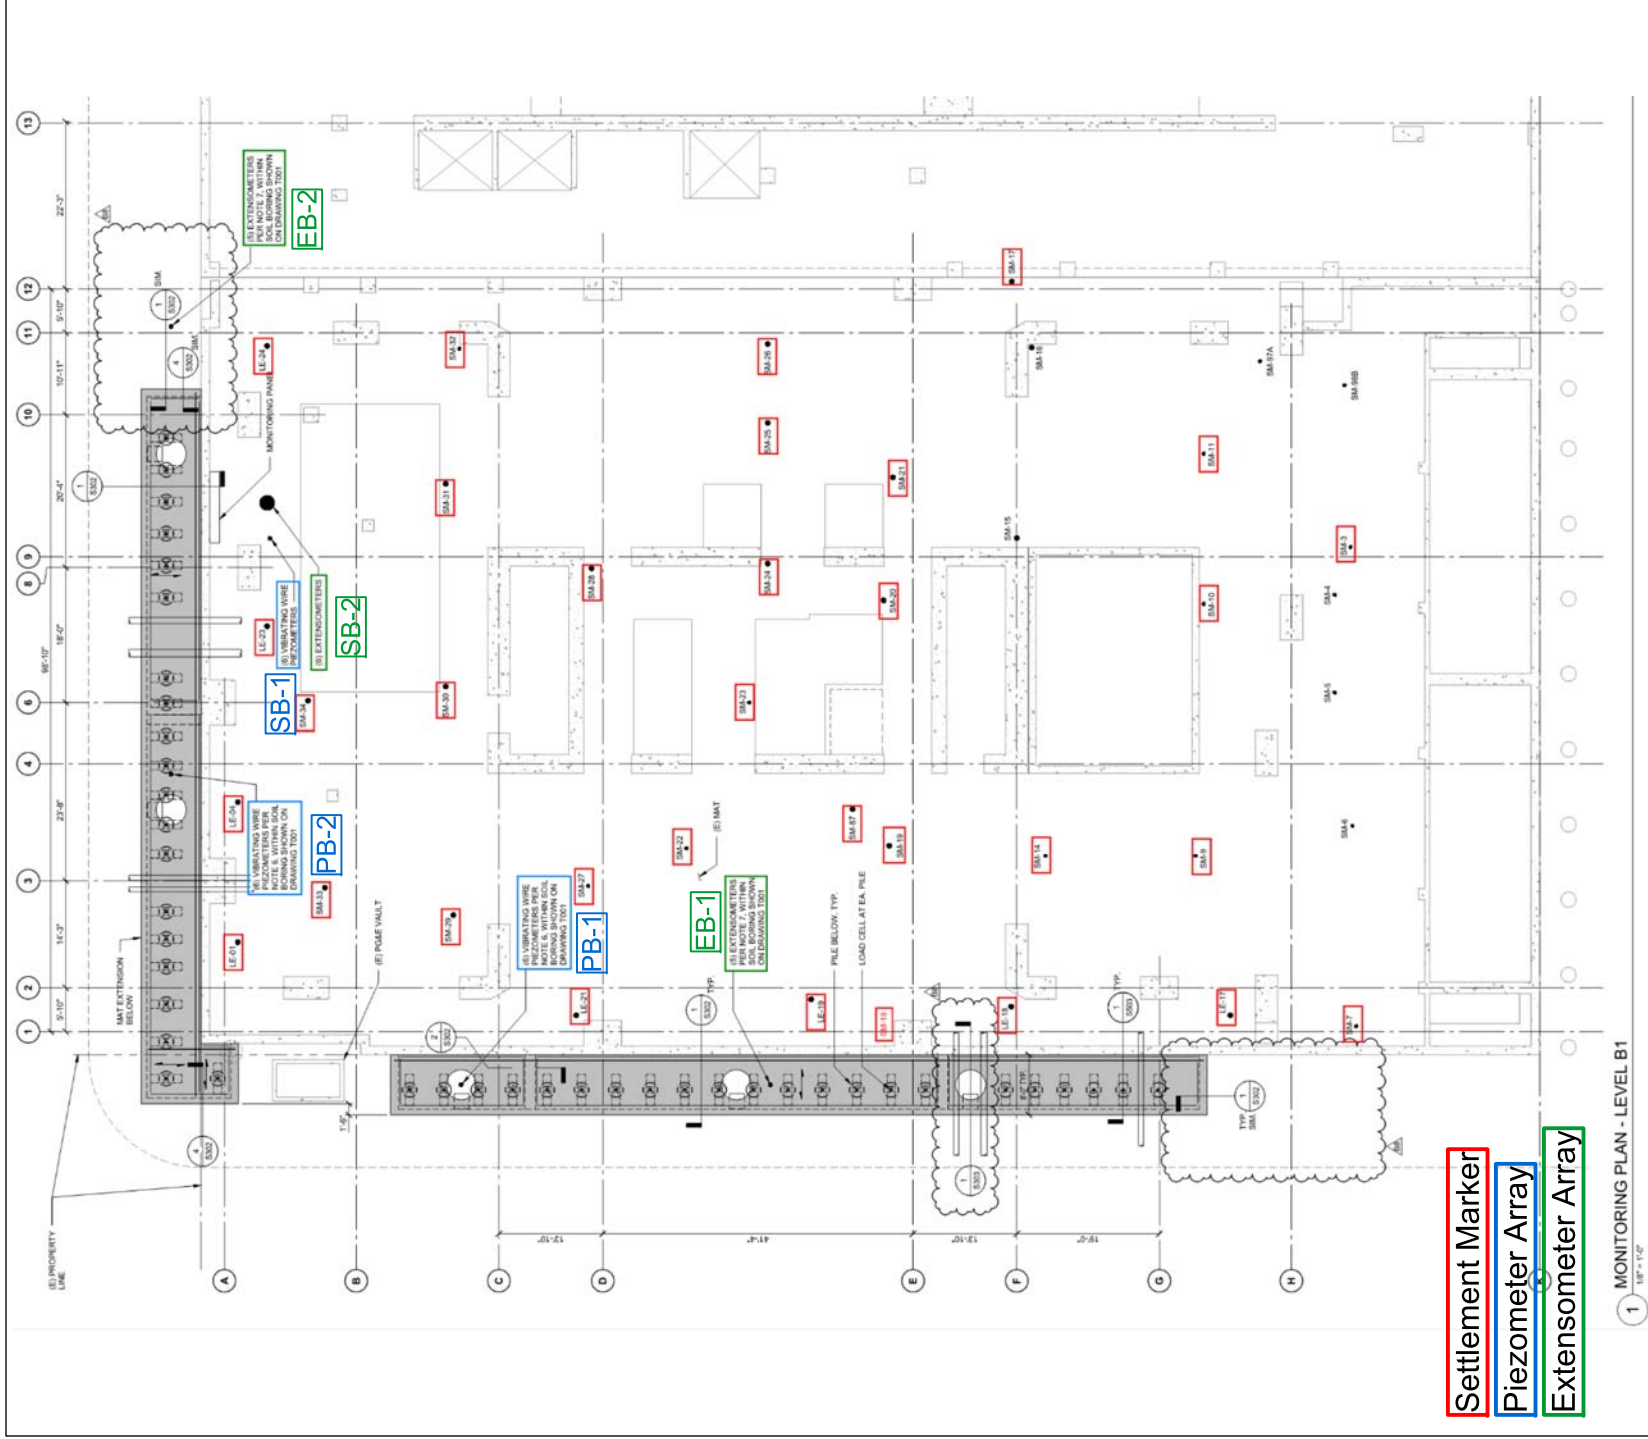
| Figure No: 036-01A | | | |

Figure 01 presents the instrument locations as referenced in later figures.

| | | INSTRUMENT LOCATION MAP<br>SETTLEMENT MARKERS, PIEZOMETERS, EXTENSOMETERS | |

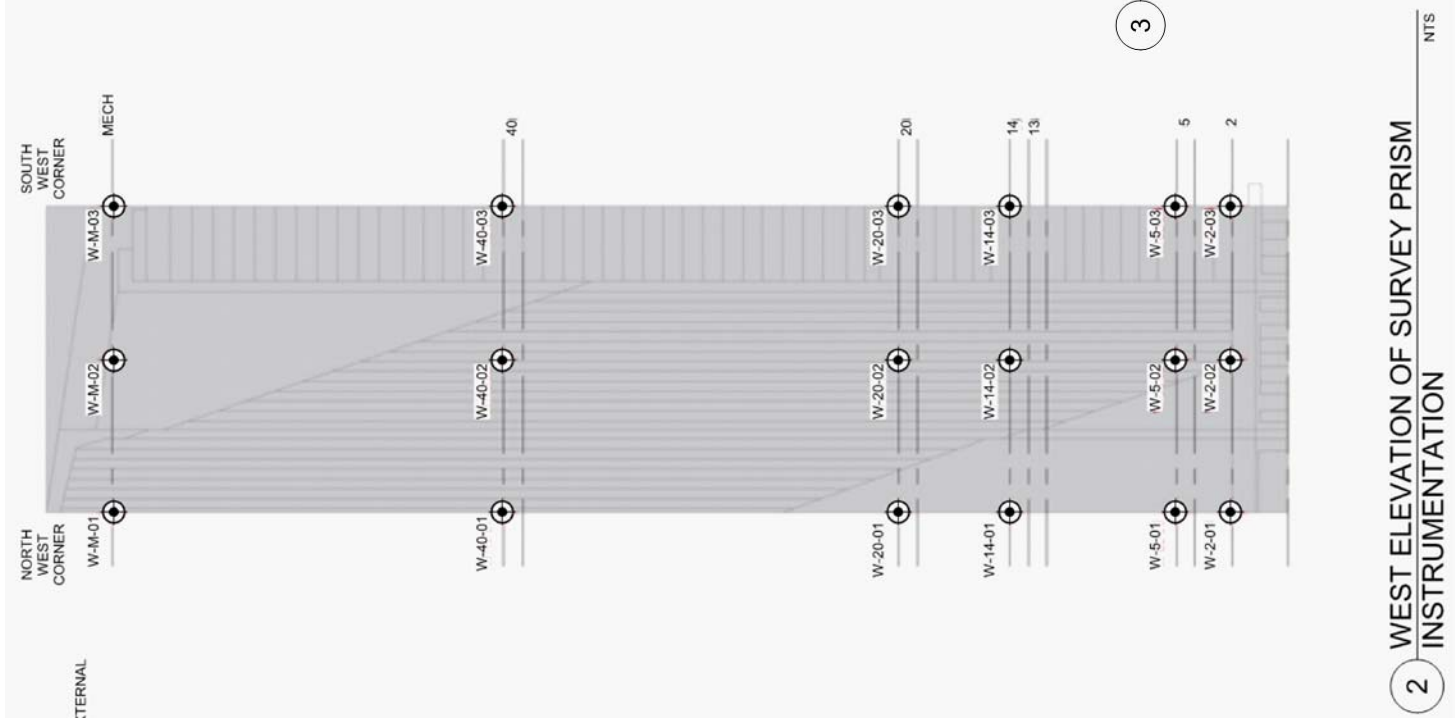
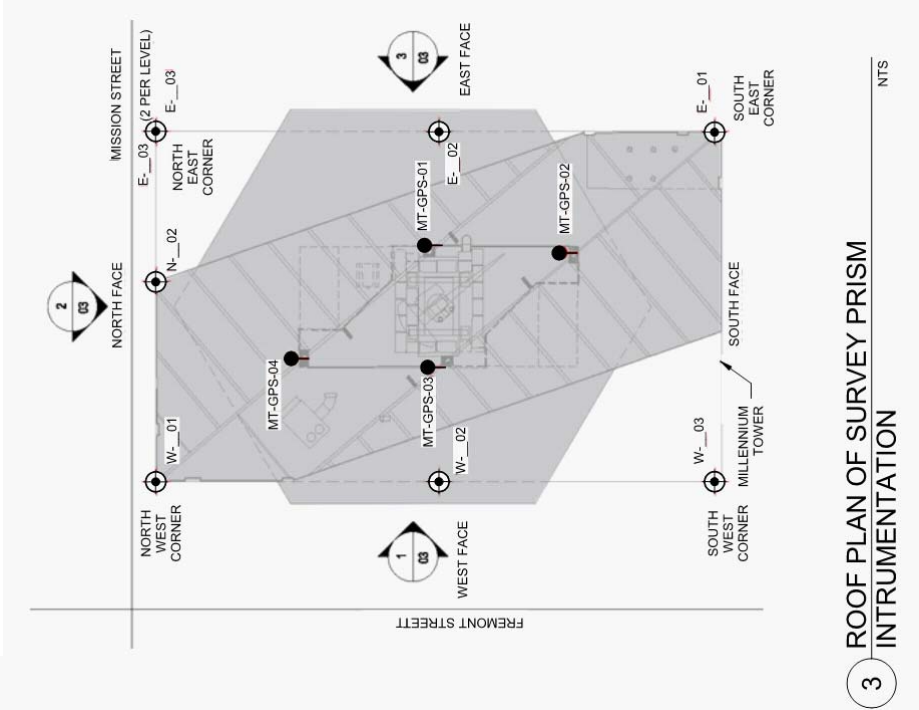
| Project No: 19-009.00 | Date: 7/26/2021 | Created By: NBW | Checked By: DGM | Figure No: 036-01B |

| TOWER SURVEY PRISM LOCATION SCHEMATIC | | | | |

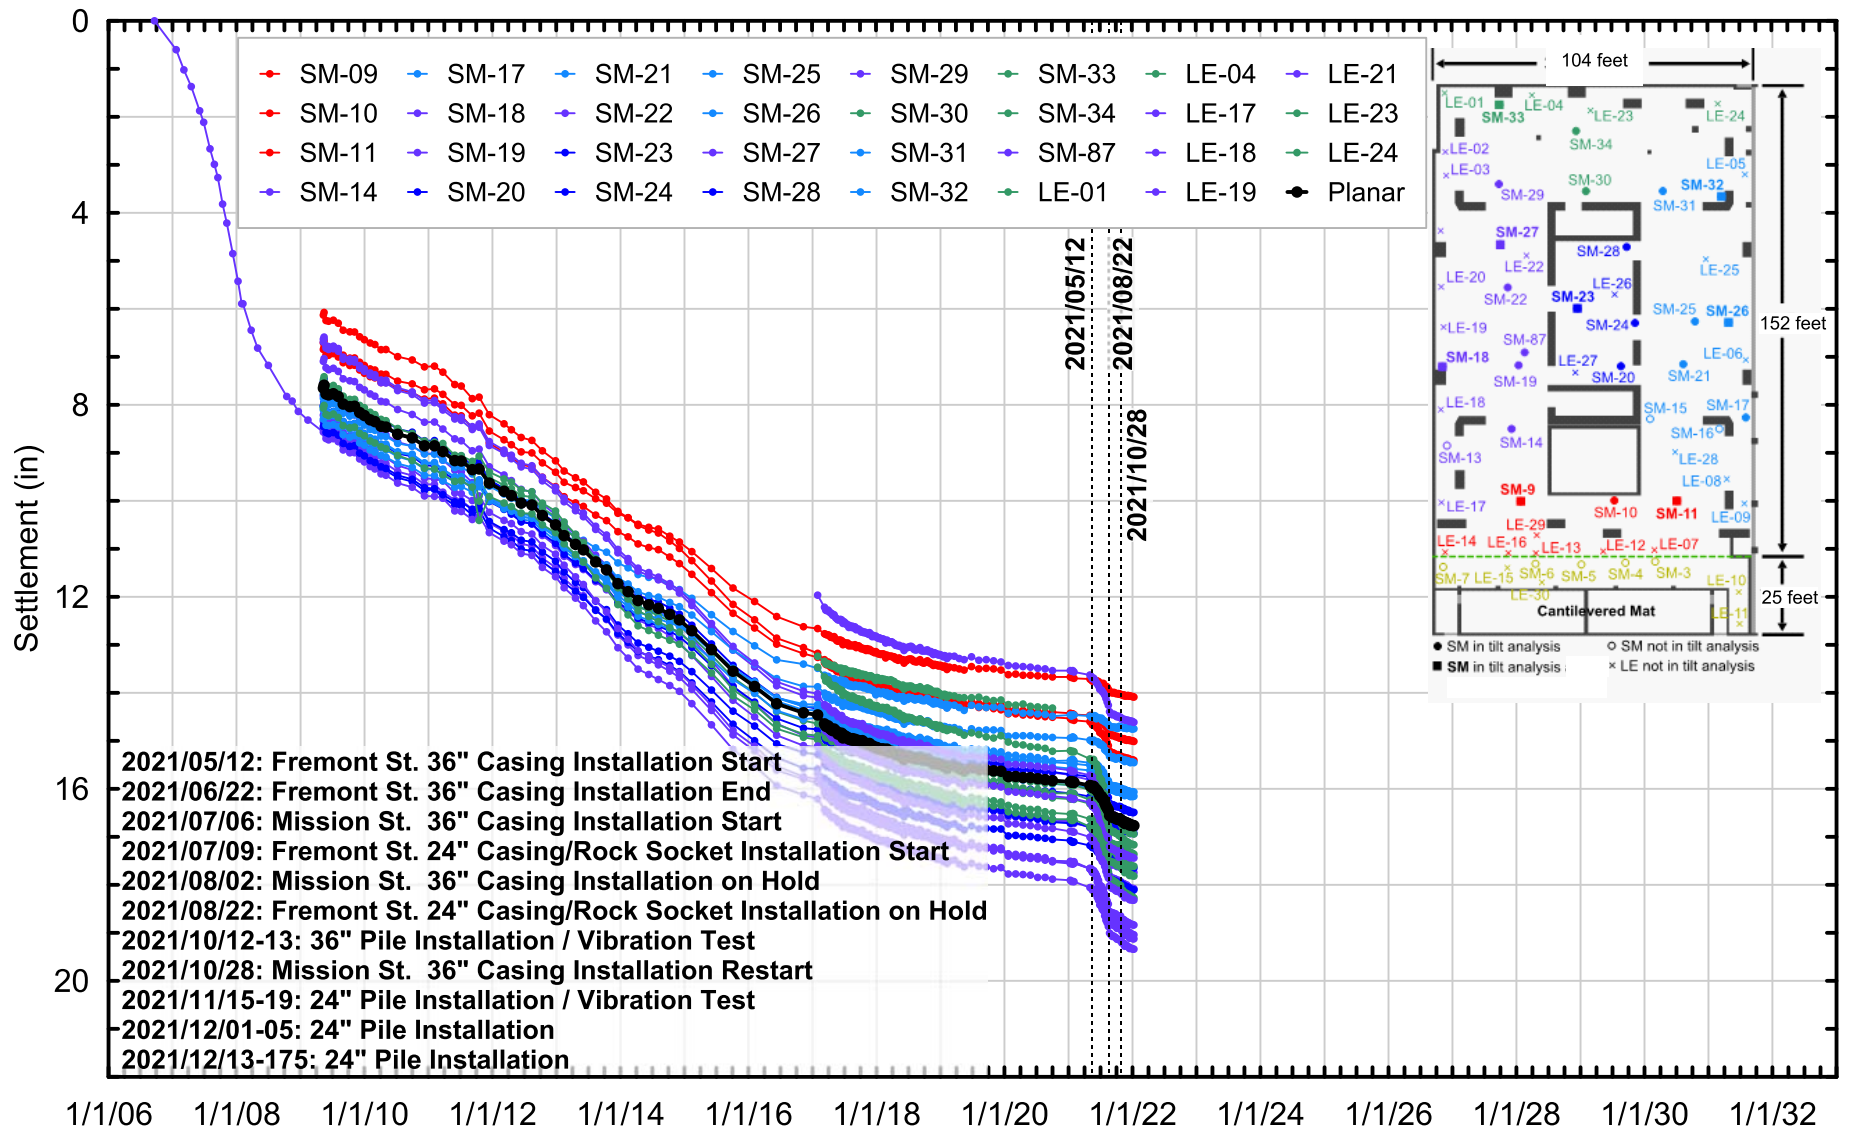
| Project No: 19-009.00 | Date: 1/11/2022 | Created By: NBW | Checked By: DGM | Figure No: <b>036-02</b> |

Figure 02 presents the historical settlement data interpreted from settlement markers installed on the B-1 Level of 301 Mission Tower. In addition, data from surveys performed during the retrofit are included. Figure 03A presents settlement data since the start of production pile installation (May 12, 2021; baseline readings on May 10, 2021) through January 9, 2022. Figure 03B presents settlement data since January 11, 2021, through January 9, 2022. Figure 04 presents current settlement contours (in inches) on January 9, 2022.

| | | <b>HISTORICAL SETTLEMENT MARKER DATA</b><br><br>Millennium Tower Perimeter Pile Upgrade: Instrumentation Monitoring Data<br>City and County of San Francisco, California | | |

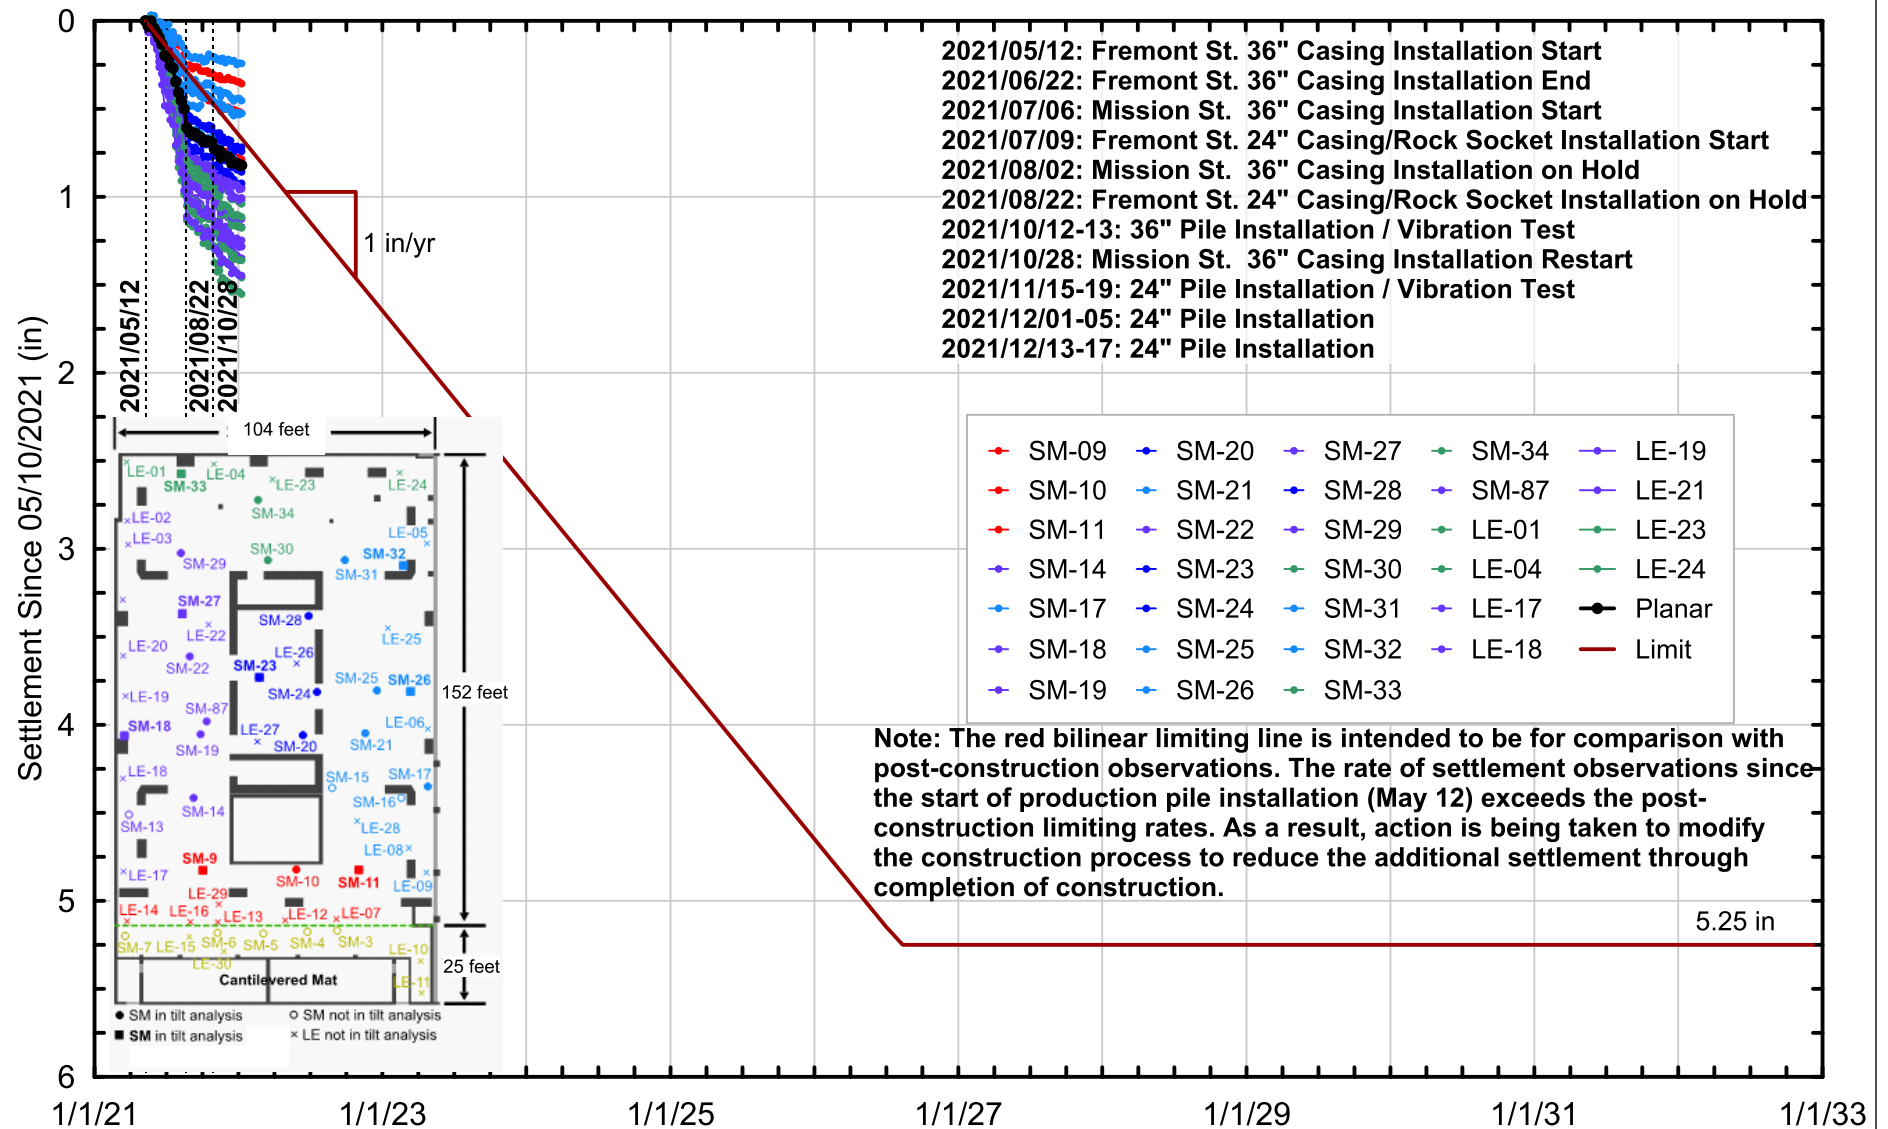
| Project No: 19-009.00 | Date: 1/11/2022 | Created By: NBW | Checked By: DGM | Figure No: <b>036-03A</b> |

| | | <p>SETTLEMENT MARKER DATA<br/> SINCE 05/10/2021 THROUGH 01/09/2022</p> <p>Millennium Tower Perimeter Pile Upgrade: Instrumentation Monitoring Data<br/> City and County of San Francisco, California</p> | | |

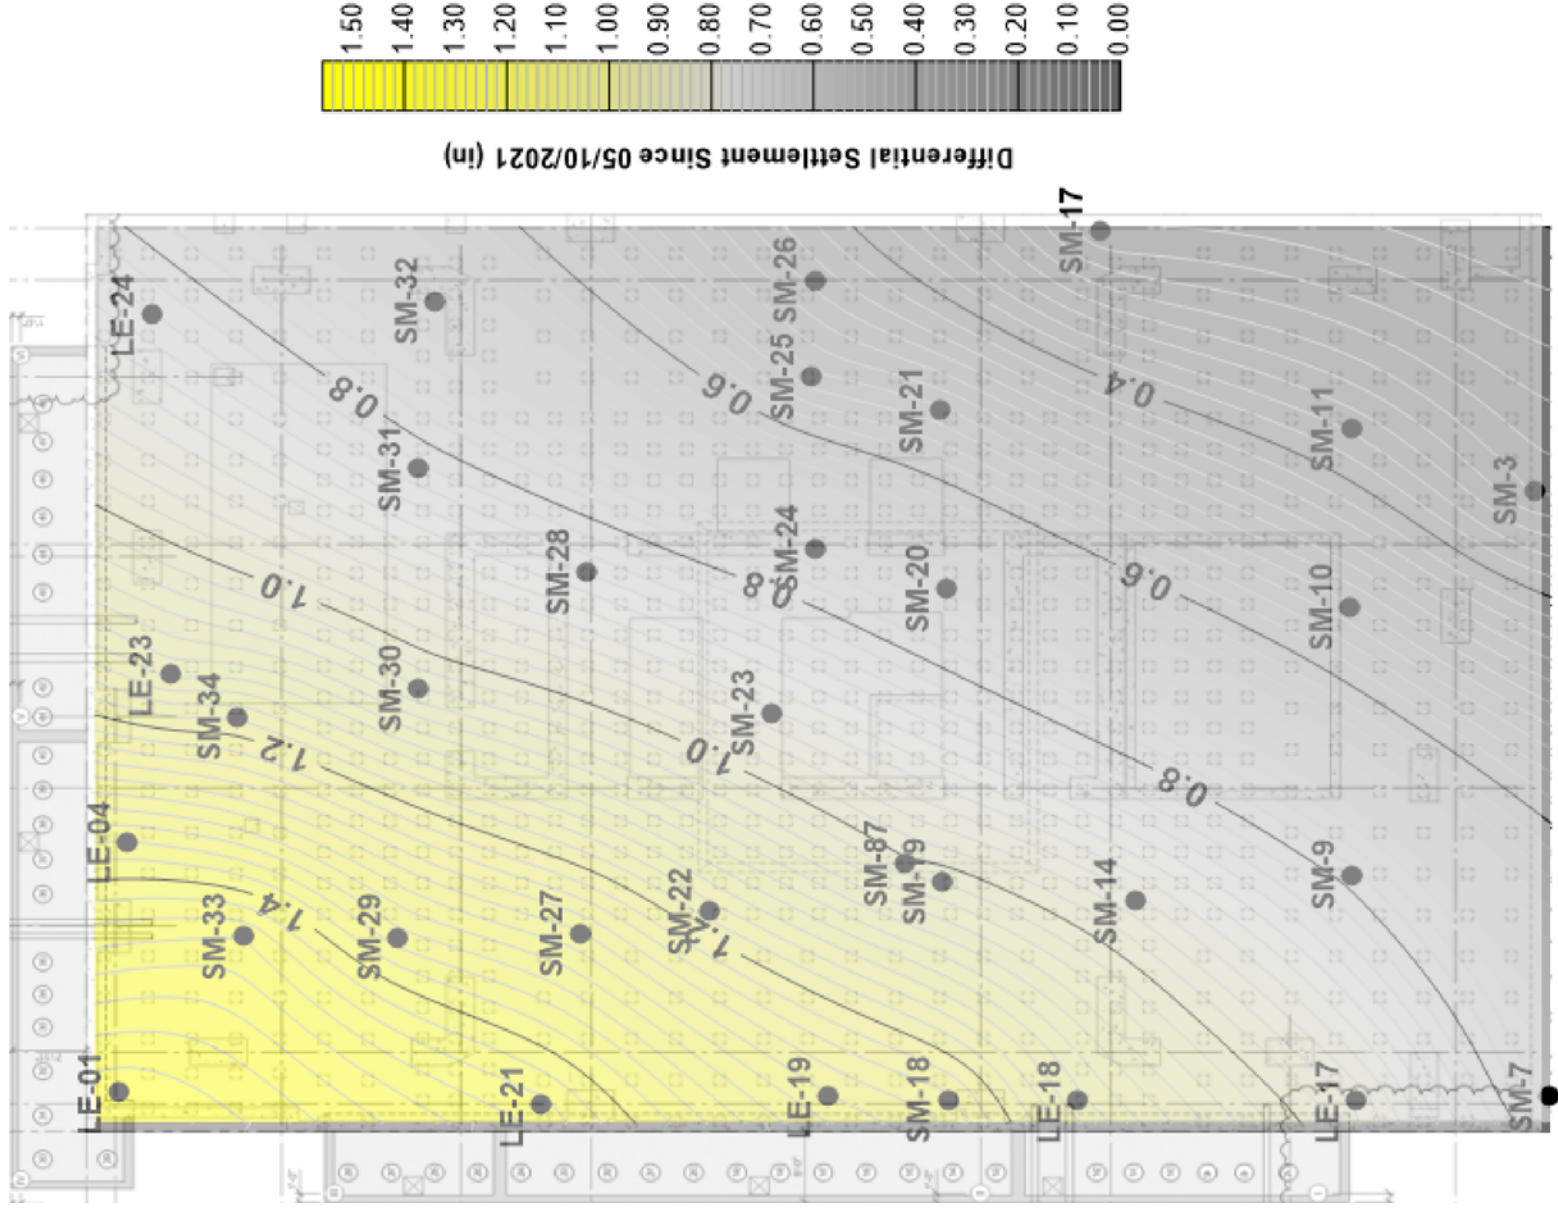
Figure No: 036-04

SETTLEMENT CONTOURS  
SINCE 05/10/2021 THROUGH 01/09/2022

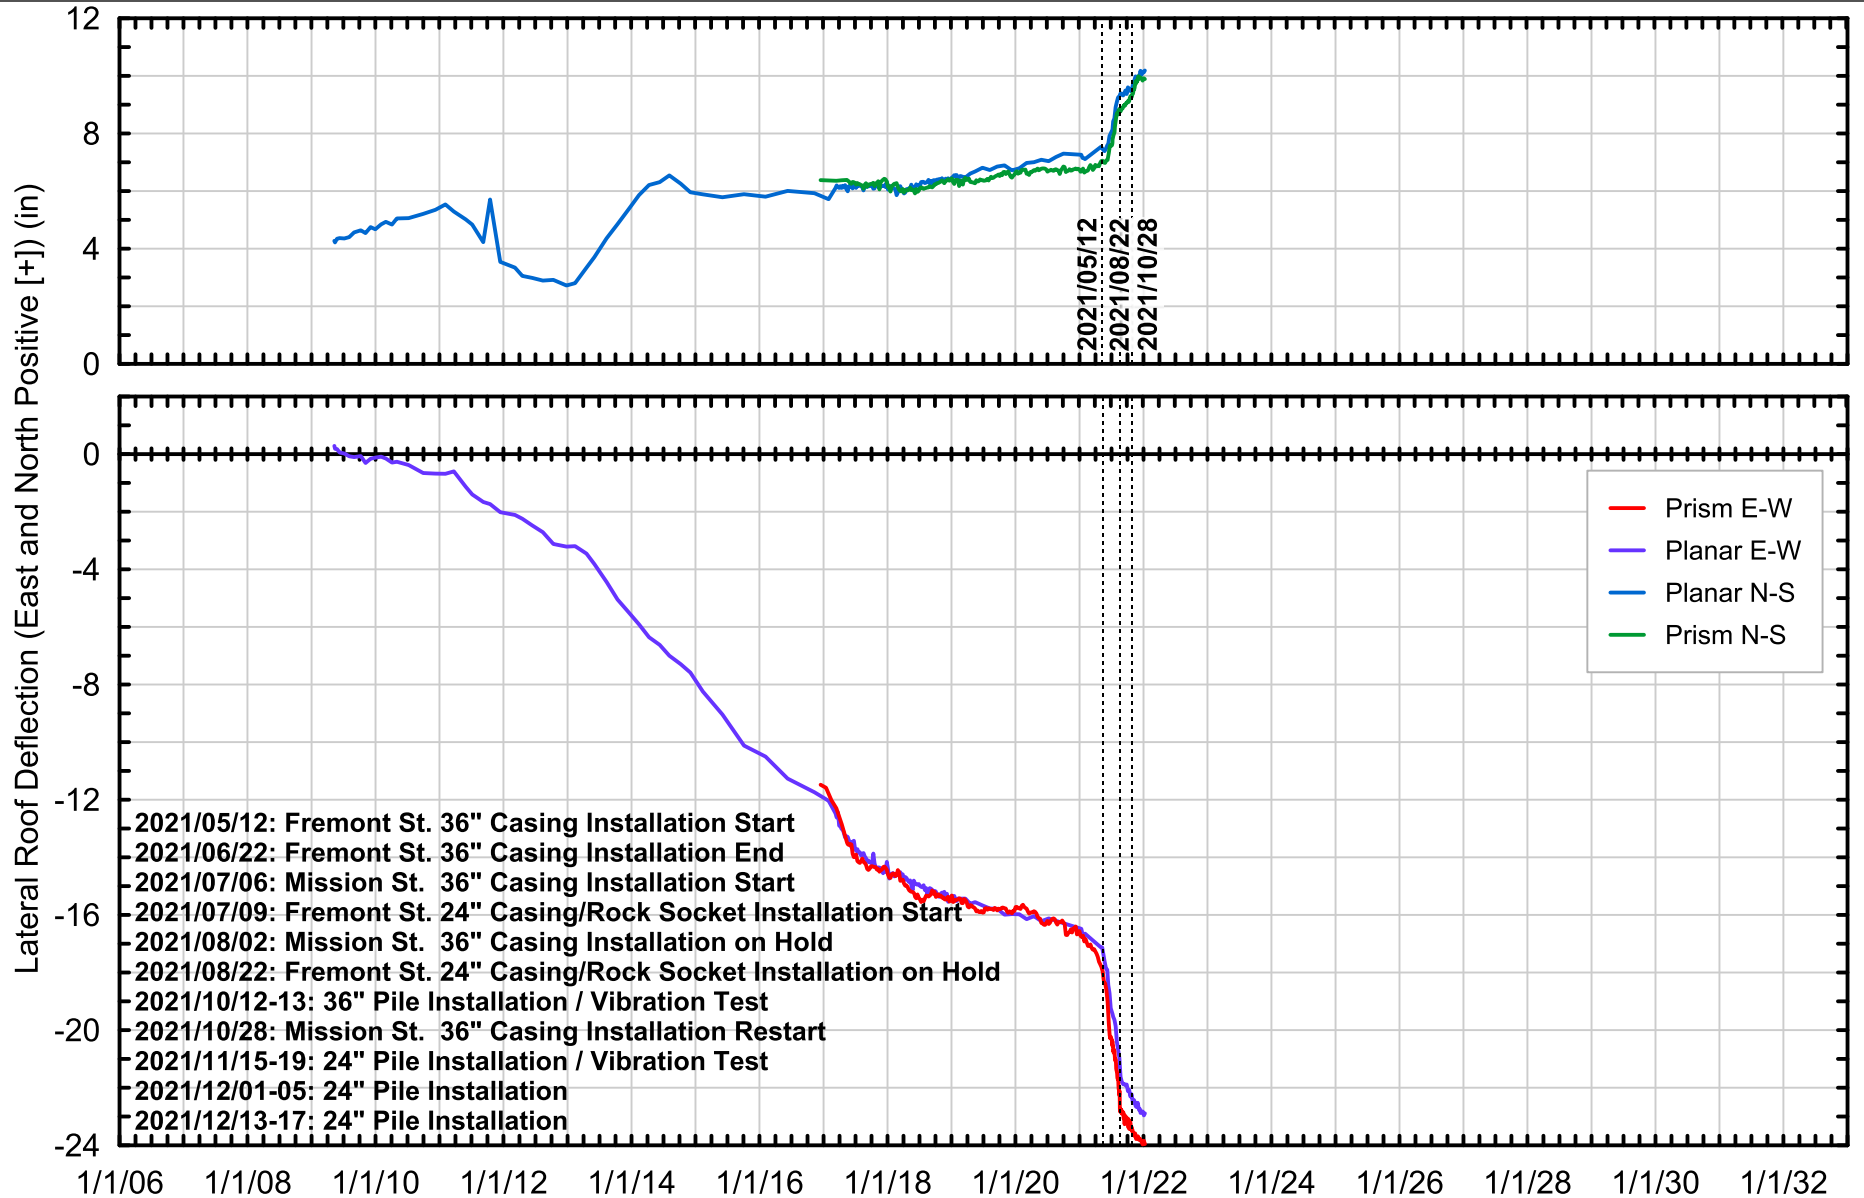
| Project No: 19-009.00 | Date: 1/11/2022 | Created By: NBW | Checked By: DGM | Figure No: <b>036-05</b> |

Figure 05 presents historical lateral roof deflections in the project north-south and project east-west directions interpreted from survey prisms mounted on the exterior of the Tower, from InSAR data, and from a planar fit of the settlement marker data. In addition, data from surveys performed during the retrofit are included. Figure 06A presents lateral roof deflection data from a planar fit of the settlement marker data and from survey prisms mounted on the exterior of the Tower since the start of production pile installation (May 12, 2021; baseline readings on May 10 and 13, 2021, respectively) through January 9, 2022. Figure 06B presents lateral roof deflection data from a planar fit of the settlement marker data and from survey prisms mounted on the exterior of the Tower since January 11, 2021, through January 9, 2022.

### HISTORICAL LATERAL ROOF DEFLECTION DATA

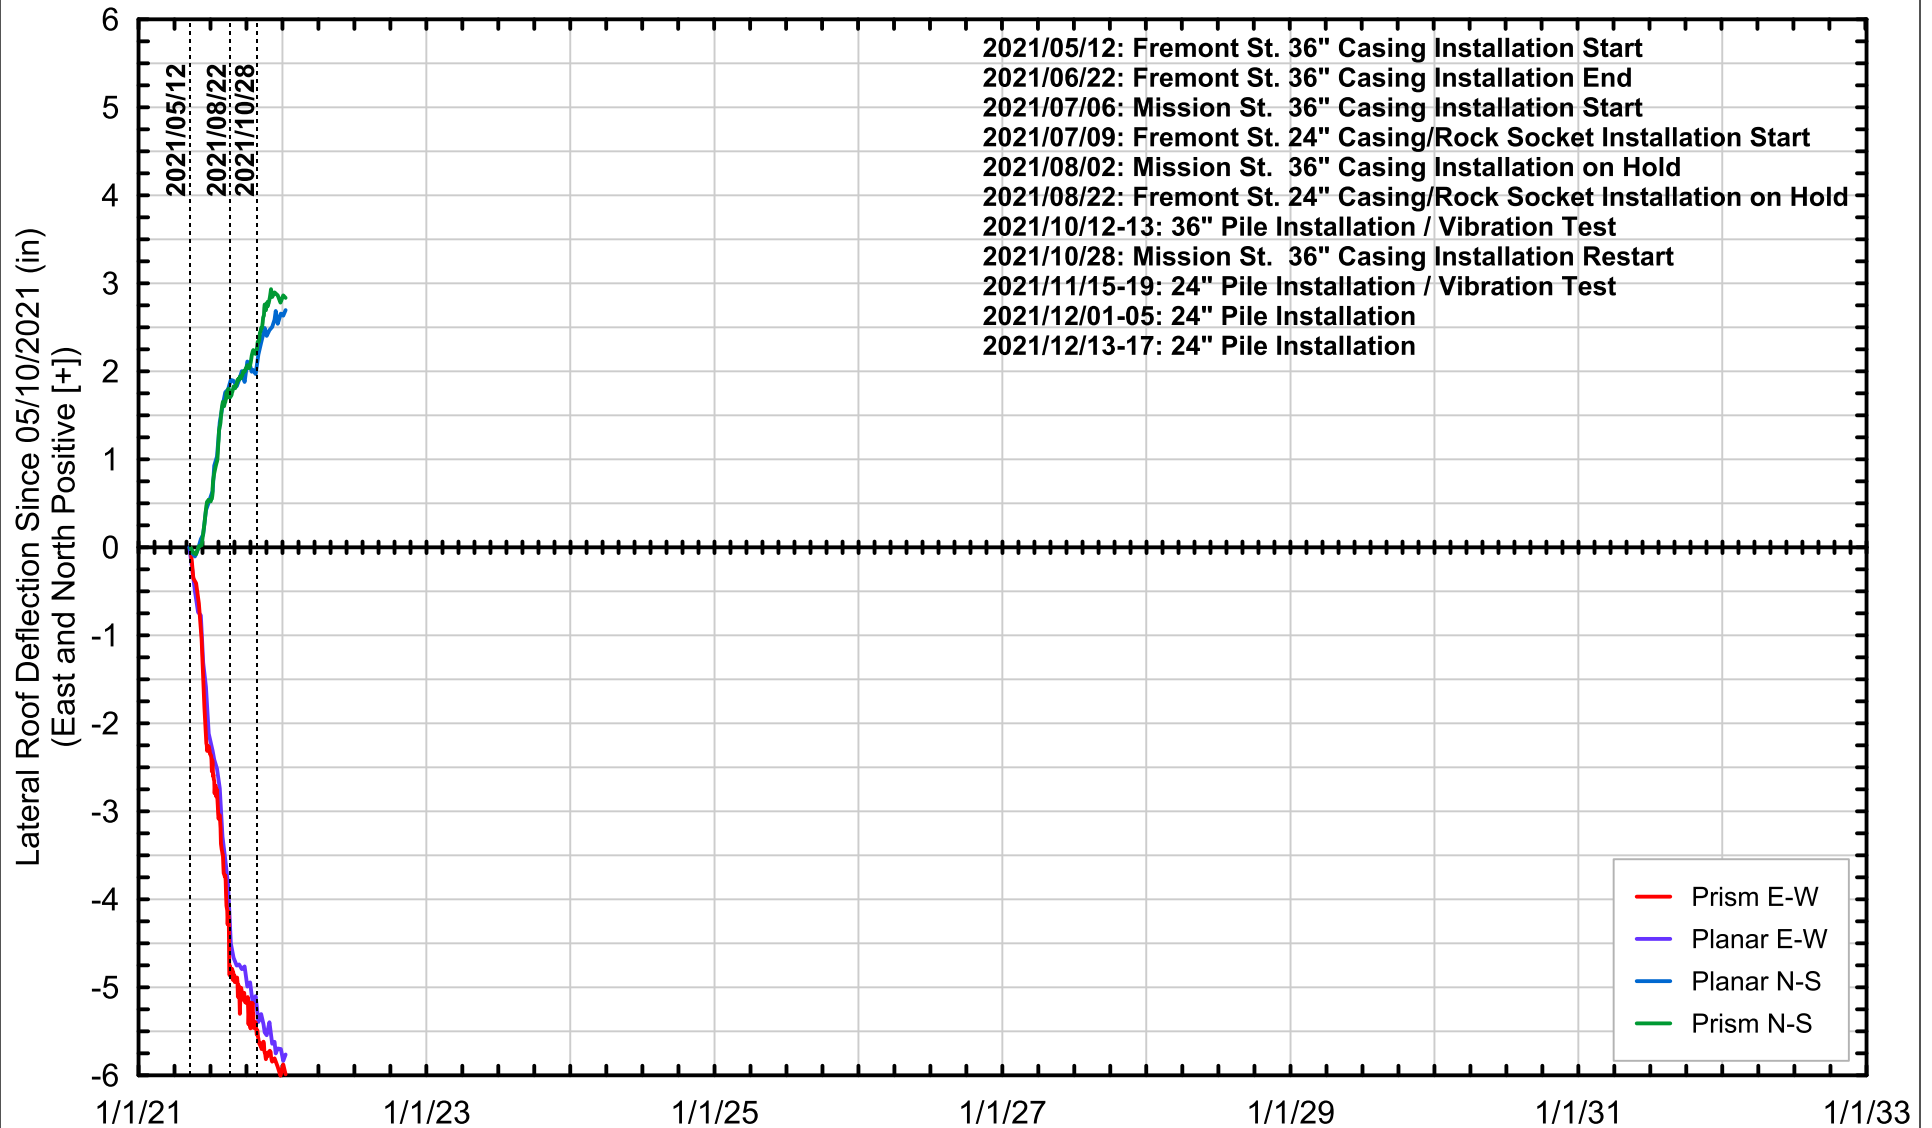
Figure No: **036-06A**

LATERAL ROOF DEFLECTION DATA  
SINCE 05/10/2021 THROUGH 01/10/2022

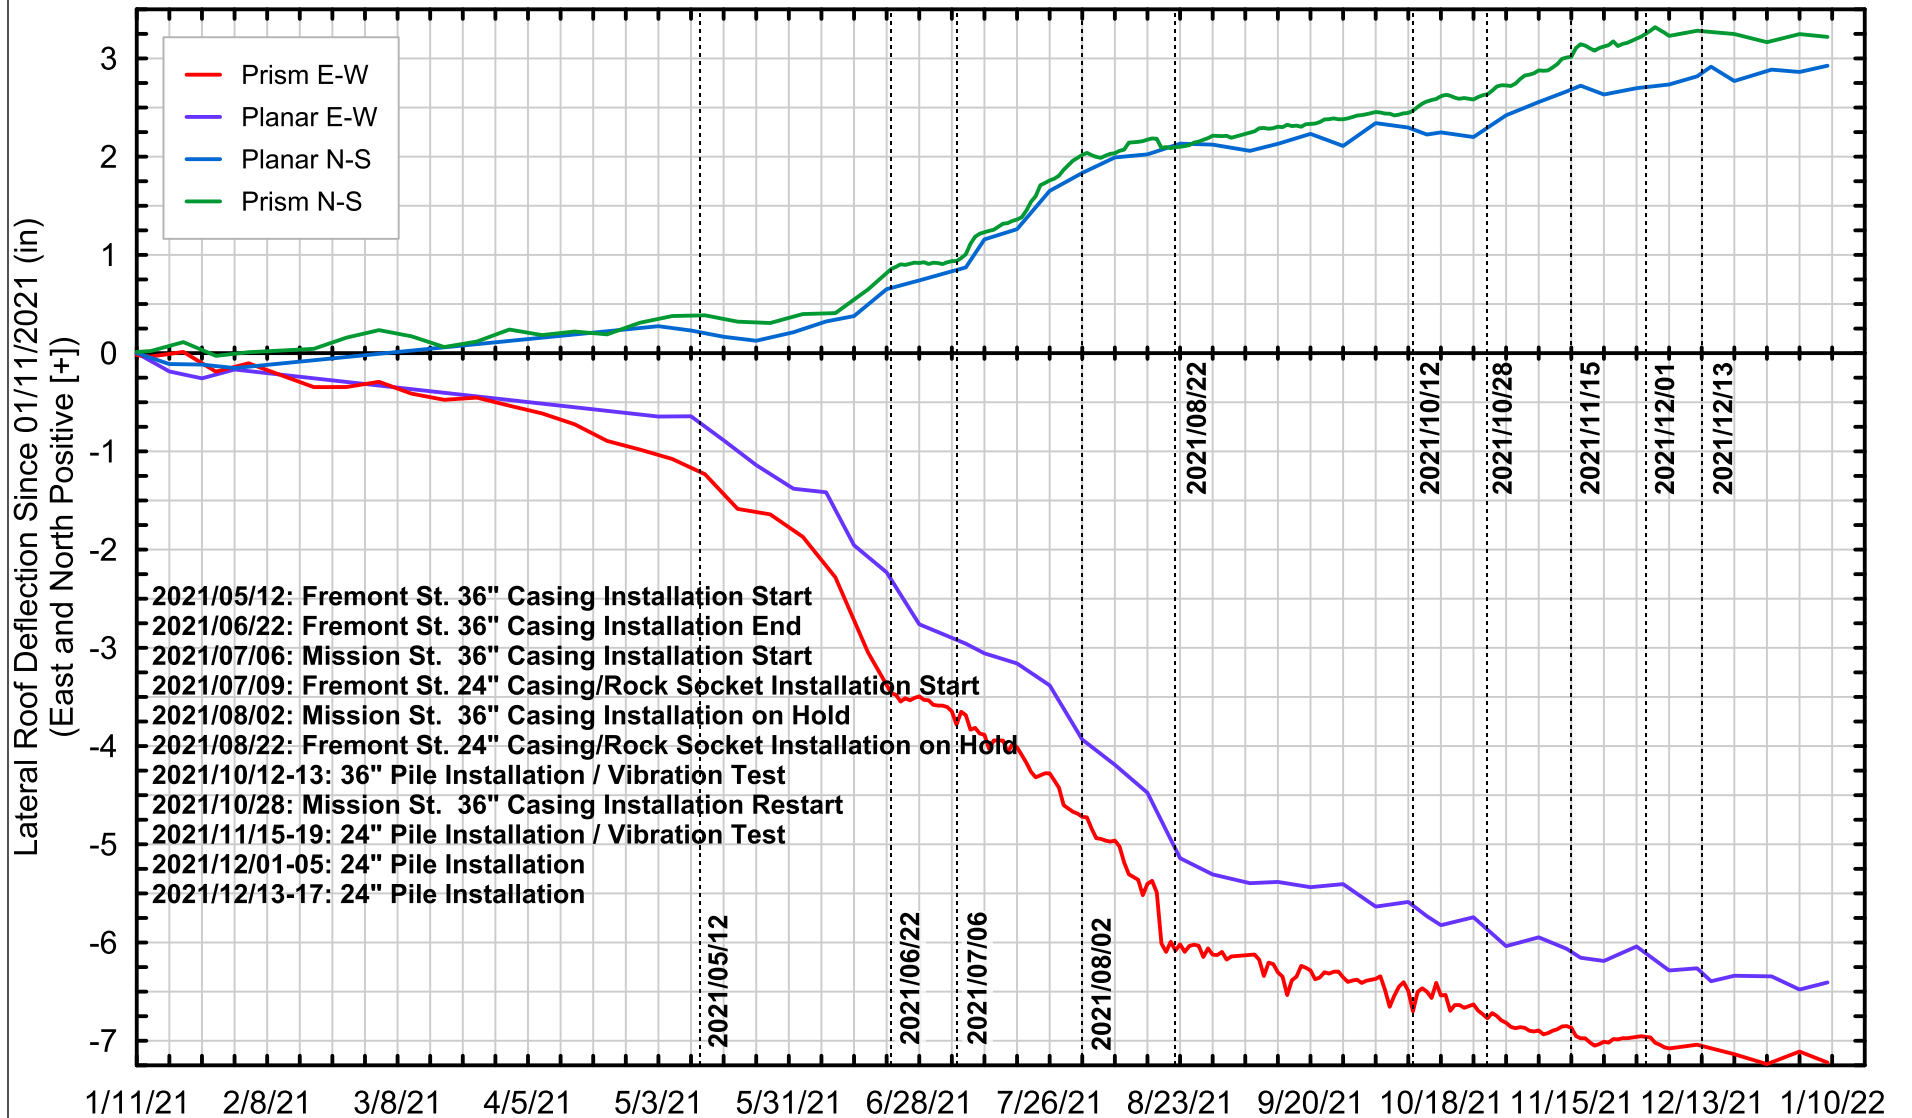
| Project No: 19-009.00 | Date: 1/11/2022 | Created By: NBW | Checked By: DGM | Figure No: <b>036-06B</b> |

LATERAL ROOF DEFLECTION DATA  
SINCE 01/11/2021 THROUGH 01/10/2022

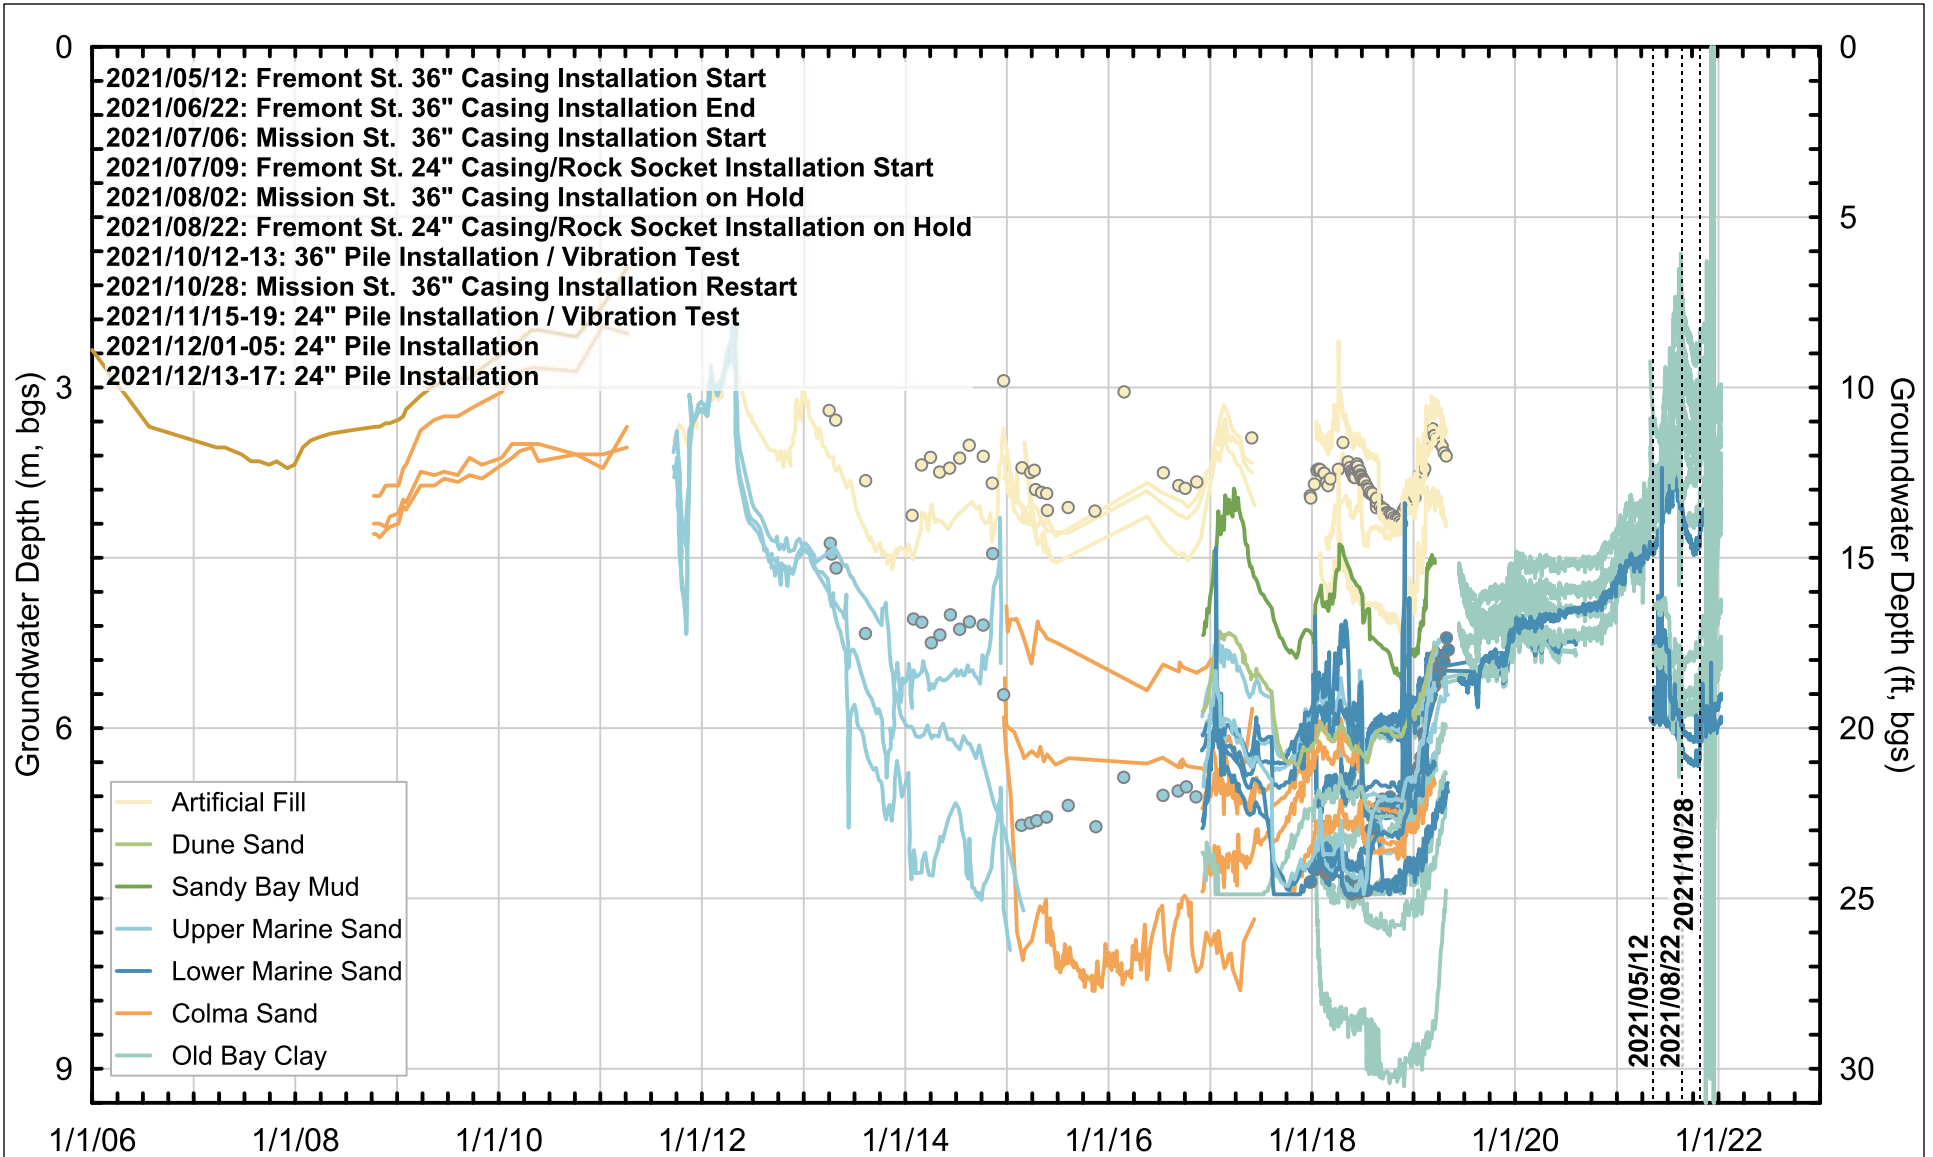
Figure 07 presents the historical groundwater elevation interpreted from piezometer readings at locations near 301 Mission. In addition, data from piezometers installed to monitor groundwater elevation during the retrofit are included. Figures 08 and 09 present groundwater elevation interpreted from piezometer readings in the Marine/Colma Sand and the Old Bay Clay, respectively, for the time period prior to the start of production pile installation (January 1, 2021) through January 10, 2022.

| | | <b>HISTORICAL GROUNDWATER ELEVATION MEASUREMENTS<br/> AT LOCATIONS NEAR 301 MISSION</b><br><br>Millennium Tower Perimeter Pile Upgrade: Instrumentation Monitoring Data<br>City and County of San Francisco, California | | |

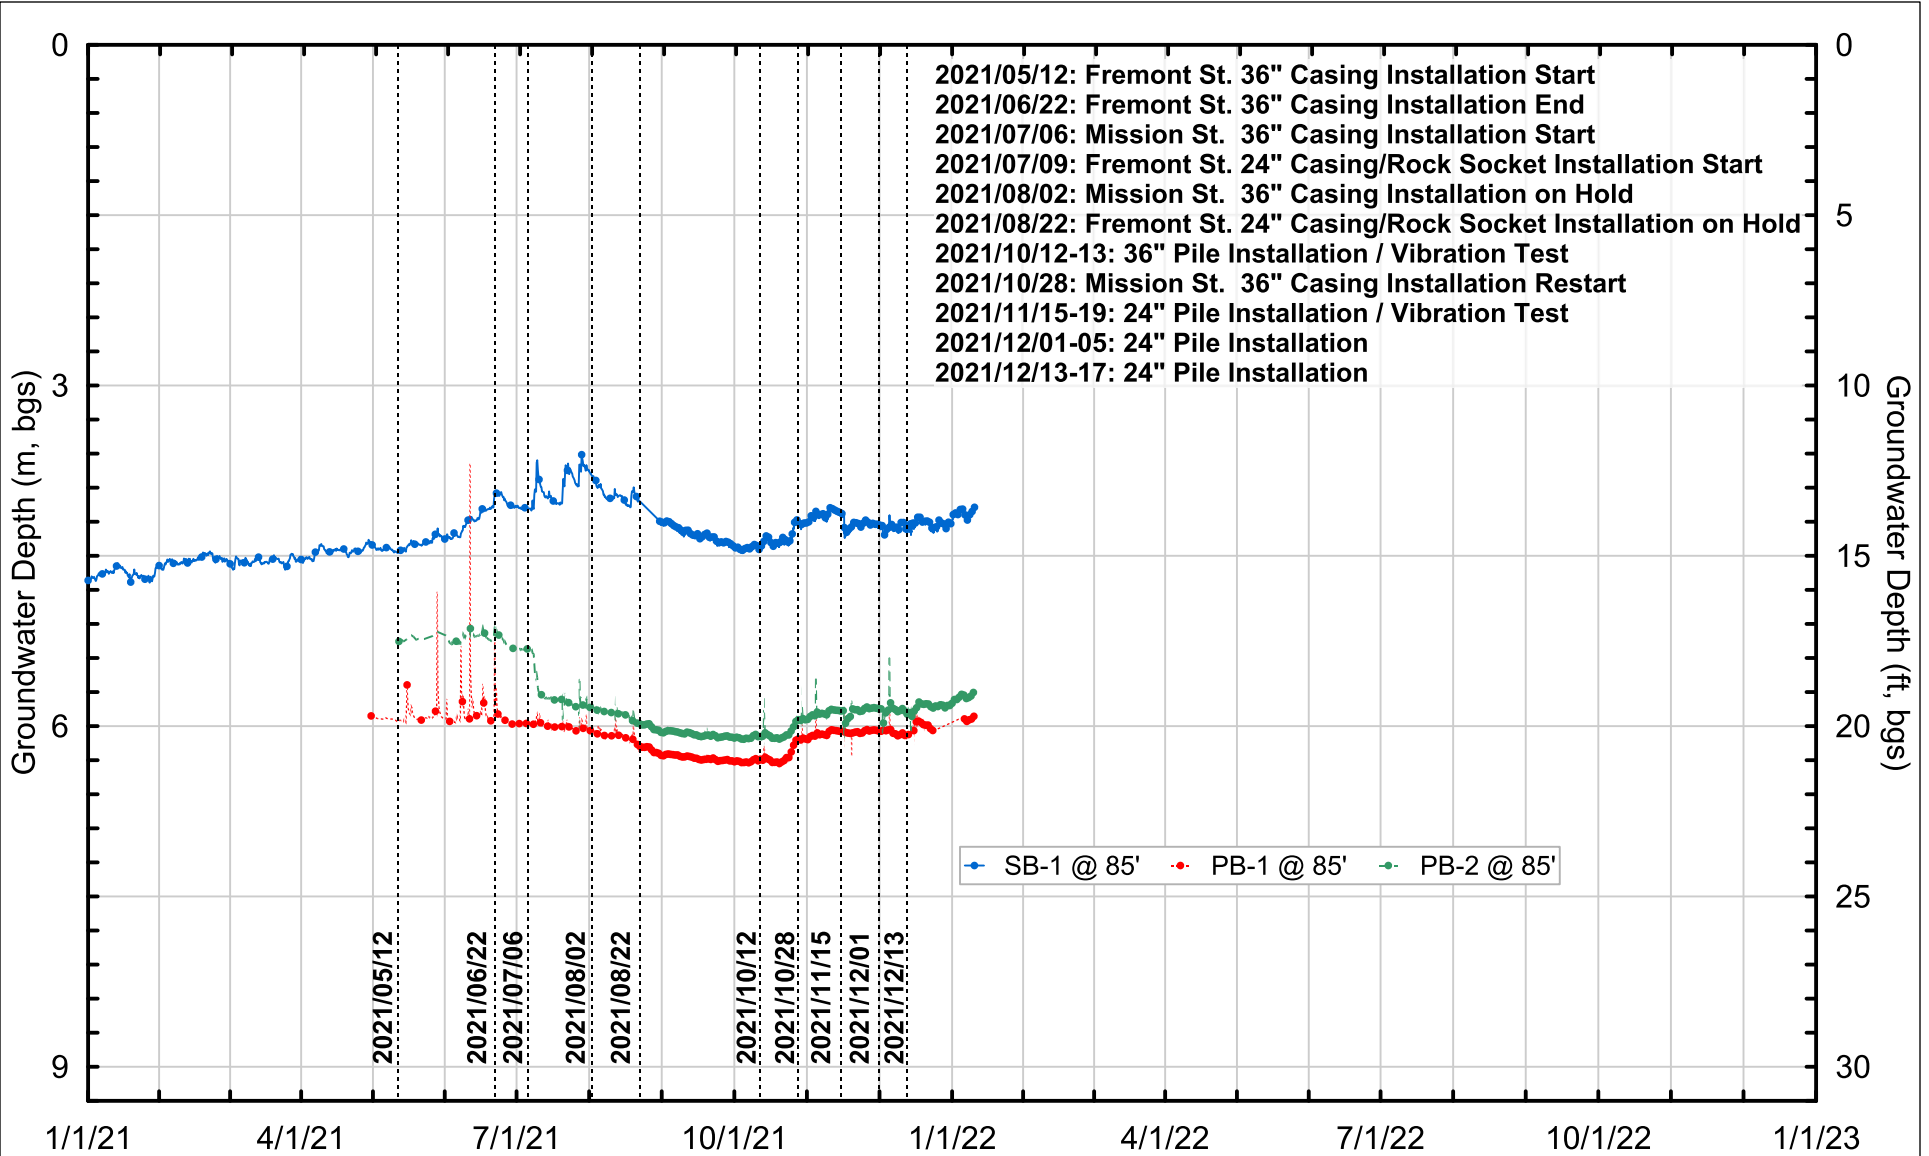
| | | <p>GROUNDWATER ELEVATION MEASUREMENTS IN MARINE AND COLMA SAND<br/>SINCE 01/01/2021 THROUGH 01/10/2022</p> <p>Millennium Tower Perimeter Pile Upgrade: Instrumentation Monitoring Data<br/>City and County of San Francisco, California</p> | | |
