Subject: 301 Mission Retrofit Monitoring Report 036: Results as of January 10, 2022

| Millennium Tower Perimeter Pile Upgrade: Instrumentation Monitoring Data<br>City and County of San Francisco, California | | | |

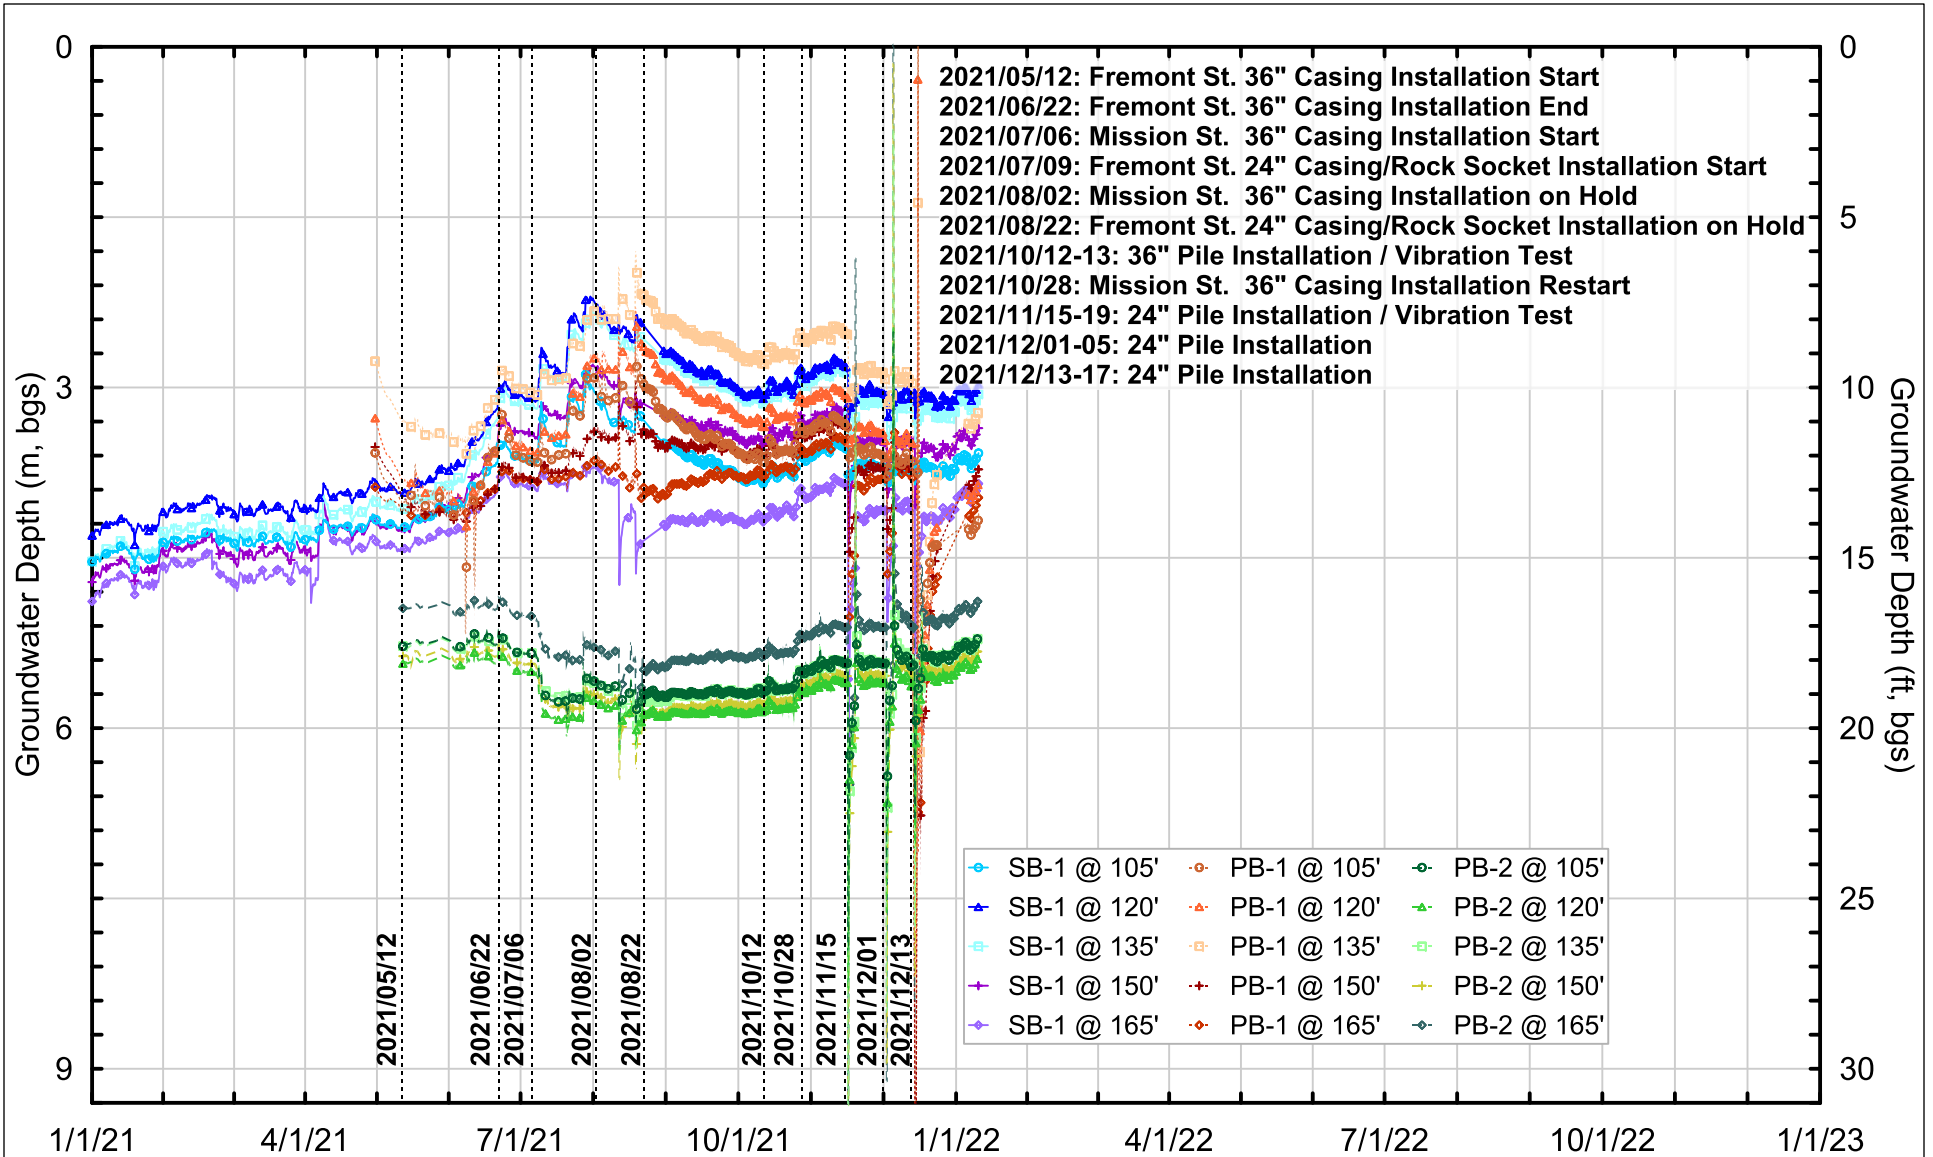
| | | <p>GROUNDWATER ELEVATION MEASUREMENTS IN OLD BAY CLAY<br/>SINCE 01/01/2021 THROUGH 01/10/2022</p> <p>Millennium Tower Perimeter Pile Upgrade: Instrumentation Monitoring Data<br/>City and County of San Francisco, California</p> | | |

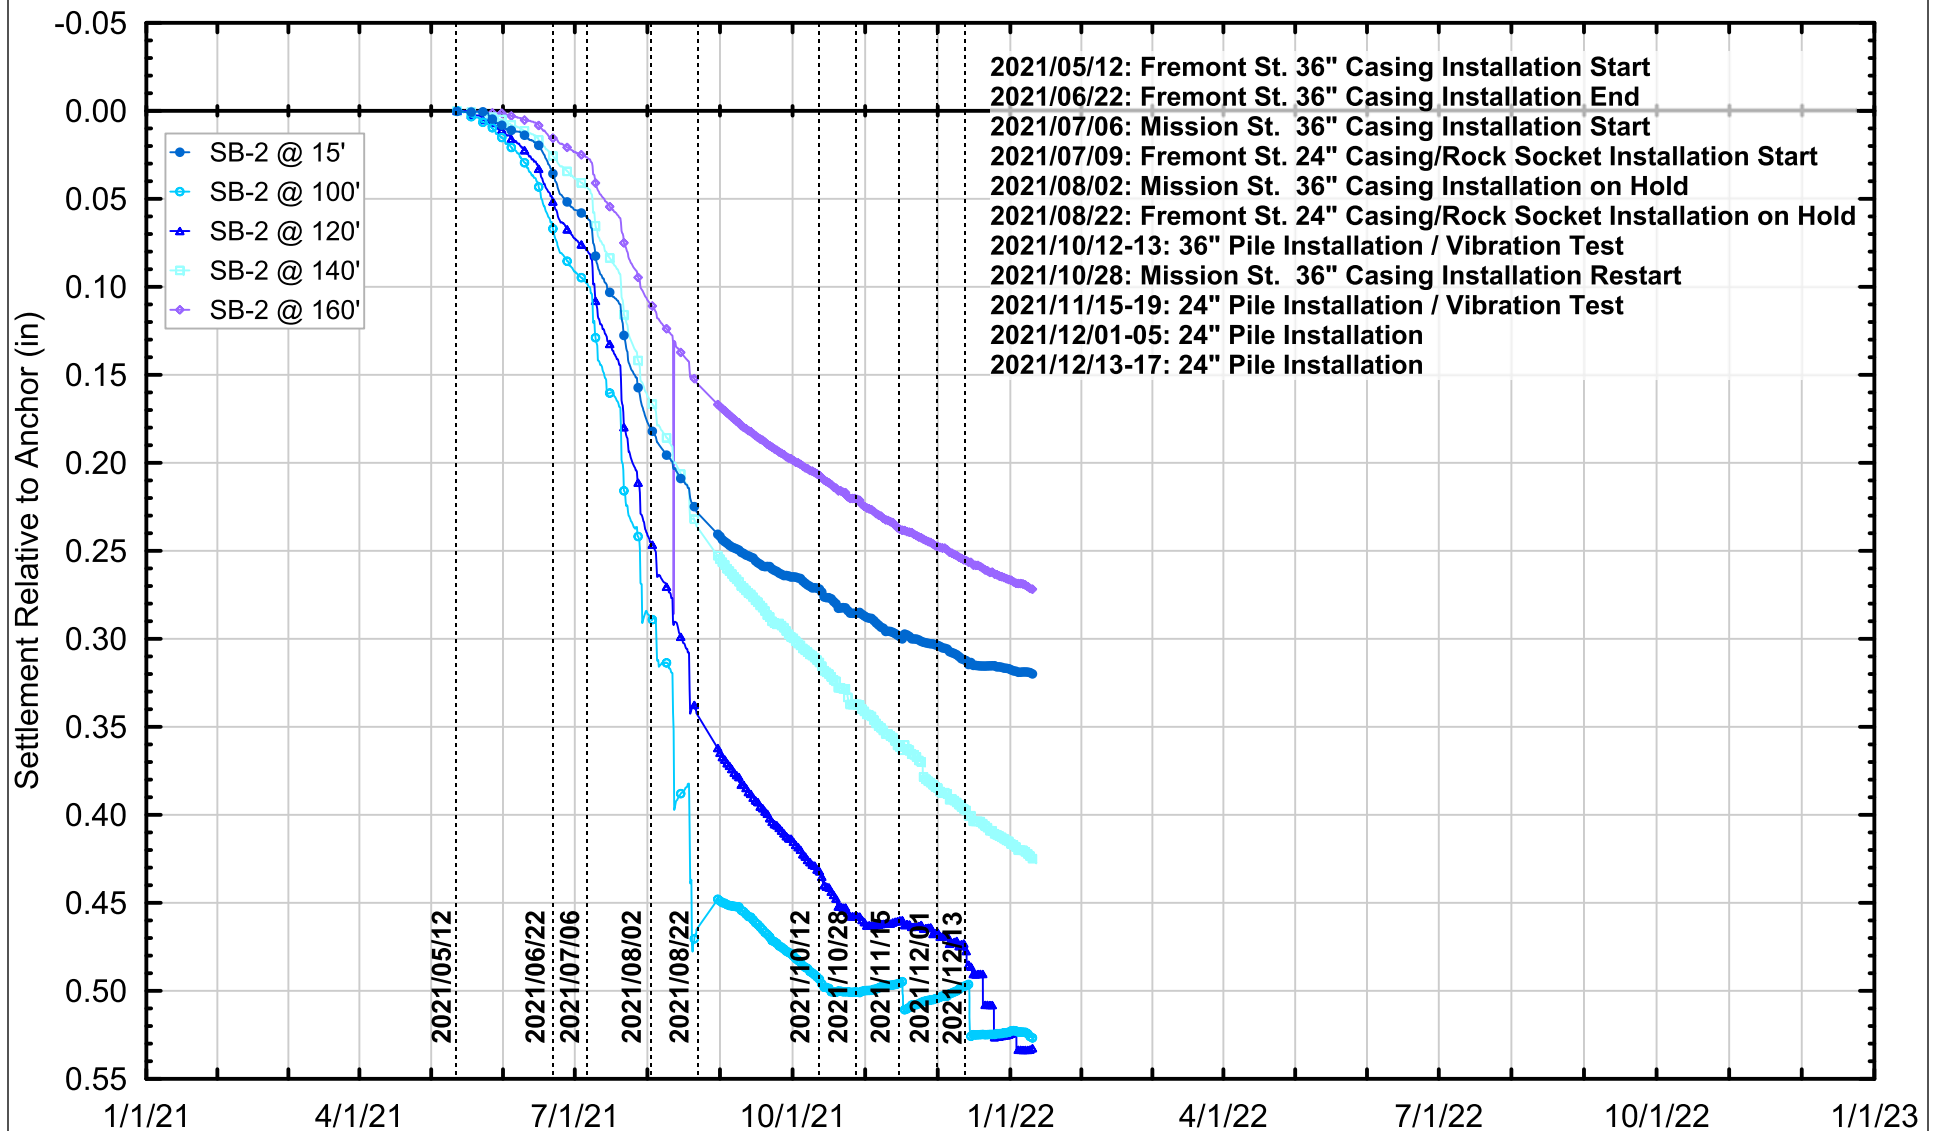
Figure 10 presents extensometer data from within the Tower basement since the start of production pile installation (May 12, 2021) through January 10, 2022. Figure 11 presents extensometer data from Fremont

| | | <p>EXTENSOMETER DATA FROM WITHIN TOWER BASEMENT<br/>SINCE 01/01/2021 THROUGH 01/10/2022</p> <p>Millennium Tower Perimeter Pile Upgrade: Instrumentation Monitoring Data<br/>City and County of San Francisco, California</p> | | |

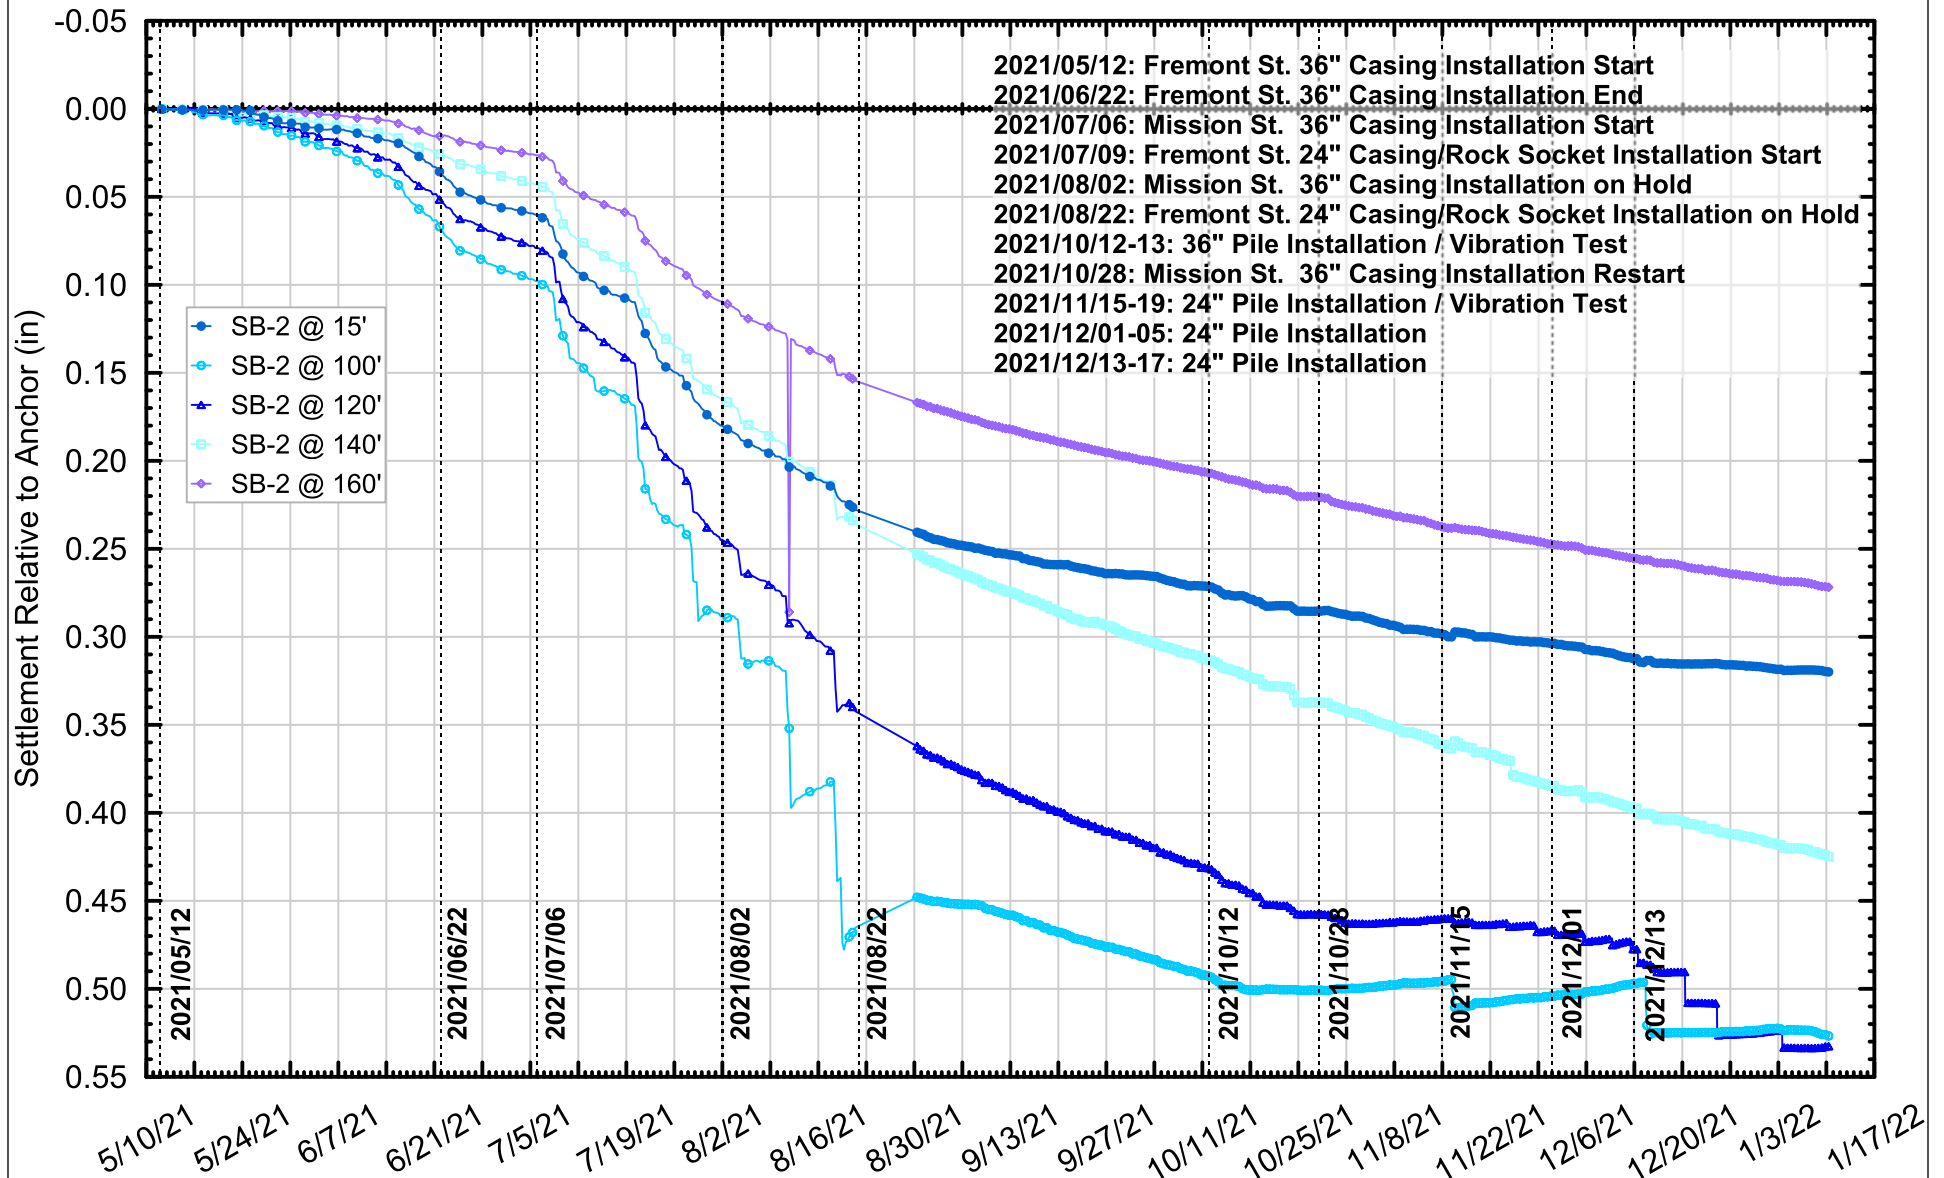
| Project No: 19-009.00 | Date: 1/11/2022 | Created By: NBW | Checked By: DGM | Figure No: <b>036-10B</b> |

EXTENSOMETER DATA FROM WITHIN TOWER BASEMENT  
SINCE 05/10/2021 THROUGH 01/10/2022

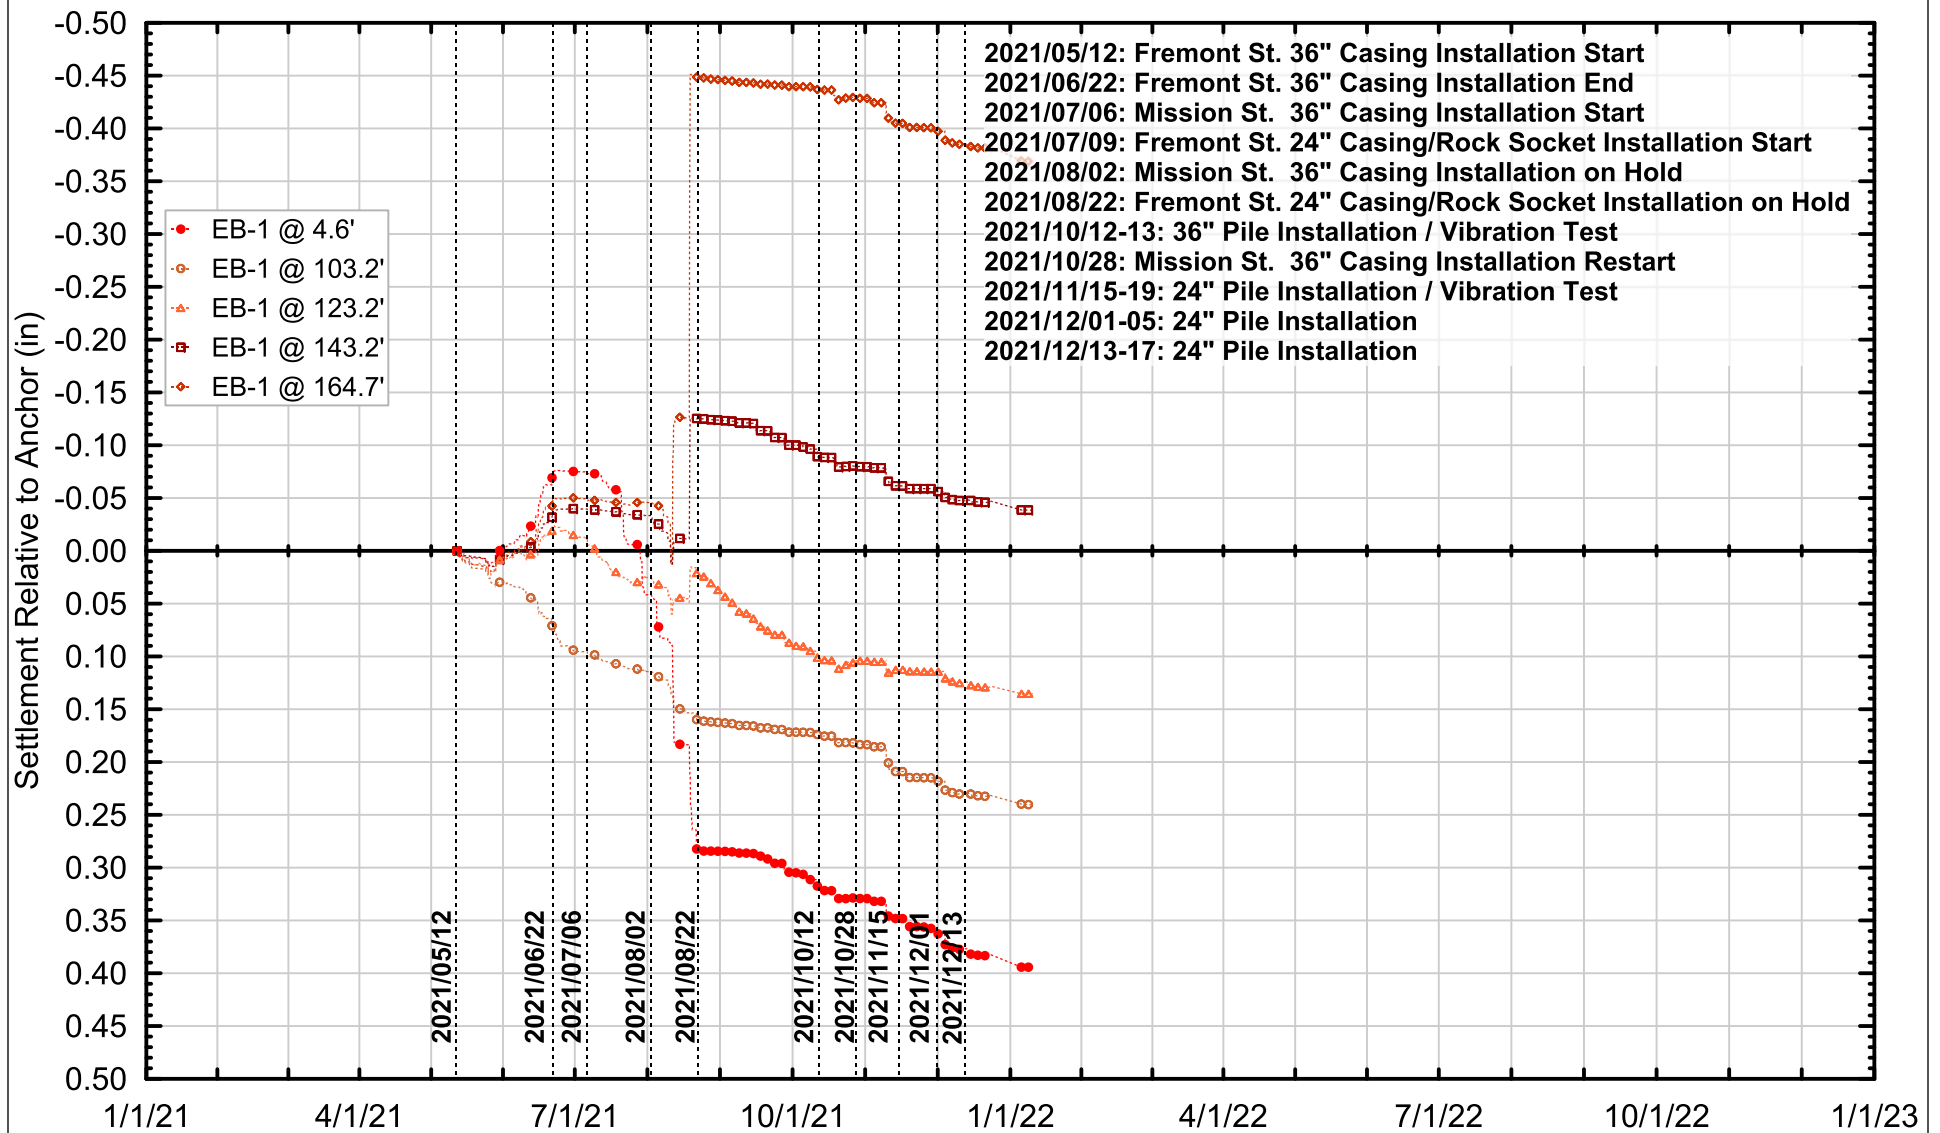
| | | <p>EXTENSOMETER DATA FROM FREMONT STREET<br/>SINCE 01/01/2021 THROUGH 01/10/2022</p> <p>Millennium Tower Perimeter Pile Upgrade: Instrumentation Monitoring Data<br/>City and County of San Francisco, California</p> | | |

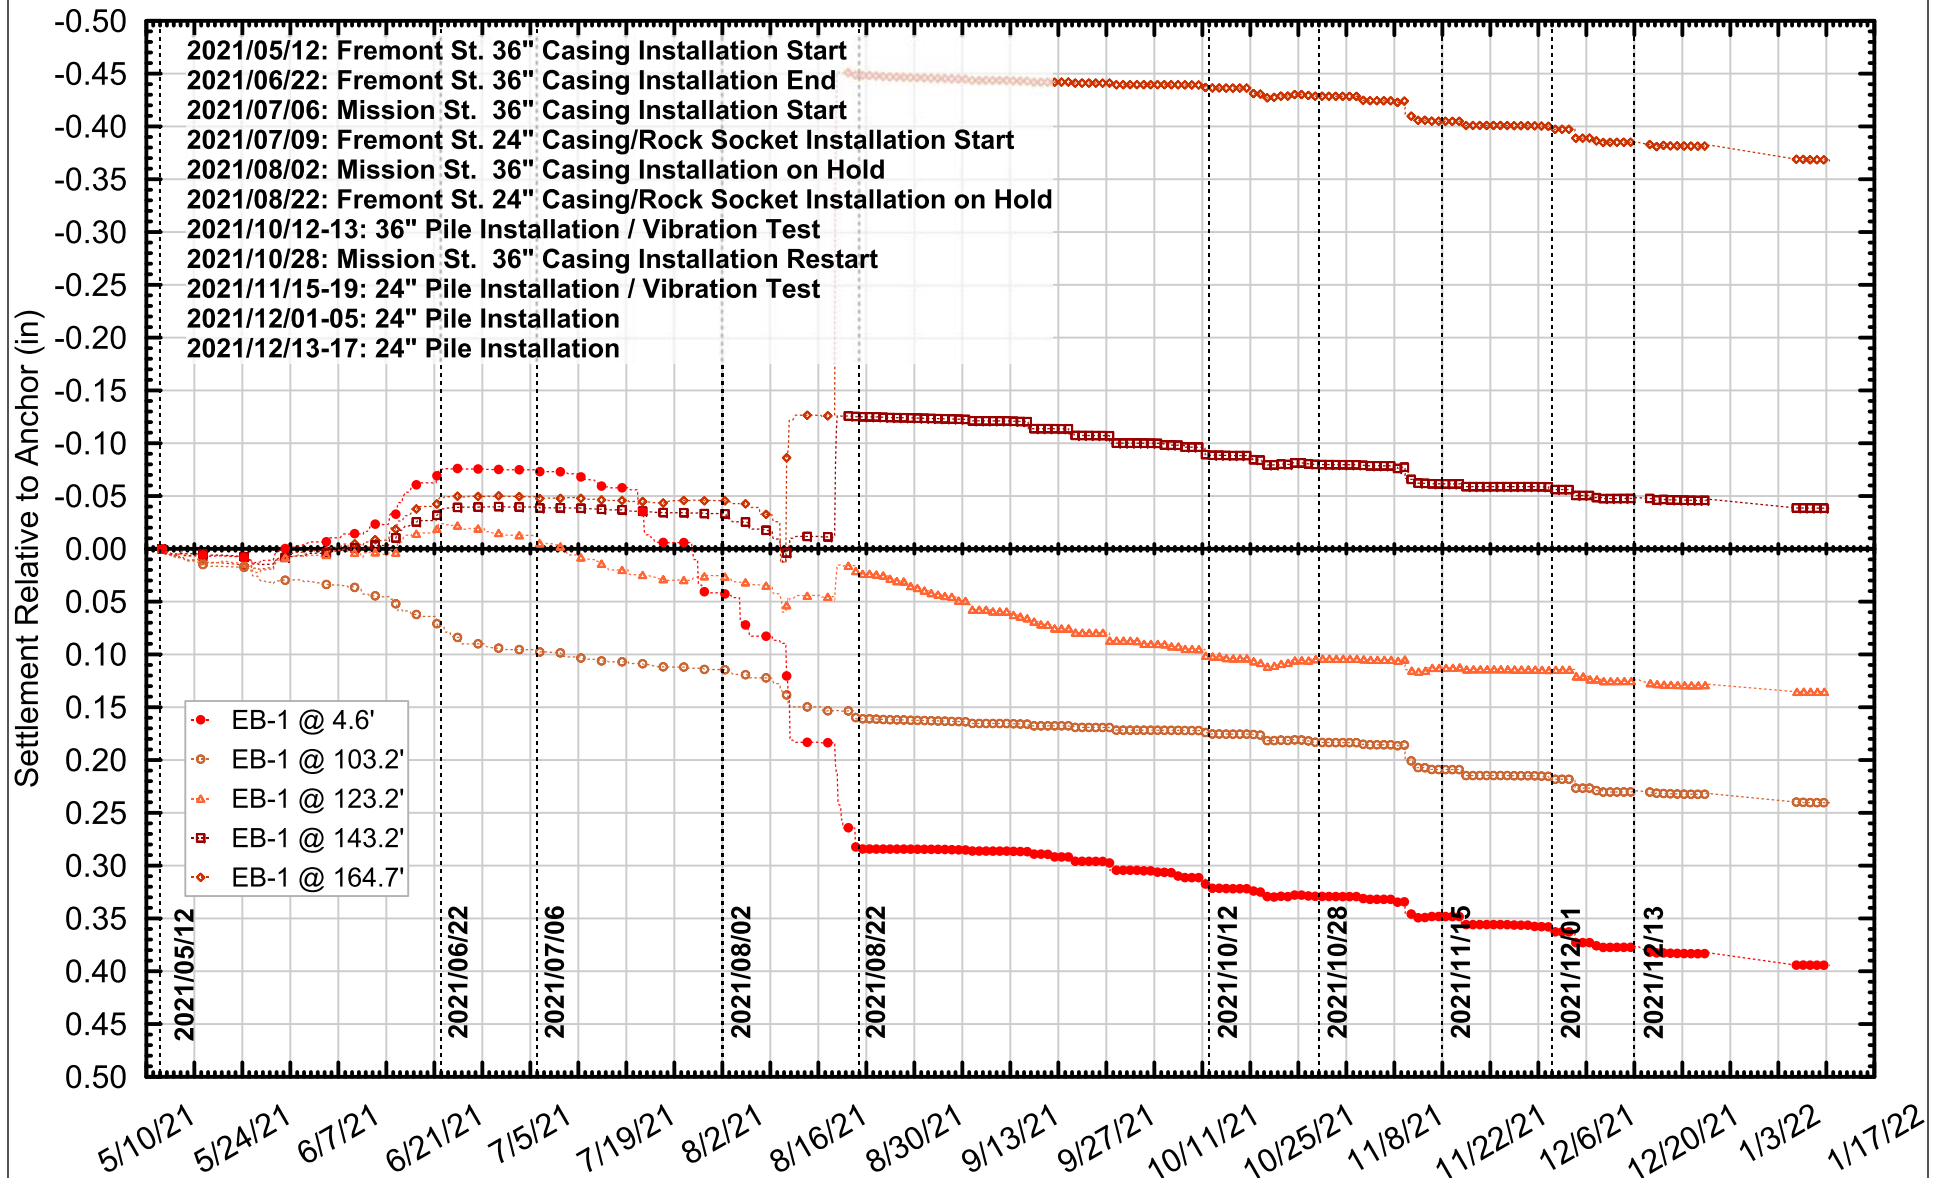
| Project No: 19-009.00 | Date: 1/11/2022 | Created By: NBW | Checked By: DGM | Figure No: <b>036-11B</b> |

EXTENSOMETER DATA FROM FREMONT STREET  
 SINCE 05/10/2021 THROUGH 01/10/2022

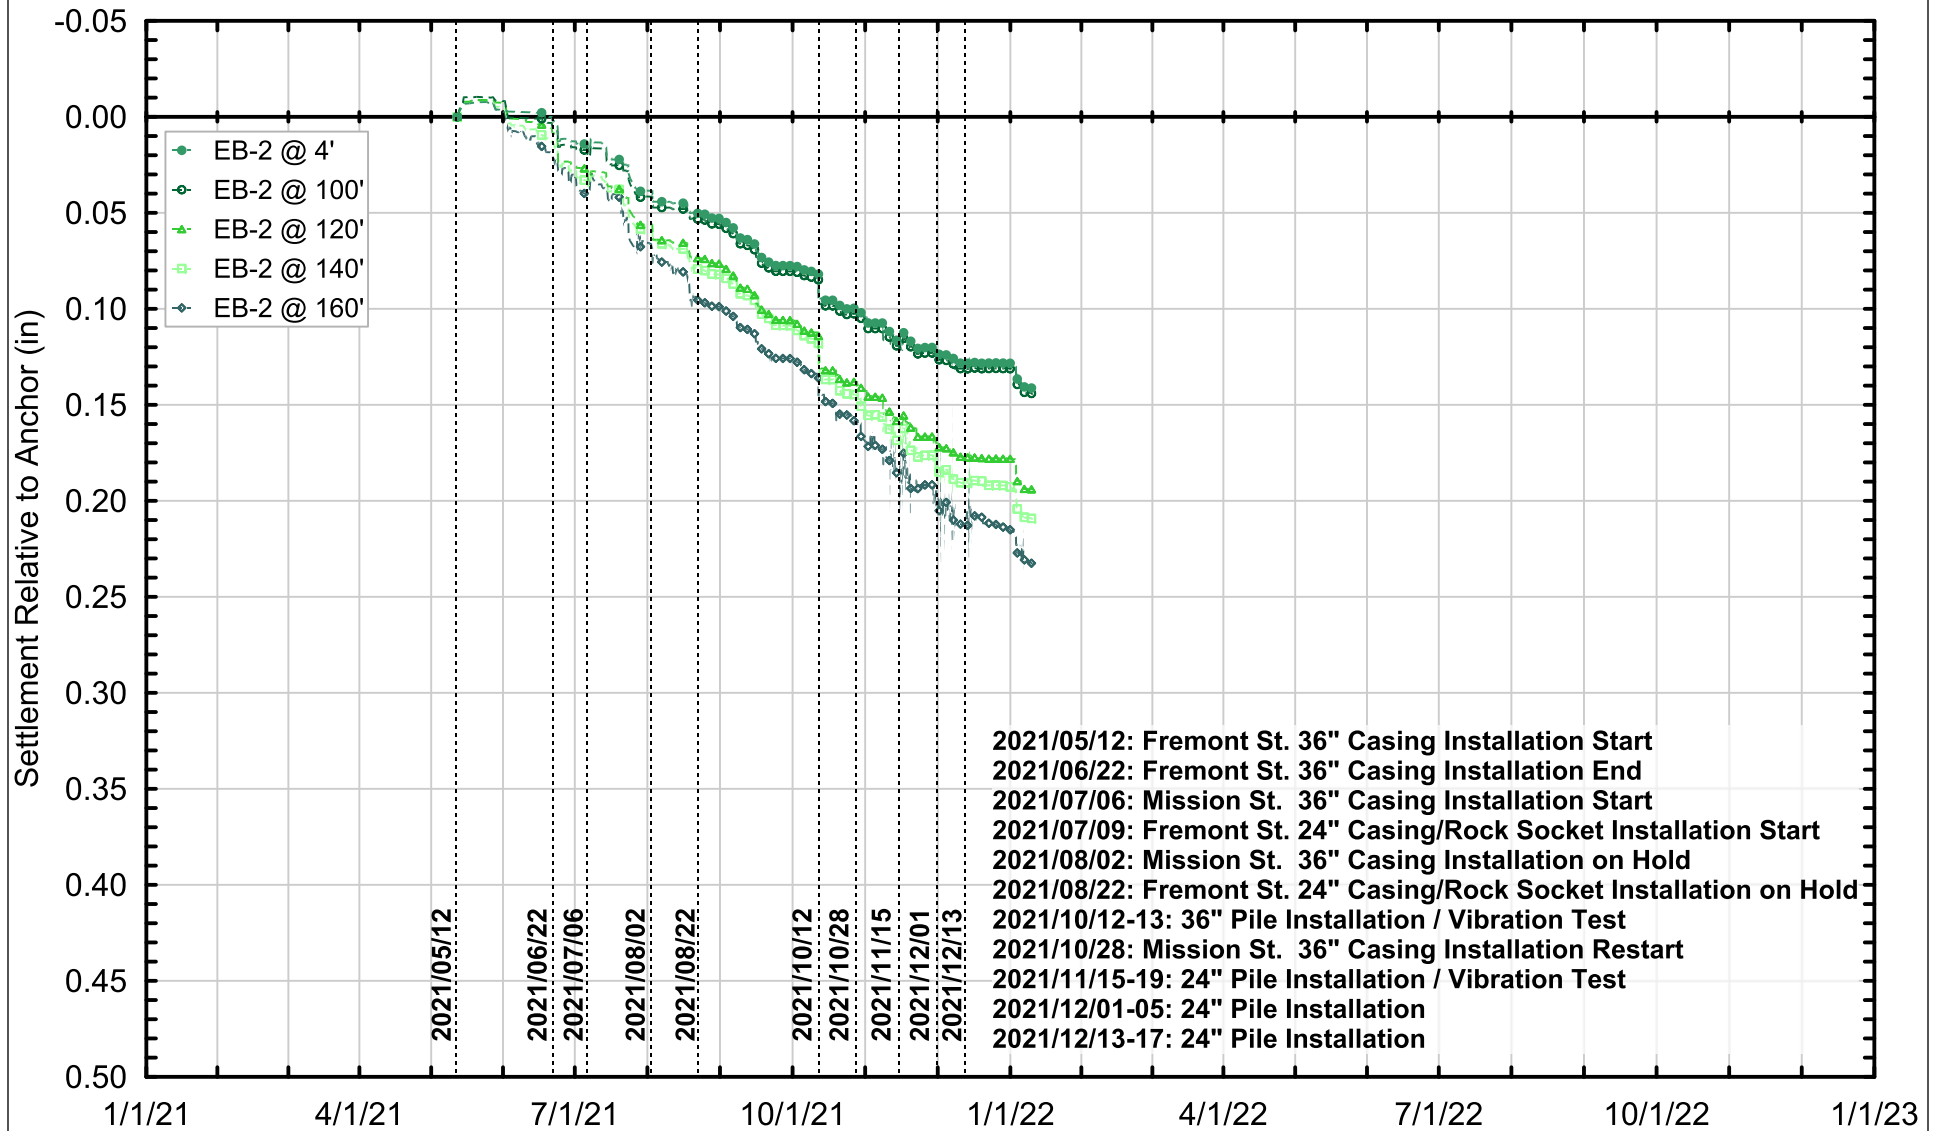
Street since the start of production pile installation (May 12, 2021) through January 10, 2022. Figure 12 presents extensometer data from Mission Street since the start of production pile installation (May 12, 2021) through January 10, 2022.

| | | EXTENSOMETER DATA FROM MISSION STREET<br>SINCE 01/01/2021 THROUGH 01/10/2022<br><br>Millennium Tower Perimeter Pile Upgrade: Instrumentation Monitoring Data<br>City and County of San Francisco, California | | |

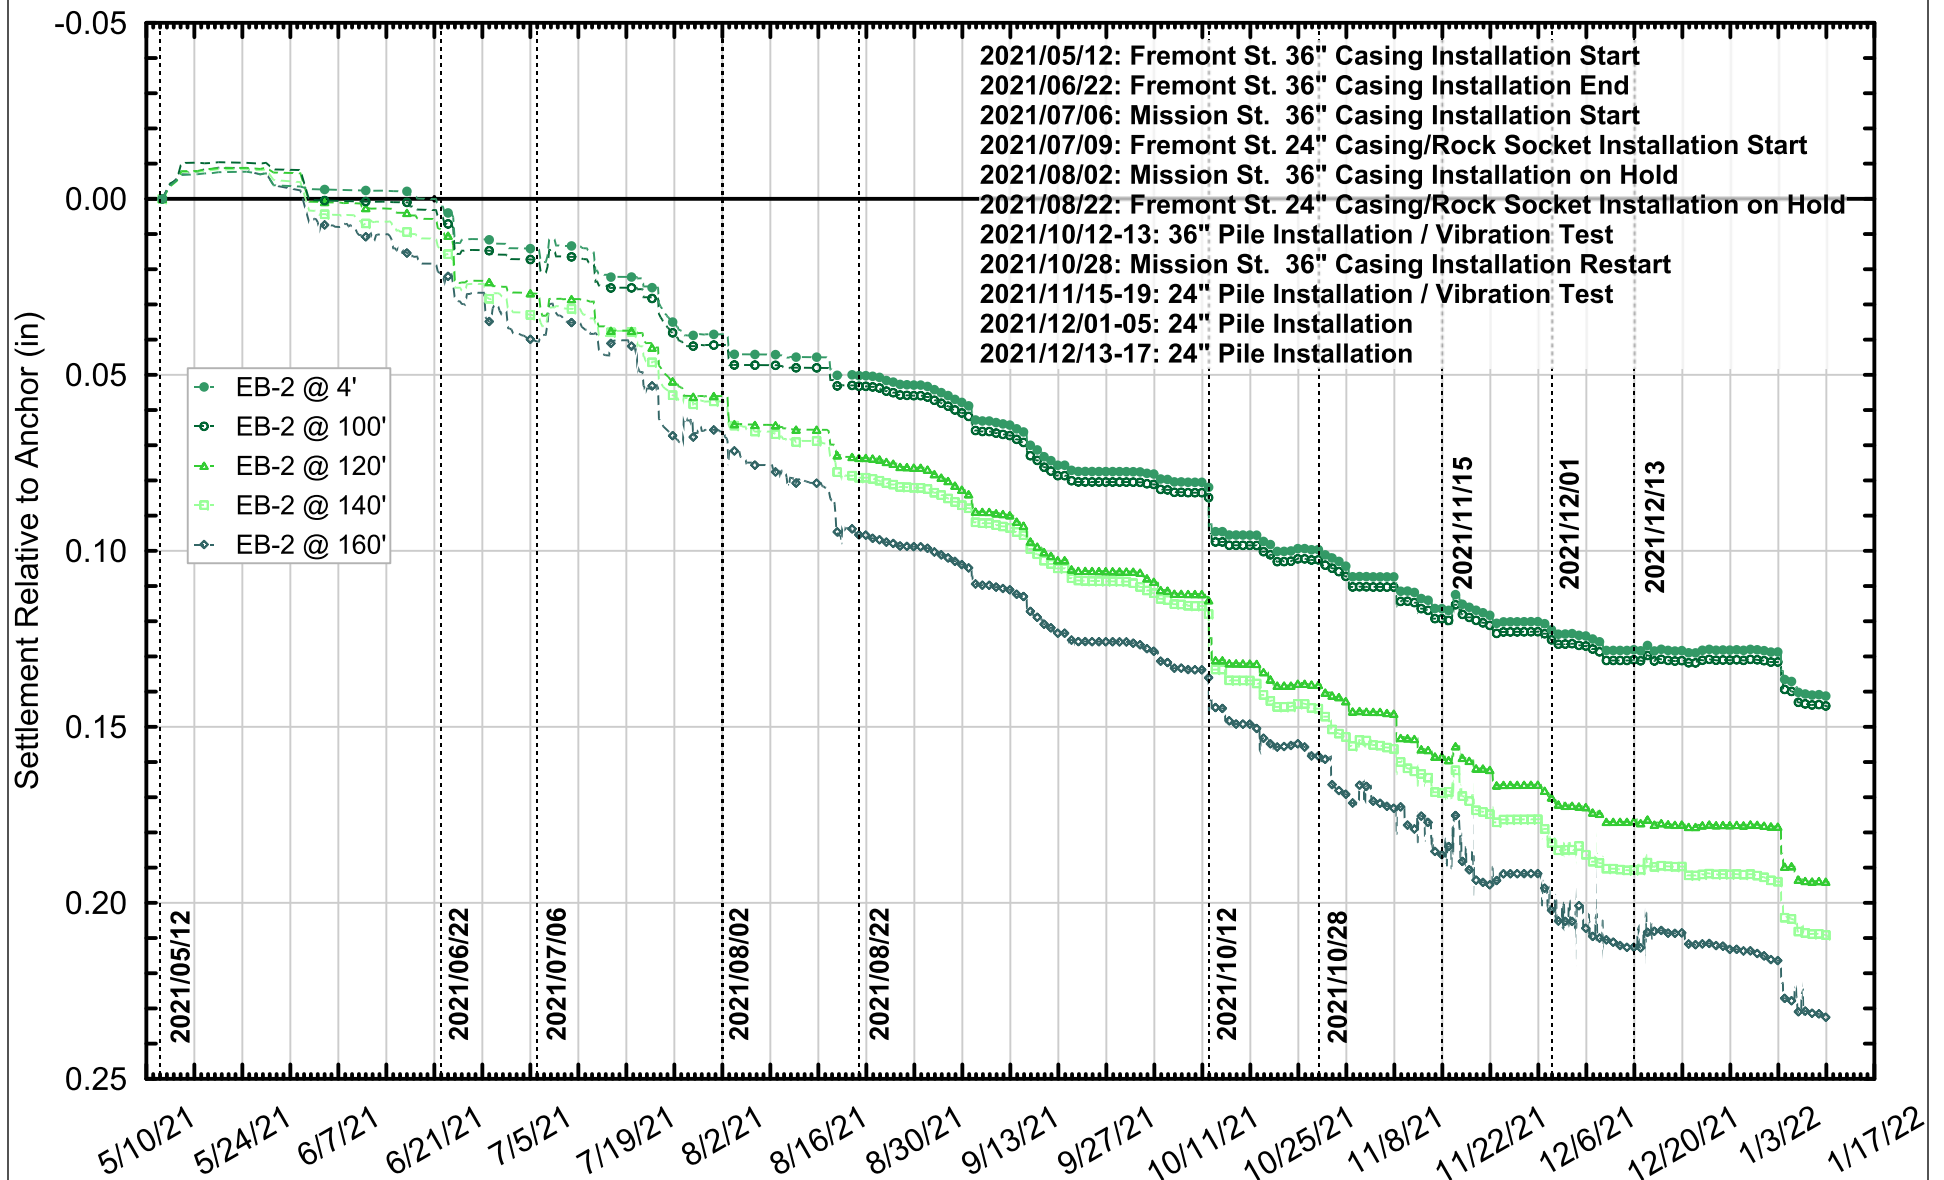
| | | <p>EXTENSOMETER DATA FROM MISSION STREET<br/>SINCE 05/10/2021 THROUGH 01/10/2022</p> <p>Millennium Tower Perimeter Pile Upgrade: Instrumentation Monitoring Data<br/>City and County of San Francisco, California</p> | | |
