Subject: 301 Mission Retrofit Monitoring Report 037: Results as of January 17, 2022

Millennium Tower Perimeter Pile Upgrade: Instrumentation Monitoring Data  
City and County of San Francisco, California

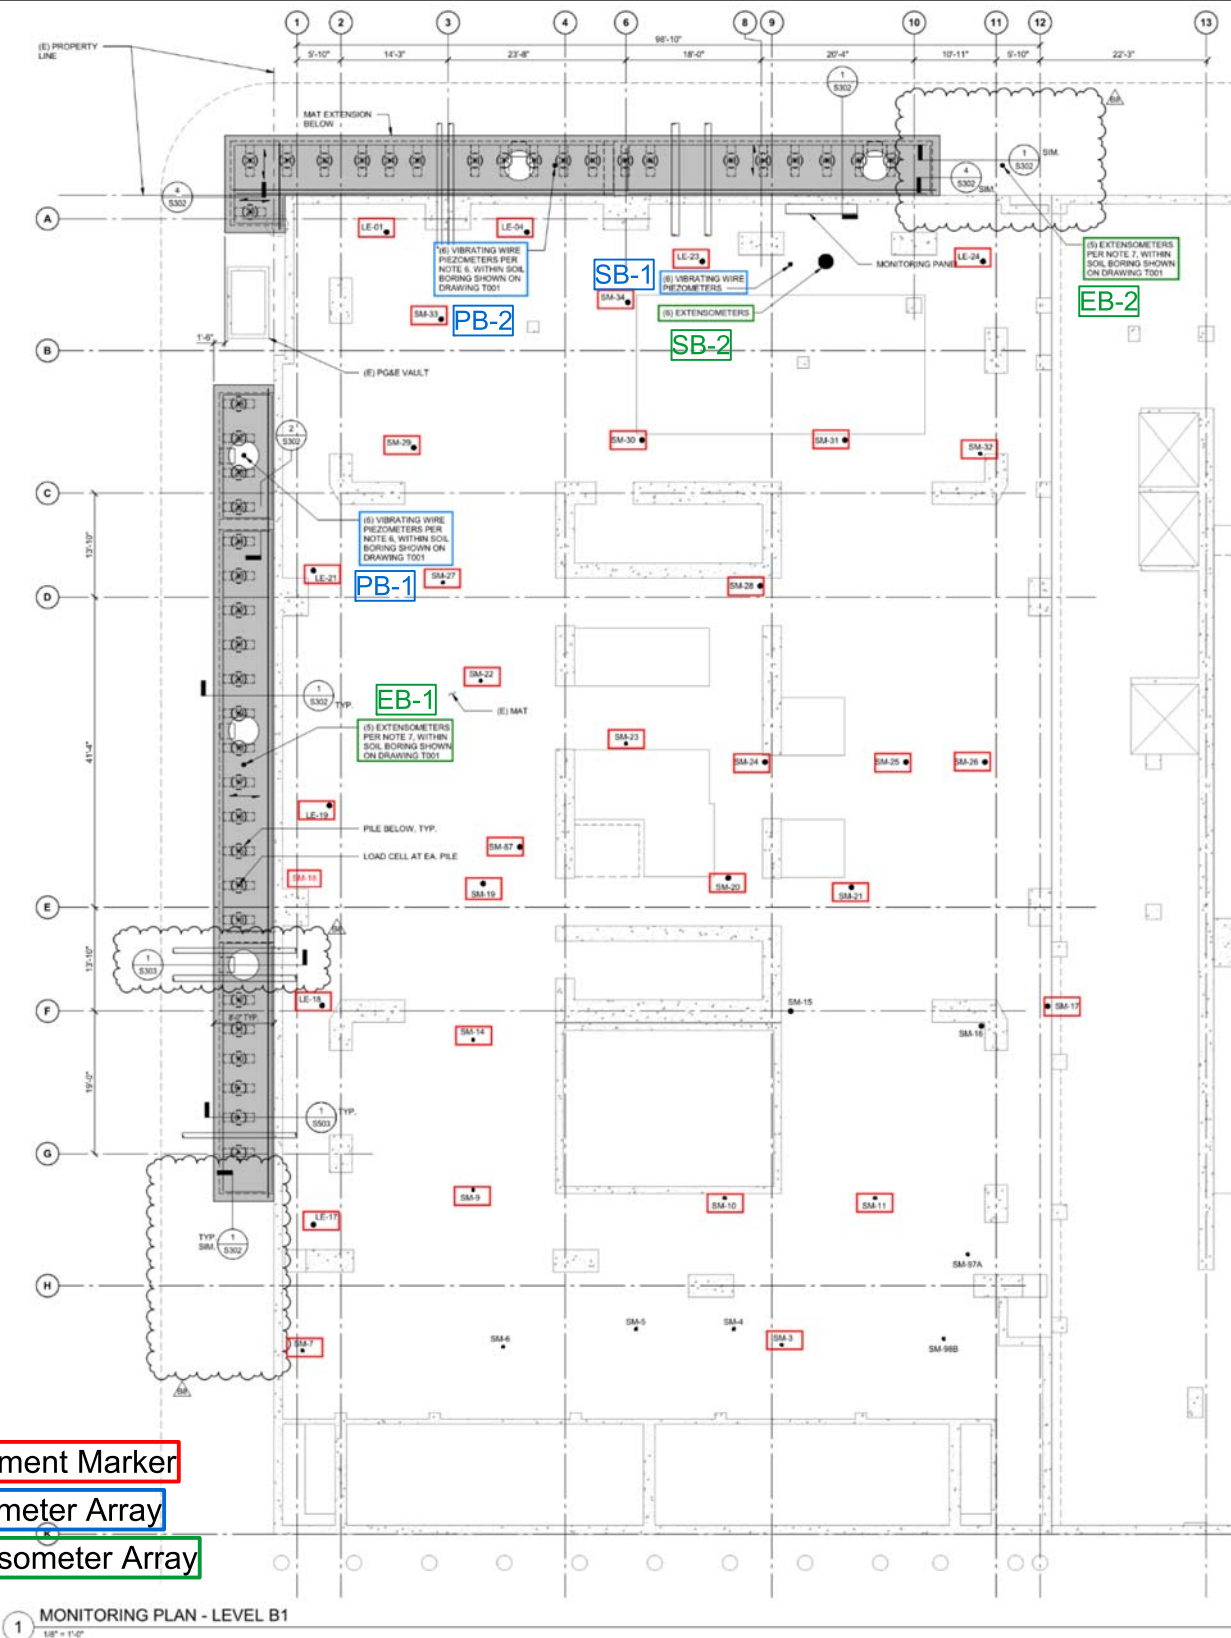
| Project No: 19-009.00 | Date: 7/26/2021 | Created By: NBW | Checked By: DGM | Figure No: <b>037-01A</b> |

Figure 01 presents the instrument locations as referenced in later figures.

### INSTRUMENT LOCATION MAP SETTLEMENT MARKERS, PIEZOMETERS, EXTENSOMETERS
