Subject: 301 Mission Retrofit Monitoring Report 063: Results as of July 19, 2022

This memorandum summarizes results from the monitoring plan implemented at the 301 Mission property. Instrumentation to monitor the structure prior to, during and after the retrofit was installed in January 2021, including piezometers and extensometers. Settlement markers installed in April 2009 and January 2017, survey prisms mounted on the exterior of the structure in December 2016, and crack gauges installed in April 2009 have also been monitored. This memorandum is for review only. It only contains ongoing monitoring information. This memorandum does not contain recommendations based upon the ongoing monitoring information.

Millennium Tower Perimeter Pile Upgrade: Instrumentation Monitoring Data  
City and County of San Francisco, California

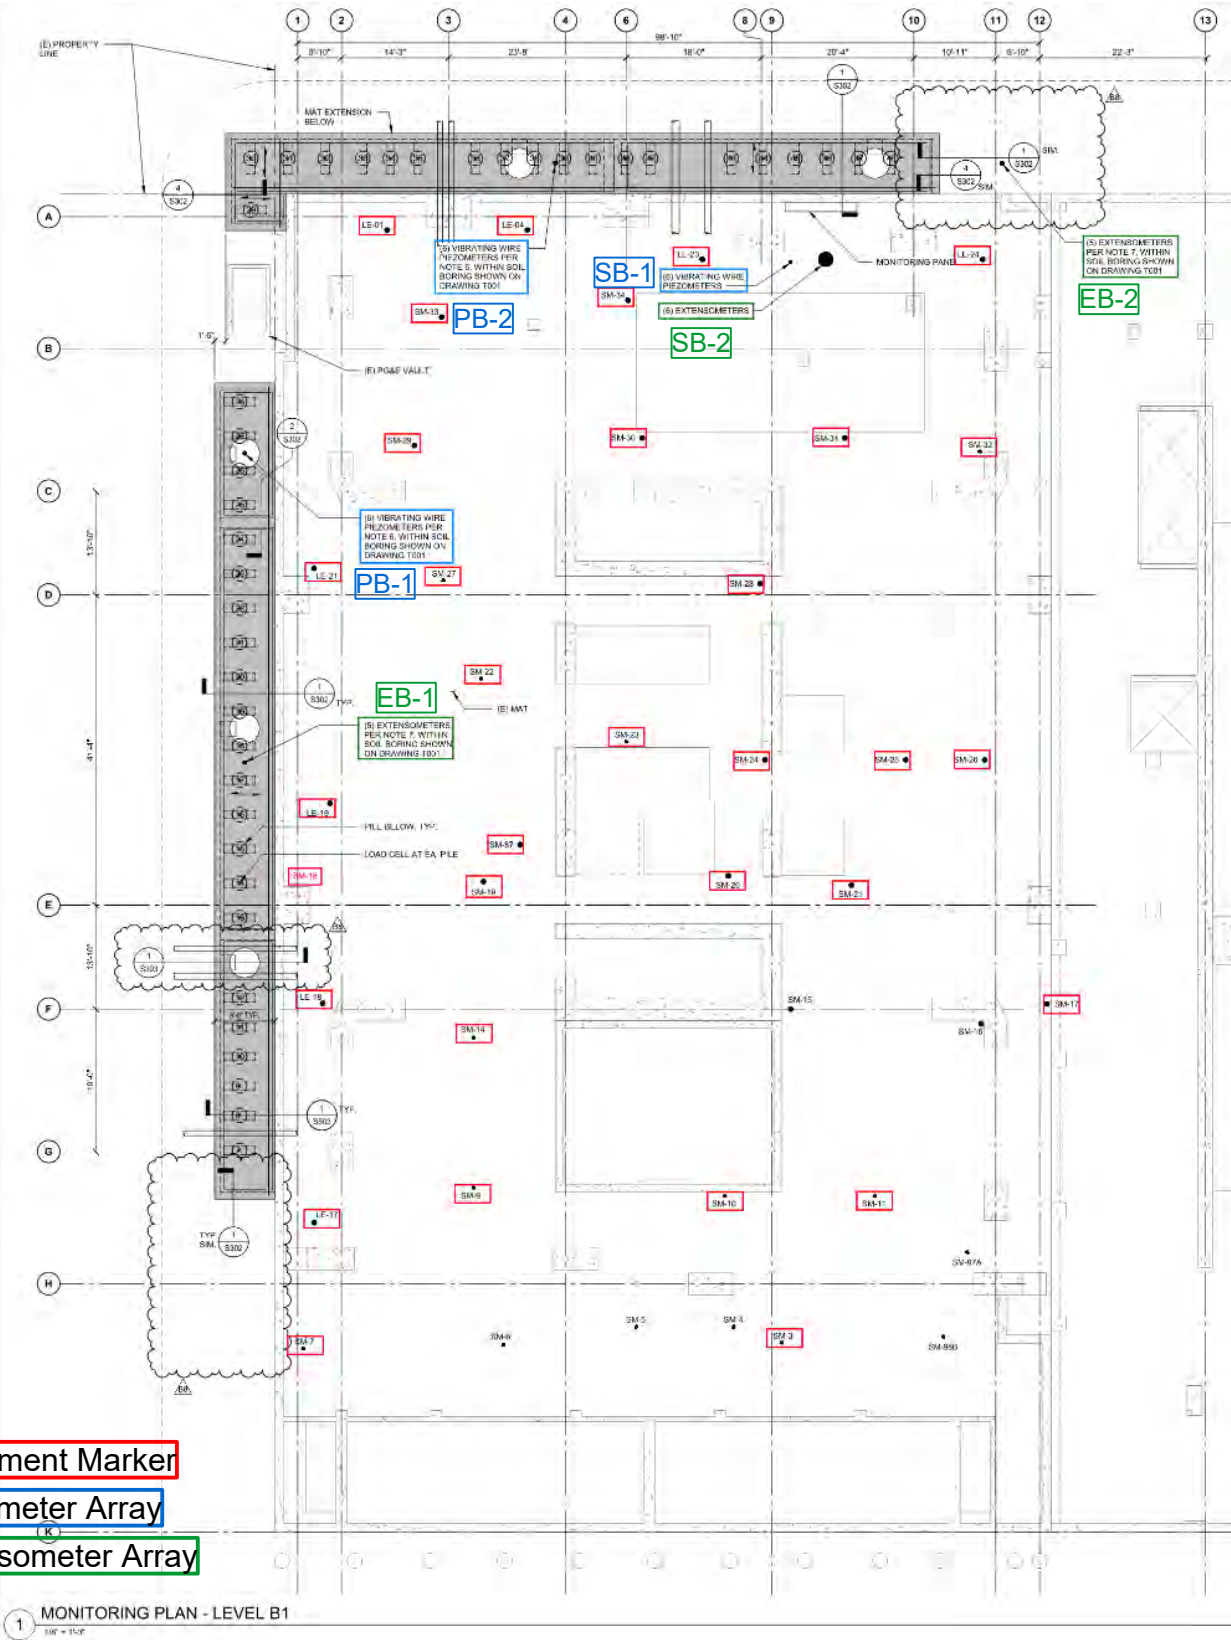
| Project No: 19-009.00 | Date: 7/26/2021 | Created By: NBW | Checked By: DGM | Figure No: <b>063-01A</b> |

Figure 01 presents the instrument locations as referenced in later figures.

### INSTRUMENT LOCATION MAP SETTLEMENT MARKERS, PIEZOMETERS, EXTENSOMETERS
