Subject: 301 Mission Retrofit Monitoring Report 064: Results as of July 26, 2022

This memorandum summarizes results from the monitoring plan implemented at the 301 Mission property. Instrumentation to monitor the structure prior to, during and after the retrofit was installed in January 2021, including piezometers and extensometers. Settlement markers installed in April 2009 and January 2017, survey prisms mounted on the exterior of the structure in December 2016, and crack gauges installed in April 2009 have also been monitored. This memorandum is for review only. It only contains ongoing monitoring information. This memorandum does not contain recommendations based upon the ongoing monitoring information.

Millennium Tower Perimeter Pile Upgrade: Instrumentation Monitoring Data  
City and County of San Francisco, California

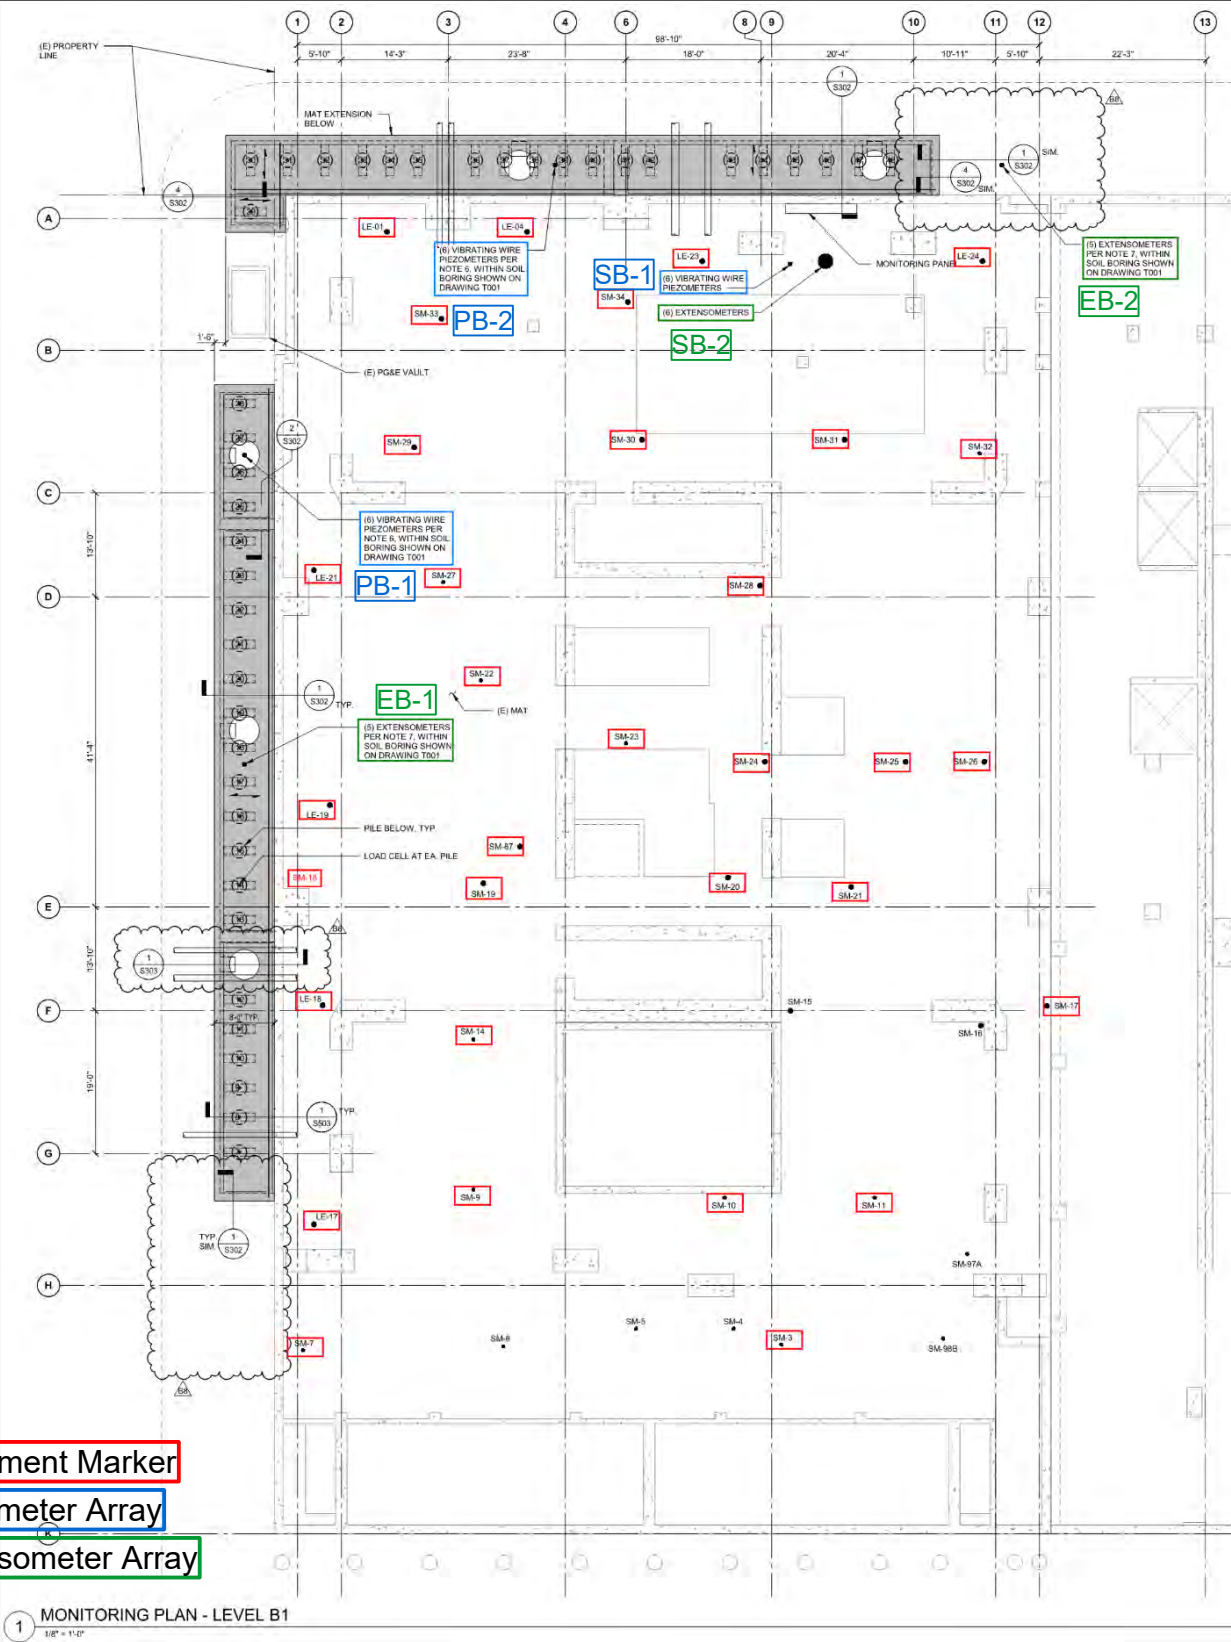
| Project No: 19-009.00 | Date: 7/26/2021 | Created By: NBW | Checked By: DGM | Figure No: <b>064-01A</b> |

Figure 01 presents the instrument locations as referenced in later figures.

## INSTRUMENT LOCATION MAP SETTLEMENT MARKERS, PIEZOMETERS, EXTENSOMETERS
