Subject: 301 Mission Retrofit Monitoring Report 088: Results as of January 10, 2023

This memorandum summarizes results from the monitoring plan implemented at the 301 Mission property. Instrumentation to monitor the structure prior to, during and after the retrofit was installed in January 2021, including piezometers and extensometers. Settlement markers installed in April 2009 and January 2017, survey prisms mounted on the exterior of the structure in December 2016, and crack gauges installed in April 2009 have also been monitored. This memorandum is for review only. It only contains ongoing monitoring information. This memorandum does not contain recommendations based upon the ongoing monitoring information.

Millennium Tower Perimeter Pile Upgrade: Instrumentation Monitoring Data  
City and County of San Francisco, California

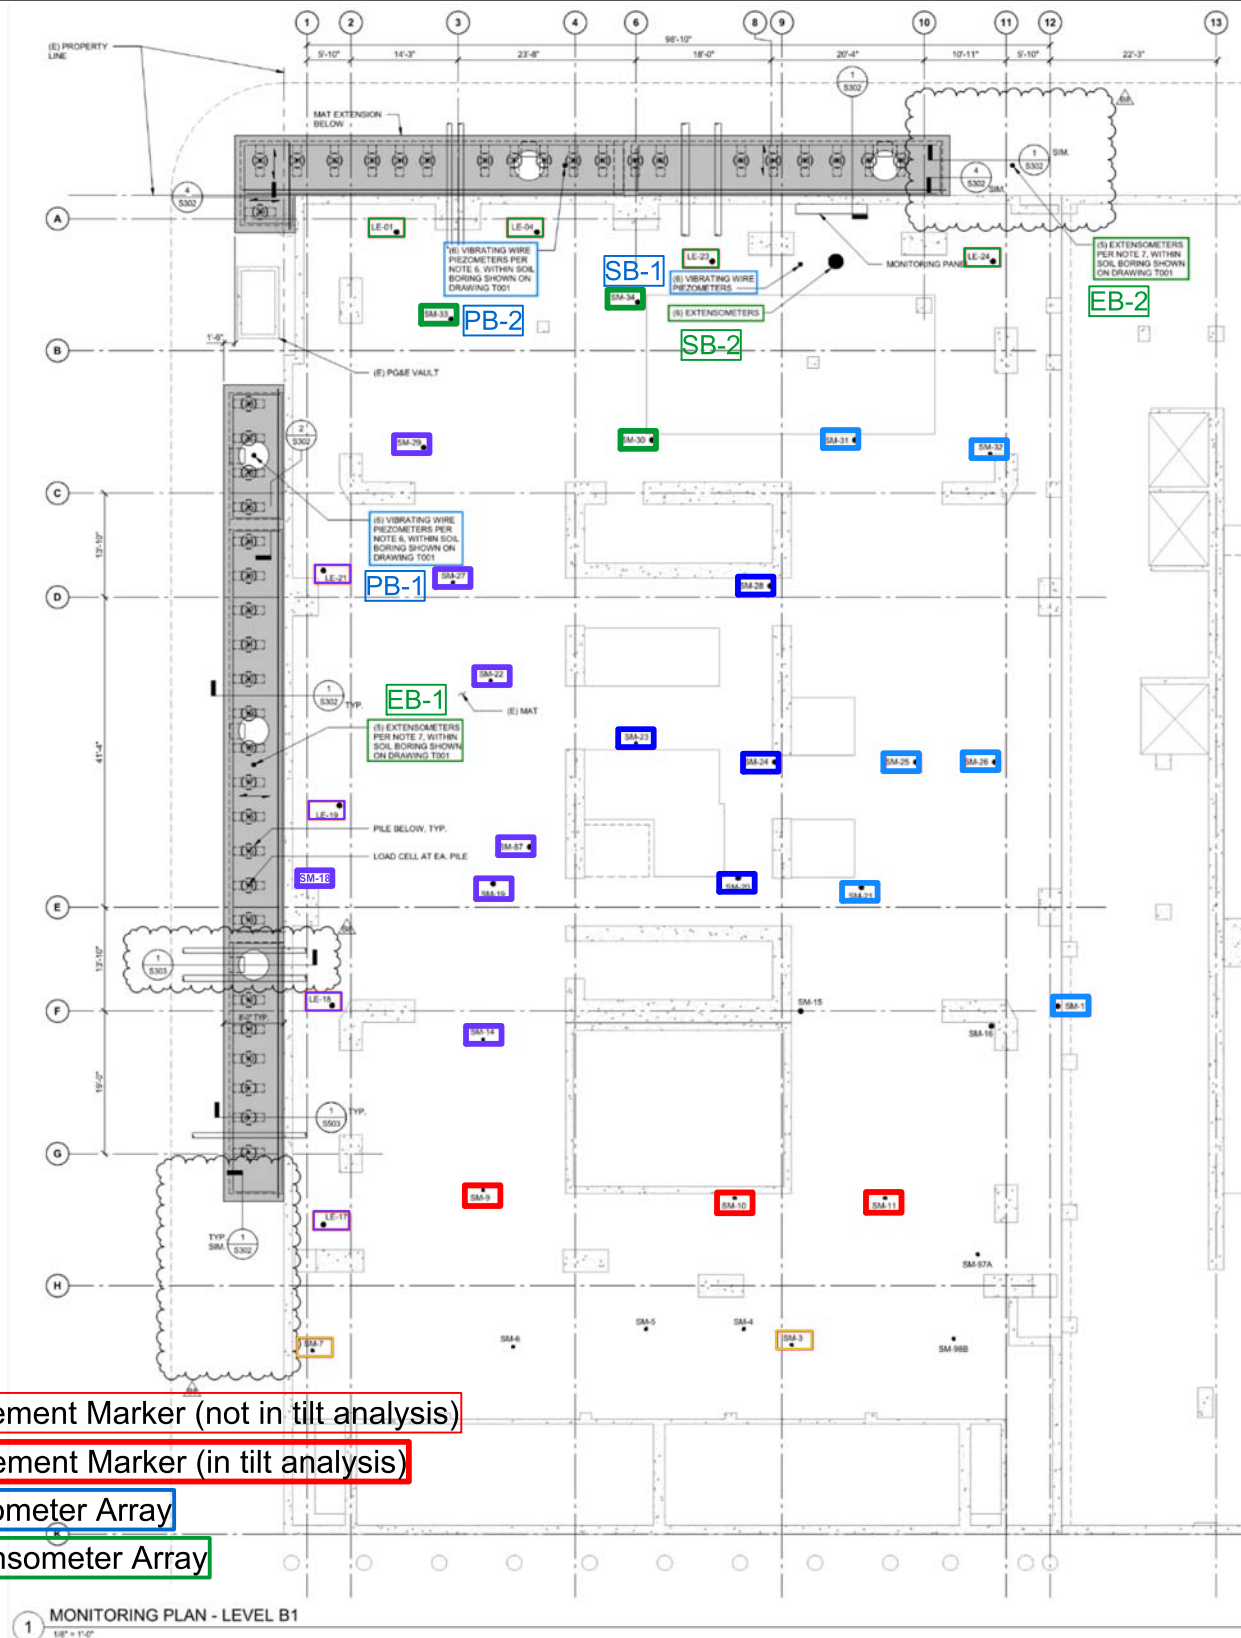
| Project No: 19-009.00 | Date: 11/23/2022 | Created By: NBW | Checked By: DGM | Figure No: <b>088-01A</b> |

Figure 01 presents the instrument locations as referenced in later figures.

## INSTRUMENT LOCATION MAP SETTLEMENT MARKERS, PIEZOMETERS, EXTENSOMETERS

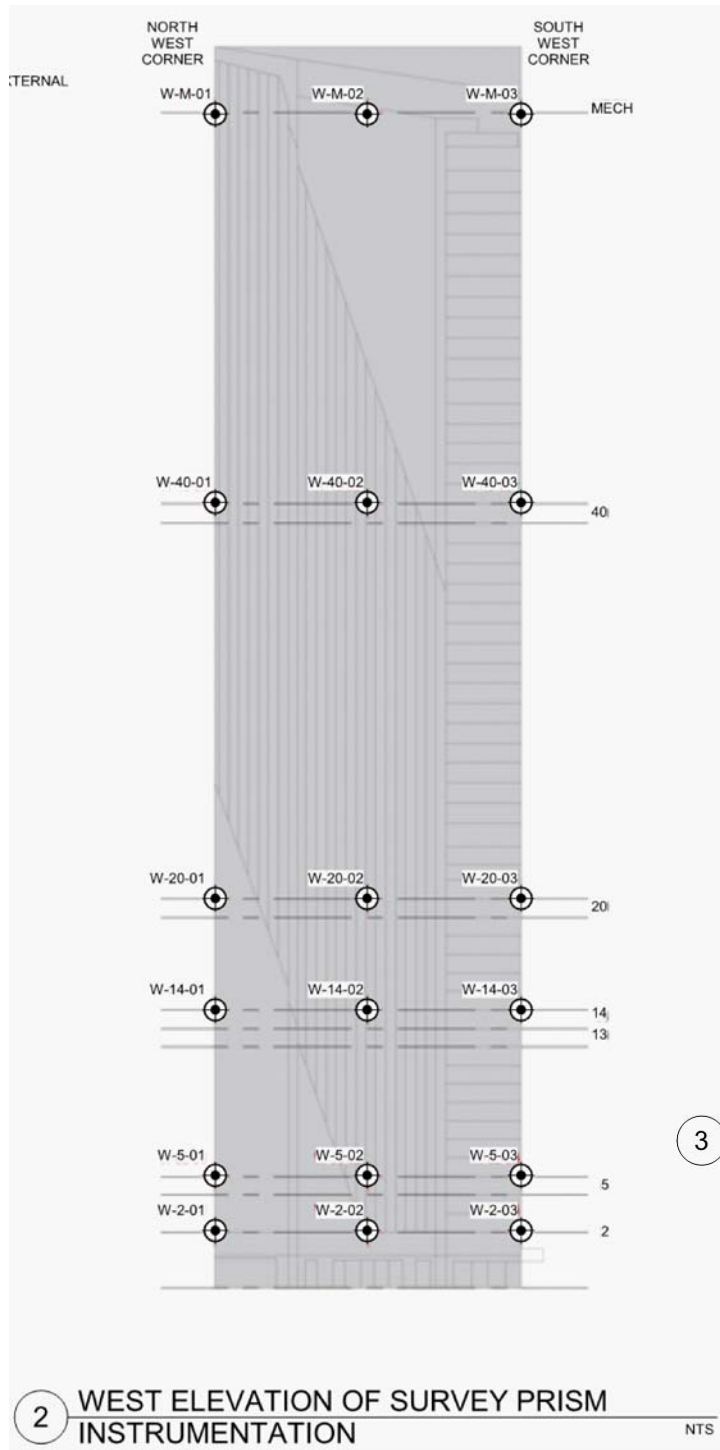
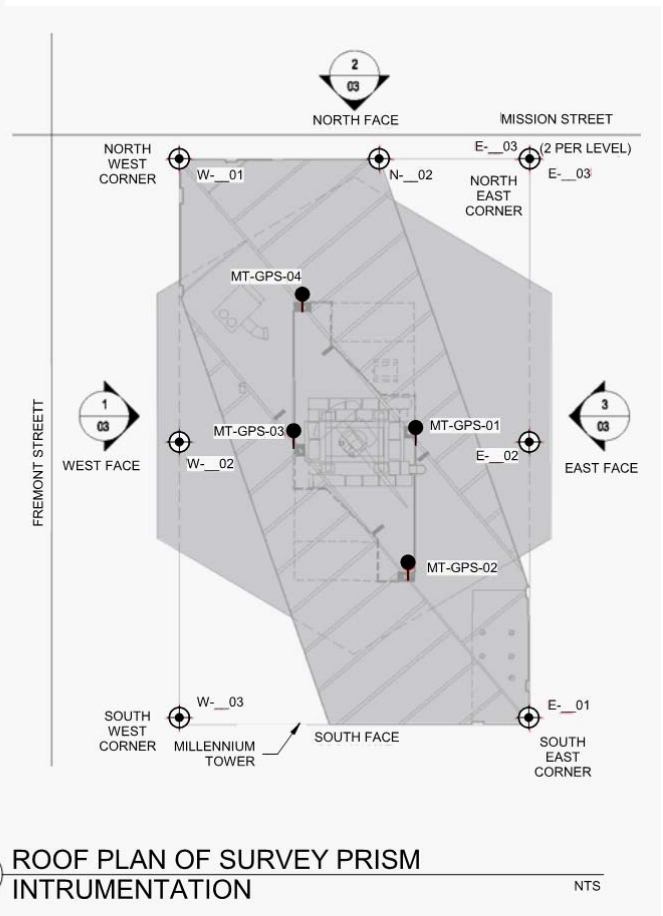
| Project No: 19-009.00 | Date: 7/26/2021 | Created By: NBW | Checked By: DGM | Figure No: <b>088-01B</b> |

### TOWER SURVEY PRISM LOCATION SCHEMATIC

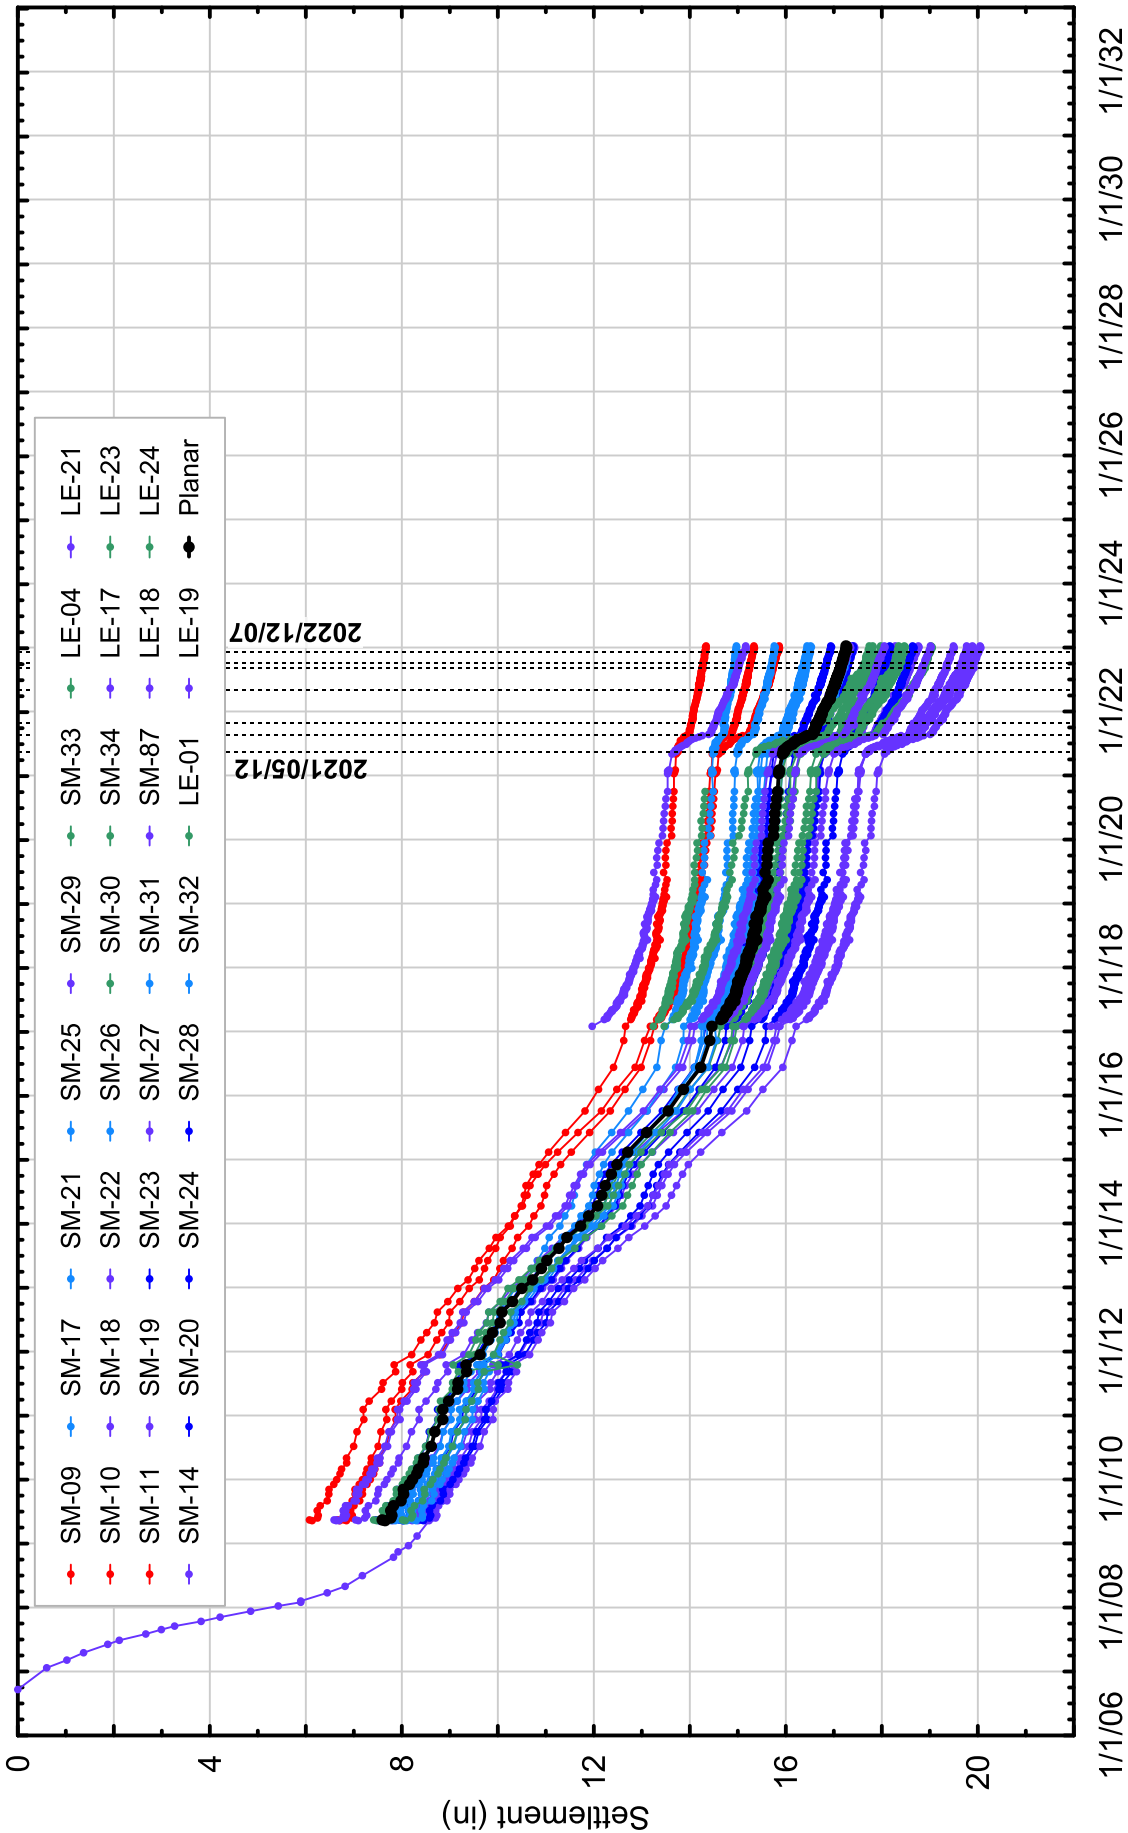
| Project No: 19-009.00 | Date: 1/1/2023 | Created By: NBW | Checked By: DGM | Figure No: 088-02 |

Figure 02 presents the historical settlement data interpreted from settlement markers installed on the B-1 Level of 301 Mission Tower. In addition, data from surveys performed during the retrofit are included. Figure 03A presents settlement data since the start of production pile installation (May 12, 2021; baseline readings on May 10, 2021) through January 10, 2023. Figure 03B presents settlement data since January 11, 2021, through January 10, 2023. Figure 04 presents current settlement contours (in inches) on January 10, 2023.

HISTORICAL SETTLEMENT MARKER DATA

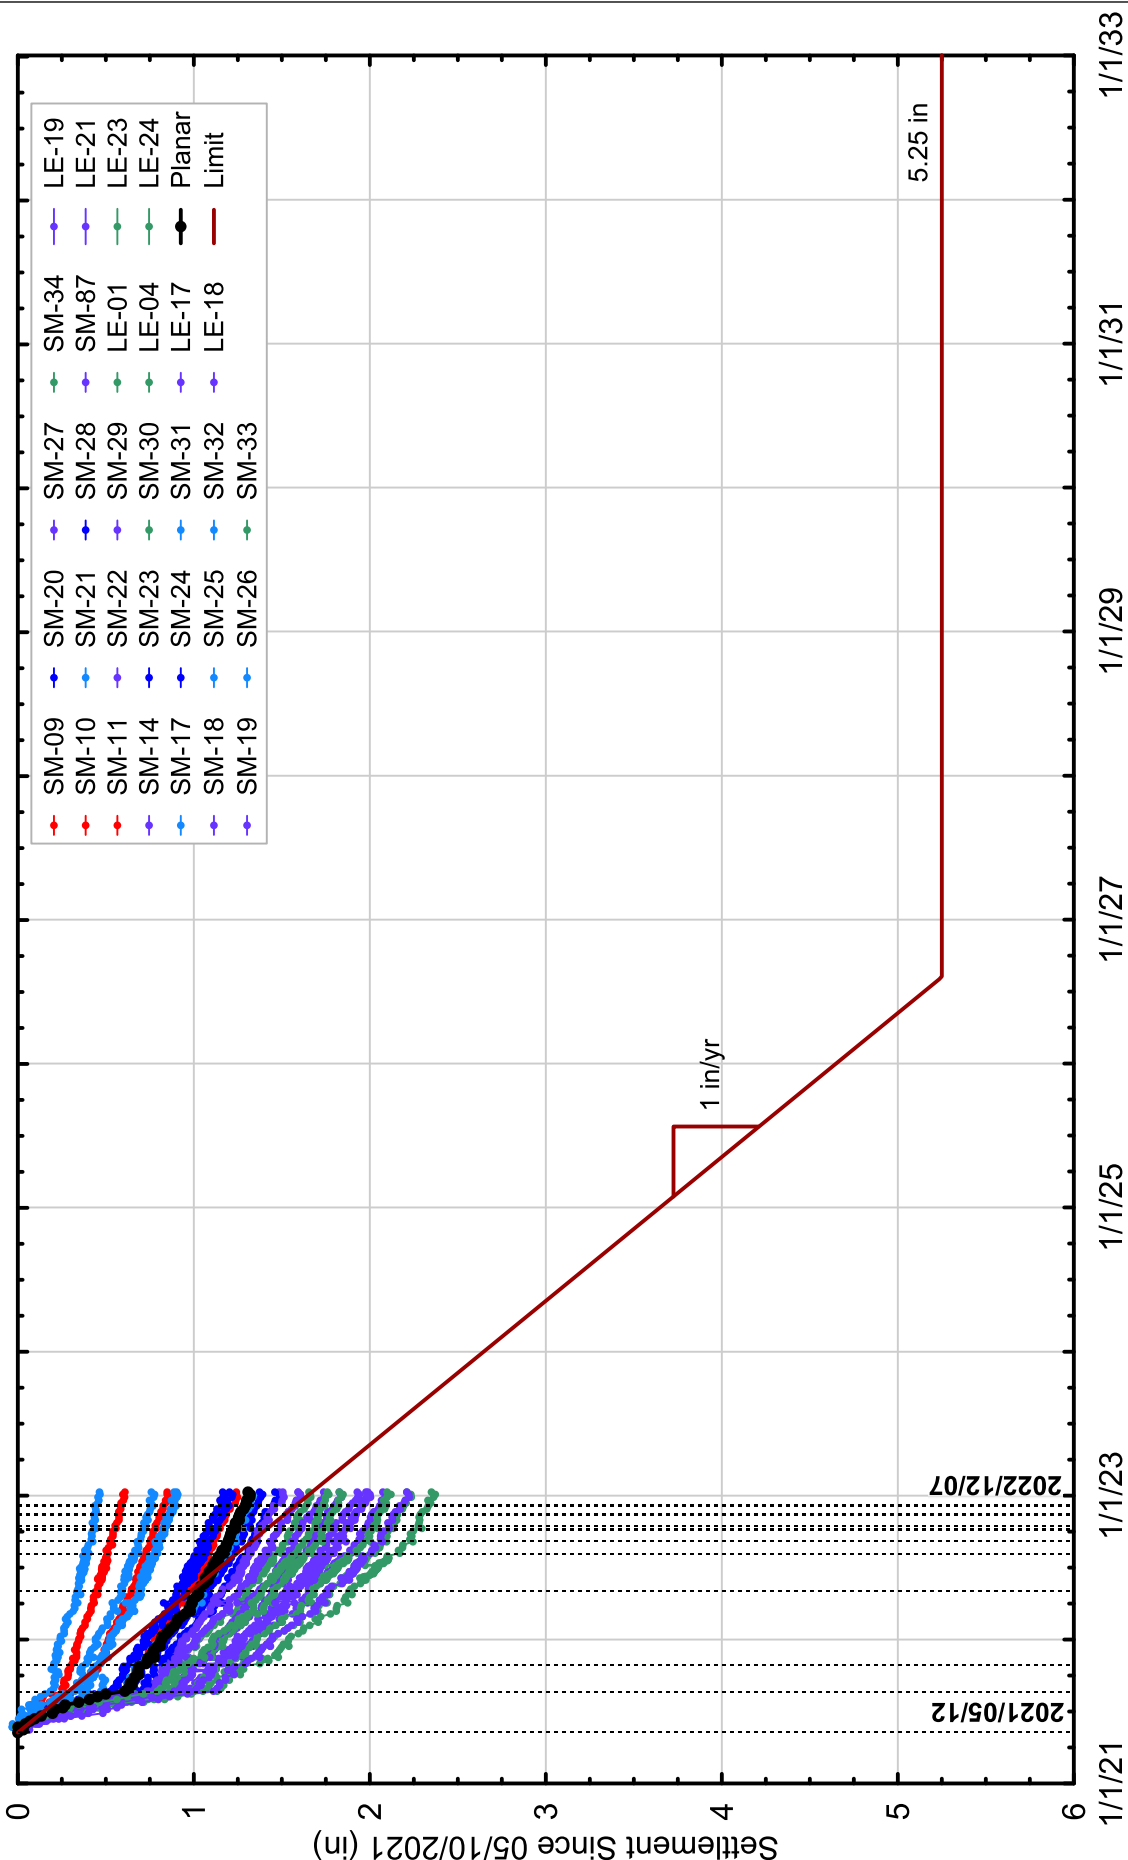
| Project No: 19-009.00 | Date: 1/11/2023 | Created By: NBW | Checked By: DGM | Figure No: 088-03A |

| SETTLEMENT MARKER DATA<br>SINCE 05/10/2021 THROUGH 01/10/2023 | | | | |

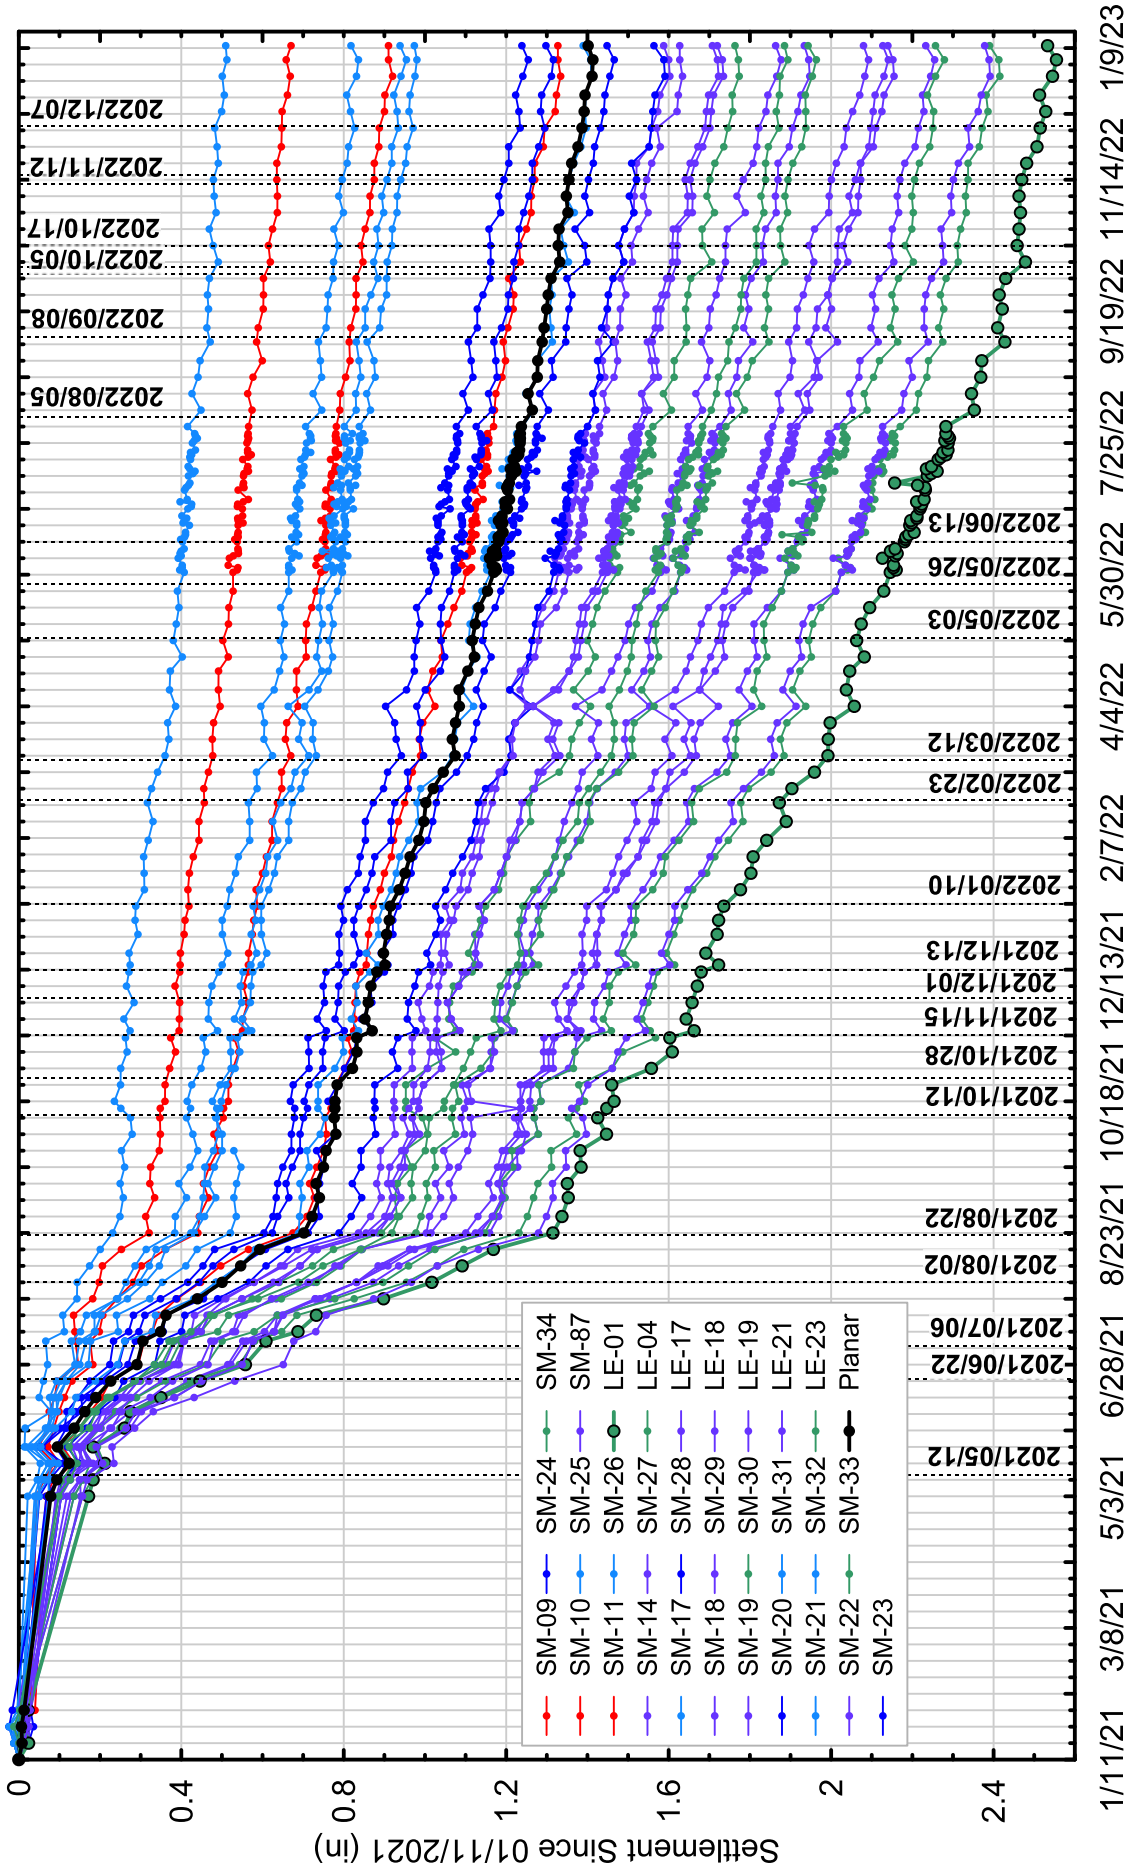
Project No: 19-009.00 Date: 1/11/2023 Created By: NBW Checked By: DGM Figure No: 088-03B

SETTLEMENT MARKER DATA  
SINCE 01/11/2021 THROUGH 01/10/2023

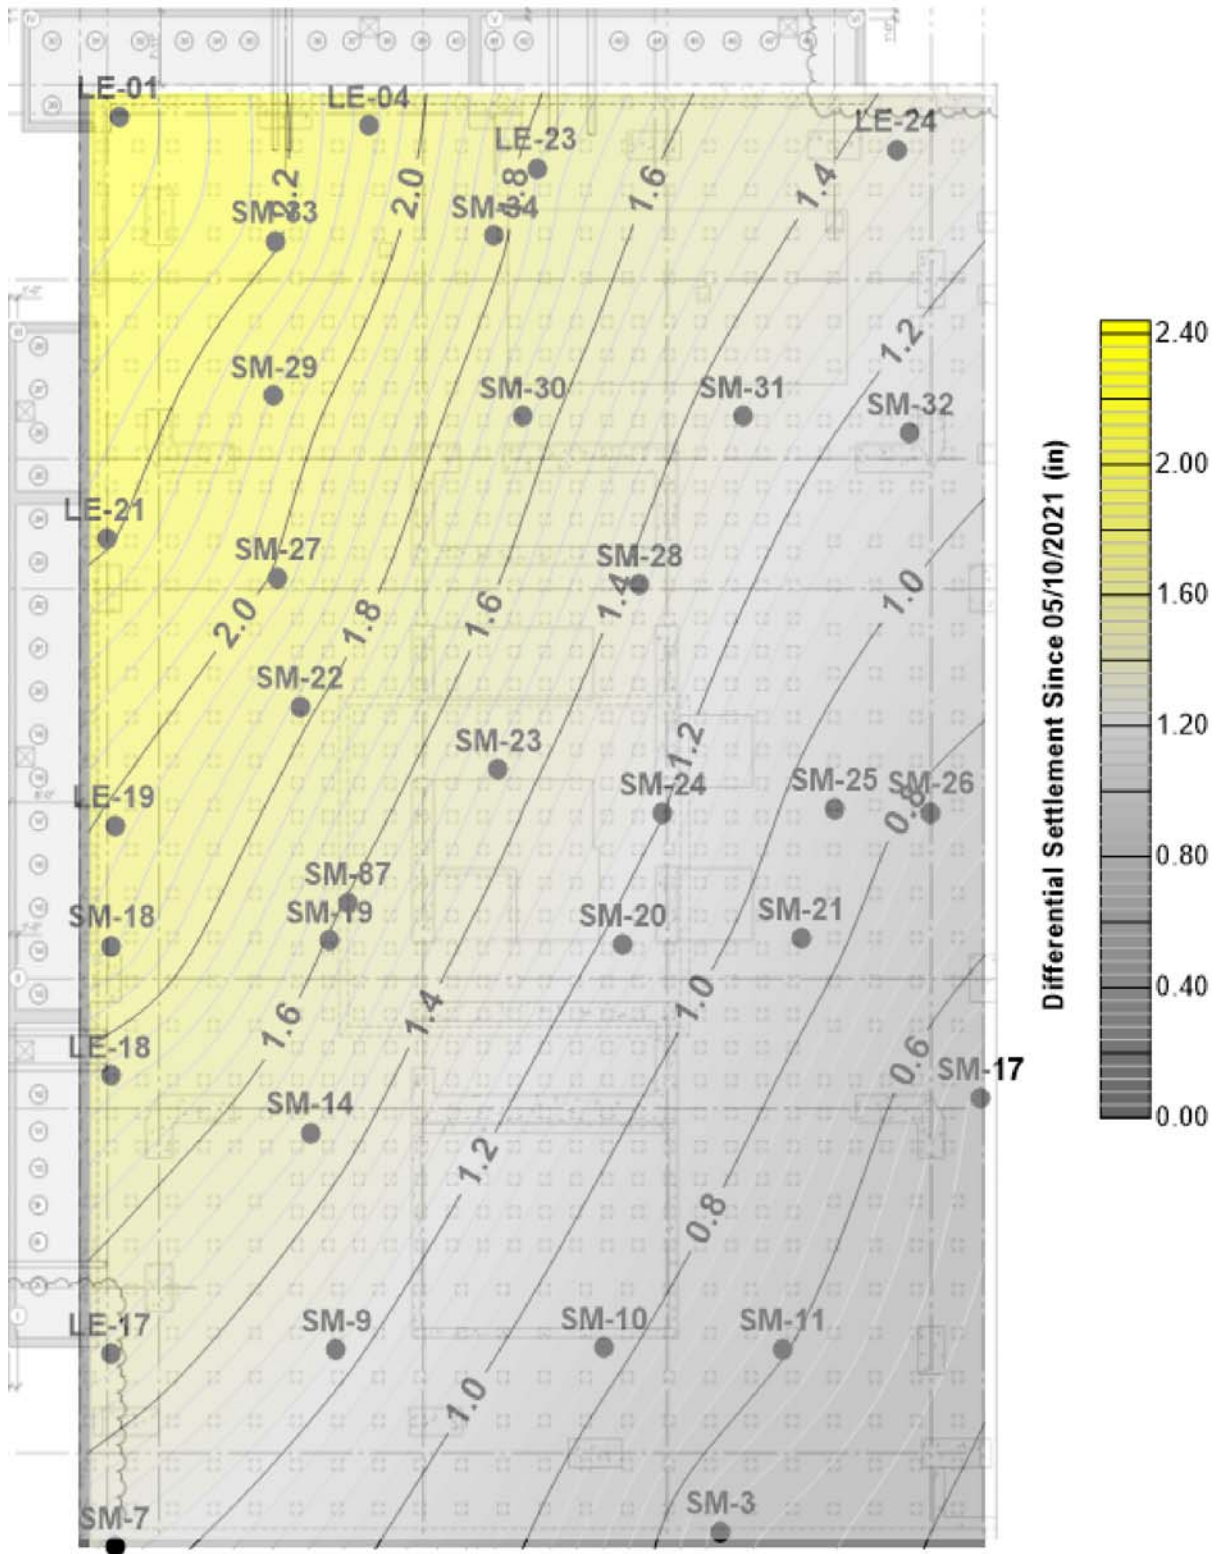
Figure No: **088-04**

SETTLEMENT CONTOURS  
SINCE 05/10/2021 THROUGH 01/10/2023

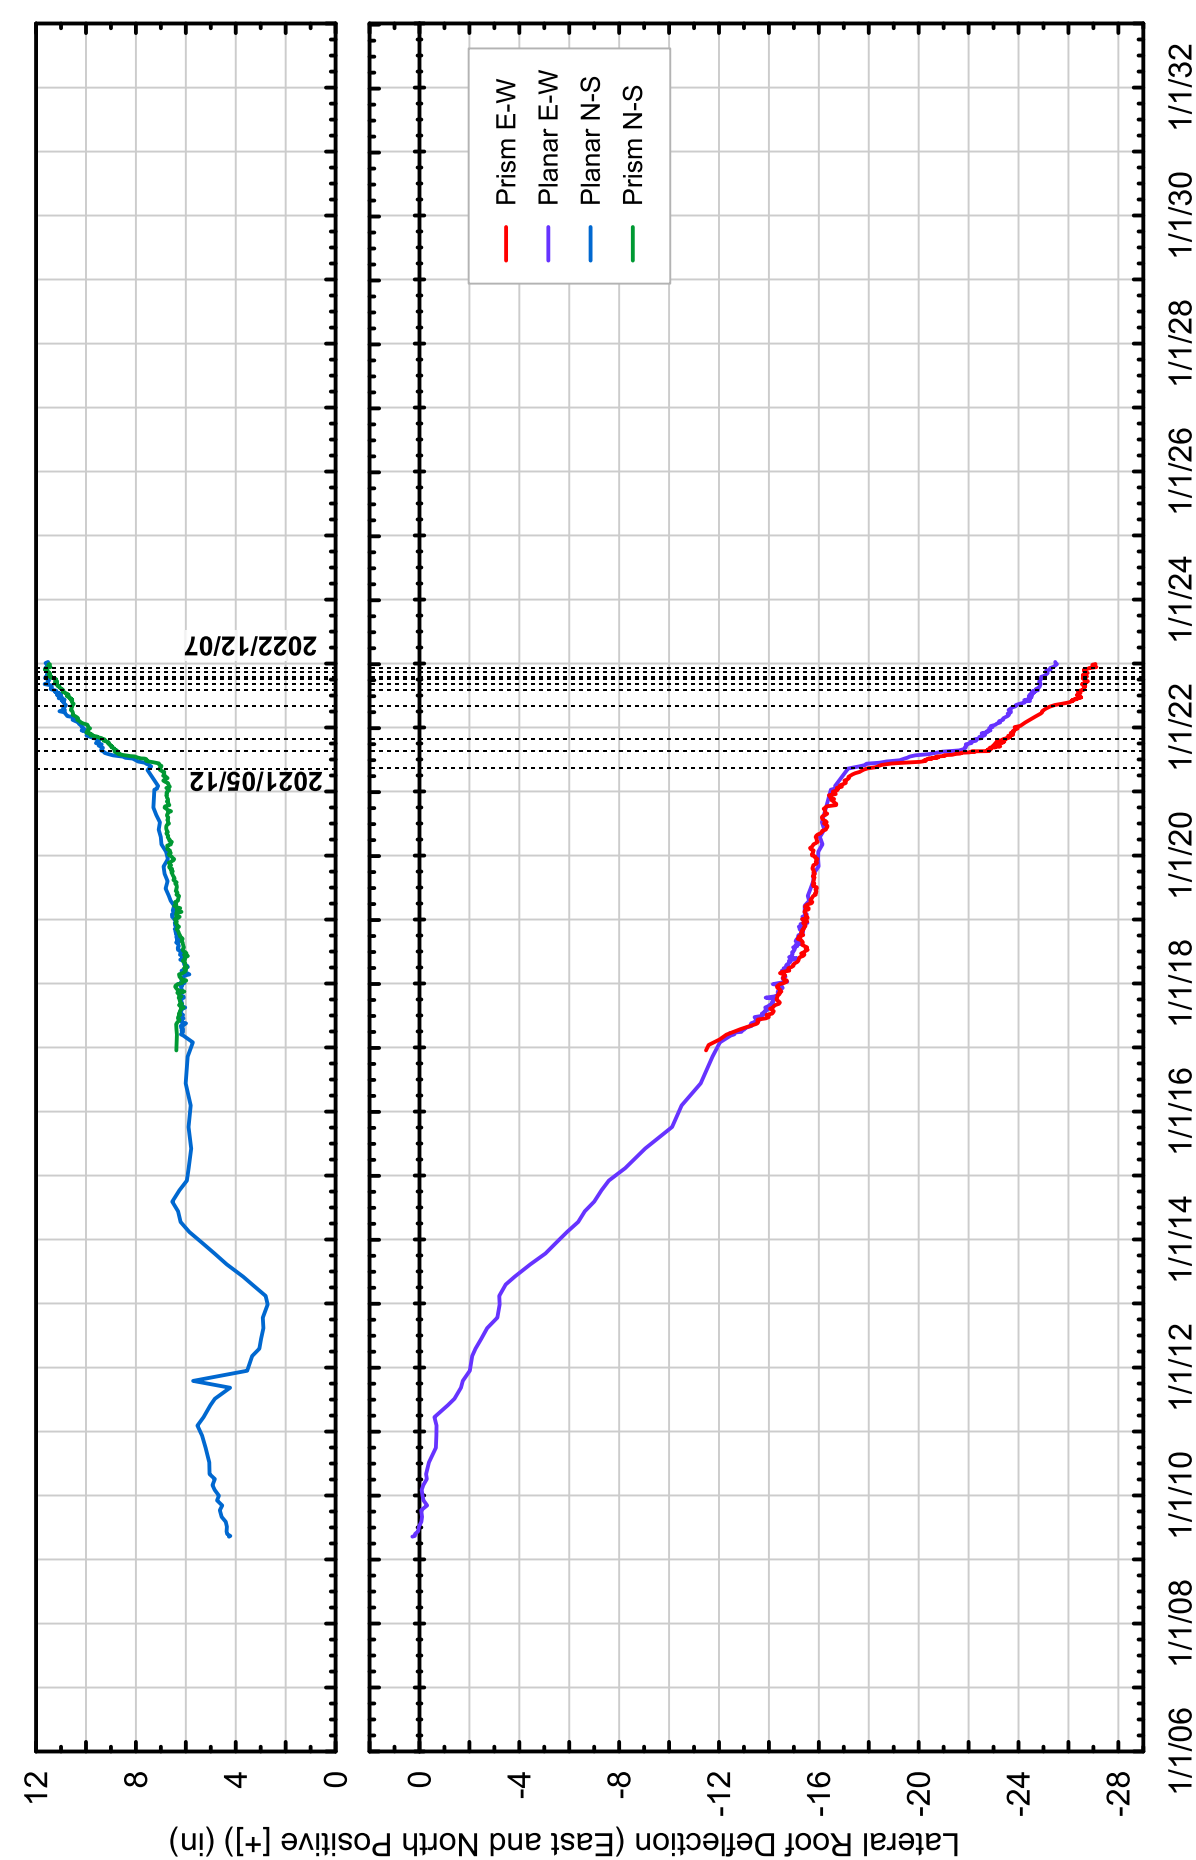
Project No: 19-009.00 Date: 1/11/2023 Created By: NBW Checked By: DGM Figure No: 088-05

Figure 05 presents historical lateral roof deflections in the project north-south and project east-west directions interpreted from survey prisms mounted on the exterior of the Tower, from InSAR data, and from a planar fit of the settlement marker data. In addition, data from surveys performed during the retrofit are included. Figure 06A presents lateral roof deflection data from a planar fit of the settlement marker data and from survey prisms mounted on the exterior of the Tower since the start of production pile installation (May 12, 2021; baseline readings on May 10 and 13, 2021, respectively) through January 10, 2023. Figure 06B presents lateral roof deflection data from a planar fit of the settlement marker data and from survey prisms mounted on the exterior of the Tower since January 11, 2021, through January 10, 2023.

HISTORICAL LATERAL ROOF DEFLECTION DATA

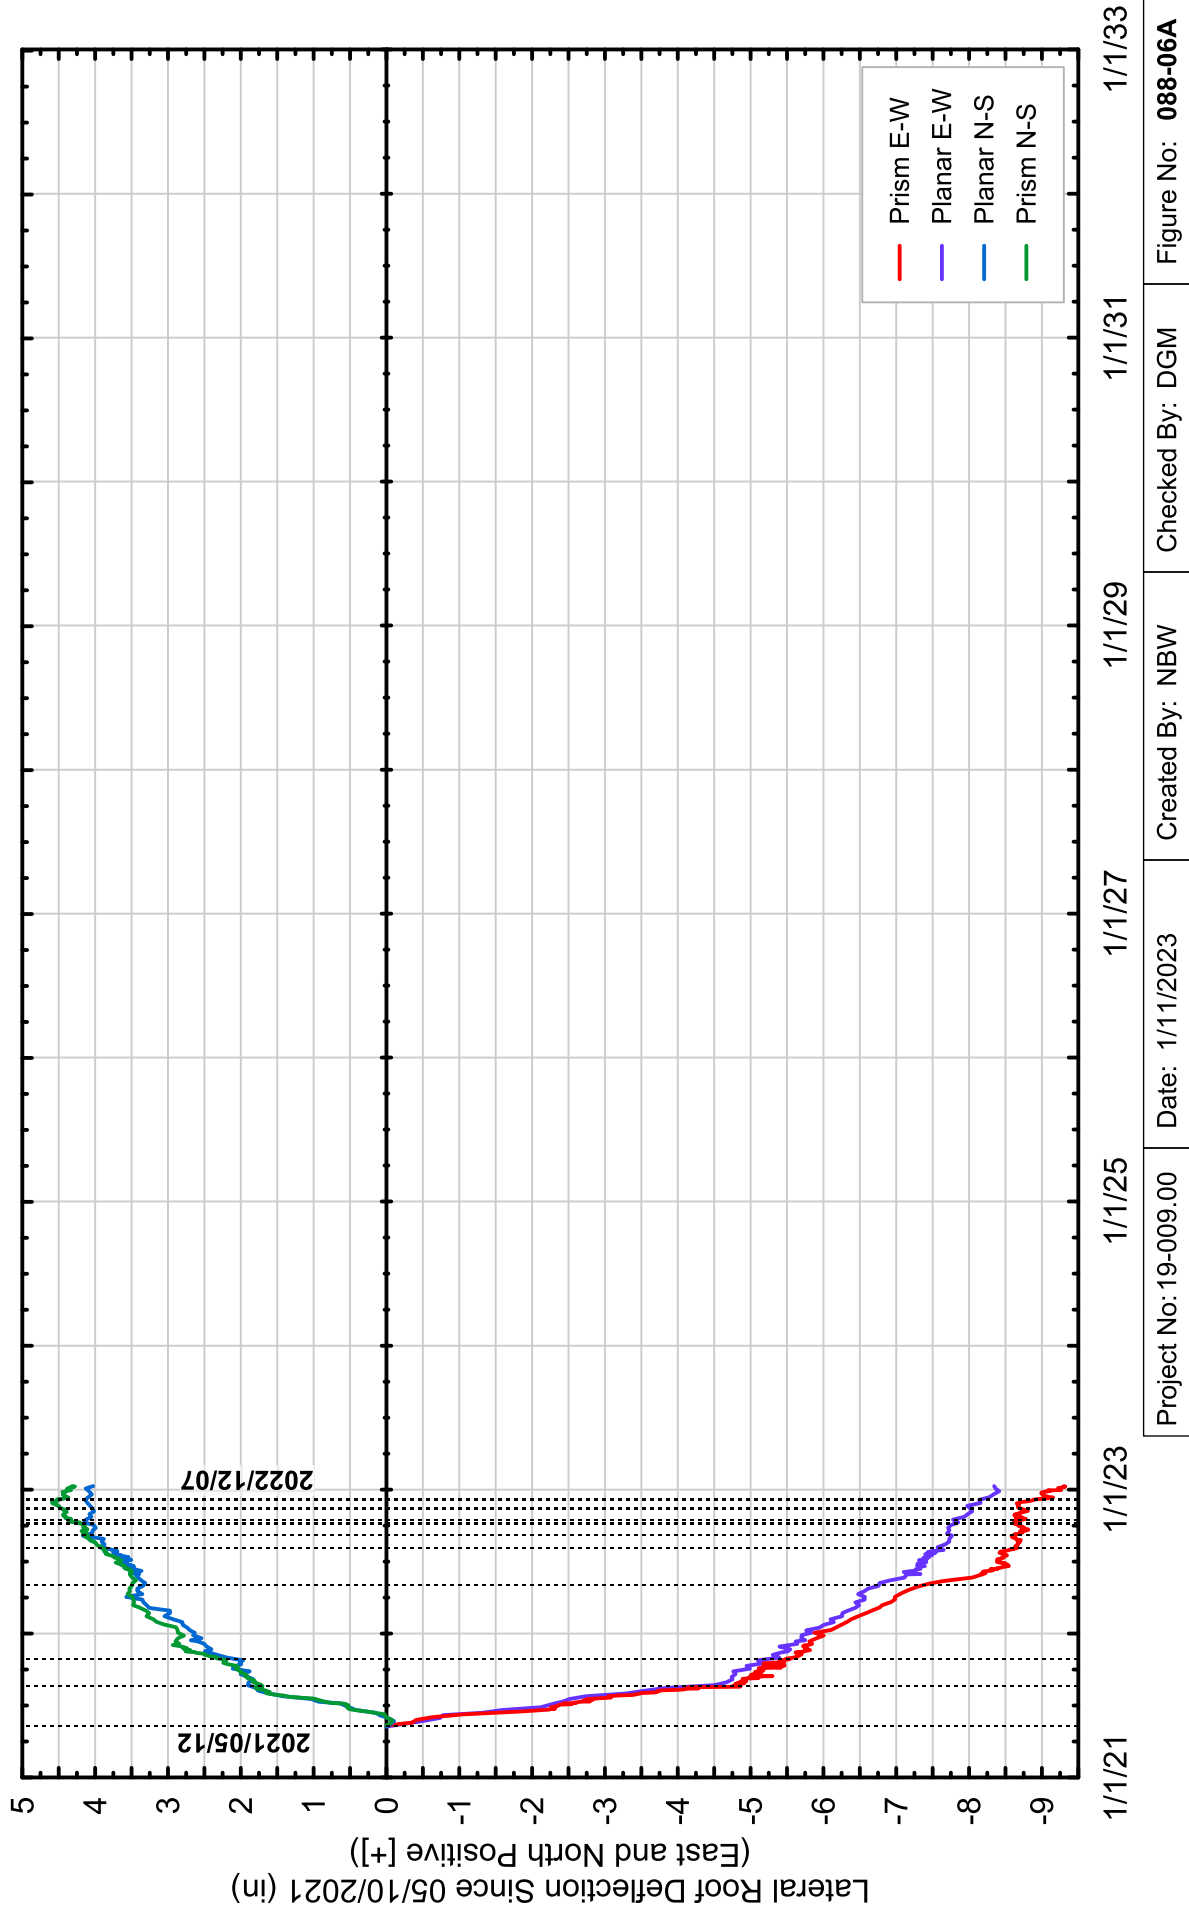
LATERAL ROOF DEFLECTION DATA  
SINCE 05/10/2021 THROUGH 01/10/2023

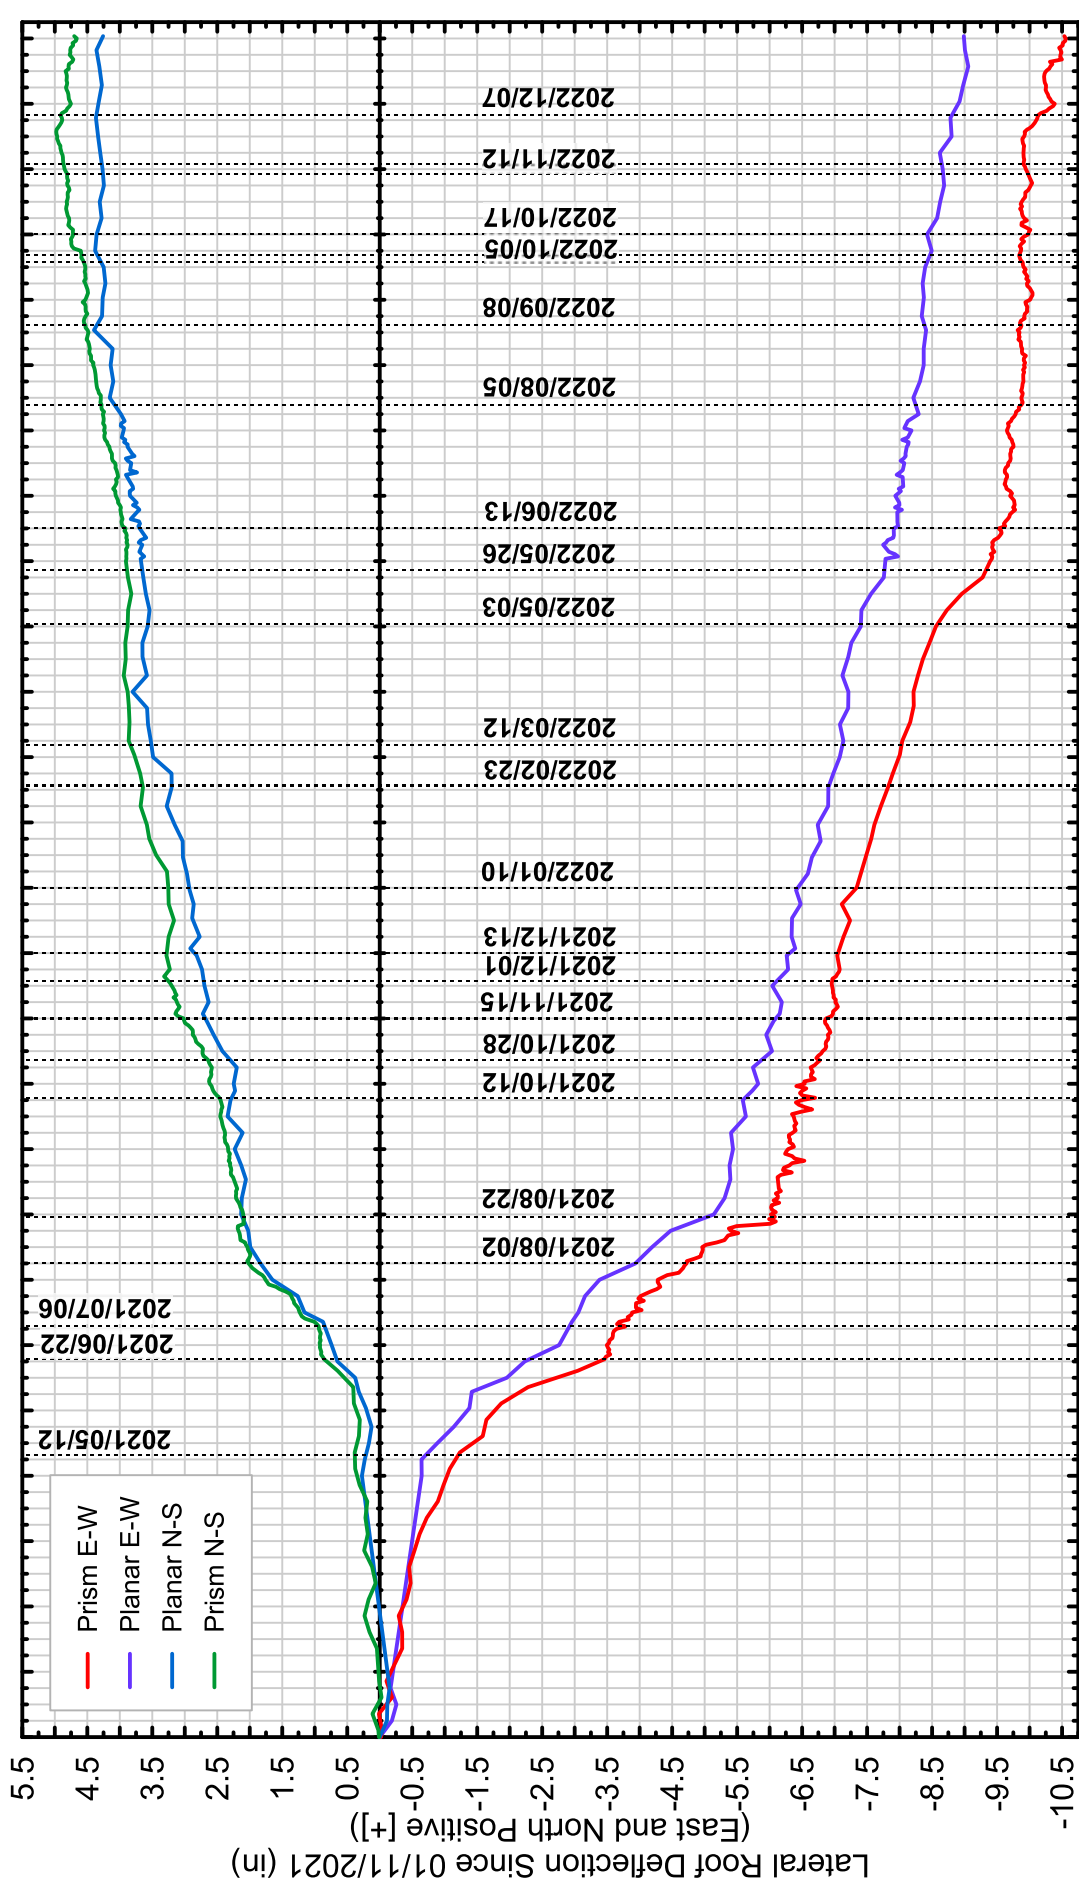
Figure No: 088-06B

LATERAL ROOF DEFLECTION DATA  
SINCE 01/11/2021 THROUGH 01/10/2023

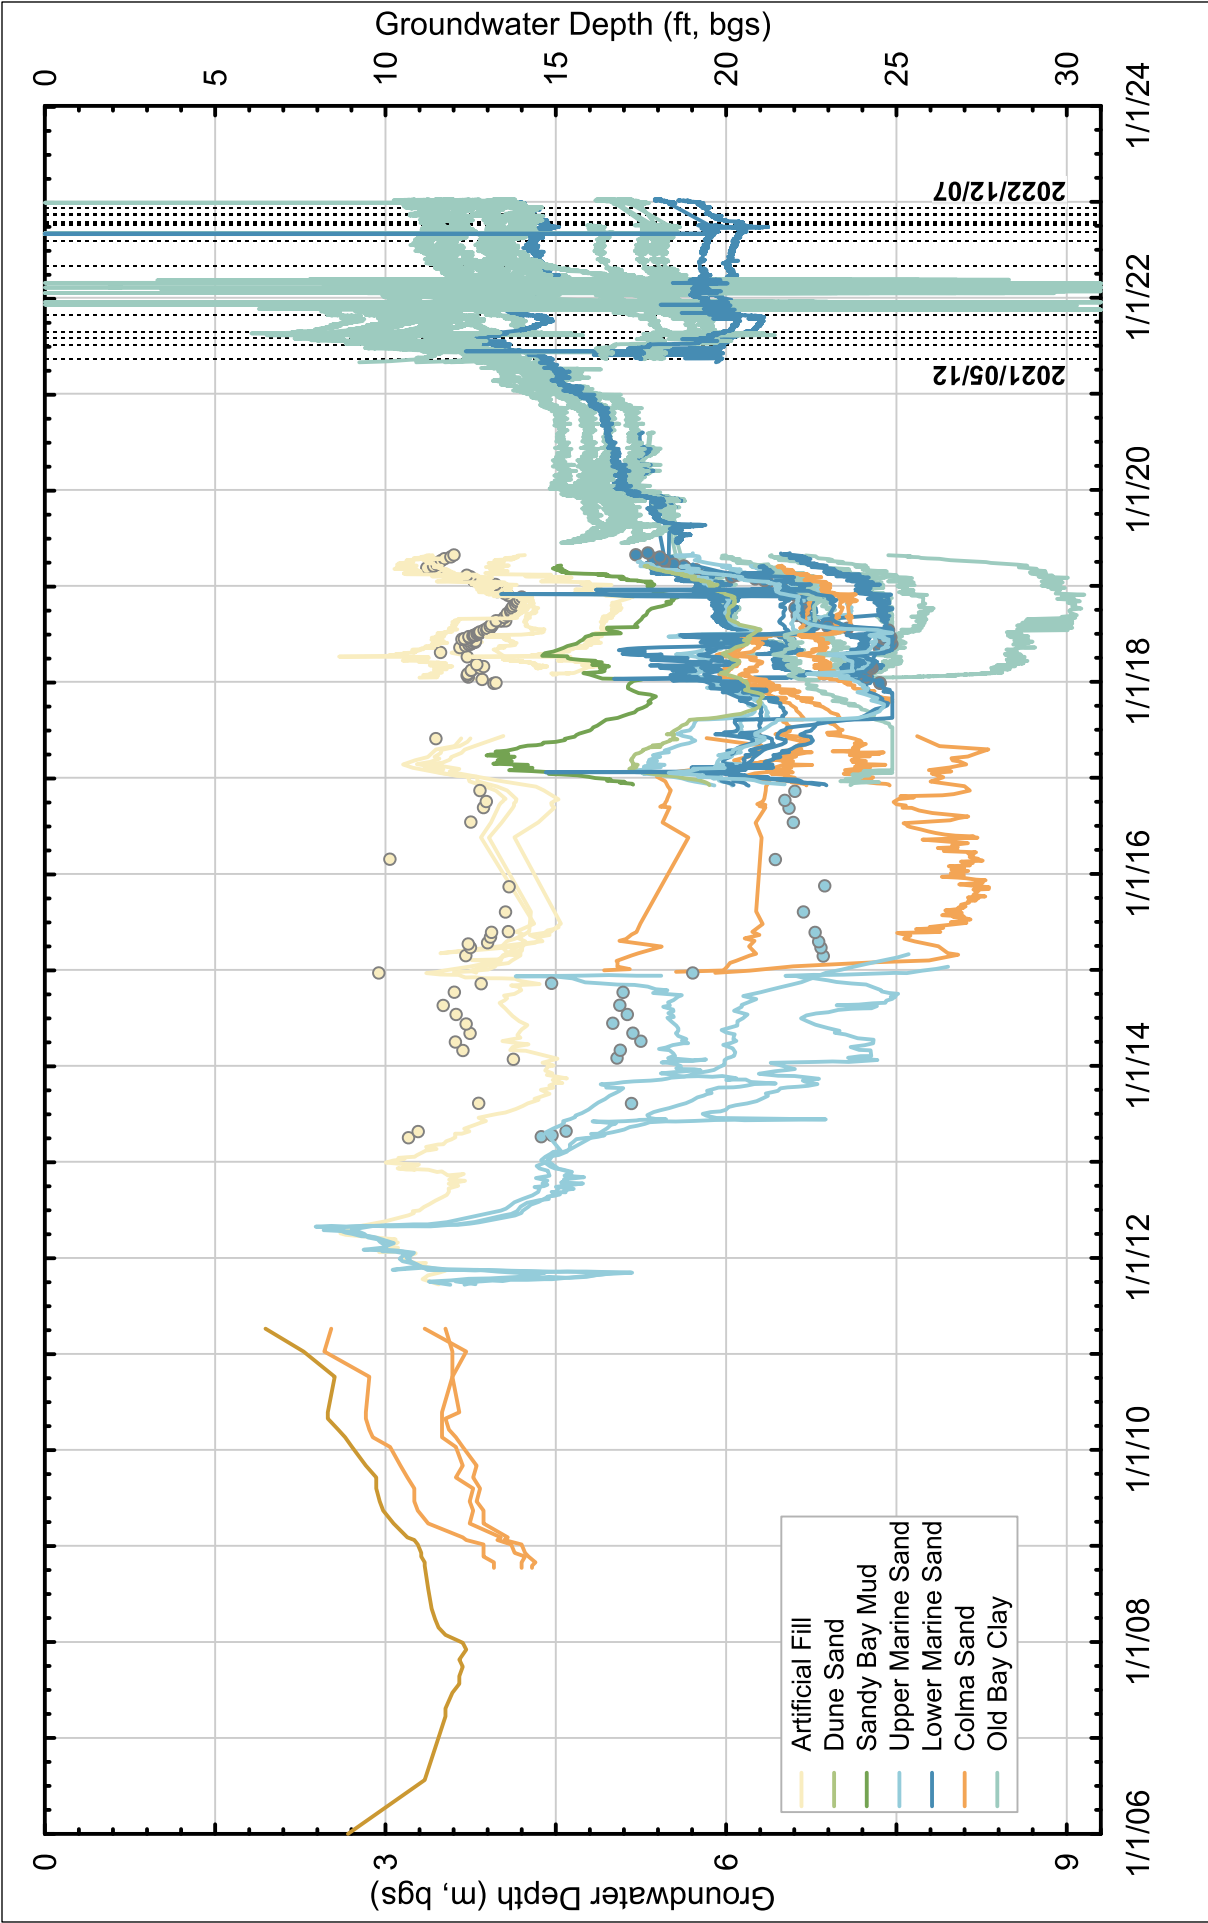
Figure 07 presents the historical groundwater elevation interpreted from piezometer readings at locations near 301 Mission. In addition, data from piezometers installed to monitor groundwater elevation during the retrofit are included. Figures 08 and 09 present groundwater elevation interpreted from piezometer readings in the Marine/Colma Sand and the Old Bay Clay, respectively, for the time period prior to the start of production pile installation (January 1, 2021) through January 10, 2023.

| <div><div>SLATE<br/>GEOTECHNICAL CONSULTANTS</div><div>HISTORICAL GROUNDWATER ELEVATION MEASUREMENTS<br/>AT LOCATIONS NEAR 301 MISSION</div><div>Millennium Tower Perimeter Pile Upgrade: Instrumentation Monitoring Data<br/>City and County of San Francisco, California</div></div> | | | | |
