Subject: 301 Mission Retrofit Monitoring Report 088: Results as of January 10, 2023

This memorandum summarizes results from the monitoring plan implemented at the 301 Mission property. Instrumentation to monitor the structure prior to, during and after the retrofit was installed in January 2021, including piezometers and extensometers. Settlement markers installed in April 2009 and January 2017, survey prisms mounted on the exterior of the structure in December 2016, and crack gauges installed in April 2009 have also been monitored. This memorandum is for review only. It only contains ongoing monitoring information. This memorandum does not contain recommendations based upon the ongoing monitoring information.

Millennium Tower Perimeter Pile Upgrade: Instrumentation Monitoring Data  
City and County of San Francisco, California

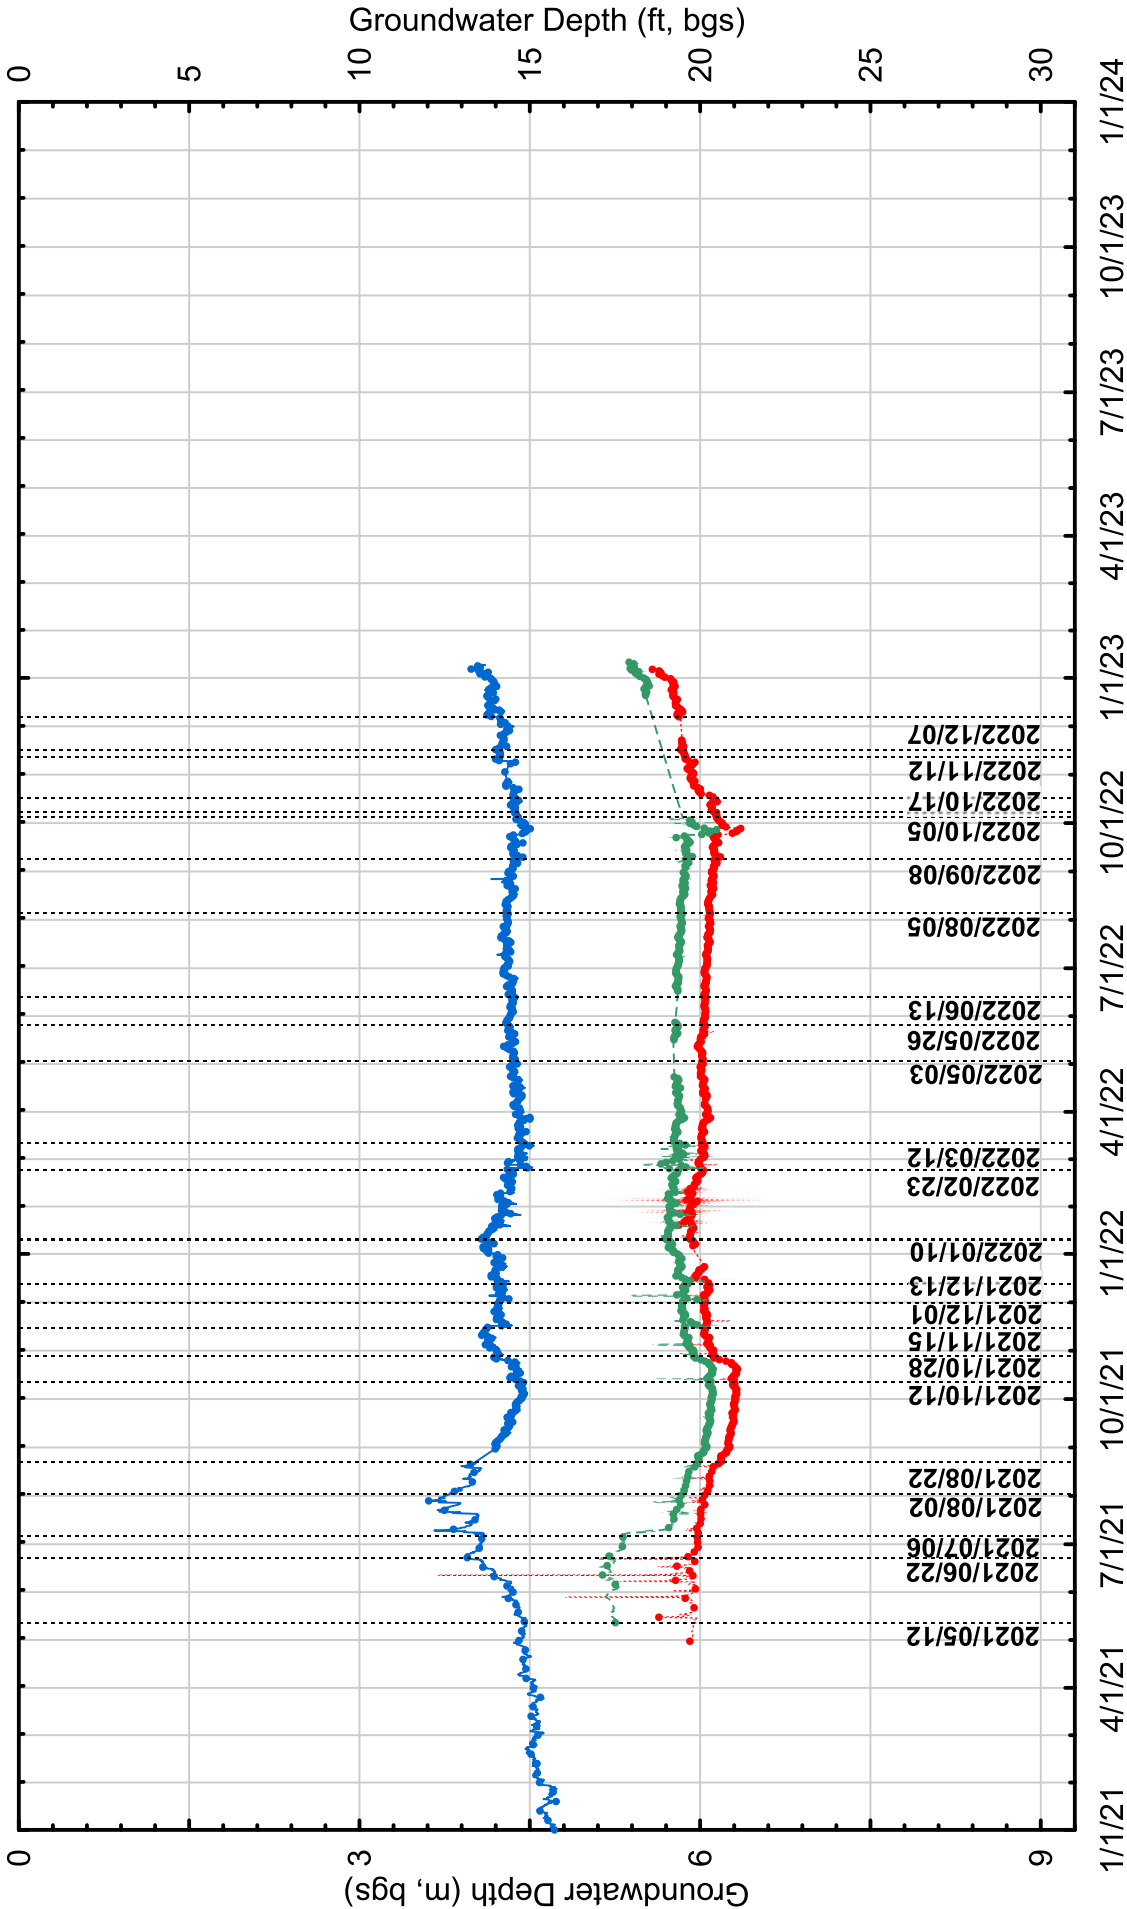
Project No: 19-009.00 Date: 1/11/2023 Created By: NBW Checked By: DGM Figure No: 088-08A

GROUNDWATER ELEVATION MEASUREMENTS IN MARINE AND COLMA SAND  
SINCE 01/01/2021 THROUGH 01/10/2023

Note that one of the Mission Street piezometers, PB-2, has been offline since October 3, 2022. One of the Fremont Street piezometers, PB-1, has been offline since December 20, 2022, and another has been offline since January 6, 2023; work to correct this is ongoing. One of the Fremont Street extensometers, EB-1, has been offline since November 30, 2022; work to correct this is ongoing. Please contact us if you have any comments or questions, or if you would like to discuss the results presented in this memorandum.

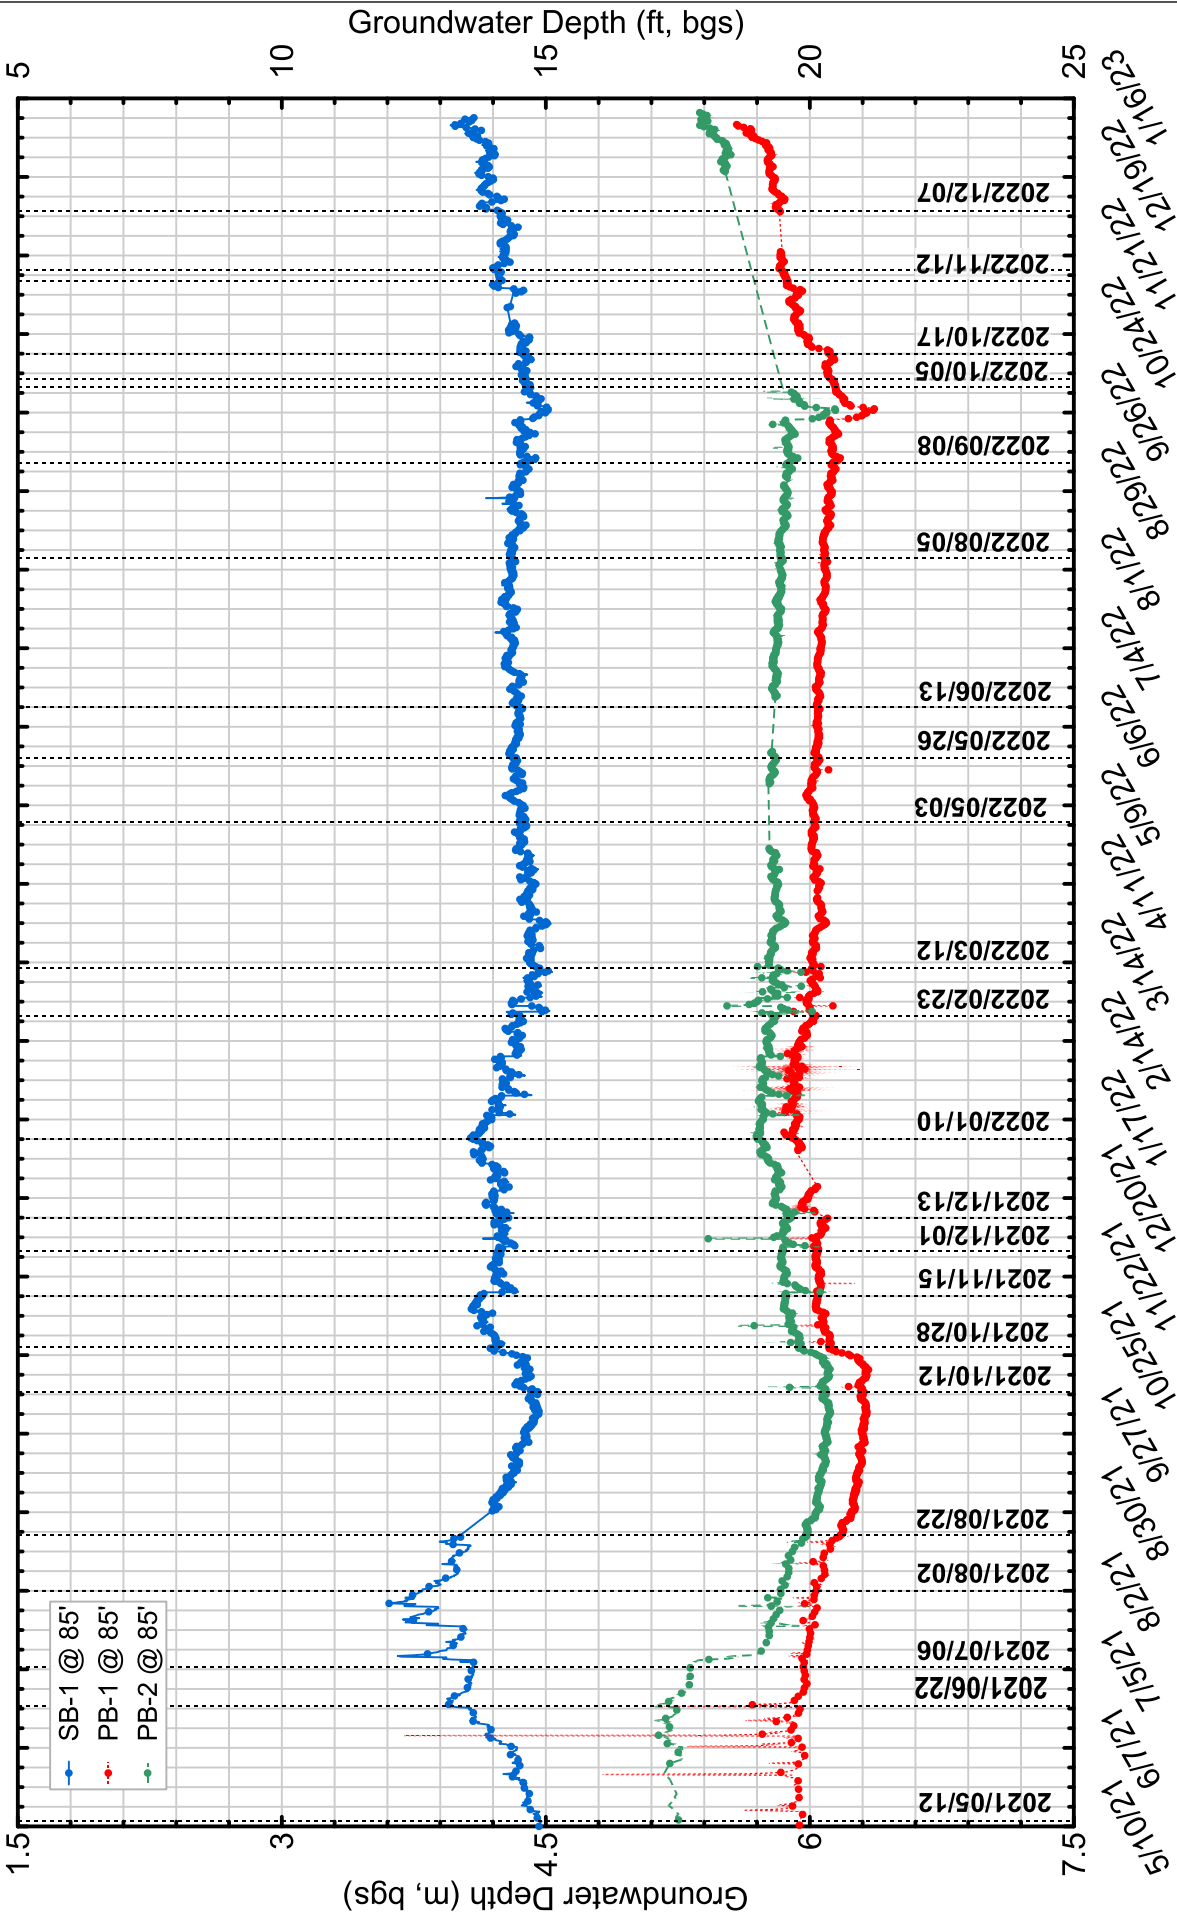
| Project No: 19-009.00 | Date: 1/11/2023 | Created By: NBW | Checked By: DGM | Figure No: 088-08B |

| GROUNDWATER ELEVATION MEASUREMENTS IN MARINE AND COLMA SAND<br>SINCE 05/10/2021 THROUGH 01/10/2023 | | | | |

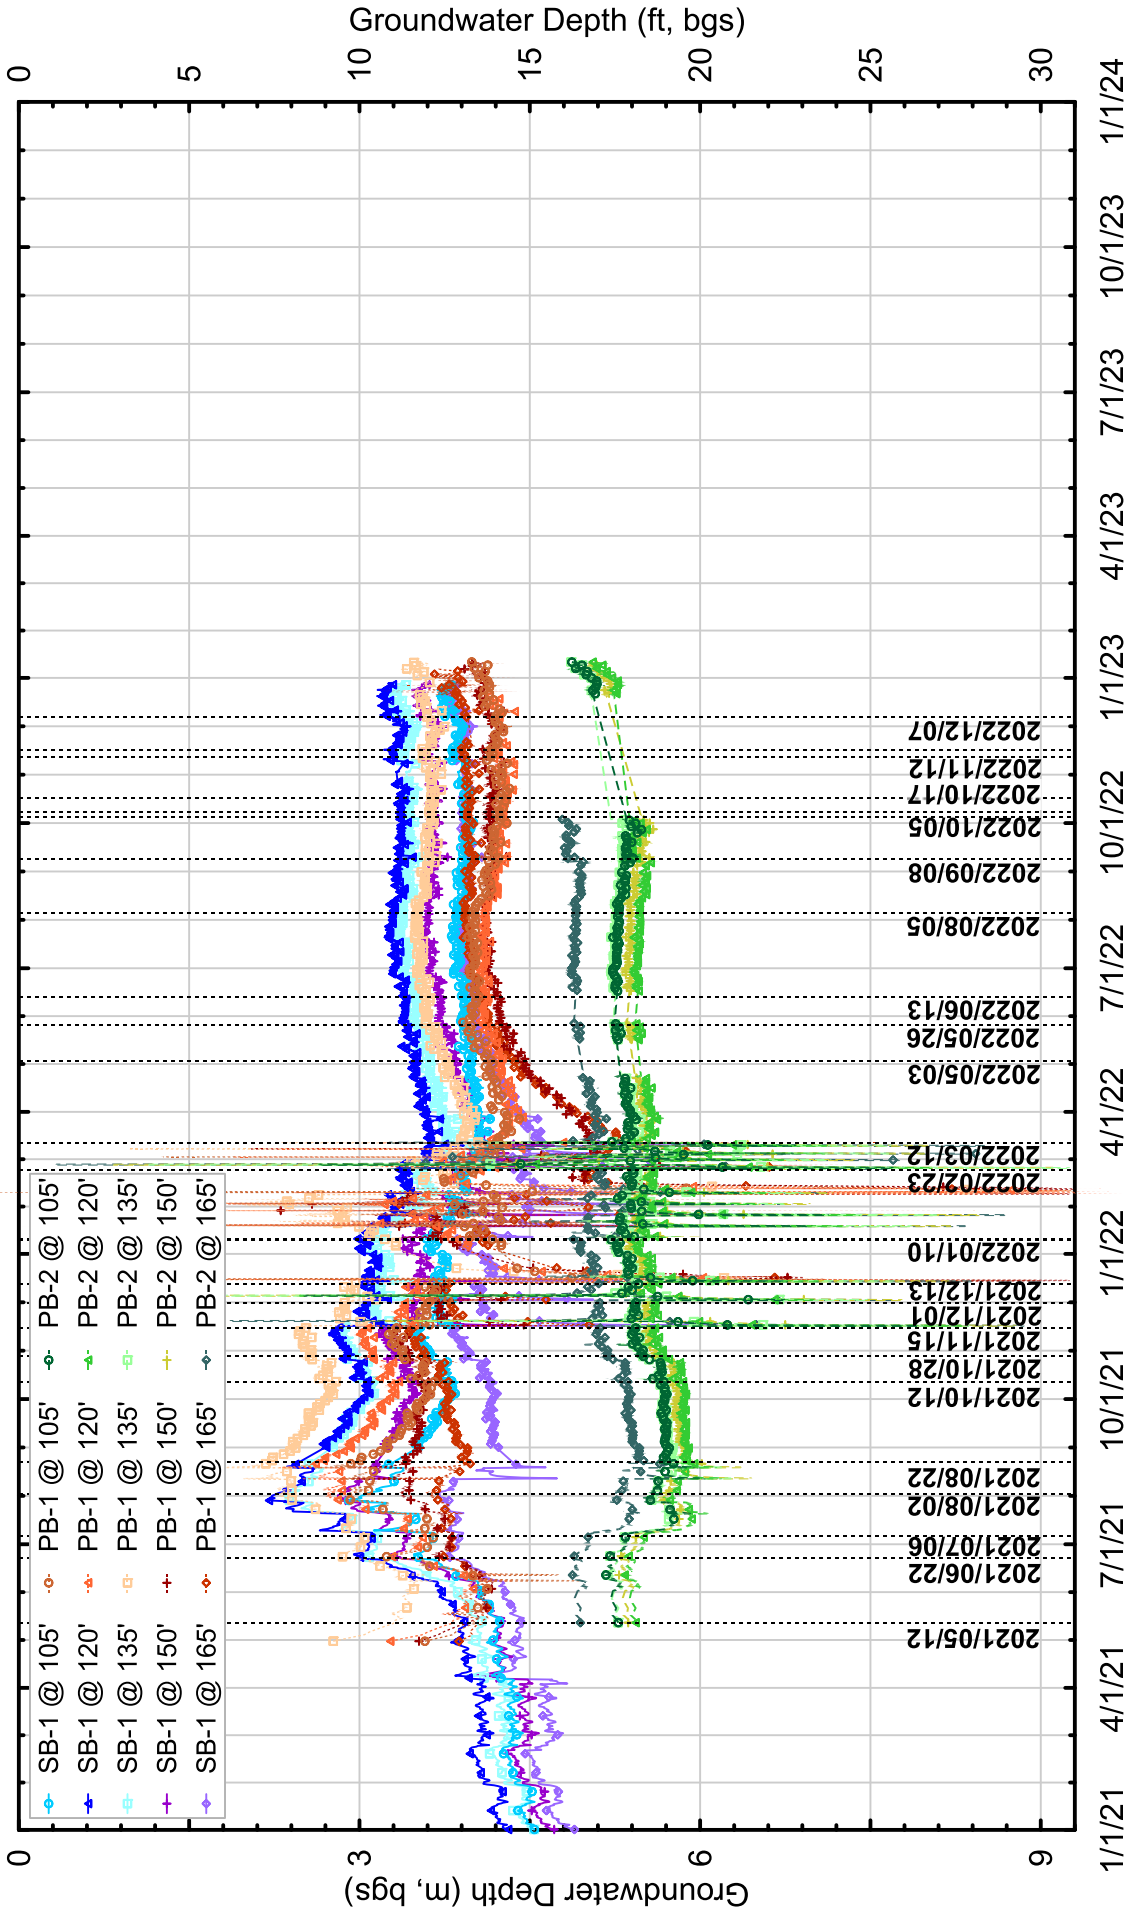
| <div><div><div>SLATE<br/>GEOTECHNICAL CONSULTANTS</div></div><div>GROUNDWATER ELEVATION MEASUREMENTS IN OLD BAY CLAY<br/>SINCE 01/01/2021 THROUGH 01/10/2023</div><div>Millennium Tower Perimeter Pile Upgrade: Instrumentation Monitoring Data<br/>City and County of San Francisco, California</div></div> | | | | |

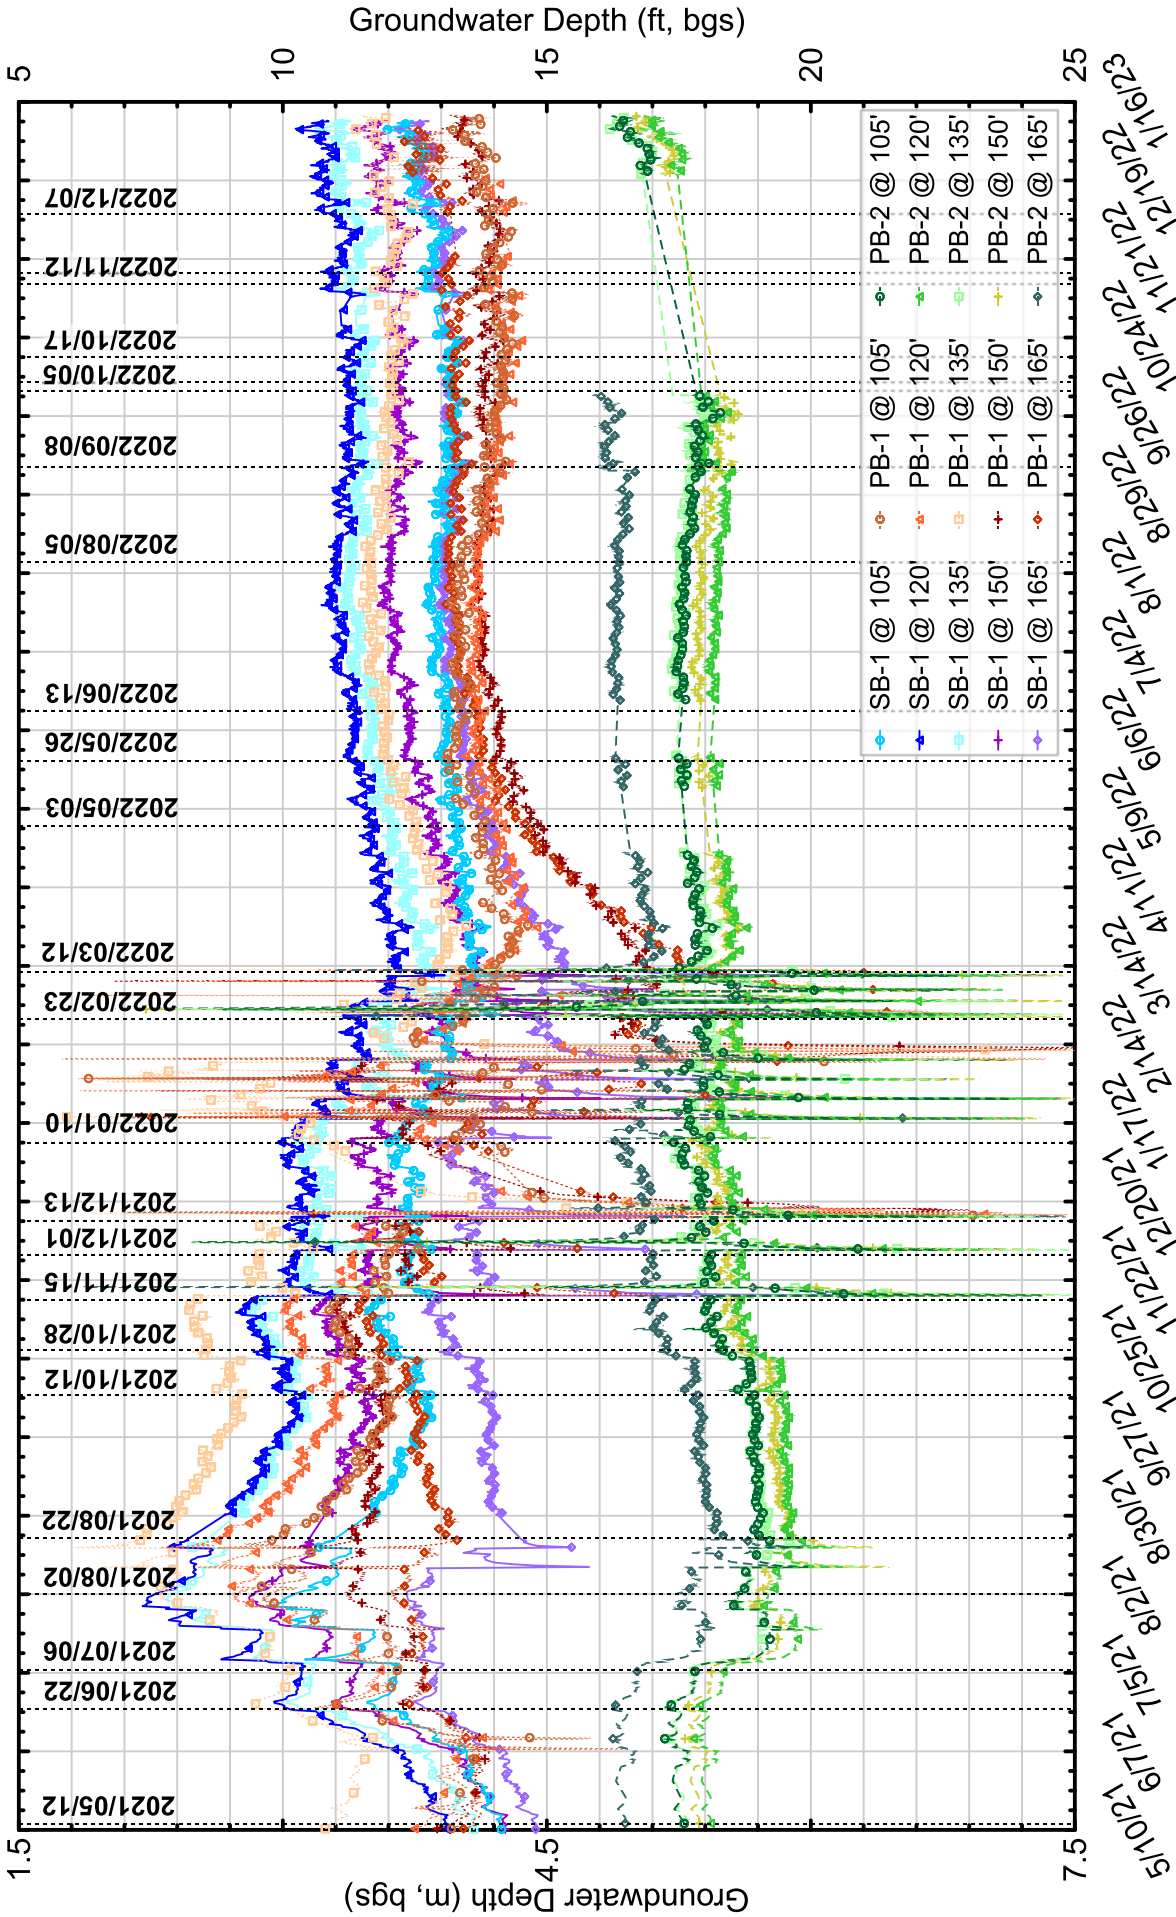
| Project No: 19-009.00 | Date: 1/11/2023 | Created By: NBW | Checked By: DGM | Figure No: 088-09B |

| GROUNDWATER ELEVATION MEASUREMENTS IN OLD BAY CLAY<br>SINCE 05/10/2021 THROUGH 01/10/2023 | | | | |

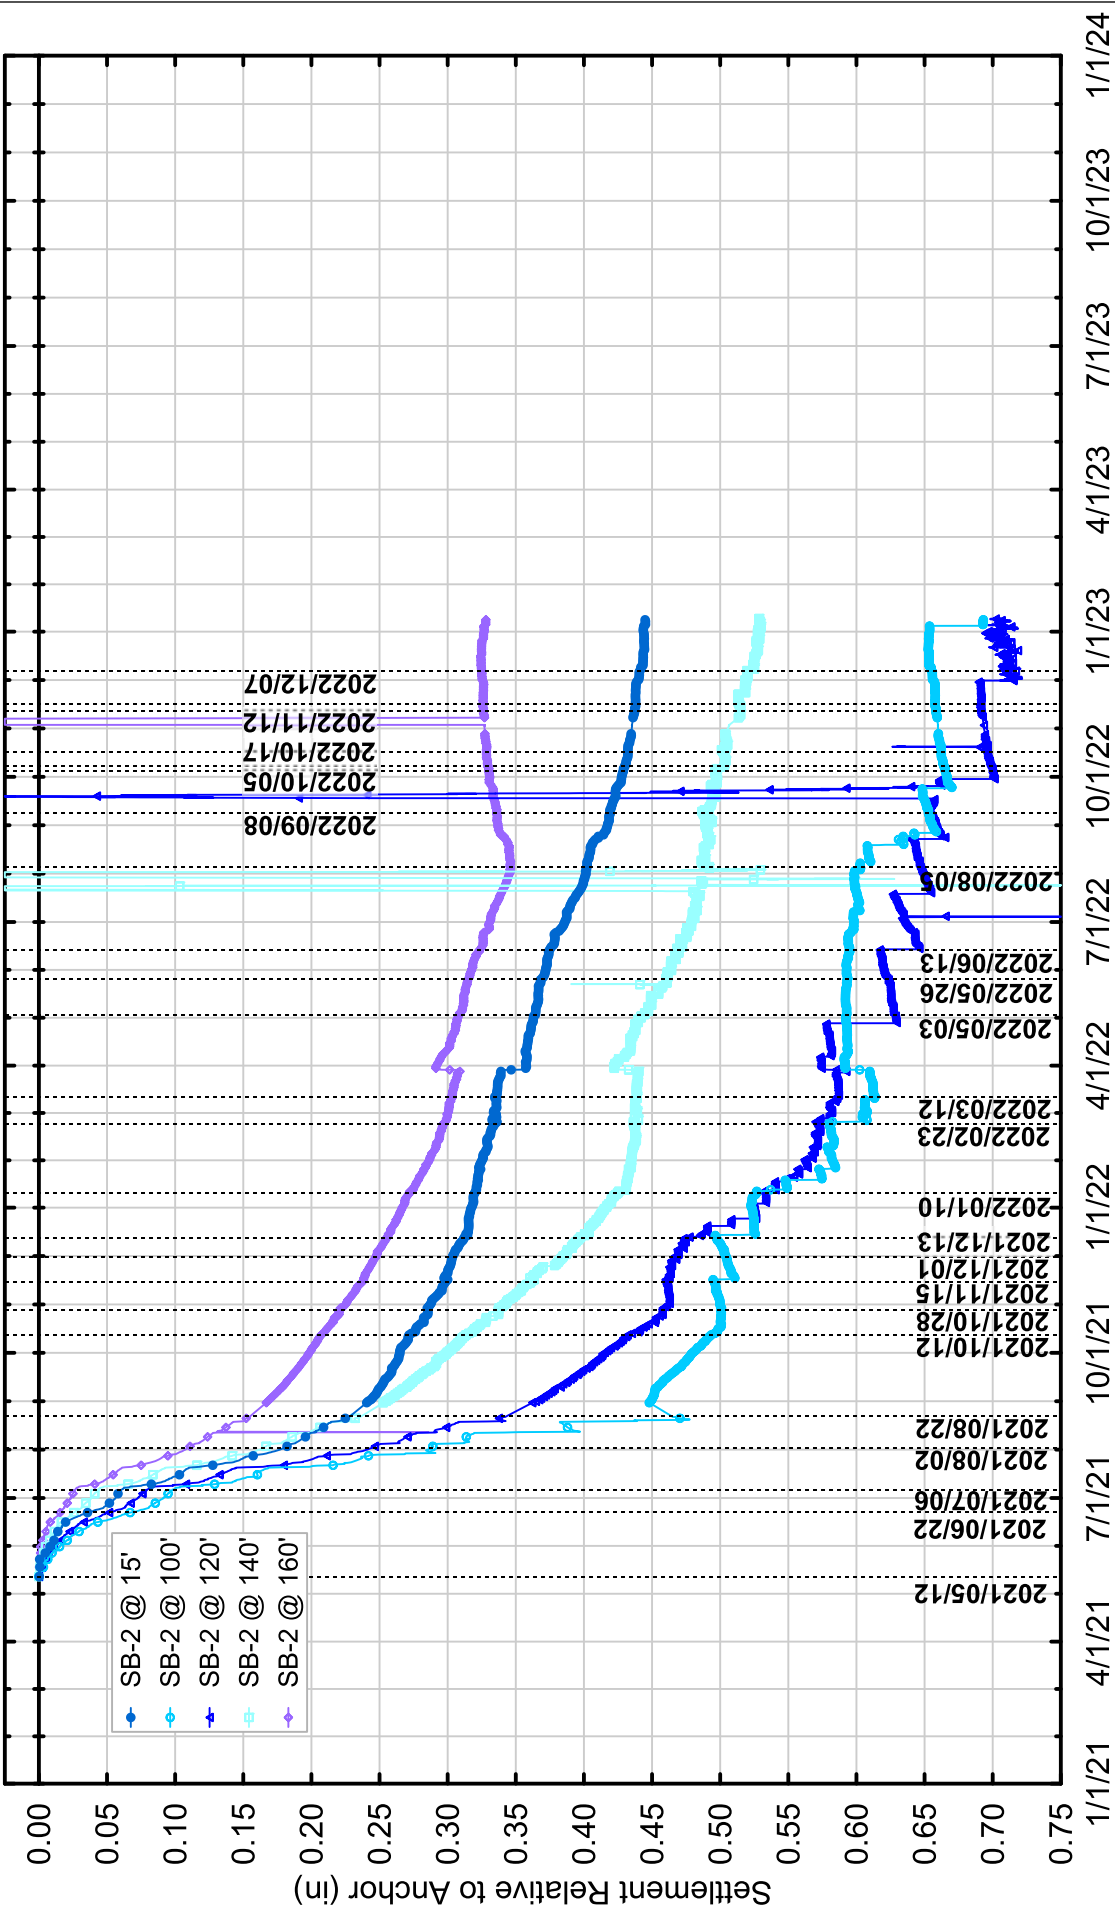
| Project No: 19-009.00 | Date: 1/1/2023 | Created By: NBW | Checked By: DGM | Figure No: 088-10A |

Figure 10 presents extensometer data from within the Tower basement since the start of production pile installation (May 12, 2021) through January 9, 2023. Figure 11 presents extensometer data from Fremont Street since the start of production pile installation (May 12, 2021) through January 10, 2023. Figure 12 presents extensometer data from Mission Street since the start of production pile installation (May 12, 2021) through January 10, 2023.

| EXTENSOMETER DATA FROM WITHIN TOWER BASEMENT<br>SINCE 01/01/2021 THROUGH 01/09/2023 | | | | |

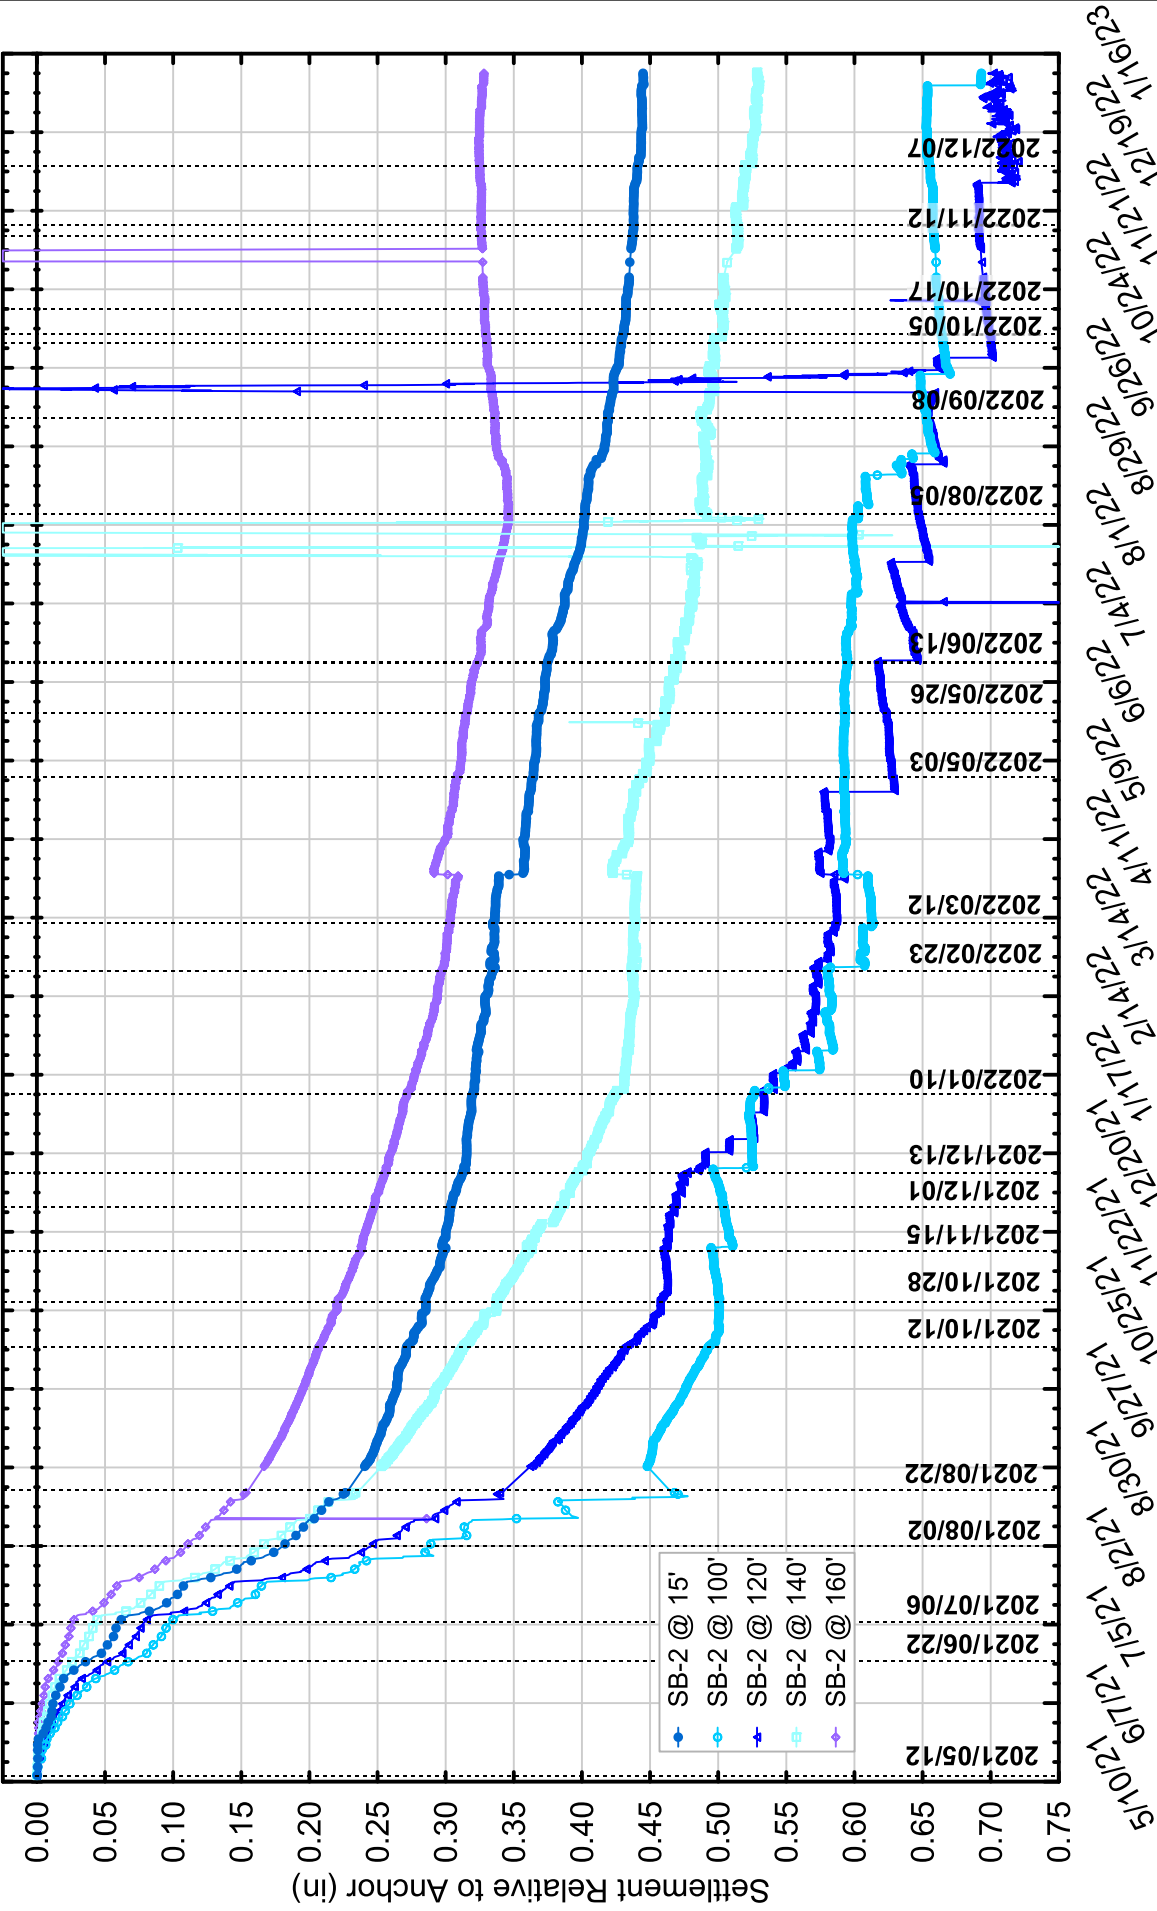
| Project No: 19-009.00 | Date: 1/11/2023 | Created By: NBW | Checked By: DGM | Figure No: 088-10B |

| EXTENSOMETER DATA FROM WITHIN TOWER BASEMENT<br>SINCE 05/10/2021 THROUGH 01/09/2023 | | | | |

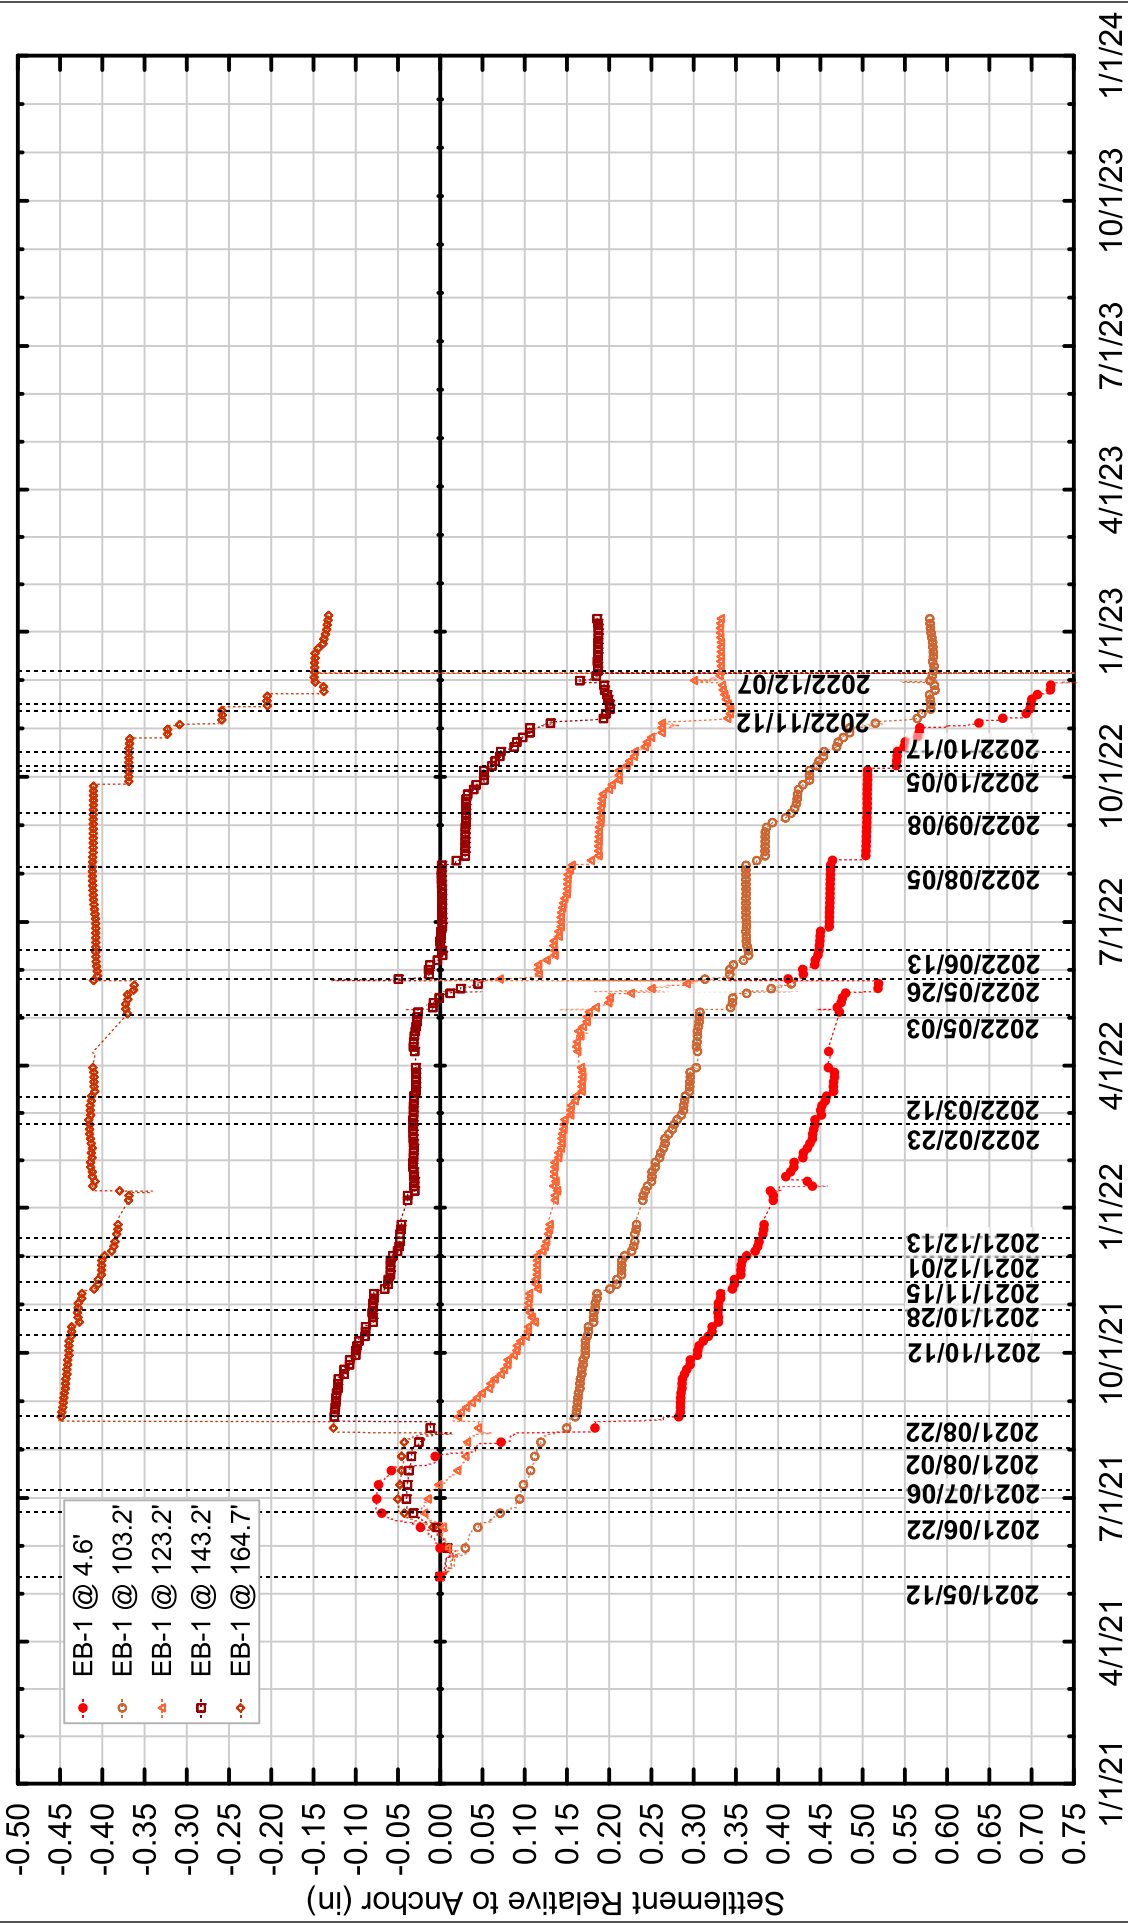
| Project No: 19-009.00 | Date: 1/1/2023 | Created By: NBW | Checked By: DGM | Figure No: 088-11A |

| EXTENSOMETER DATA FROM FREMONT STREET<br>SINCE 01/01/2021 THROUGH 01/10/2023 | | | | |

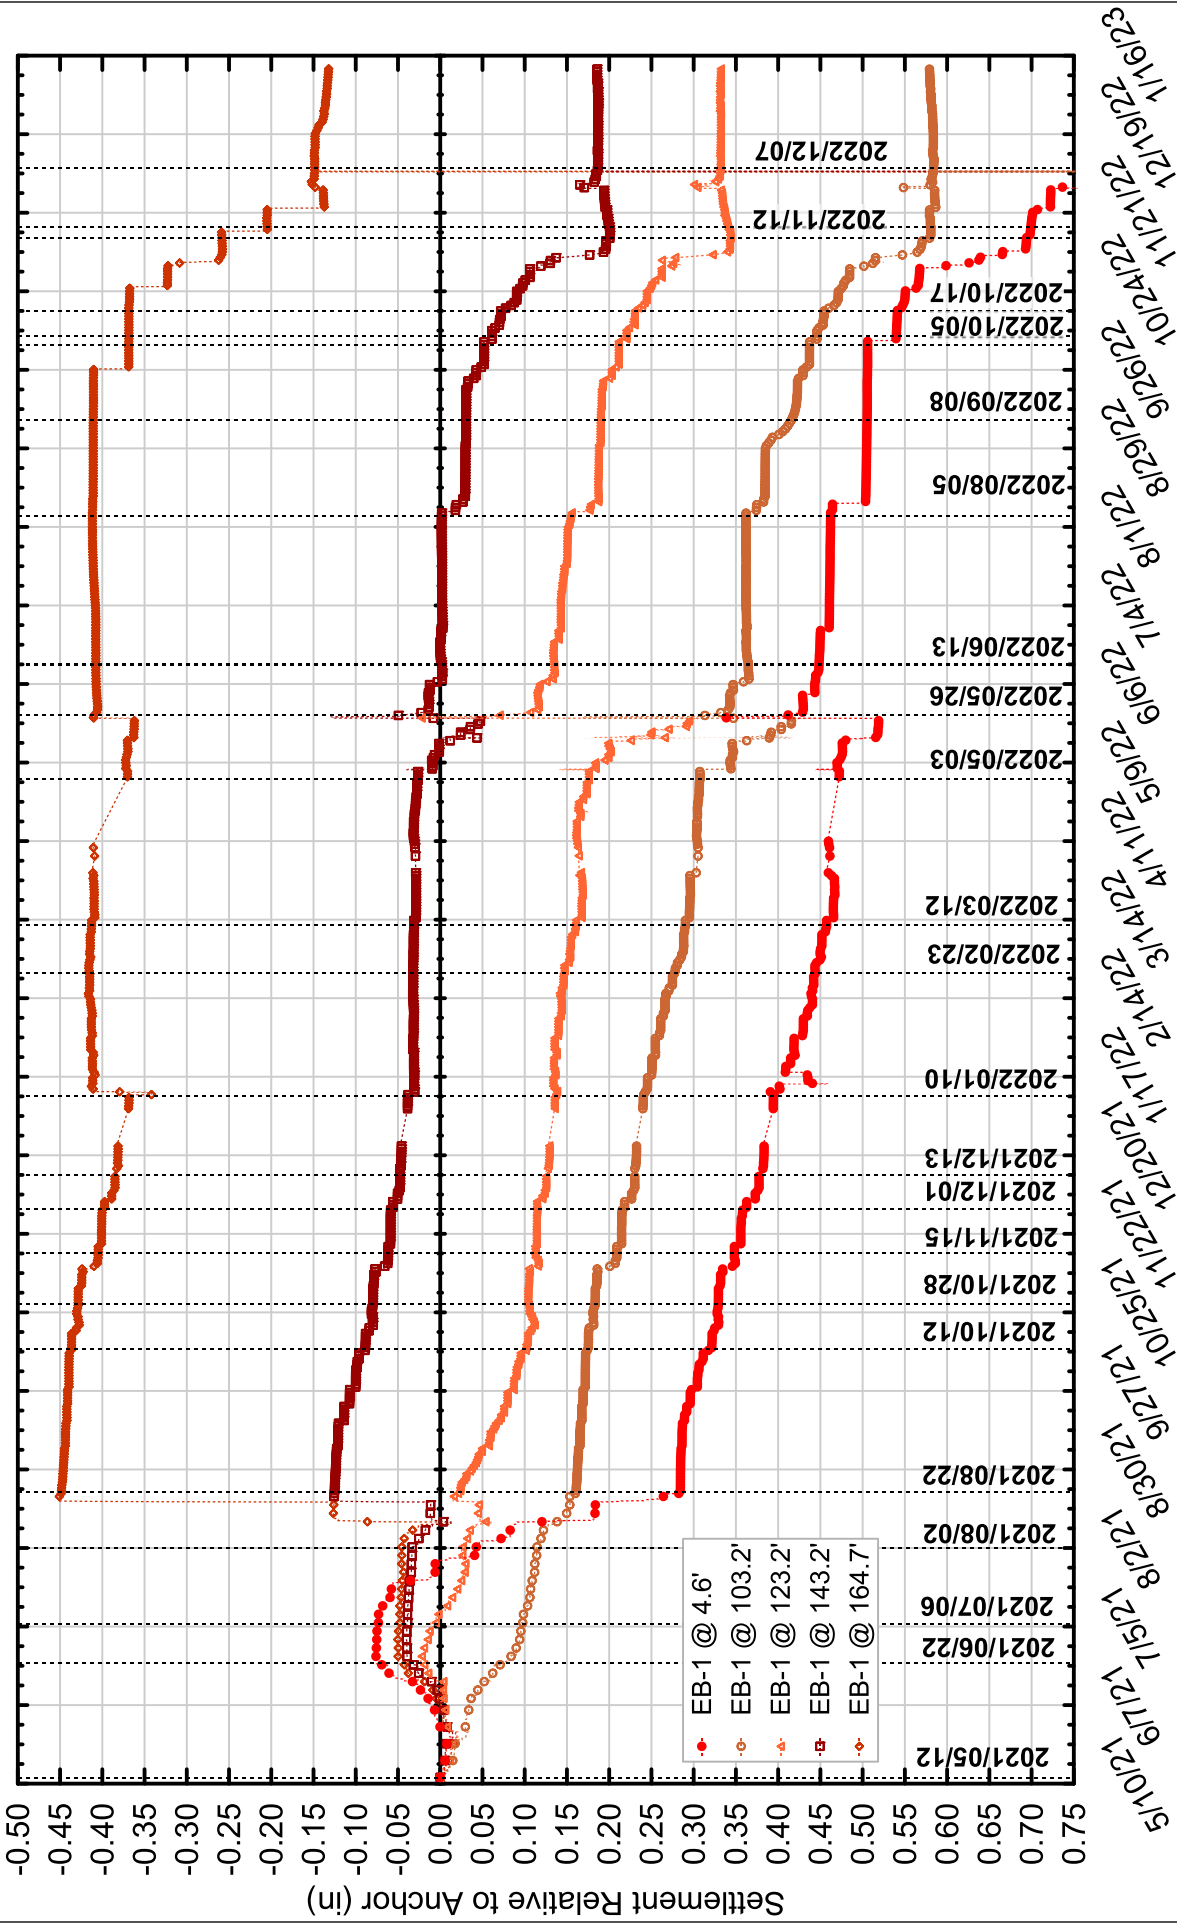
| Project No: 19-009.00 | Date: 1/11/2023 | Created By: NBW | Checked By: DGM | Figure No: 088-11B |

| <b>EXTENSOMETER DATA FROM FREMONT STREET</b><br>SINCE 05/10/2021 THROUGH 01/10/2023 | | | | |

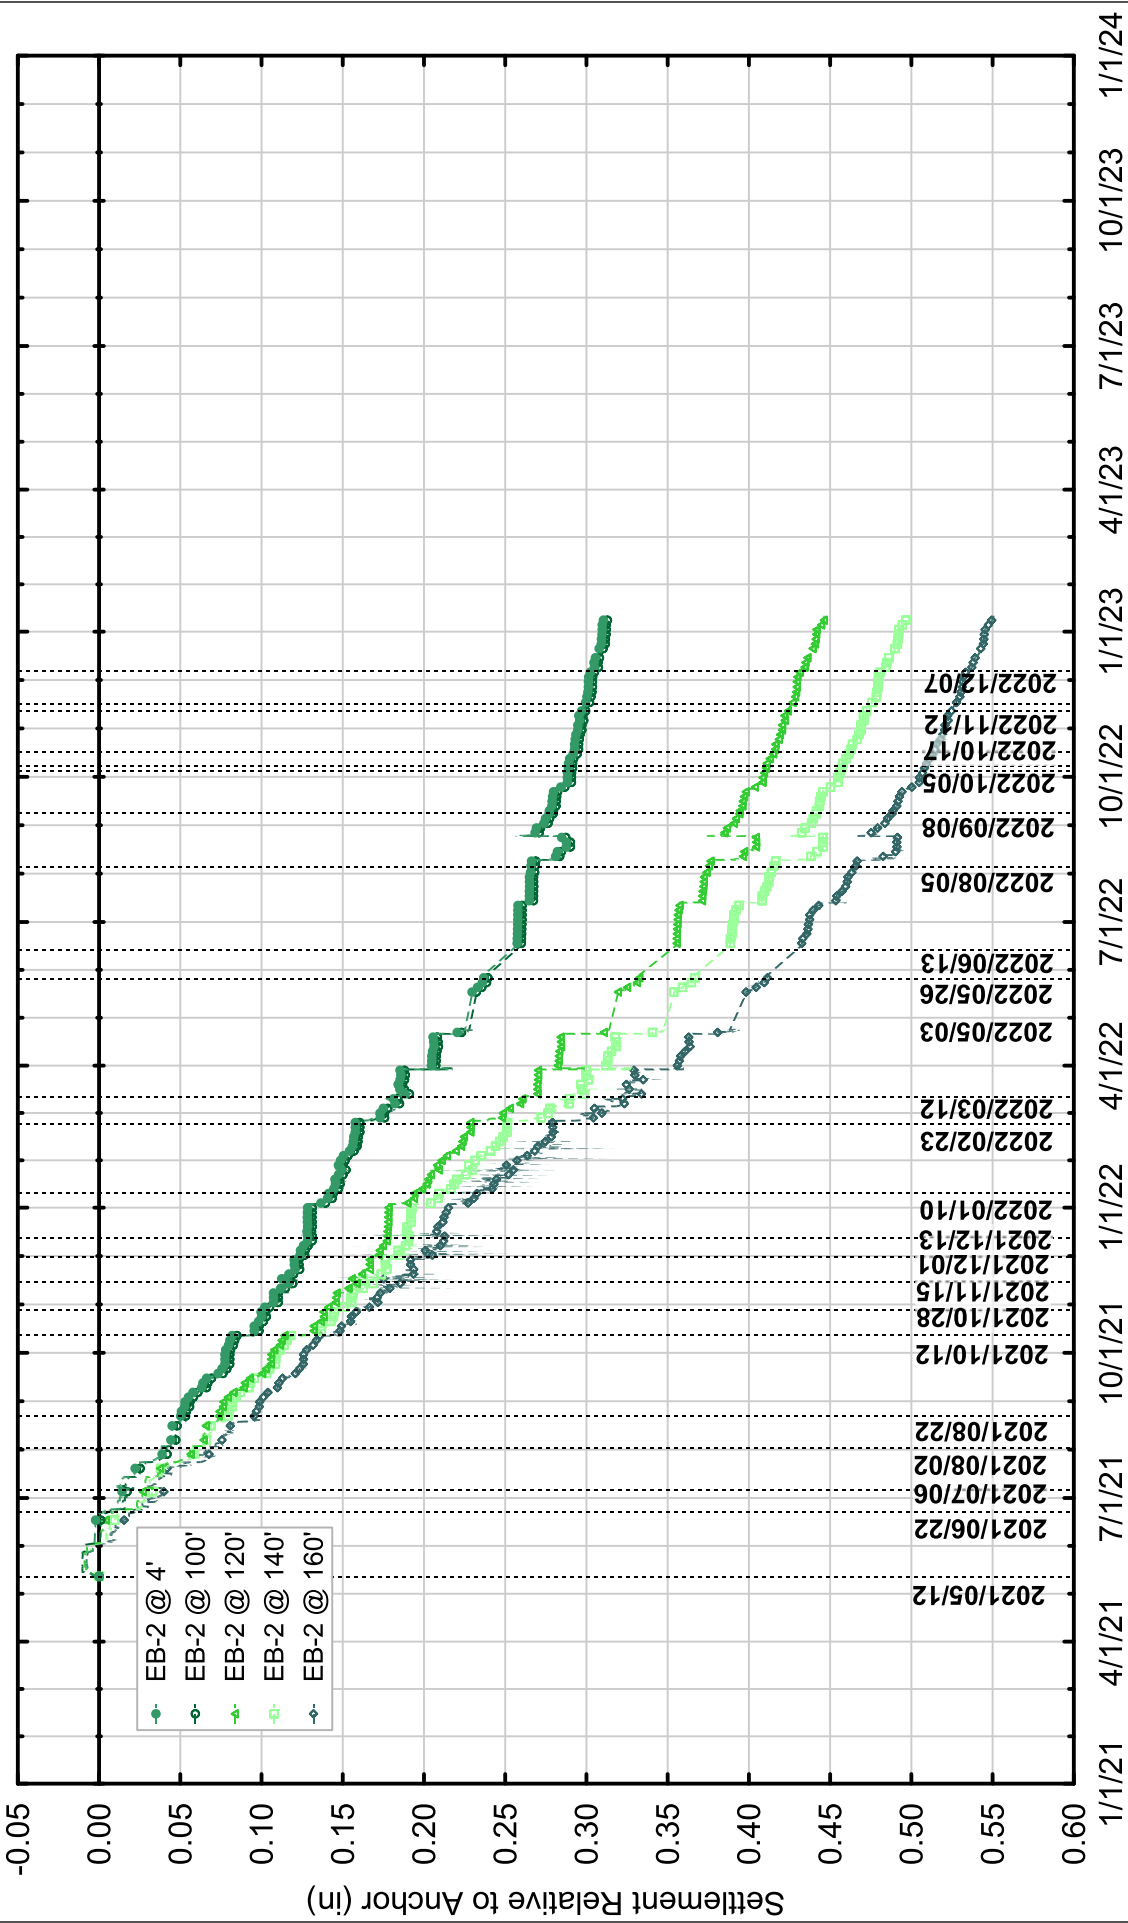
| Project No: 19-009.00 | Date: 1/11/2023 | Created By: NBW | Checked By: DGM | Figure No: 088-12A |

| EXTENSOMETER DATA FROM MISSION STREET<br>SINCE 01/01/2021 THROUGH 01/10/2023 | | | | |

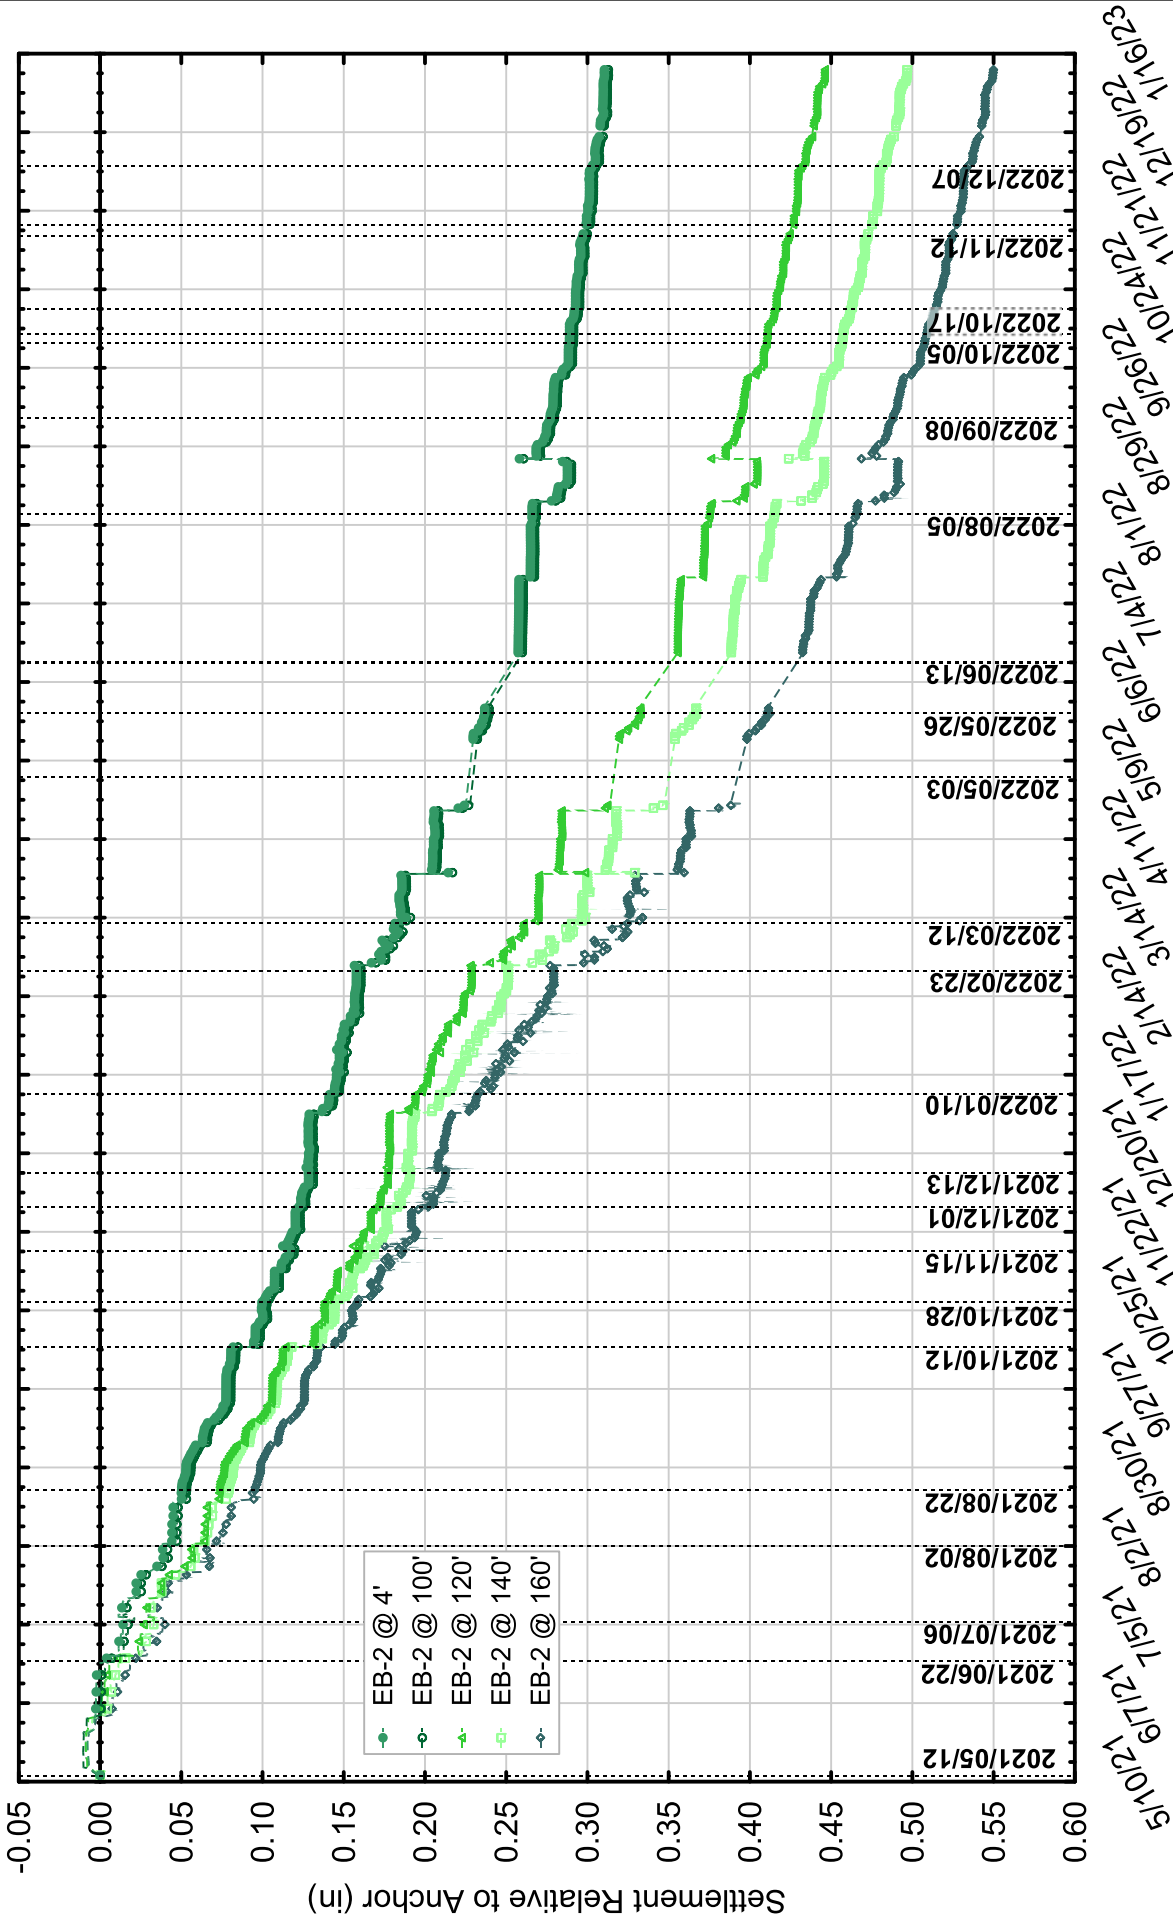
| Project No: 19-009.00 | Date: 1/11/2023 | Created By: NBW | Checked By: DGM | Figure No: 088-12B |

| <b>EXTENSOMETER DATA FROM MISSION STREET</b><br>SINCE 05/10/2021 THROUGH 01/10/2023 | | | | |
