### NEPA SECTION 106 RESEARCH FORM

PROJECT INFORMATION **1044 Howard Street (United Playaz**

**Building Rehab)**

Address: **1044 Howard St, San Francisco, CA 94103**

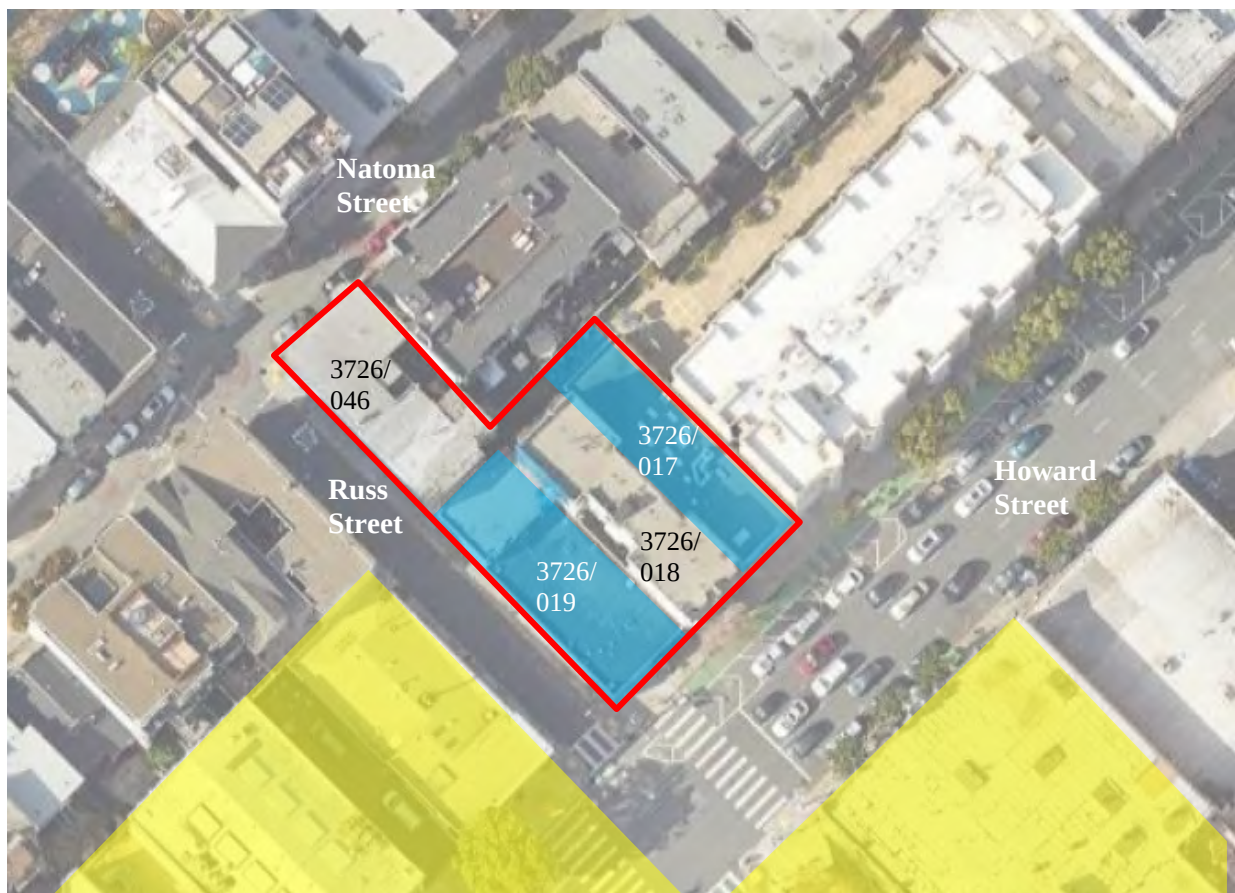
**The APE is outlined in red. The project site is shaded blue. A portion of the adjacent National Register-eligible Western SoMa Light Industrial and Residential Historic District is shaded yellow.**

For the purposes of this undertaking, the architectural APE includes the two parcels that comprise the project site (1038 and 1044 Howard Street) and the two adjacent parcels (1040–1042 Howard Street and 543–545 Natoma Street) and is defined as the property boundary for each parcel (i.e., APNs 3726/017, 3726/018, 3726/019, and 3726/046) (**Figure 1**).

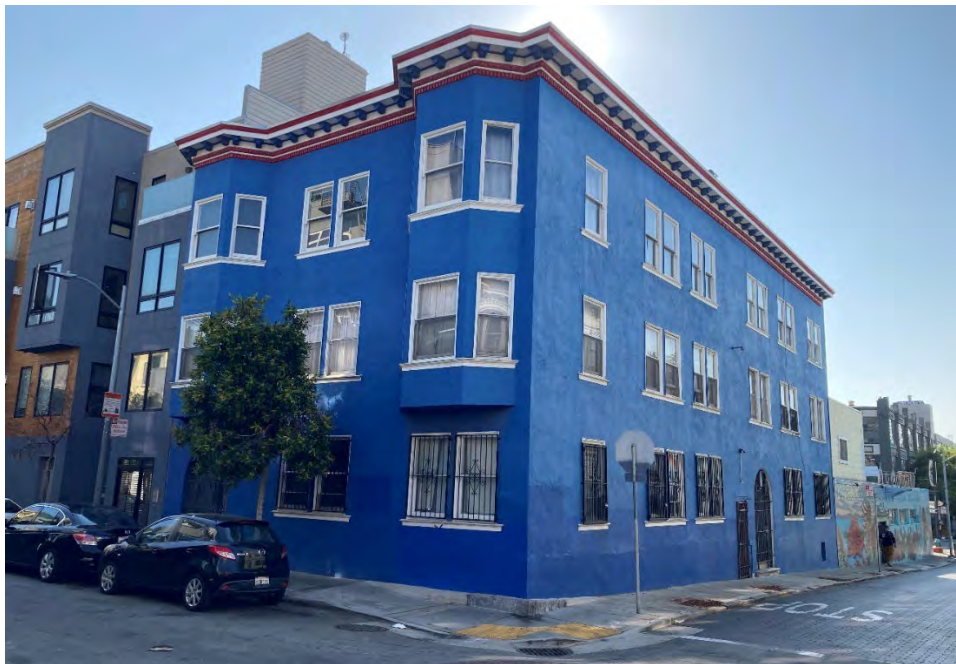
The secondary (southwest) façade faces Russ Street and is clad in stucco (Figure 4). The first floor features four pairs of one-over-one, single-hung, wood-sash windows and one individual one-over-one, single-hung, wood-sash window; a gated doorway; and an arched opening with concrete steps and a metal security grille. The second floor features four pairs of one-over-one, single-hung, wood-sash windows and one individual one-over-one, single-hung, wood-sash window as well as one pair of sliding, vinyl-sash replacement windows. The third floor features five pairs of one-over-one, single-hung, wood-sash windows and one individual one-over-one, single-hung, wood-sash window. The façade terminates in a cornice with egg-and-dart molding, dentil molding, and carved brackets.

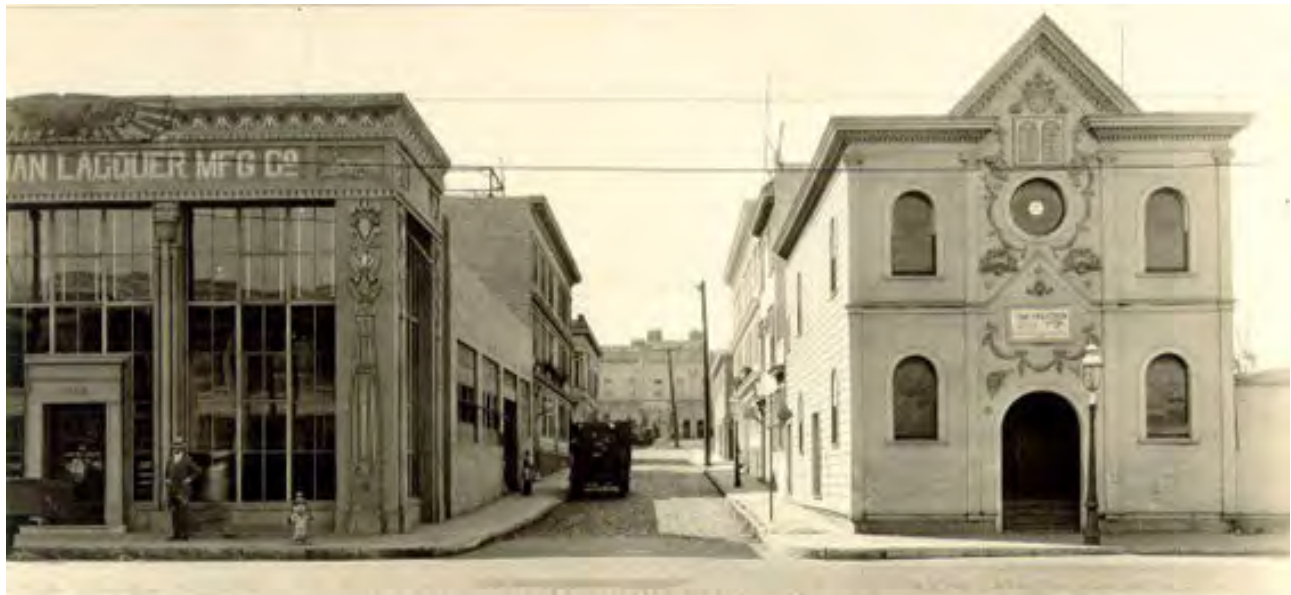
**Figure 7**  
Congregation Chevra Thilim (at right, formerly at 1044 Howard Street), 1927

By 1913, all four parcels within the APE had been redeveloped. There was a tin shop at the present-day location of 1038 Howard Street, three commercial shops at 1040–1042 Howard Street, the synagogue of Congregation Chevra Thilim at 1044 Howard Street (**Figure 7**) with a three-unit residential flats building behind it on Russ Street, and the extant six-unit residential flats building at 543–545 Natoma Street (constructed in 1909).<sup>29,30</sup> Of these reconstruction-era buildings, only the building with frontage on Natoma Street remains.

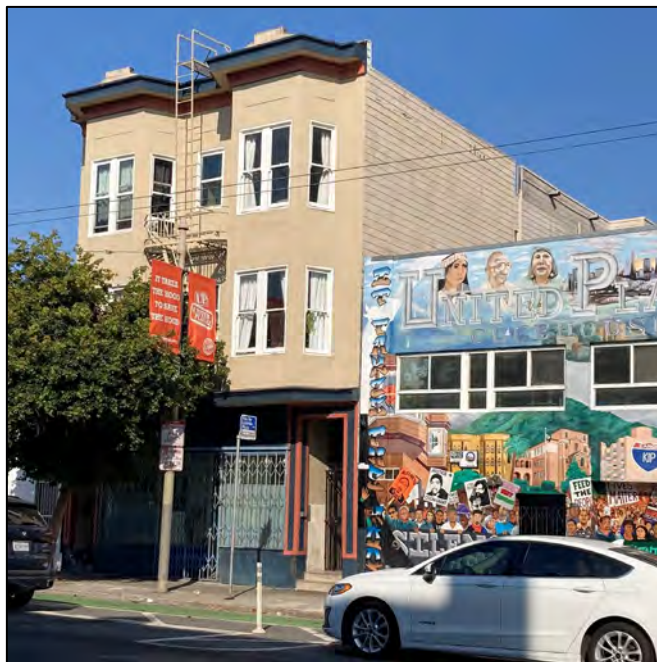
**P5a. Photograph or Drawing** (Photograph required for buildings, structures, and objects).

View of primary (southeast) façade on Howard Street, facing northwest. Photo by ESA, August 31, 2023.

The primary (southeast) façade faces Howard Street. At the first floor, an aluminum-frame storefront assembly is located behind a metal security grille. The storefront is flanked by two recessed entrances to the residential units above. The recessed entrances are fitted with metal security grilles and contain concrete steps, and the steps to the east entrance are covered with mosaic tiles. Stacked, angled bay windows on the second and third floors feature one-over-one, single-hung, wood-sash windows; some of the original windows have been replaced with single-hung, vinyl-sash windows. The façade terminates in a simple cornice with egg-and-dart molding that disguises a stepped parapet behind.

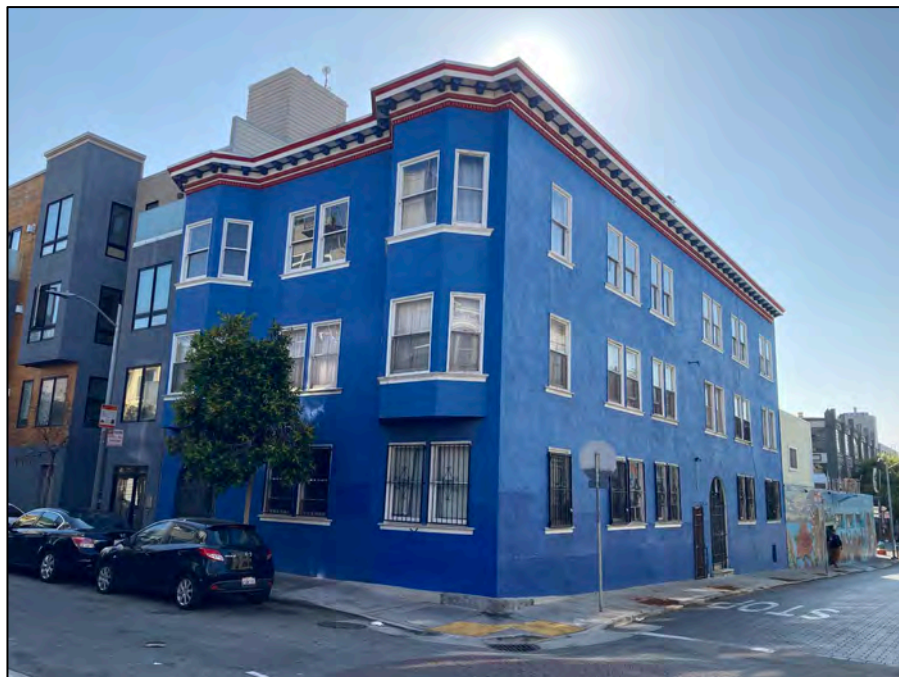
P5a. Photograph or Drawing (Photograph required for buildings, structures, and objects.)

View of primary (northwest) and secondary (southwest) façades, view facing southeast. Photo by ESA, August 31, 2023.

The secondary (southwest) façade faces Russ Street and is clad in stucco. The first floor features four pairs of one-over-one, single-hung, wood-sash windows and one individual one-over-one, single-hung, wood-sash window; a gated doorway; and an arched opening with concrete steps and a metal security grille. The second floor features four pairs of one-over-one, single-hung, wood-sash windows and one individual one-over-one, single-hung, wood-sash window as well as one pair of sliding, vinyl-sash replacement windows. The third floor features five pairs of one-over-one, single-hung, wood-sash windows and one individual one-over-one, single-hung, wood-sash window. The façade terminates in a cornice with egg-and-dart molding, dentil molding, and carved brackets. The rear façade faces southeast and is clad in channel-drop wood siding. Only the third story is visible above the adjacent building at 1044 Howard Street, and it features a pair of one-over-one, single-hung, wood-sash windows.
