Project Number: 23-018-01

Subject: 301 Mission Retrofit Monitoring Report 133: Results as of April 29, 2024

Millennium Tower Perimeter Pile Upgrade: Instrumentation Monitoring Data
 City and County of San Francisco, California

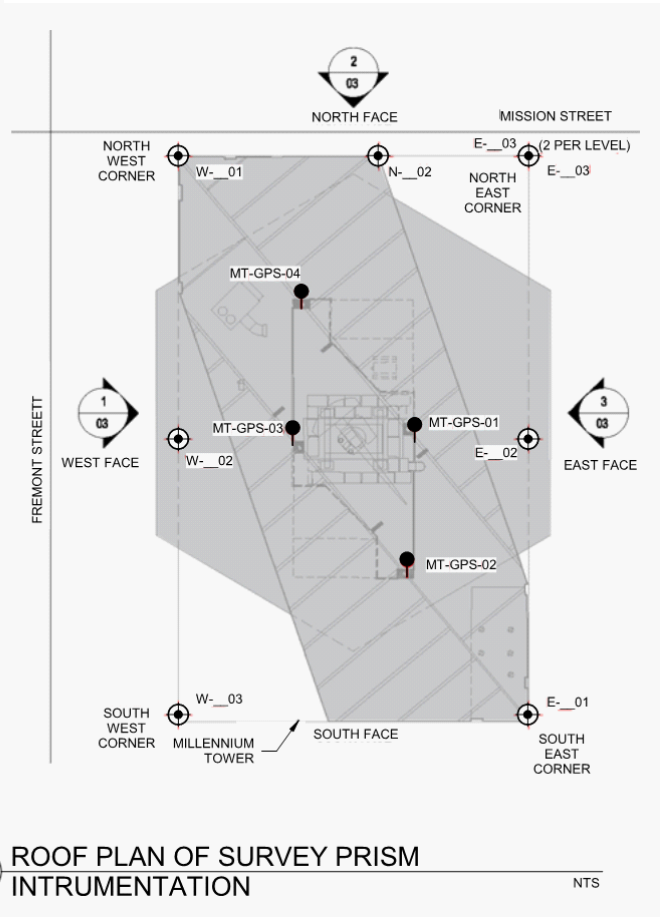
Project No: 23-018-01	Date: 7/26/2021	Created By: NBW	Checked By: DGM	Figure No: 133-01B
-----------------------	-----------------	-----------------	-----------------	---------------------------

TOWER SURVEY PRISM LOCATION SCHEMATIC

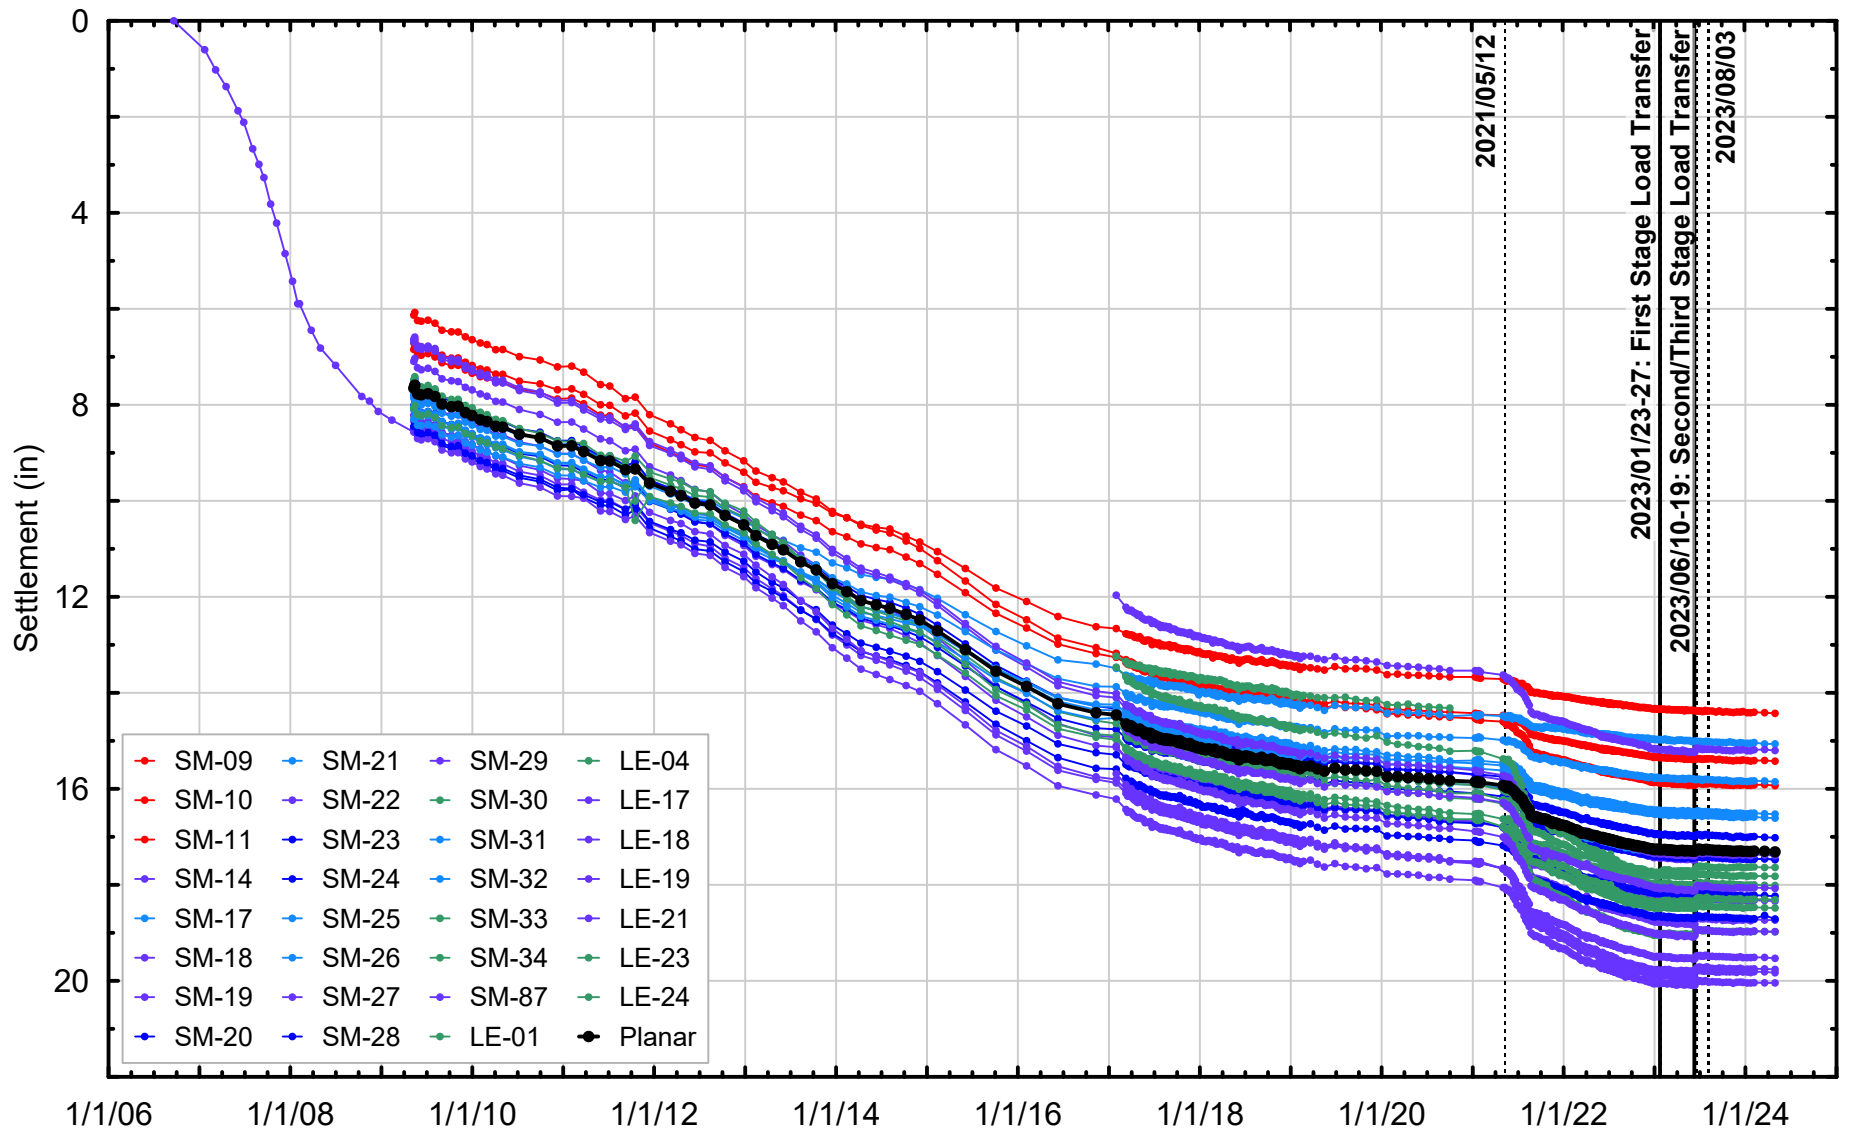
Project No: 23-018-01	Date: 5/3/2024	Created By: TB	Checked By: DGM	Figure No: 133-02

HISTORICAL SETTLEMENT MARKER DATA		
		Millennium Tower Perimeter Pile Upgrade: Instrumentation Monitoring Data City and County of San Francisco, California

Figure 02 presents the historical settlement data interpreted from settlement markers installed on the B-1 Level of 301 Mission Tower. In addition, data from surveys performed during the retrofit are included. Figure 03 presents settlement data since the start of production pile installation (May 12, 2021; baseline readings on May 10, 2021) through April 29, 2024. Figure 04 presents current settlement contours (in inches) on April 29, 2024.

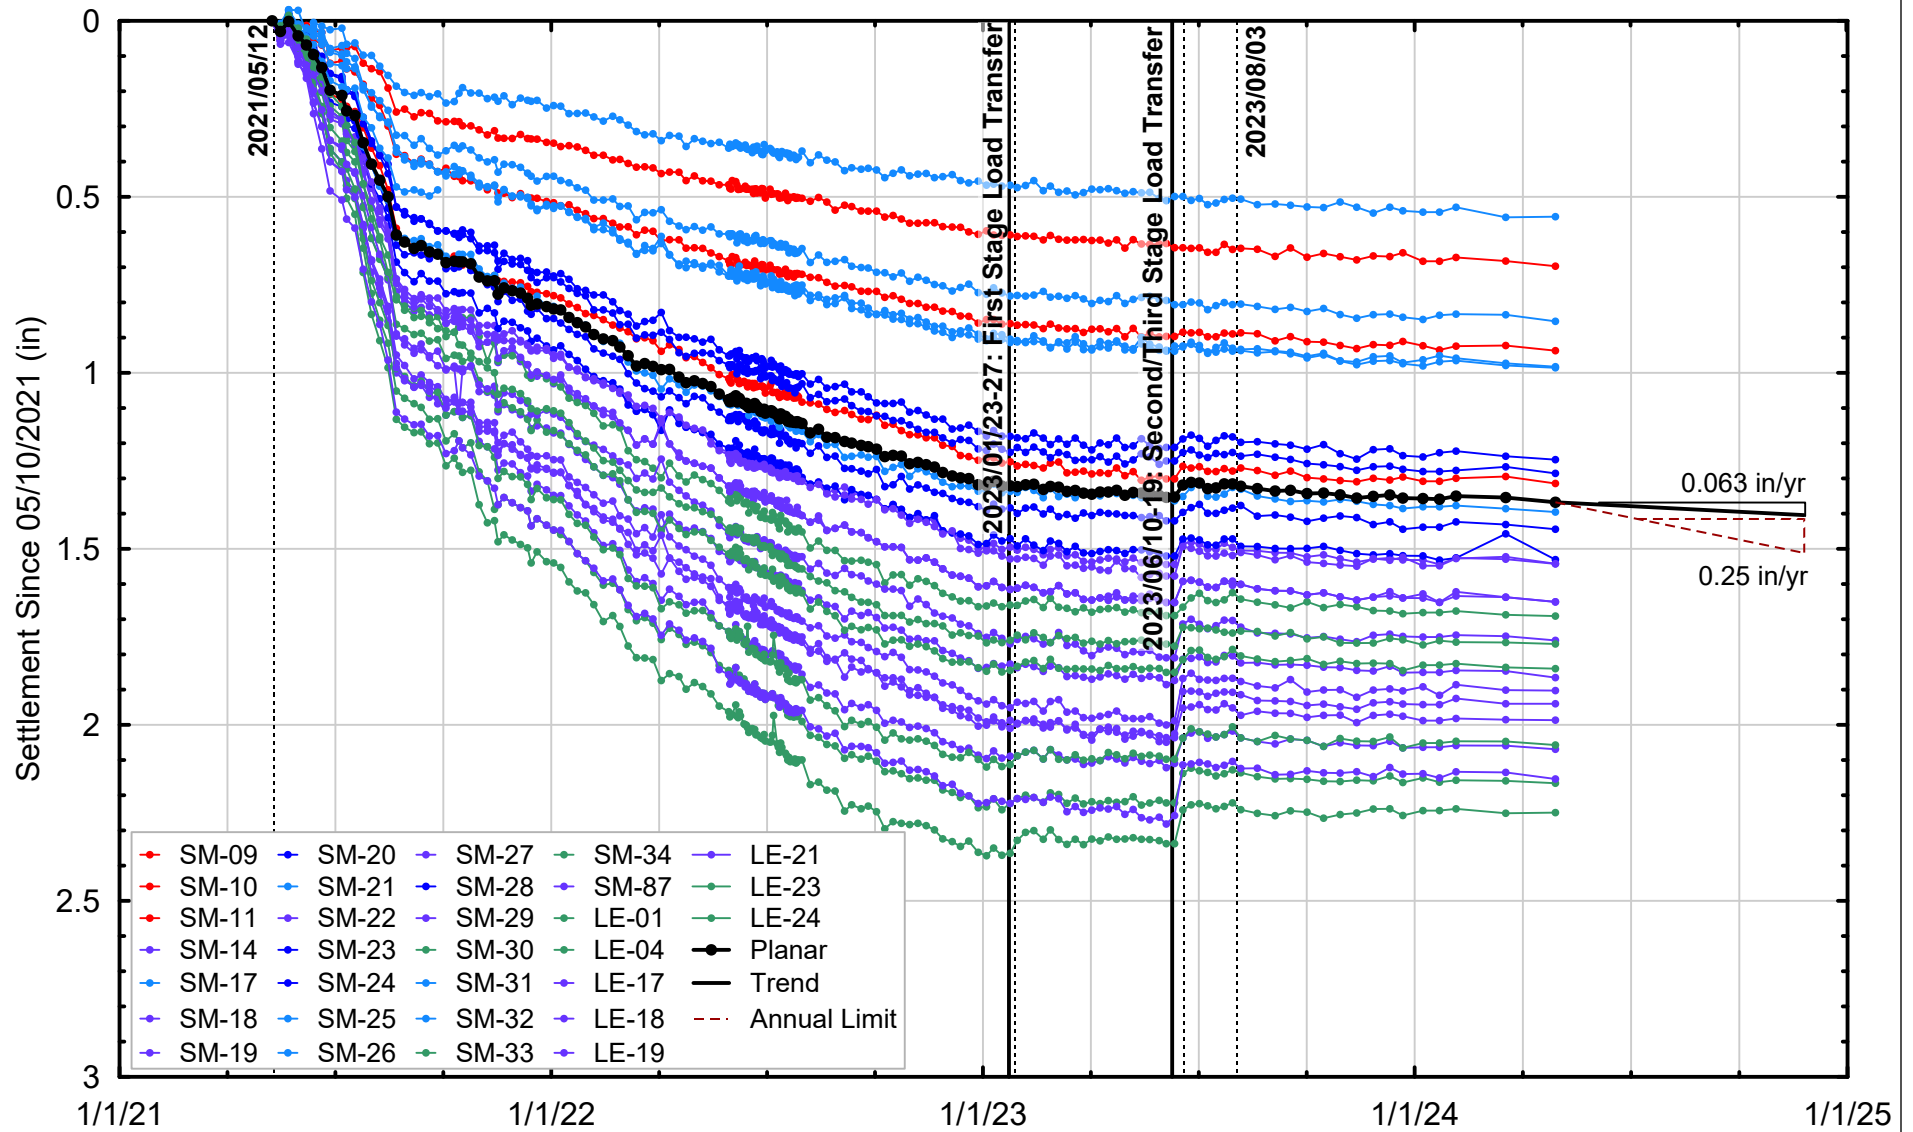
Project No: 23-018-01	Date: 5/3/2024	Created By: TB	Checked By: DGM	Figure No: 133-03

SETTLEMENT MARKER DATA SINCE 05/10/2021 THROUGH 04/29/2024		
		Millennium Tower Perimeter Pile Upgrade: Instrumentation Monitoring Data City and County of San Francisco, California

⁵ As plotted on Figure 03. The annual rate is calculated starting on the settlement monitoring date closest to one year prior to the current date or on June 19, 2023 (the settlement monitoring date corresponding to the last day of jacking load application), whichever is later, and ending on the current date.

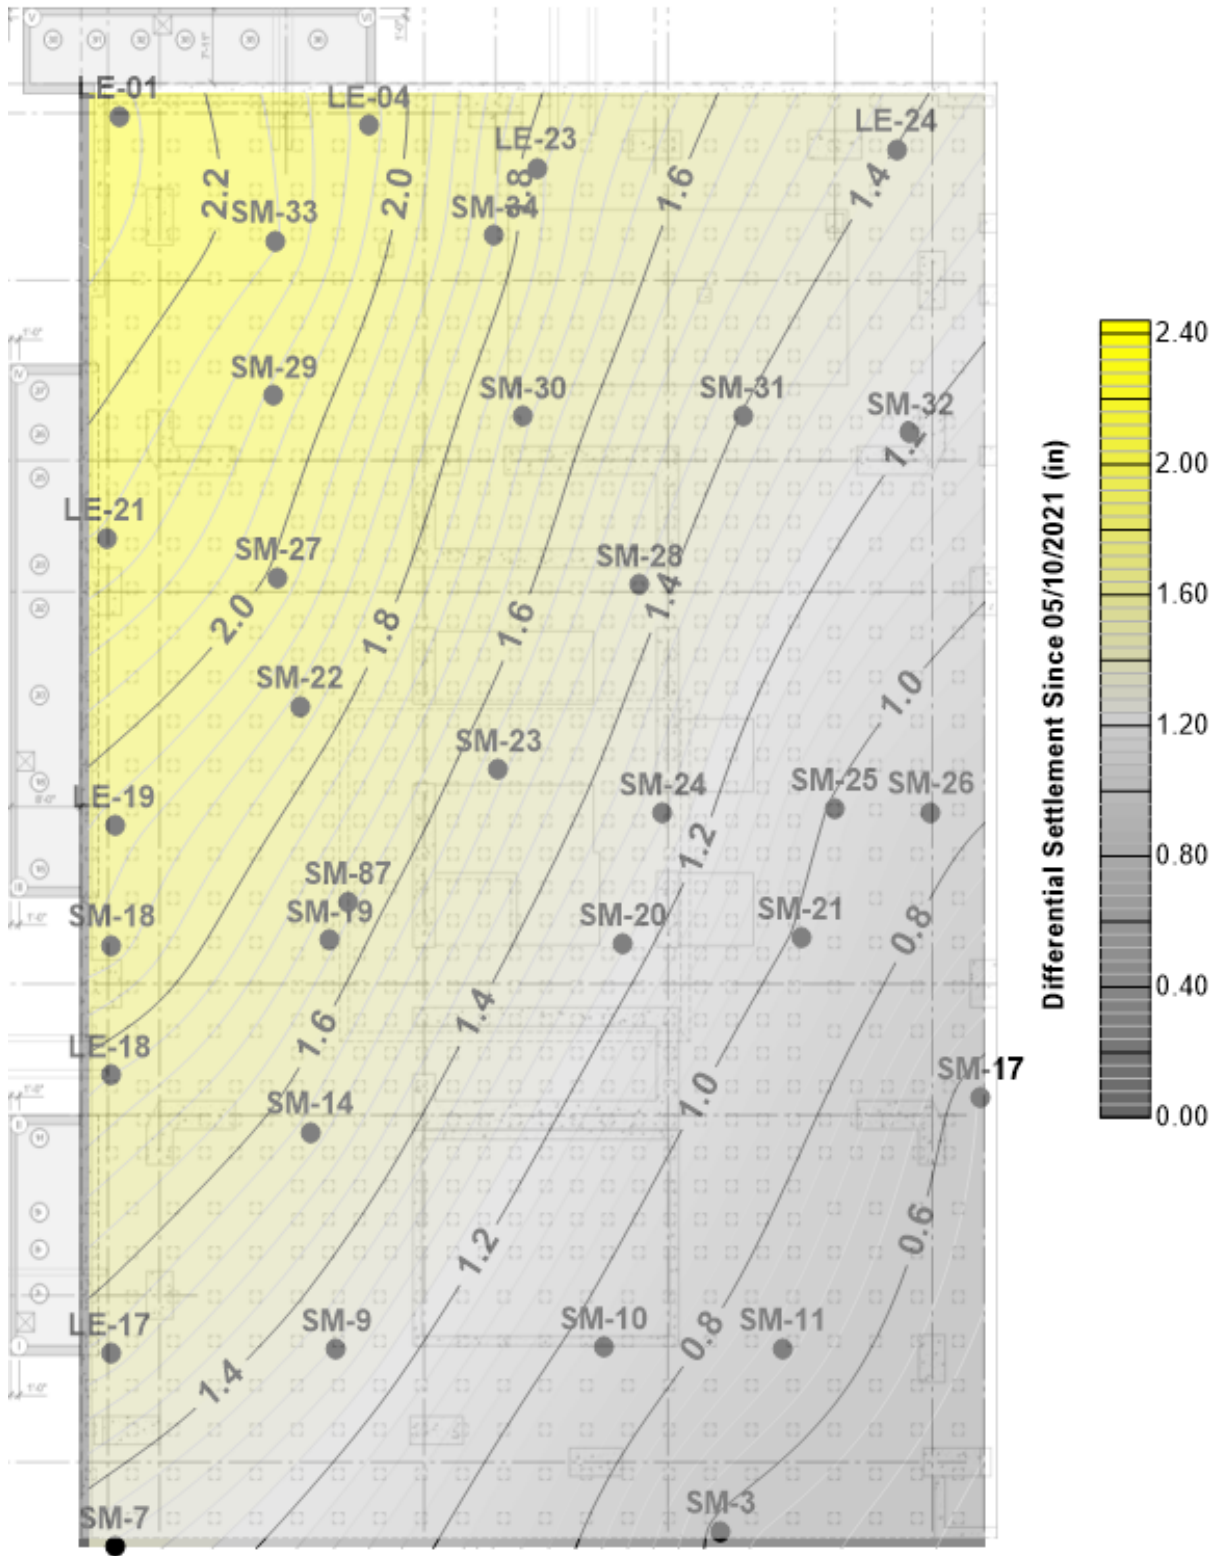
Figure No: **133-04**

SETTLEMENT CONTOURS
SINCE 05/10/2021 THROUGH 04/29/2024

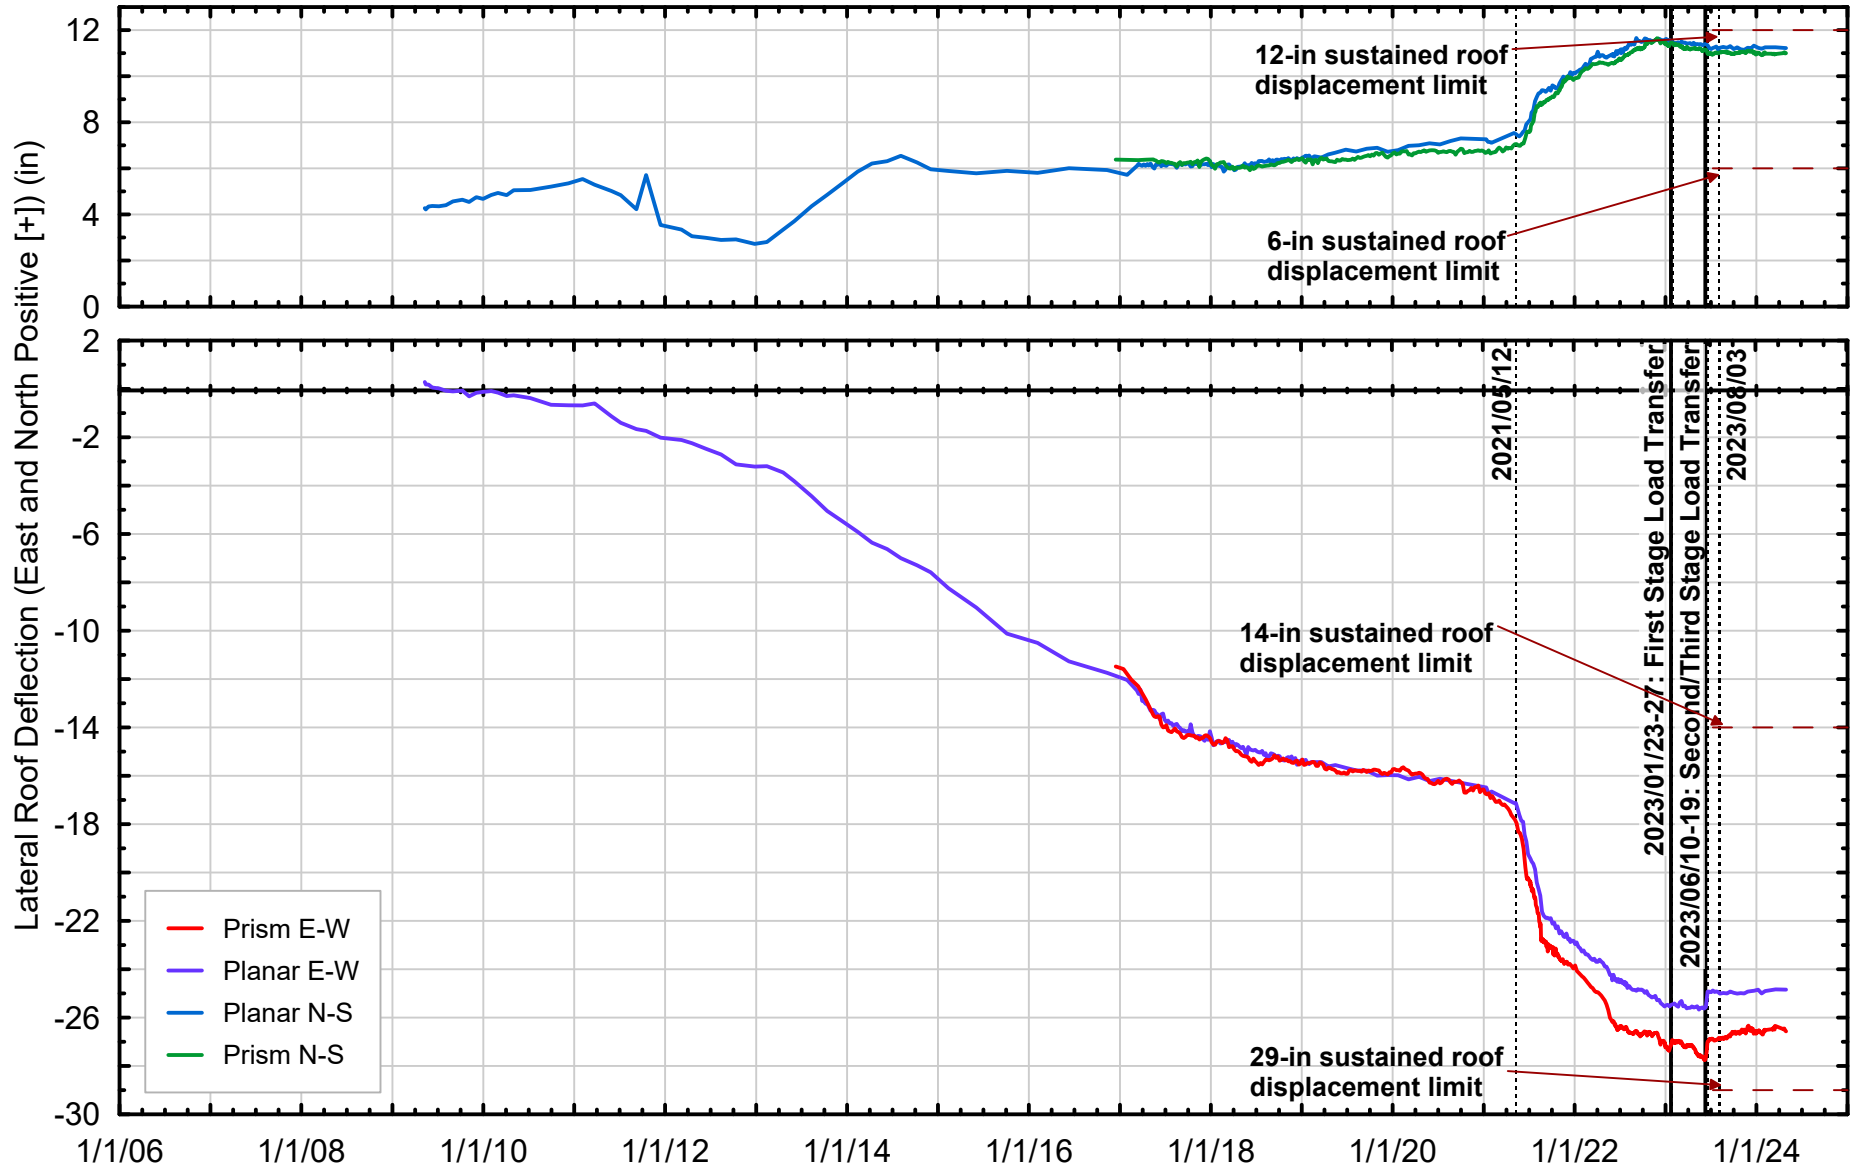
Project No: 23-018-01	Date: 5/3/2024	Created By: TB	Checked By: DGM	Figure No: 133-05
-----------------------	----------------	----------------	-----------------	-------------------

HISTORICAL LATERAL ROOF DEFLECTION DATA

Figure 05 presents historical lateral roof deflections in the project north-south and project east-west directions interpreted from survey prisms mounted on the exterior of the Tower, from InSAR data, and from a planar fit of the settlement marker data. In addition, data from surveys performed during the retrofit are included. Figure 06A presents lateral roof deflection data from a planar fit of the settlement marker data and from survey prisms mounted on the exterior of the Tower since the start of production pile installation (May 12, 2021; baseline readings on May 10 and 13, 2021, respectively) through April 29, 2024.

⁶ As plotted on Figure 05, relative to a plumb condition.

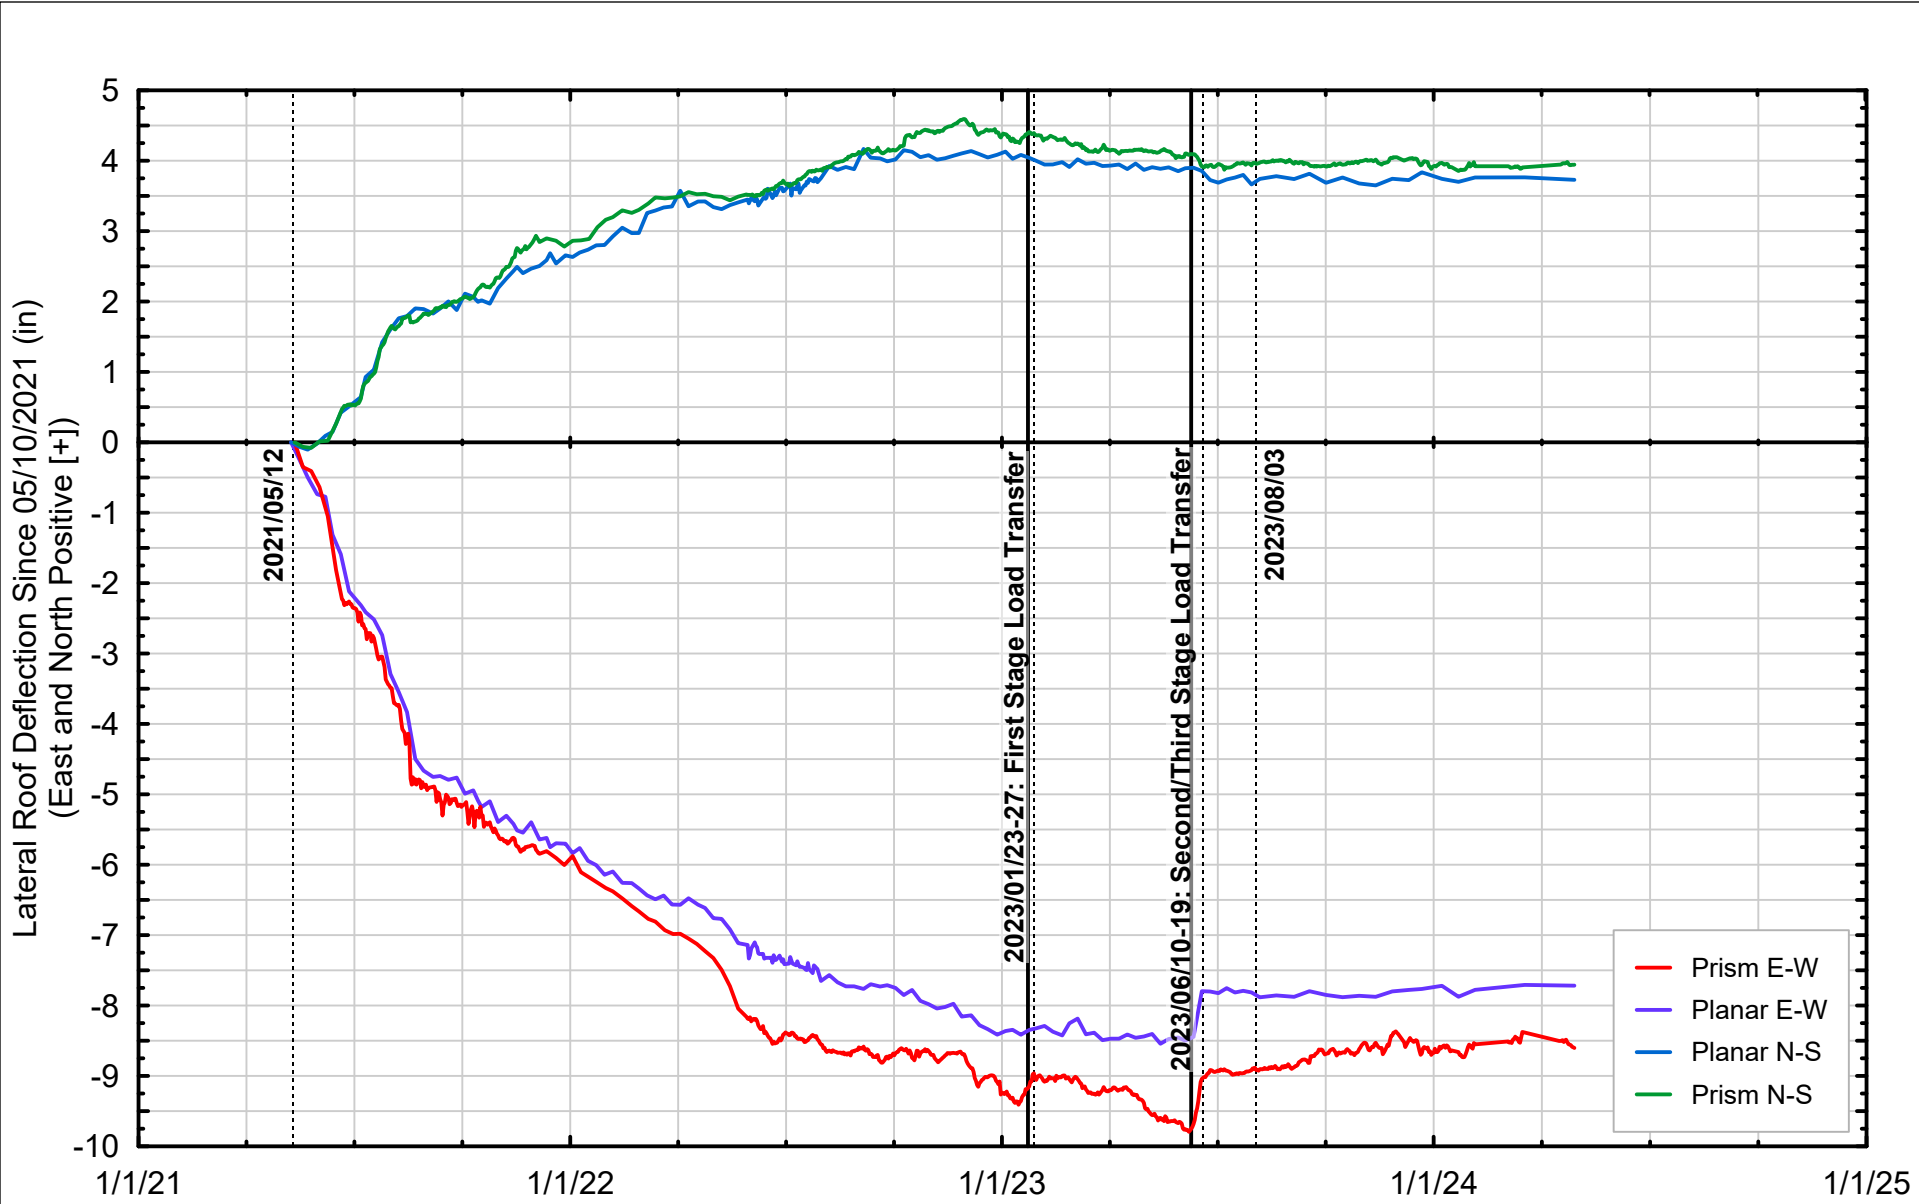
Project No: 23-018-01	Date: 5/3/2024	Created By: TB	Checked By: DGM	Figure No: 133-06
-----------------------	----------------	----------------	-----------------	--------------------------

LATERAL ROOF DEFLECTION DATA
SINCE 05/10/2021 THROUGH 04/29/2024

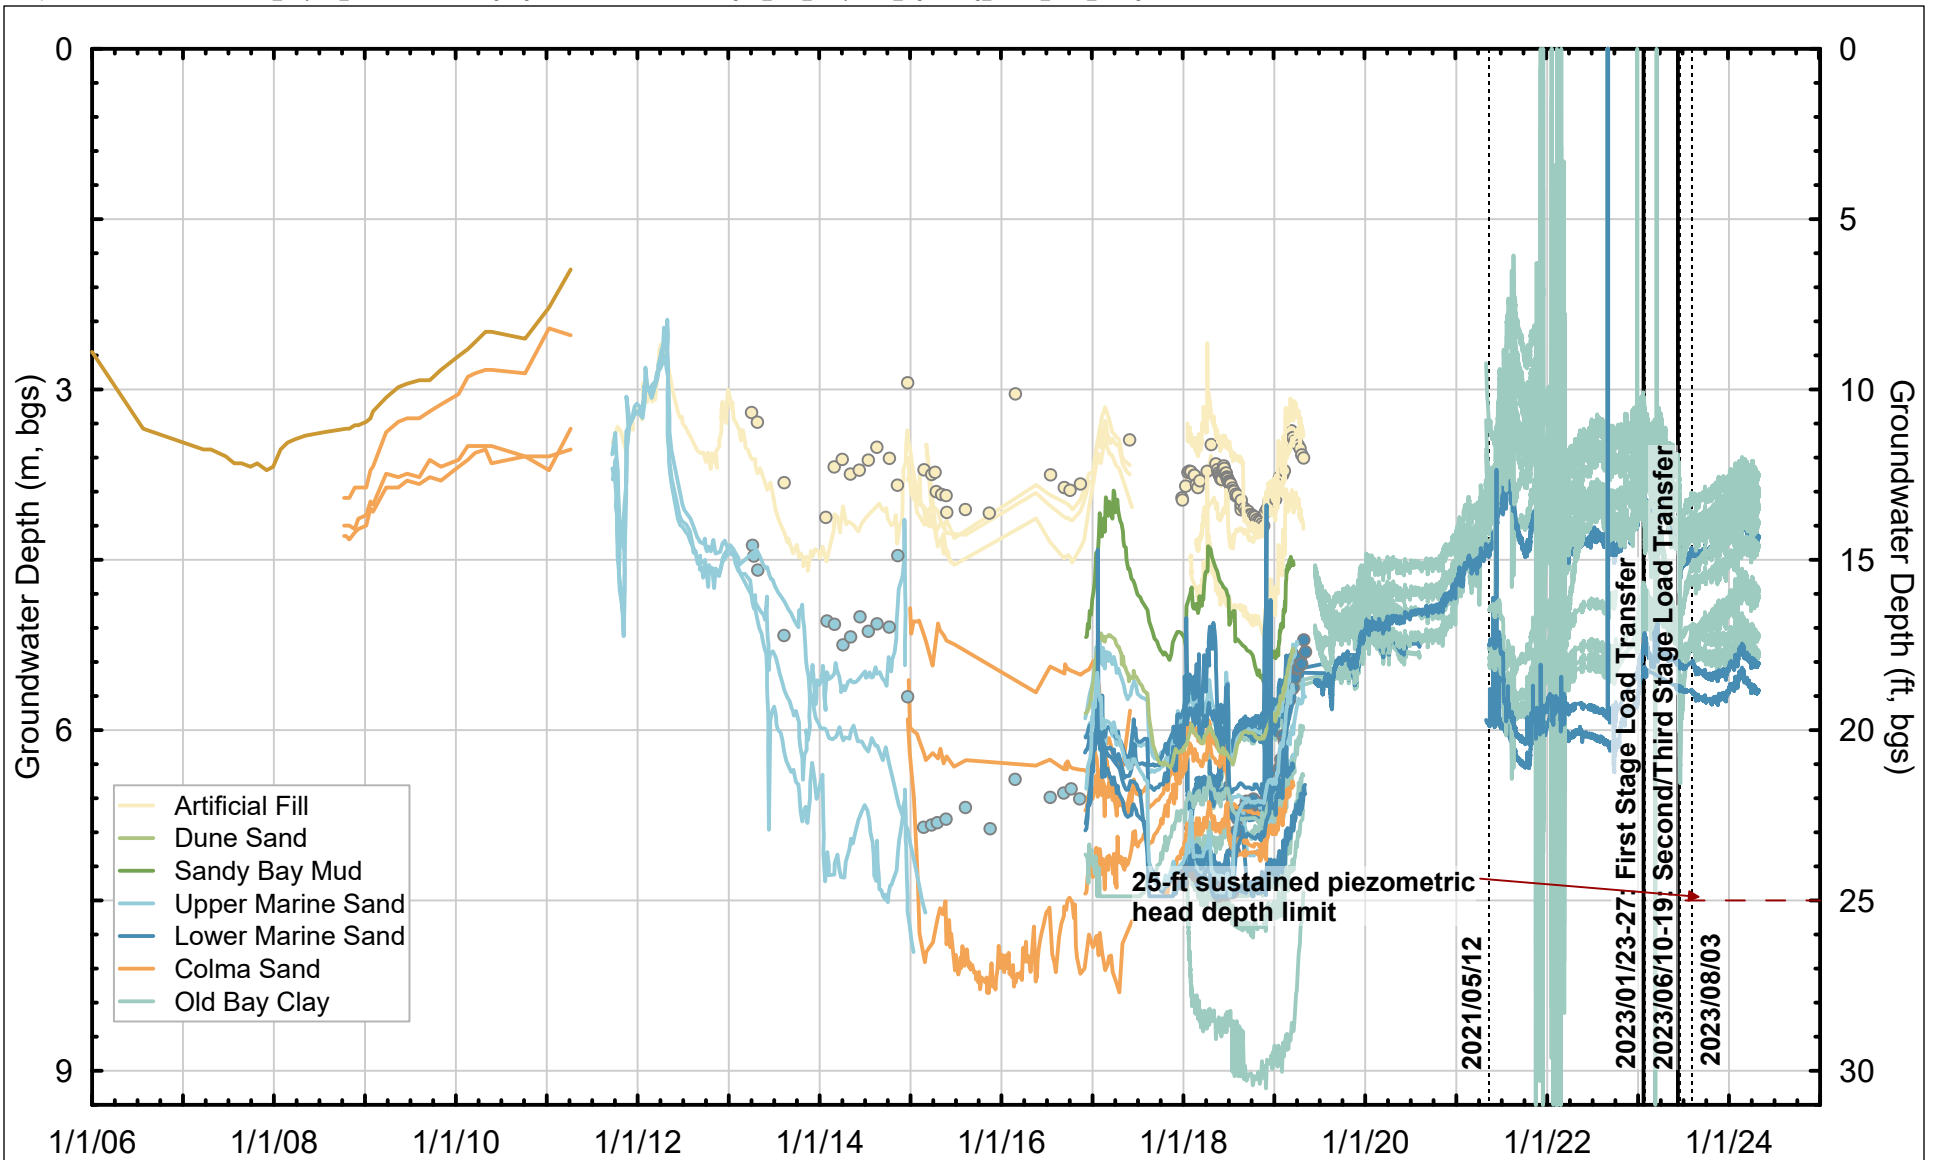
Project No: 23-018-01	Date: 5/3/2024	Created By: TB	Checked By: DGM	Figure No: 133-07
-----------------------	----------------	----------------	-----------------	-------------------

HISTORICAL GROUNDWATER ELEVATION MEASUREMENTS
AT LOCATIONS NEAR 301 MISSION

Figure 07 presents the historical groundwater elevation interpreted from piezometer readings at locations near 301 Mission. In addition, data from piezometers installed to monitor groundwater elevation during the retrofit are included. Figures 08 and 09 present groundwater elevation interpreted from piezometer readings

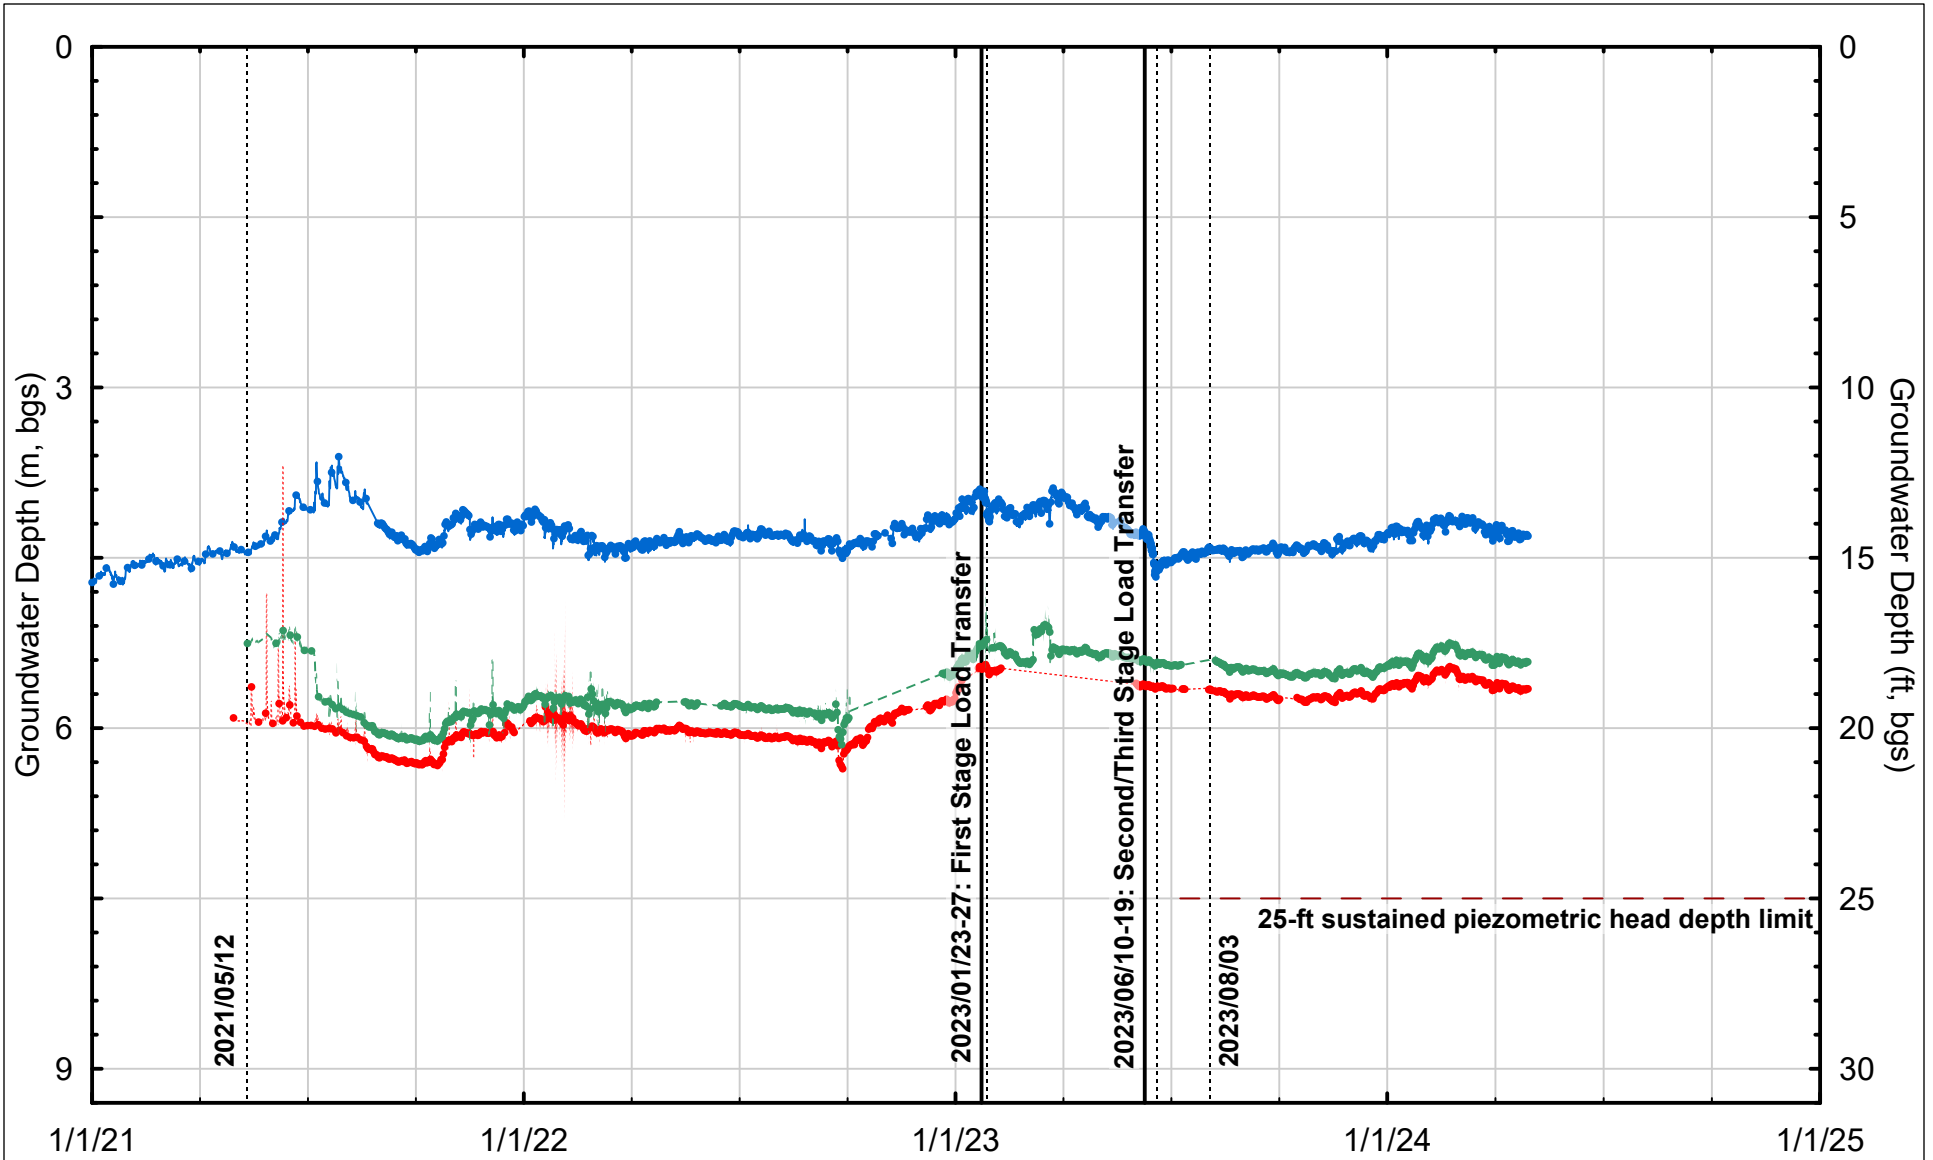
Project No: 23-018-01	Date: 5/3/2024	Created By: TB	Checked By: DGM	Figure No: 133-08

- SB-1 @ 85'
- PB-1 @ 85'
- PB-2 @ 85'

GROUNDWATER ELEVATION MEASUREMENTS IN MARINE AND COLMA SAND SINCE 01/01/2021 THROUGH 04/29/2024		
		Millennium Tower Perimeter Pile Upgrade: Instrumentation Monitoring Data City and County of San Francisco, California

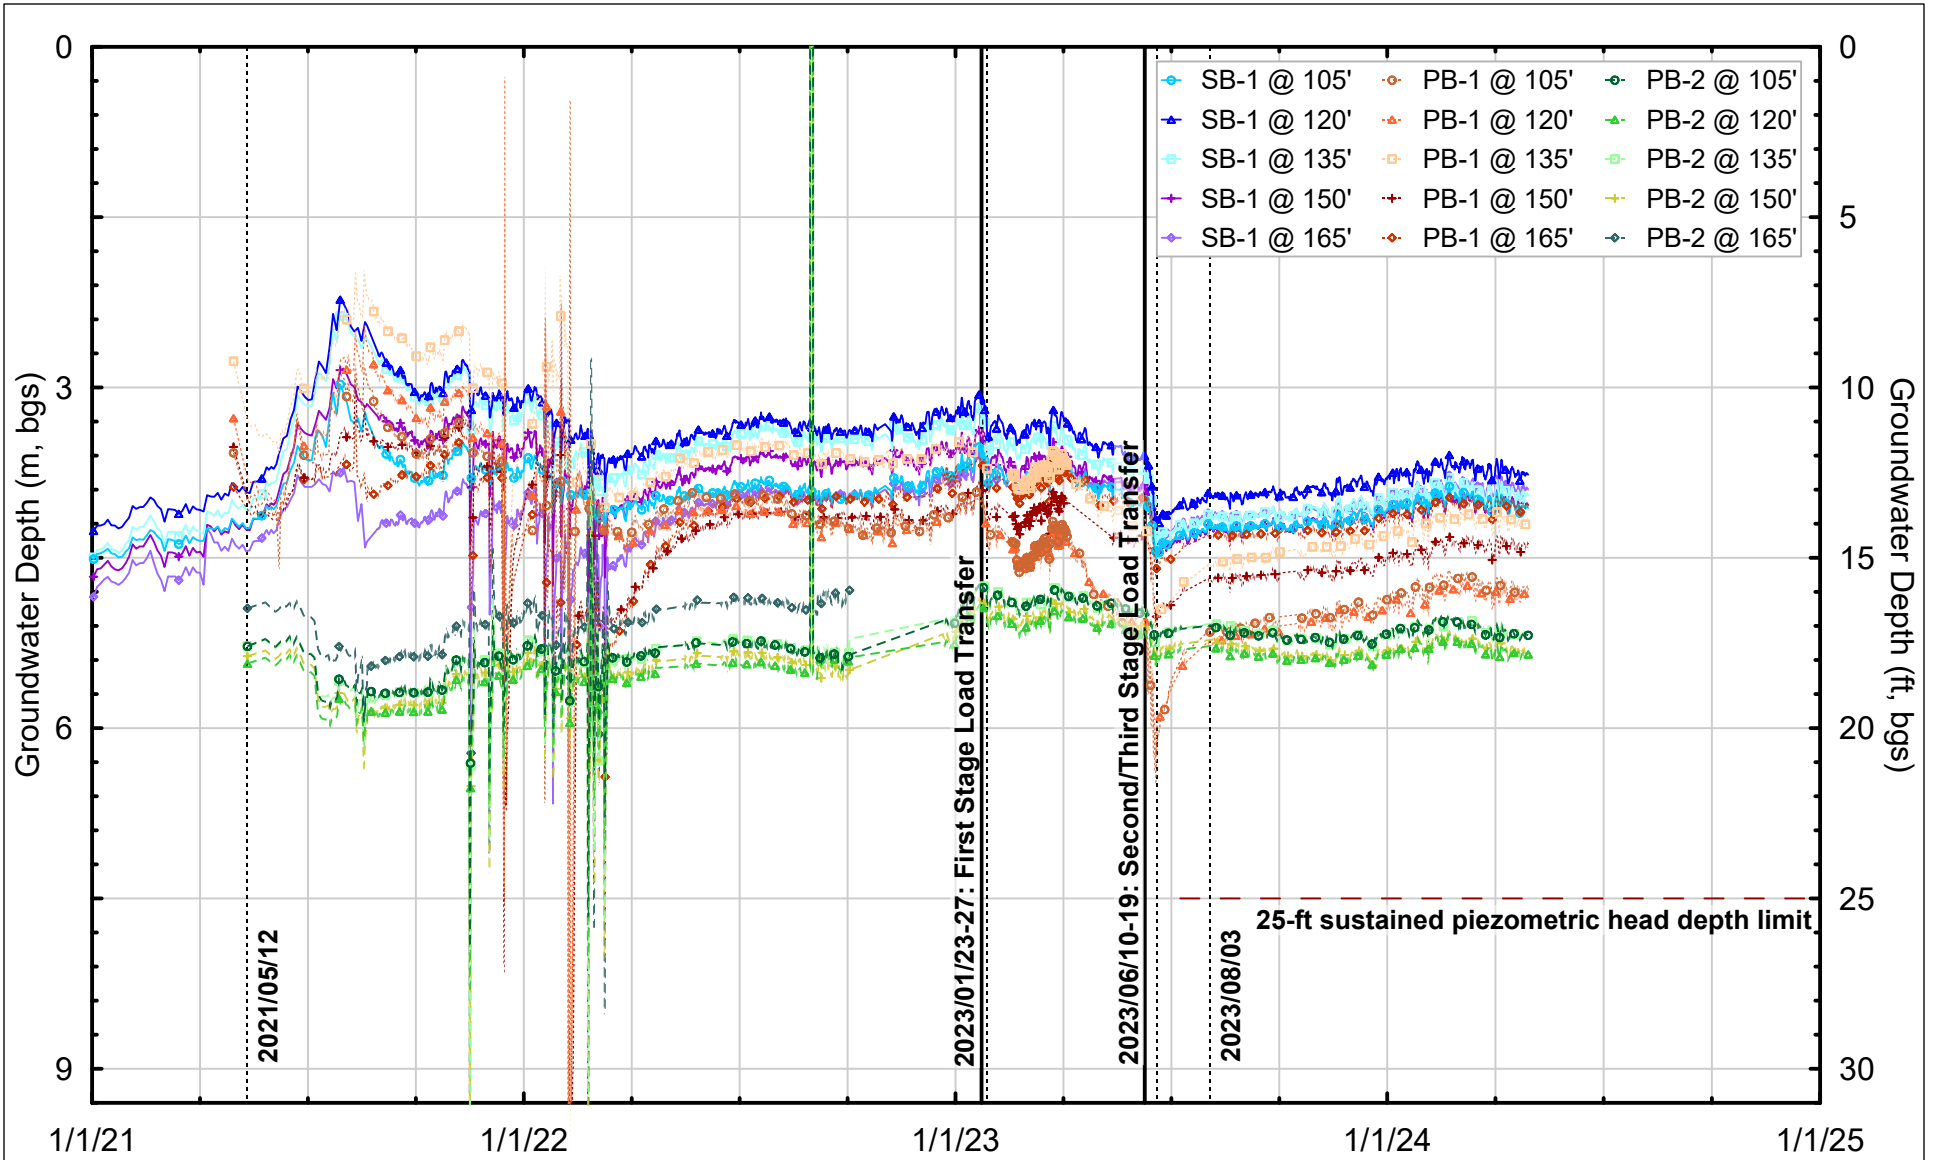
Project No: 23-018-01	Date: 5/3/2024	Created By: TB	Checked By: DGM	Figure No: 133-09
-----------------------	----------------	----------------	-----------------	-------------------

GROUNDWATER ELEVATION MEASUREMENTS IN OLD BAY CLAY
SINCE 01/01/2021 THROUGH 04/29/2024

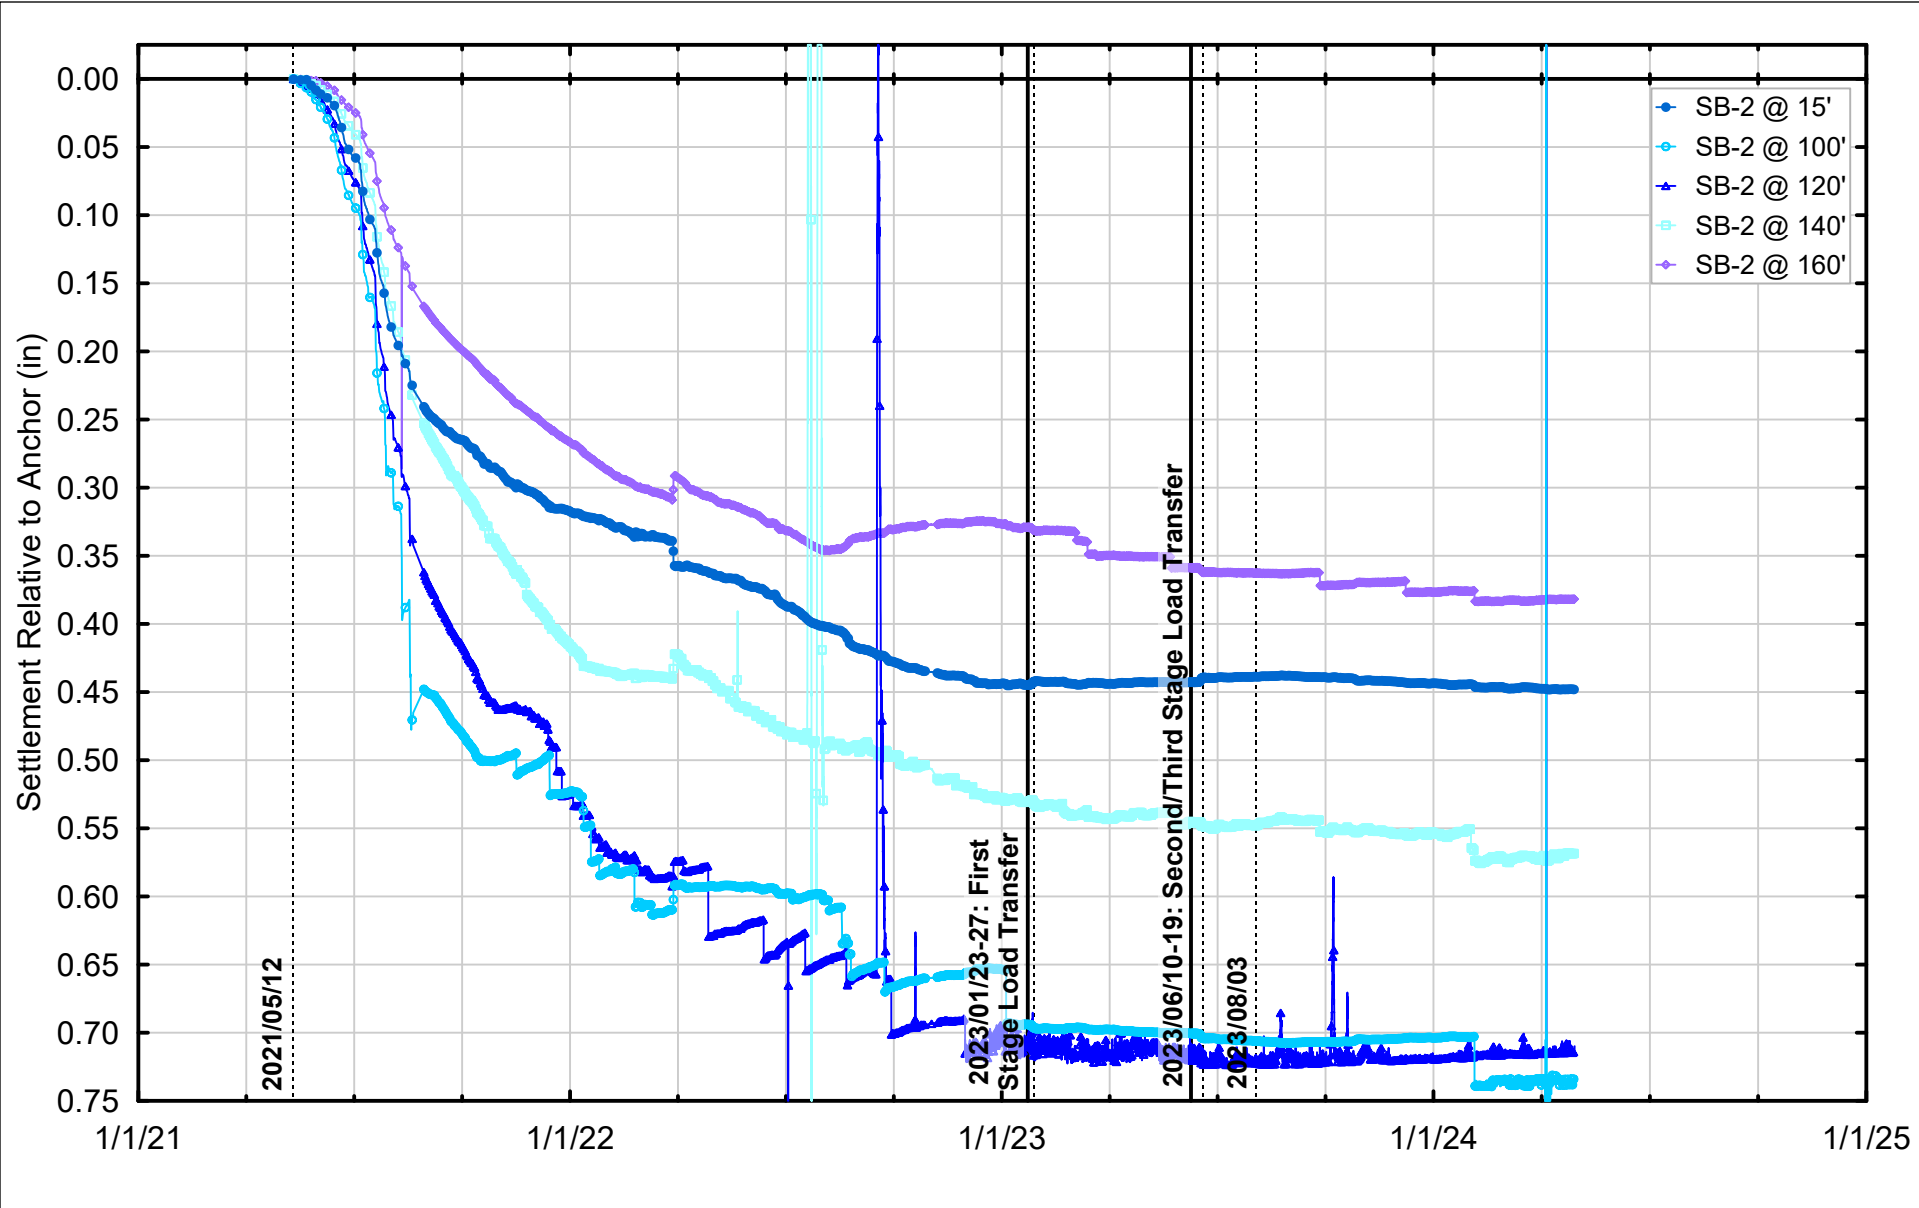
Project No: 23-018-01	Date: 5/3/2024	Created By: TB	Checked By: DGM	Figure No: 133-10

EXTENSOMETER DATA FROM WITHIN TOWER BASEMENT SINCE 01/01/2021 THROUGH 04/29/2024 Millennium Tower Perimeter Pile Upgrade: Instrumentation Monitoring Data City and County of San Francisco, California

Figure 10 presents extensometer data from within the Tower basement since the start of production pile installation (May 12, 2021) through April 29, 2024. Figure 11 presents extensometer data from Fremont Street since the start of production pile installation (May 12, 2021) through May 16, 2023, and from the restart after fixing the extensometer (May 30, 2023) through April 29, 2024. Figure 12 presents extensometer data from Mission Street since the start of production pile installation (May 12, 2021) through April 29, 2024.
