Project Number: 23-018-01

Subject: 301 Mission Retrofit Monitoring Report 133: Results as of April 29, 2024

Millennium Tower Perimeter Pile Upgrade: Instrumentation Monitoring Data
 City and County of San Francisco, California

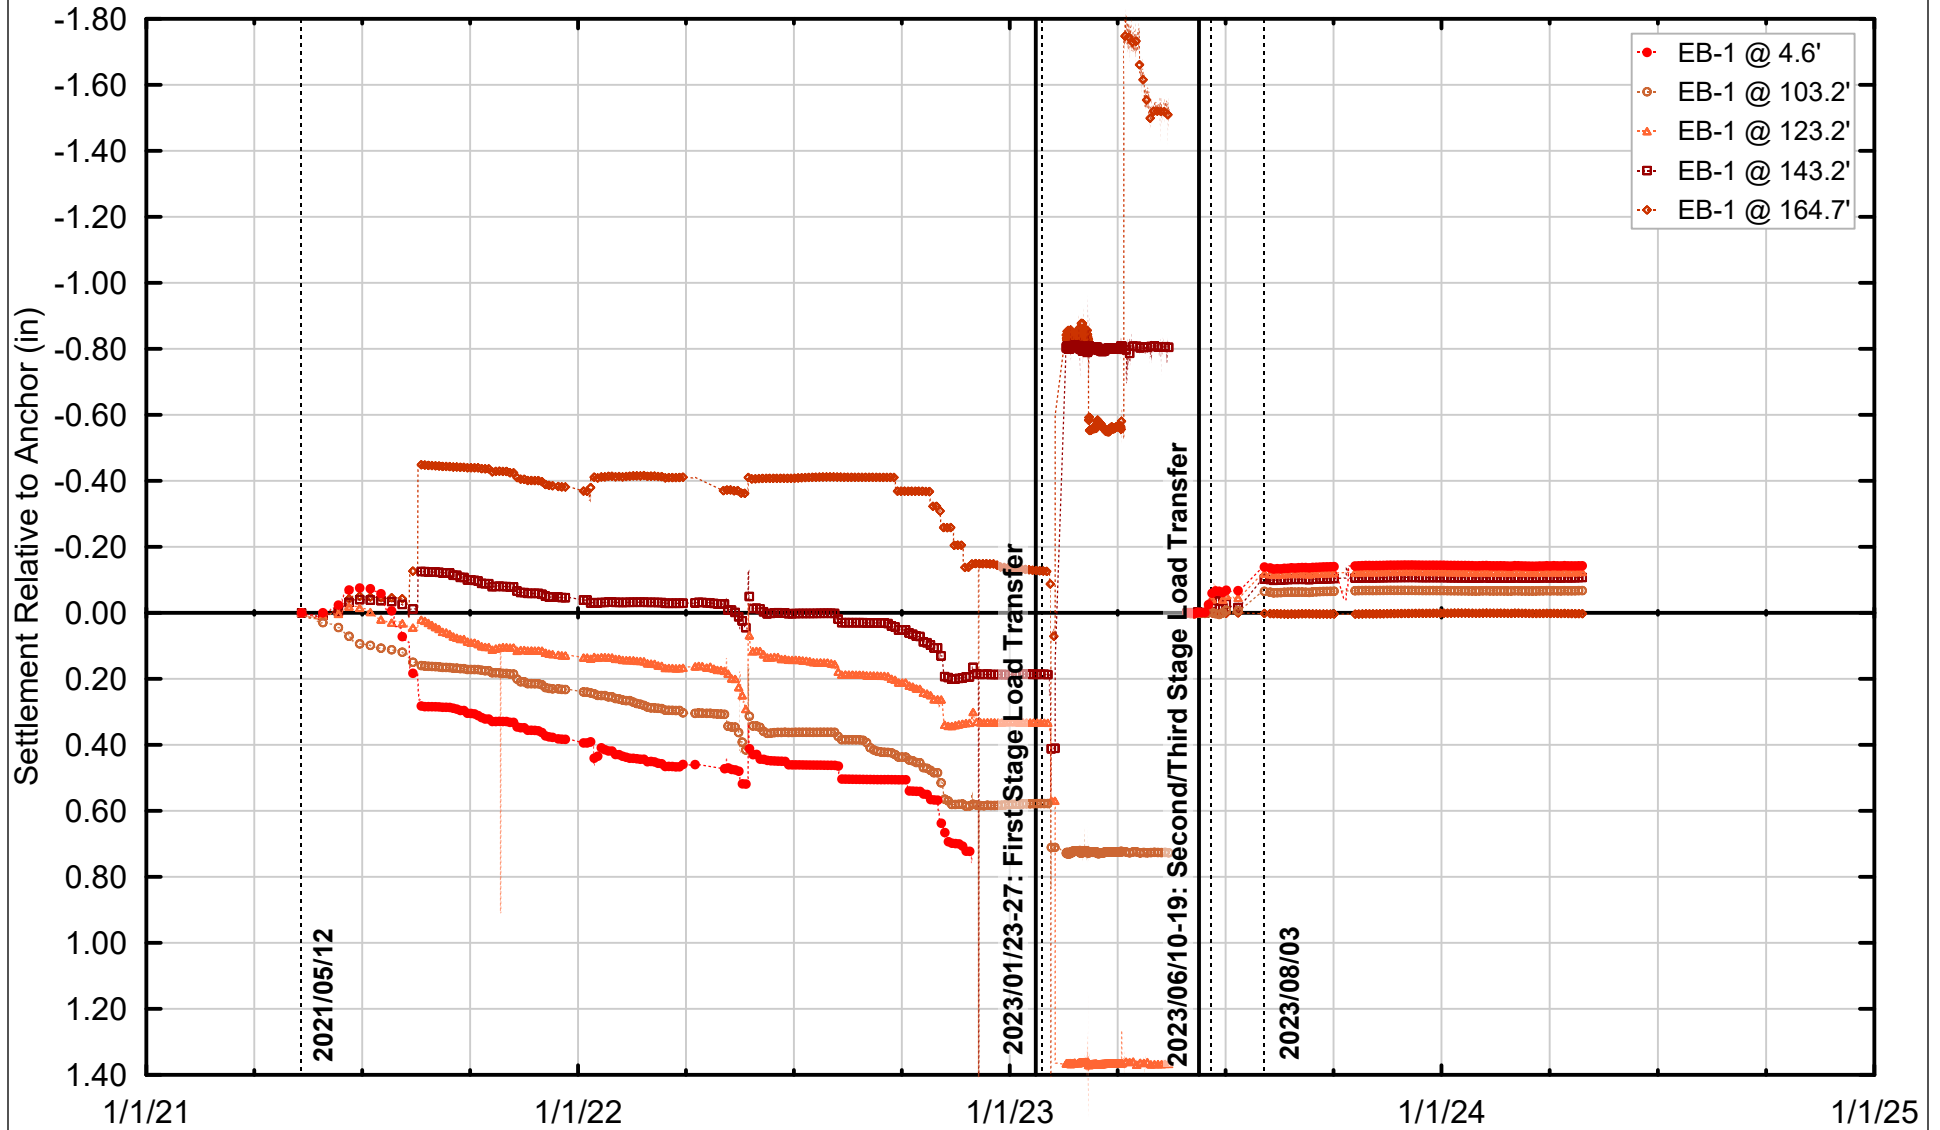
Figure No: 133-11

Note: EB-1 was repaired and reset on 2023/05/30

EXTENSOMETER DATA FROM FREMONT STREET
 SINCE 05/10/2021 THROUGH 05/16/2023
 SINCE 05/30/2023 THROUGH 04/29/2024
 Millennium Tower Perimeter Pile Upgrade: Instrumentation Monitoring Data
 City and County of San Francisco, California

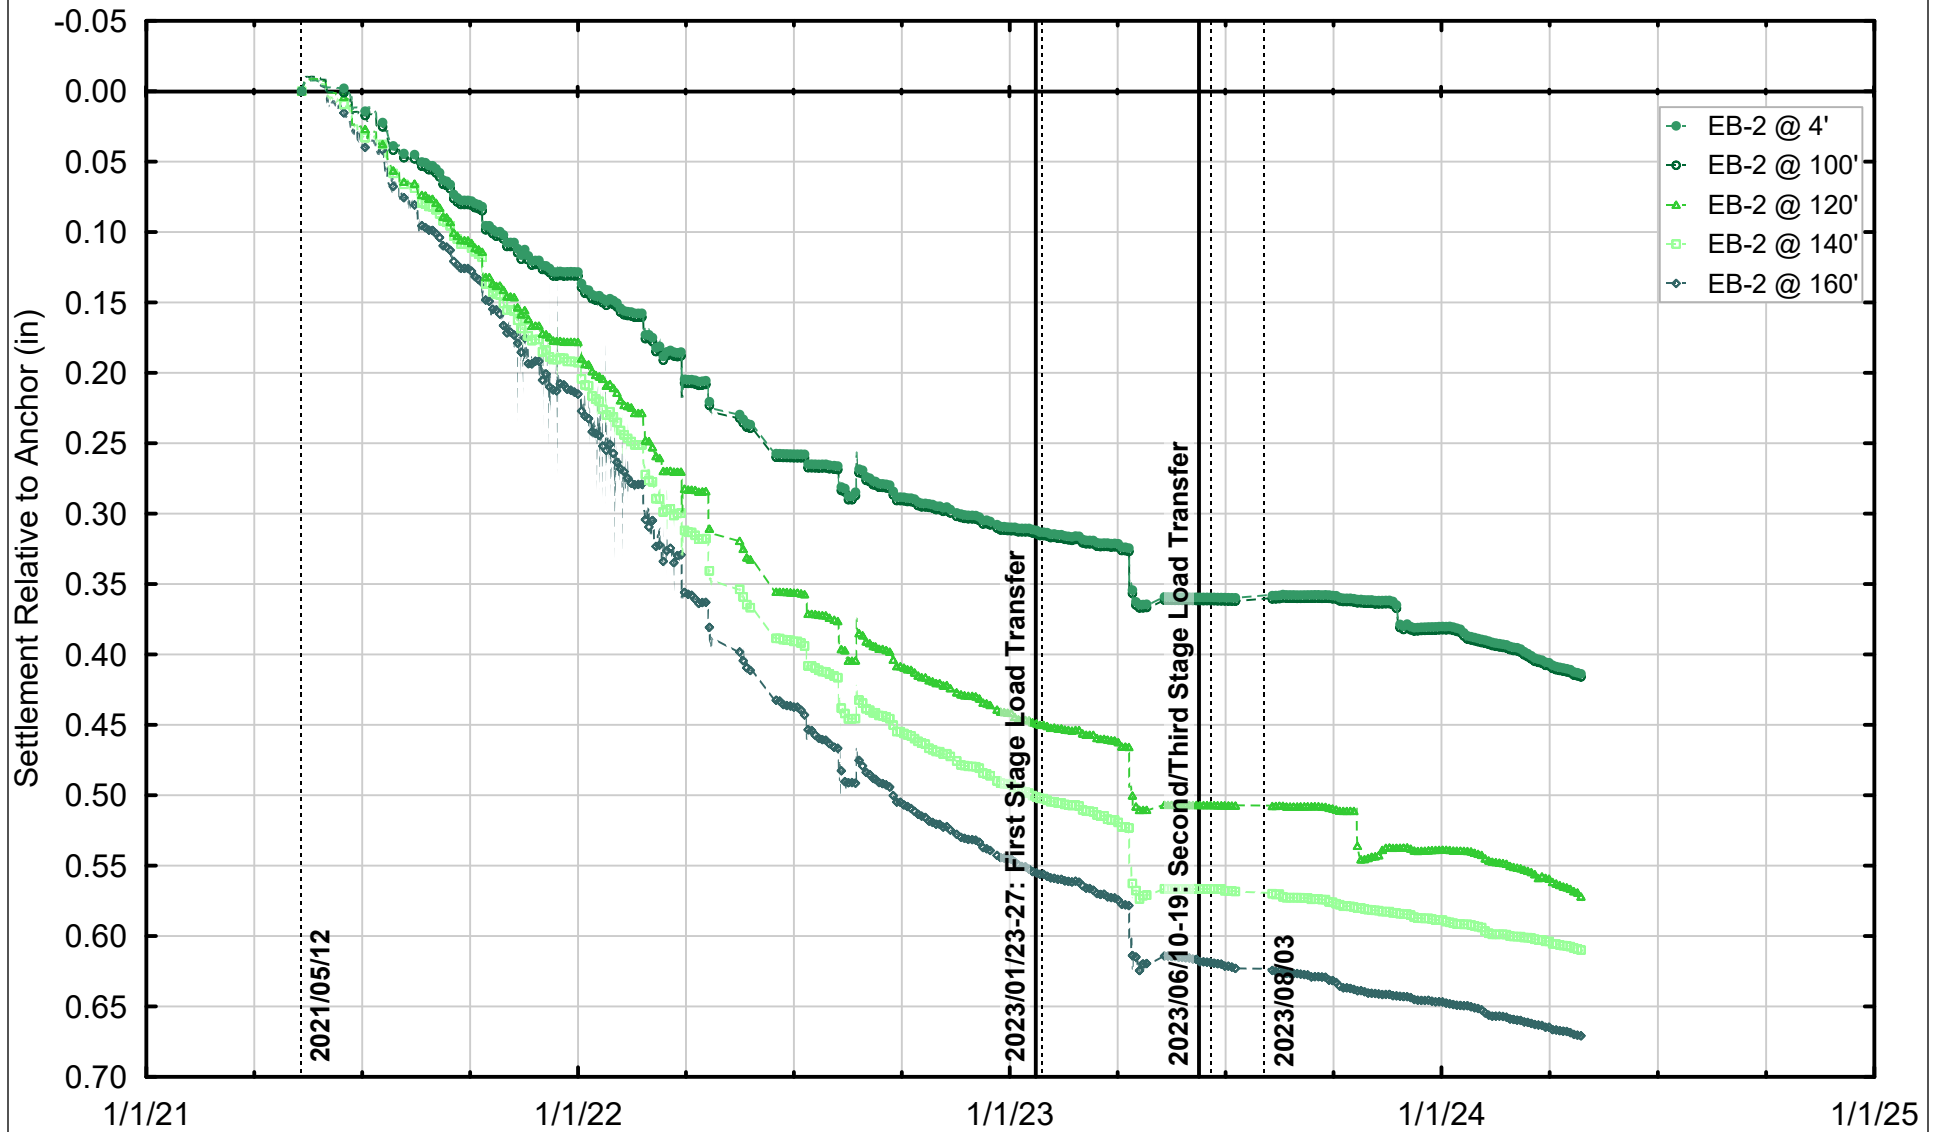
Project No: 23-018-01	Date: 5/3/2024	Created By: TB	Checked By: DGM	Figure No: 133-12
-----------------------	----------------	----------------	-----------------	-------------------

EXTENSOMETER DATA FROM MISSION STREET
SINCE 01/01/2021 THROUGH 04/29/2024

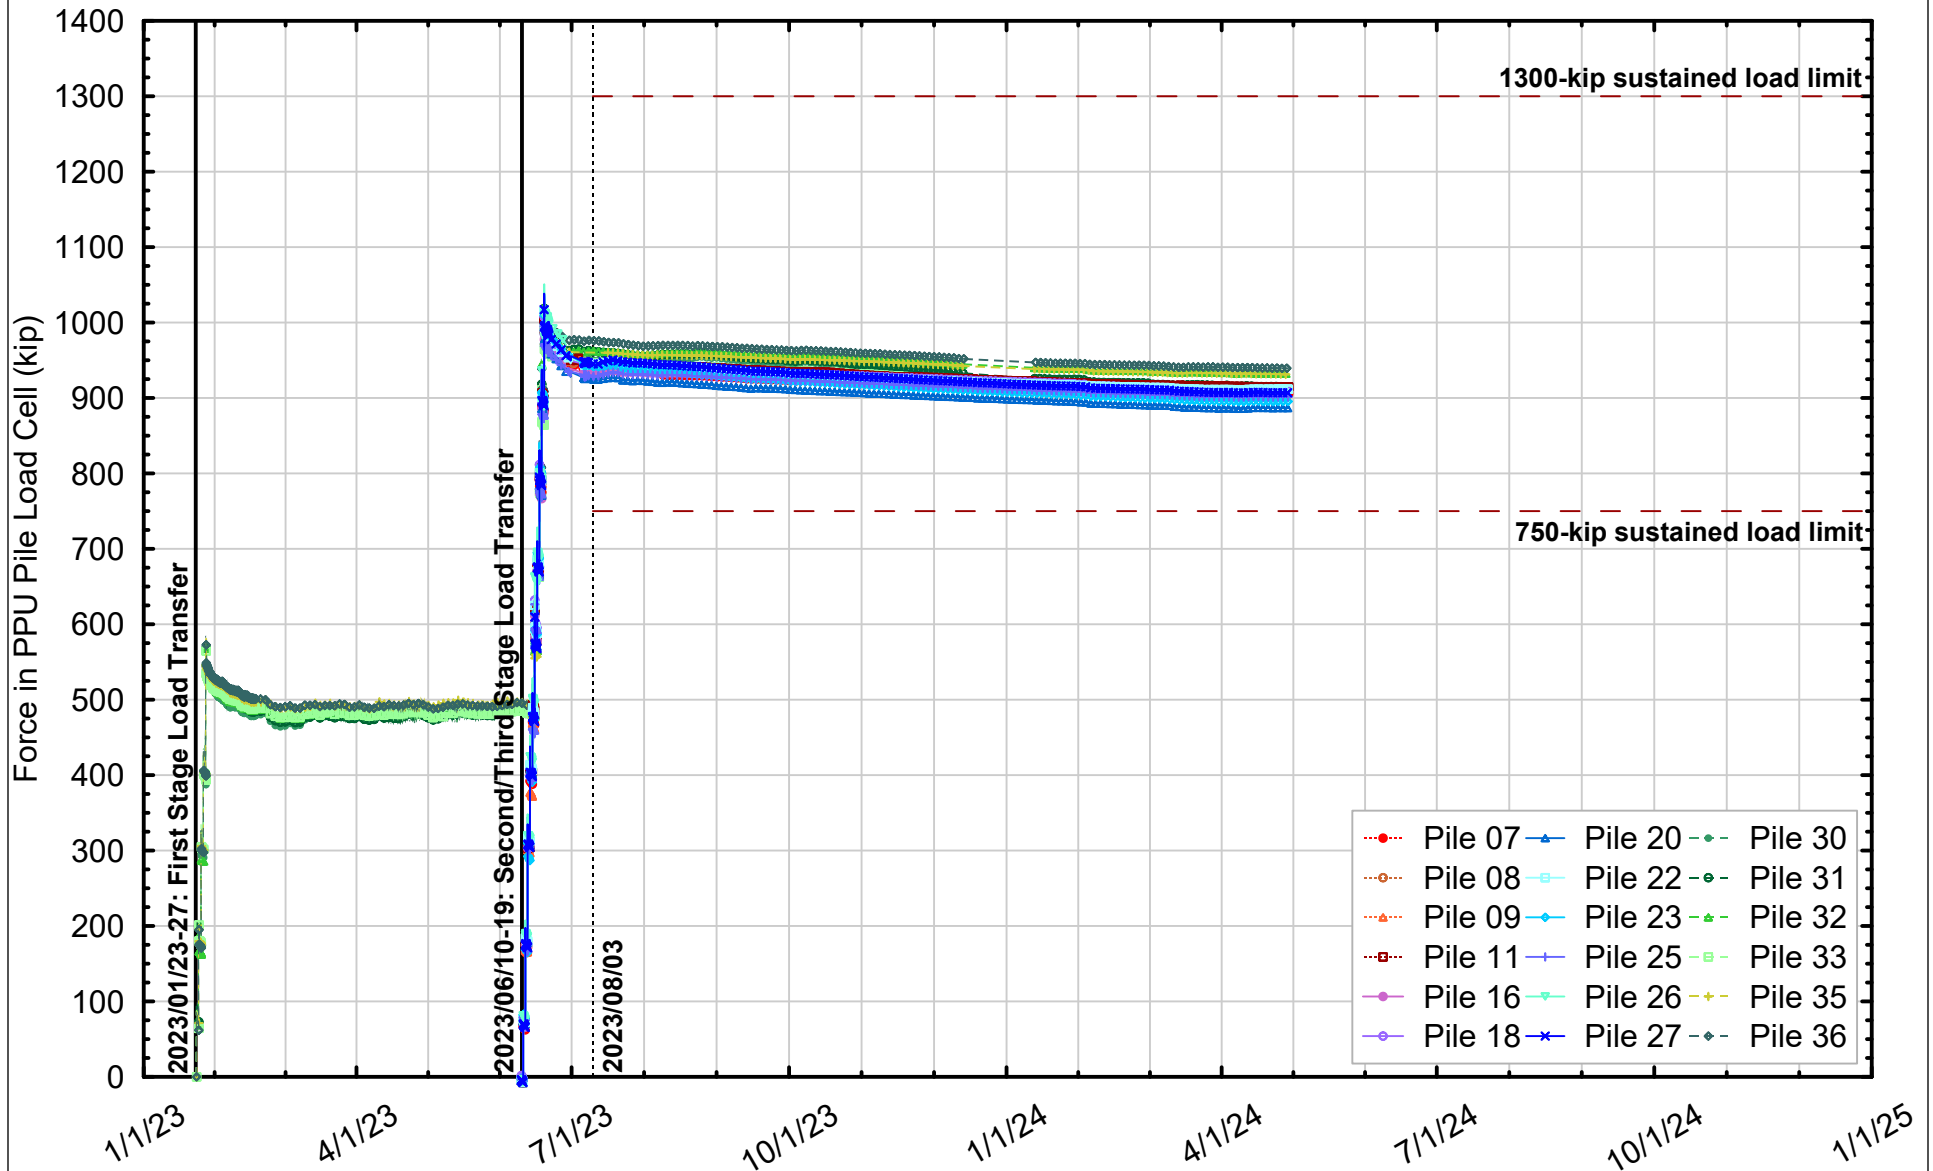
Project No: 23-018-01	Date: 5/3/2024	Created By: TB	Checked By: DGM	Figure No: 133-13A
-----------------------	----------------	----------------	-----------------	--------------------

PILE LOAD CELL DATA
SINCE 01/23/2023 THROUGH 04/29/2024

Figure 13A presents pile load cell data since the start of the First Stage Load Transfer (January 23, 2023) through April 29, 2024. Figure 13B presents the total pile load cell data since July 15, 2023, through April 29, 2024.

⁴ The load transfer rods have a maximum safe loading of 375 kips per rod, or 1,500 kips per pile. The 1,300-kip threshold is set to allow sufficient time to evaluate building behavior, should excessive load develop in one or more piles.

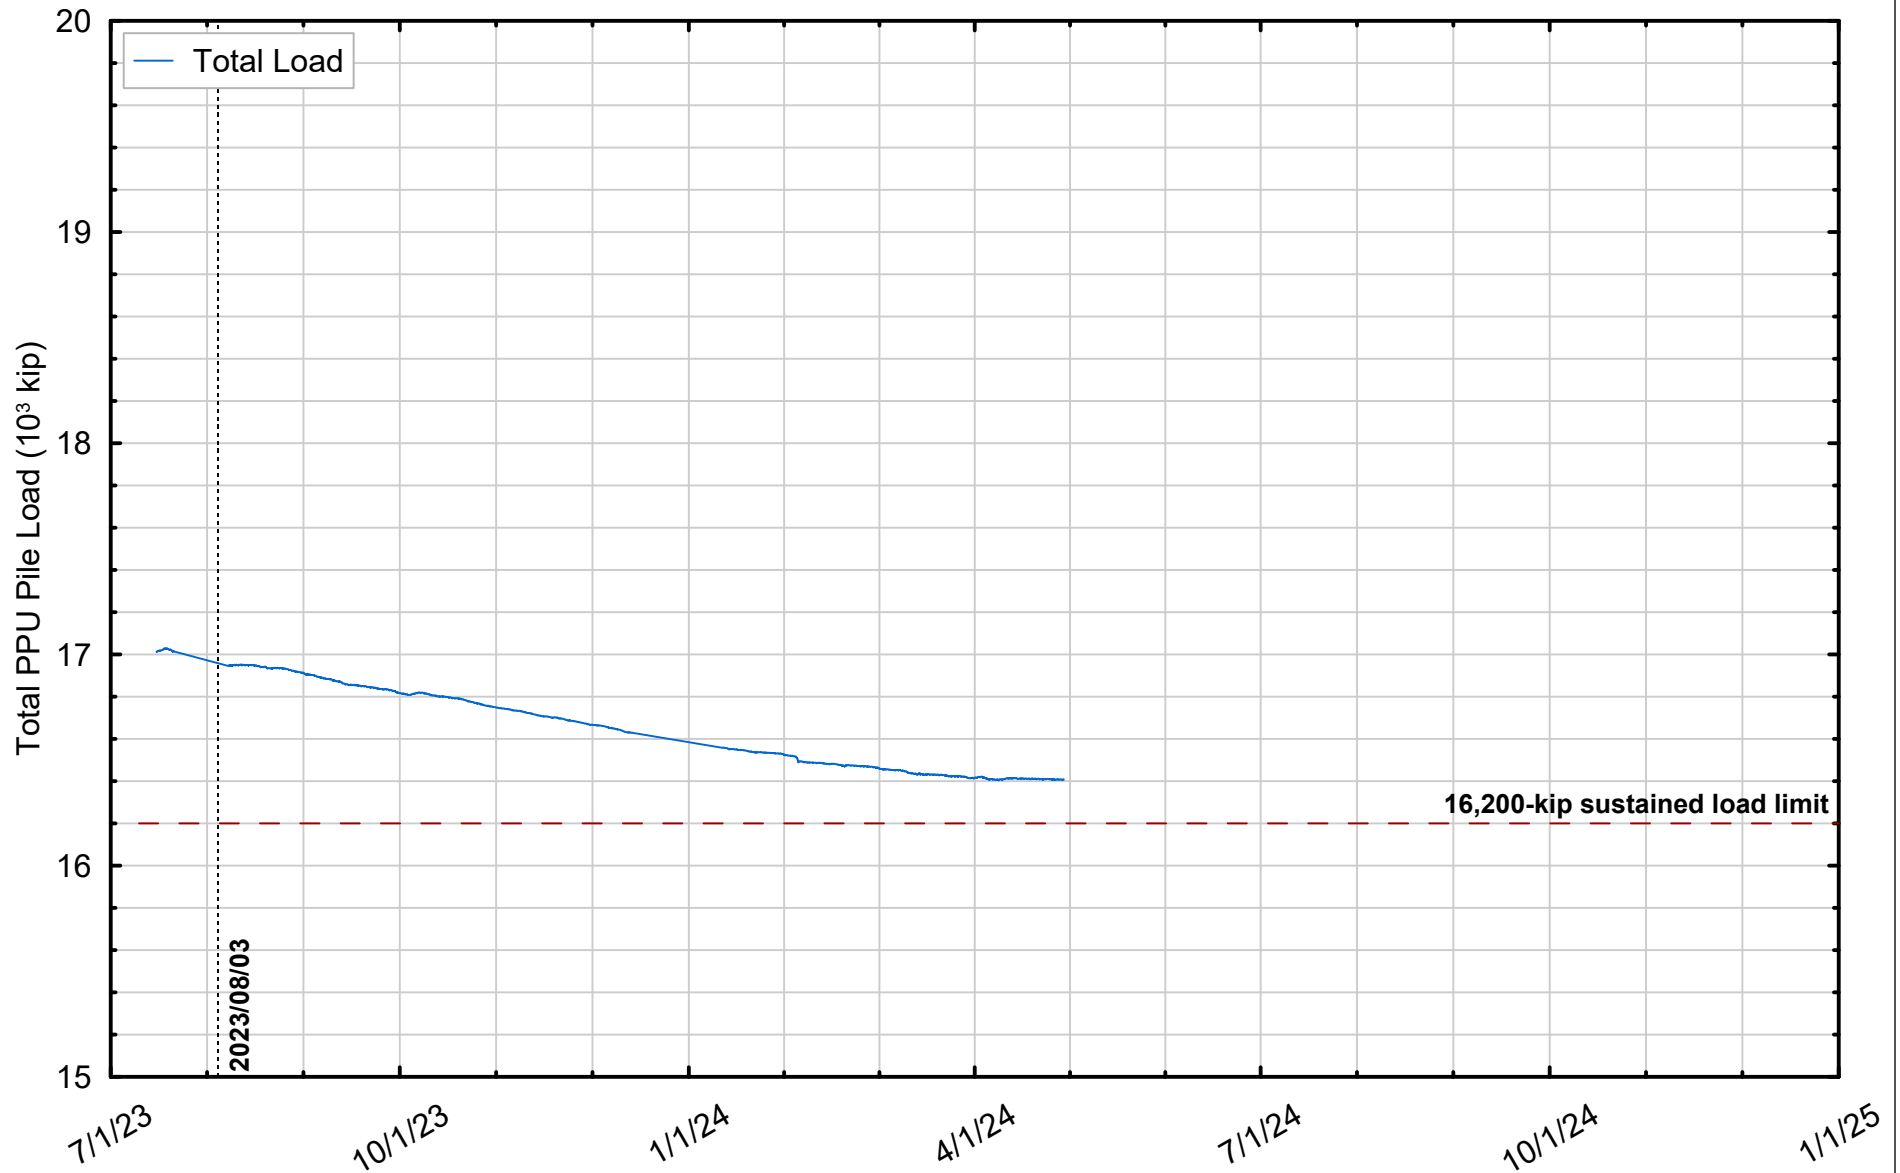
Project No: 23-018-01	Date: 5/3/2024	Created By: TB	Checked By: DGM	Figure No: 133-13B
-----------------------	----------------	----------------	-----------------	--------------------

TOTAL PILE LOAD CELL DATA
SINCE 07/15/2023 THROUGH 04/29/2024

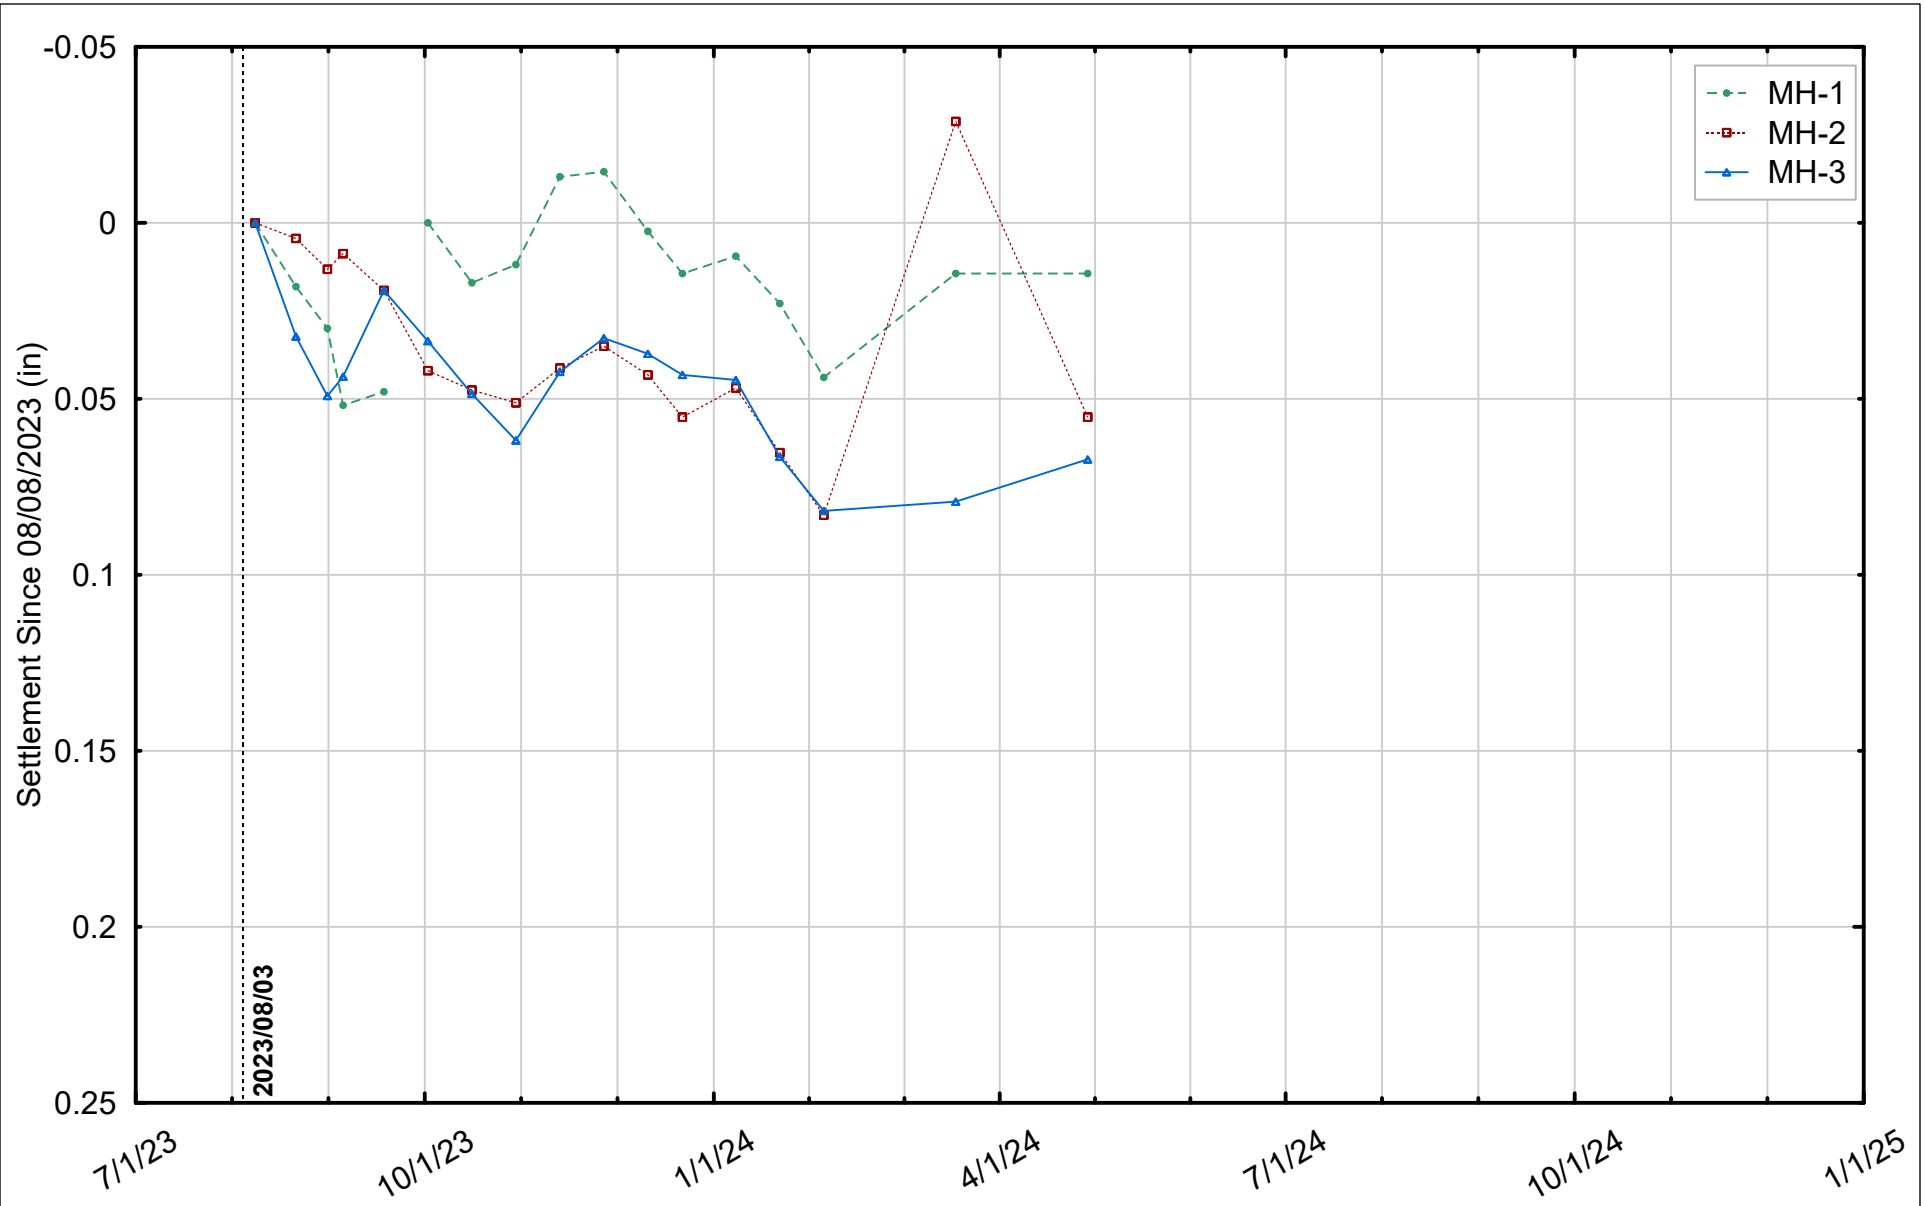
Project No: 23-018-01	Date: 5/3/2024	Created By: TB	Checked By: DGM	Figure No: 133-14
-----------------------	----------------	----------------	-----------------	-------------------

Note: MH-1 was reset on 10/02/2023

MANHOLE SETTLEMENT DATA
SINCE 08/08/2023 THROUGH 04/29/2024

Figure 14 presents settlement data interpreted from survey points located on manholes around the Tower since August 8, 2023, through April 29, 2024.
