BOARD OF APPEALS, CITY & COUNTY OF SAN FRANCISCO

Appeal No. **23-046**

NOTICE OF APPEAL

PRELIMINARY STATEMENT FOR APPEAL NO. 23-046

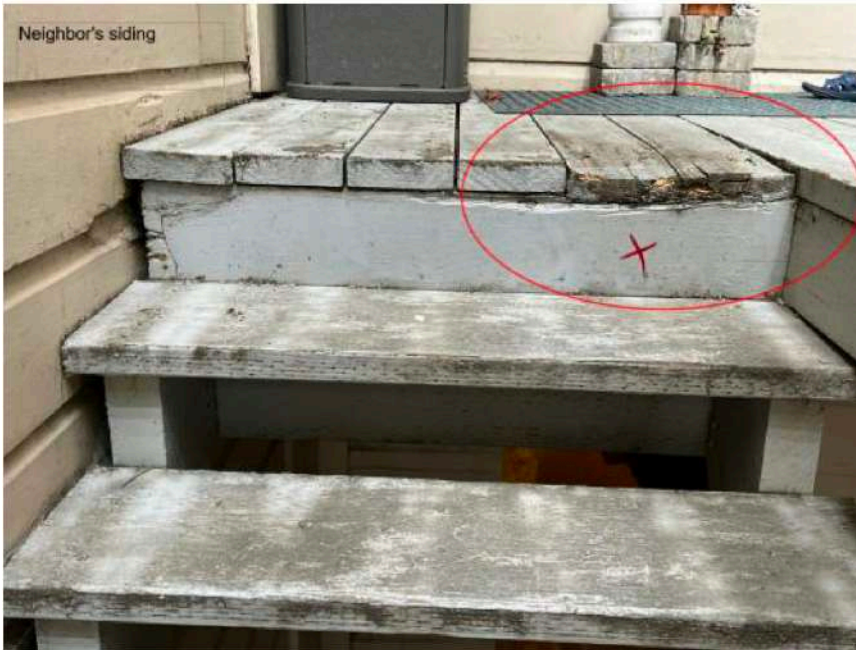
**Dwelling/Exterior/Stairwell - 11-
Overview**

Dry rot on Insured's 1st landing.

No dry rot on neighbor's siding.

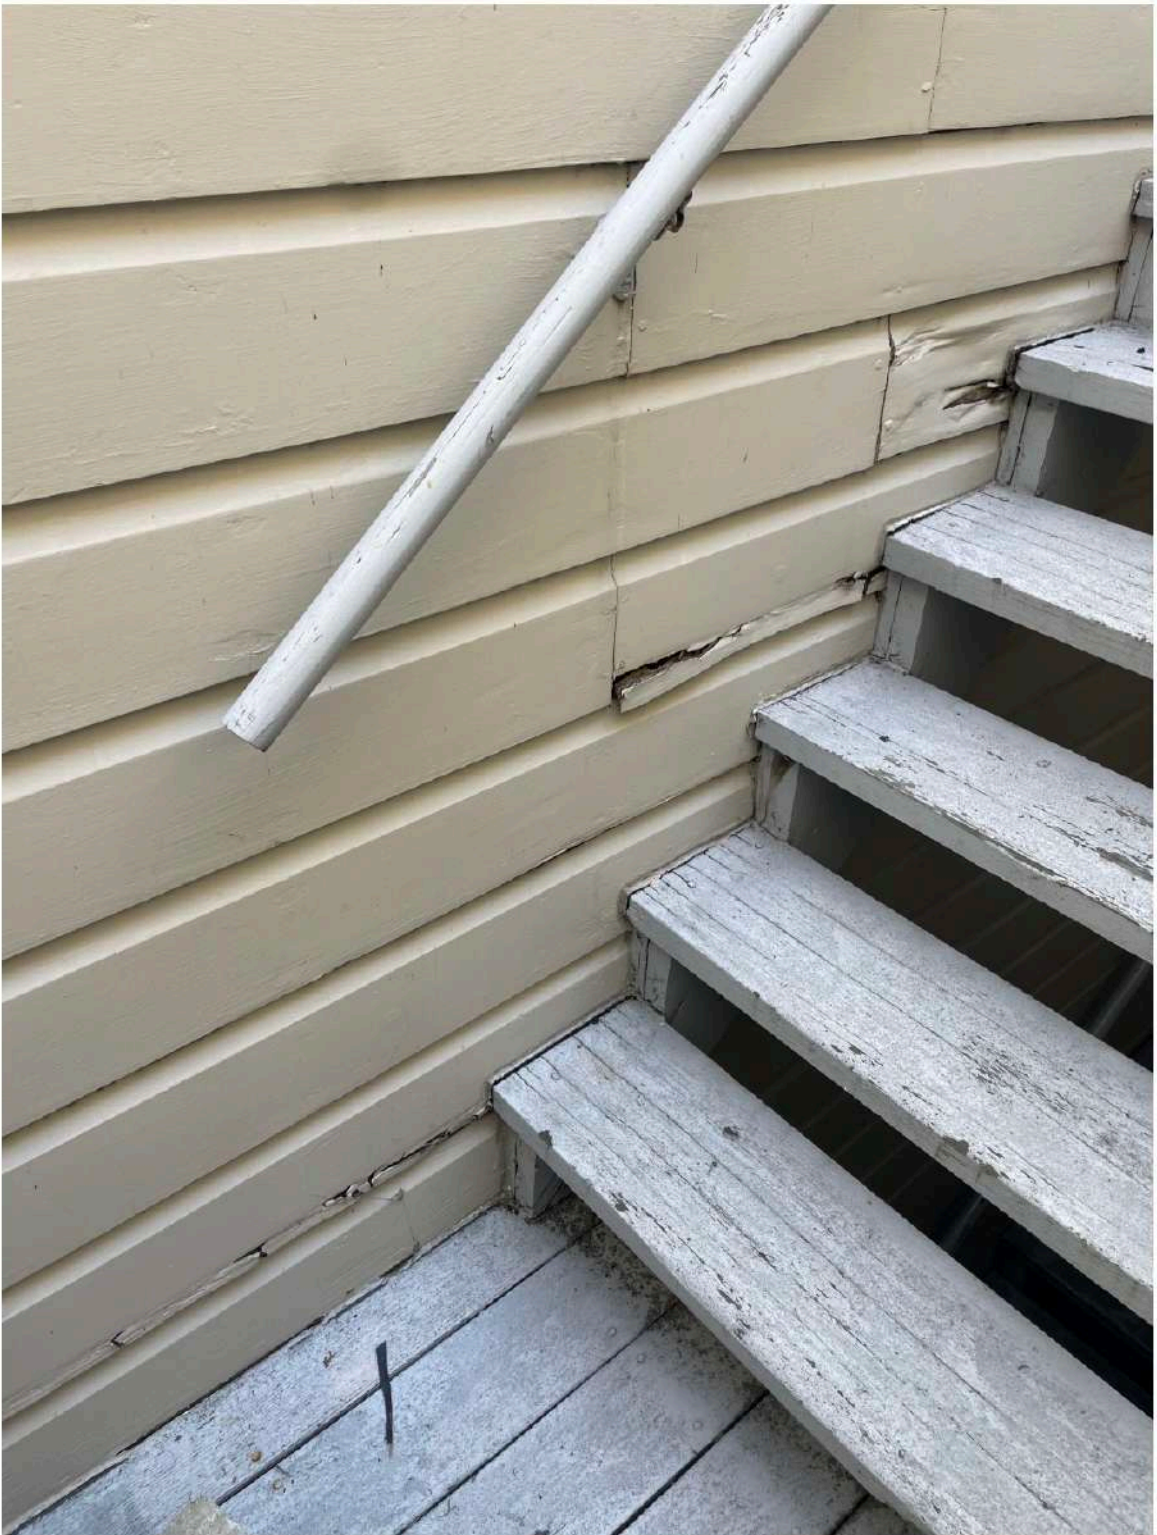
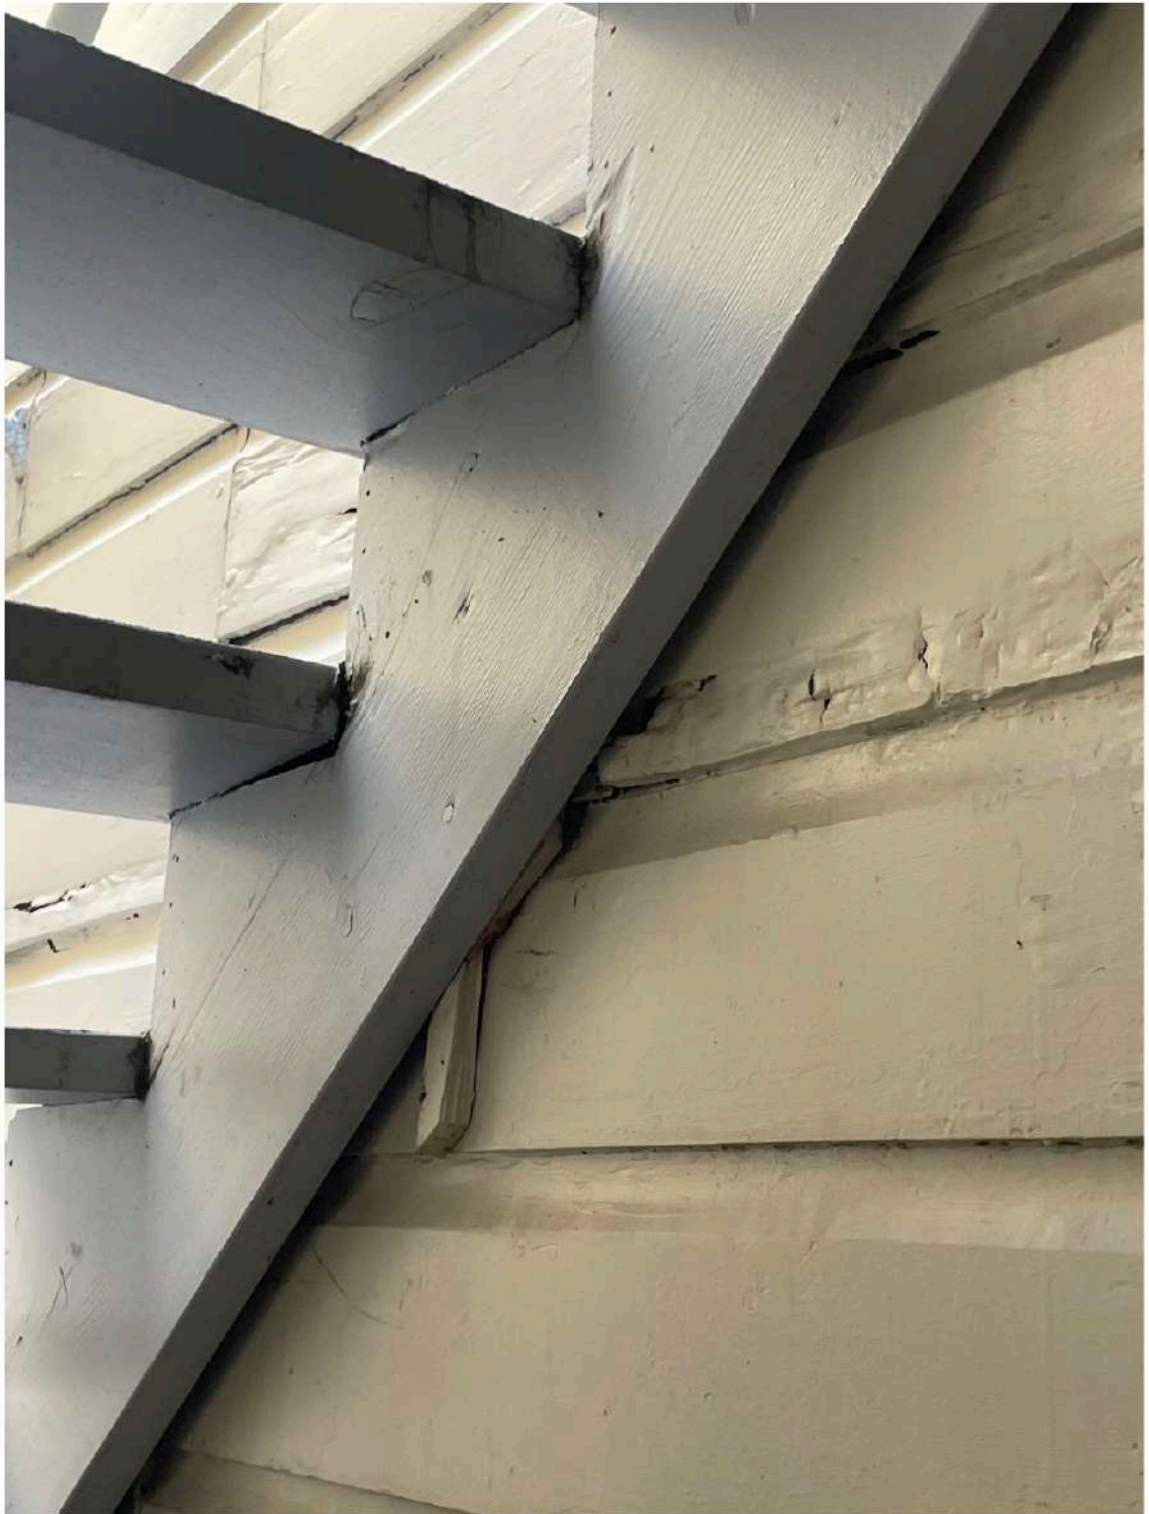
We observed:

- A substandard three level stair column structure. This structure appears to be significantly deteriorated.
- The structure belonging to 1331/33 Church Street property, is at points connected to the adjacent building 1325/27 Church Street.
- This staircase was not built to code
- Some damage to the property 1325/27 Church Street was observed which was local to these points of connection.
- Some siding exhibits water damage and rot and will need to be replaced.
- There is some other minor damage in areas not associated with the staircase connections. We estimate that this applies to roughly 20% of the overall damage/cost to repair.
- Vertical boards deteriorated and attachment to house is insufficient.

- Stair structure to be removed.
- Scaffold to be set up in its place , and closer inspection made.
- Replace siding to match as needed .
- Caulking, paintwork and flashing work to be employed.
- A new compliant stair structure will need to be erected.

- Materials: -waterproofing membranes
 - shiplap siding to match existing
 - exterior grade trim
- Labor - Our best estimate is 2 weeks for 2 carpenters to replace and repair the damaged areas. We estimate roughly this will cost for labor and materials in the ballpark of **\$20,000.** **\$4,000** of which is not related to the damaged areas caused by the staircase.
- Estimated cost to replace vertical boards **\$800.**

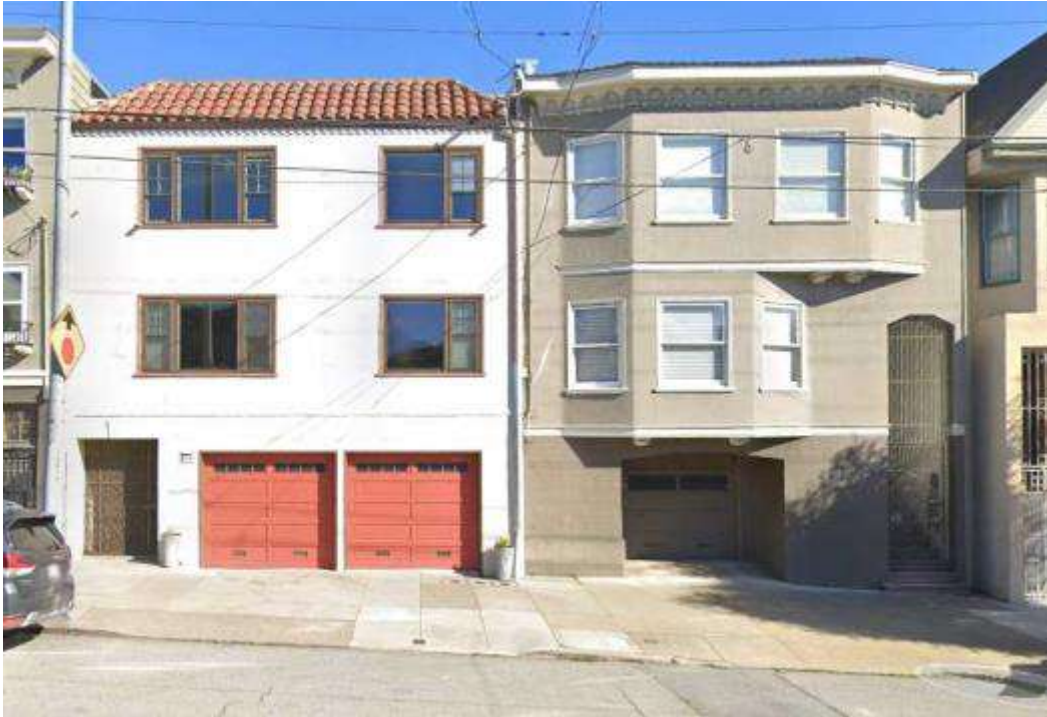
Dwelling/Risk - 3

1325 Church on the left.

Insured's home on right: 1331-1333 Church.

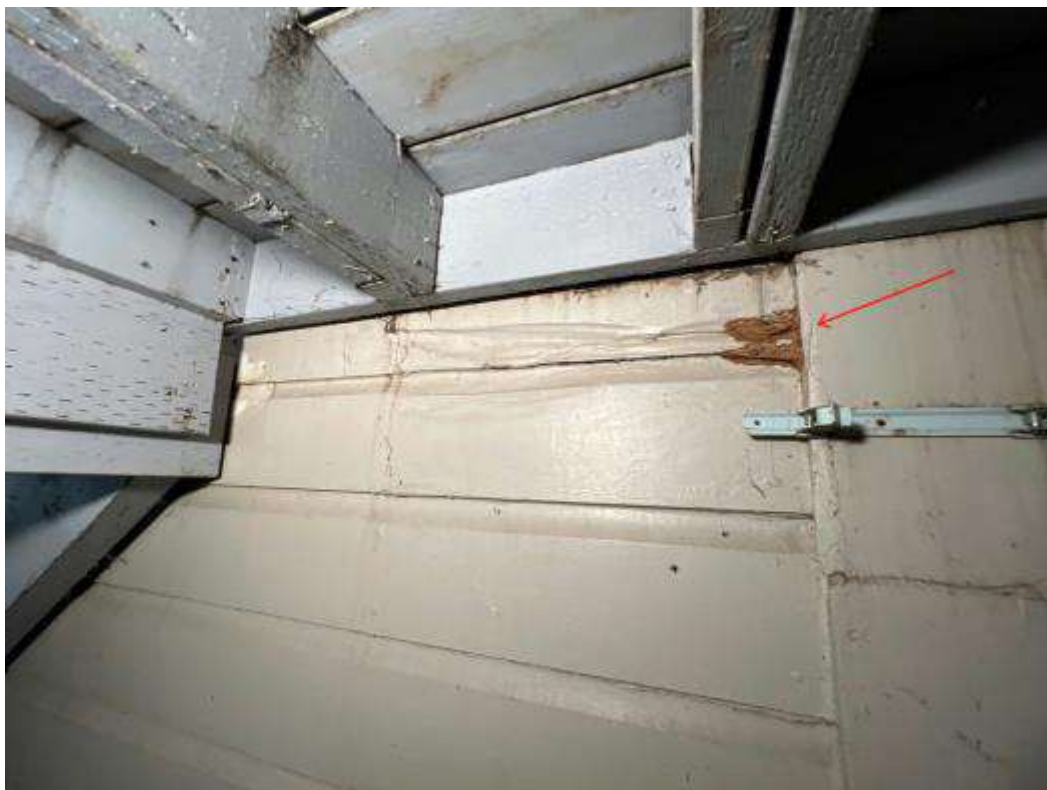
1325 Church St - 22

Dry rot and signs of termites (arrow) on neighbor's siding.

No visible dry rot on 2x6 joist for Insured's 1st landing.

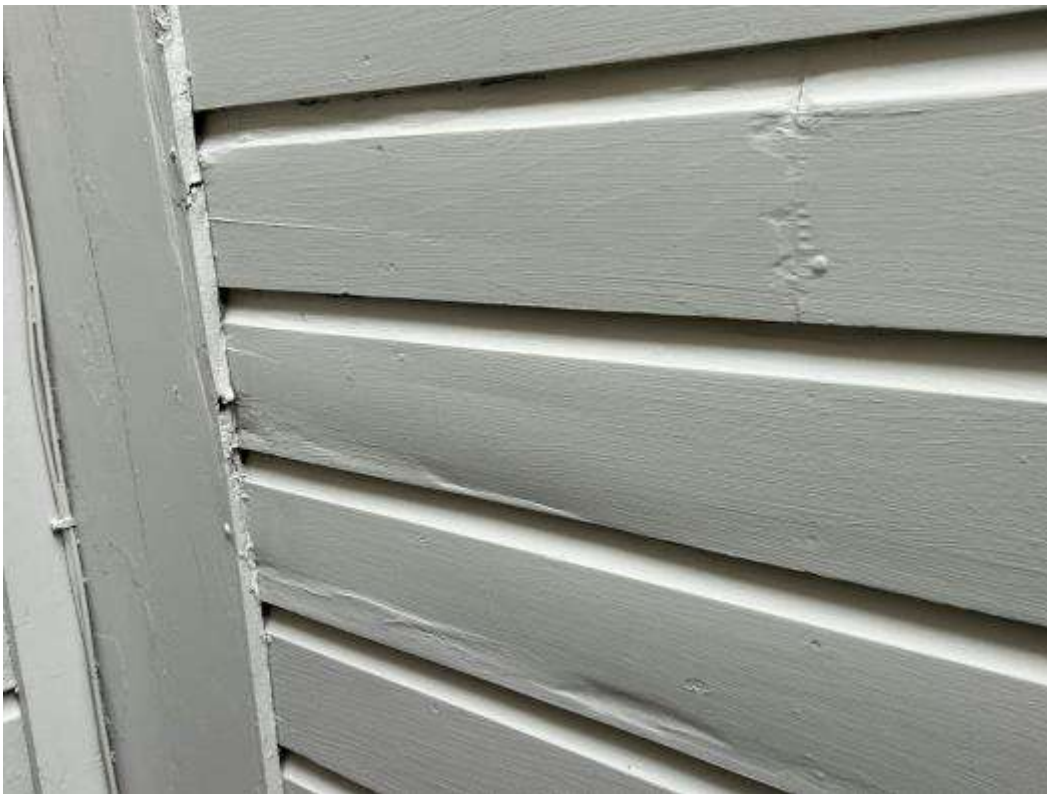
1325 Church St - 27

Dry rot on the neighbor's siding at least 2 feet away from the Insured's stairs.

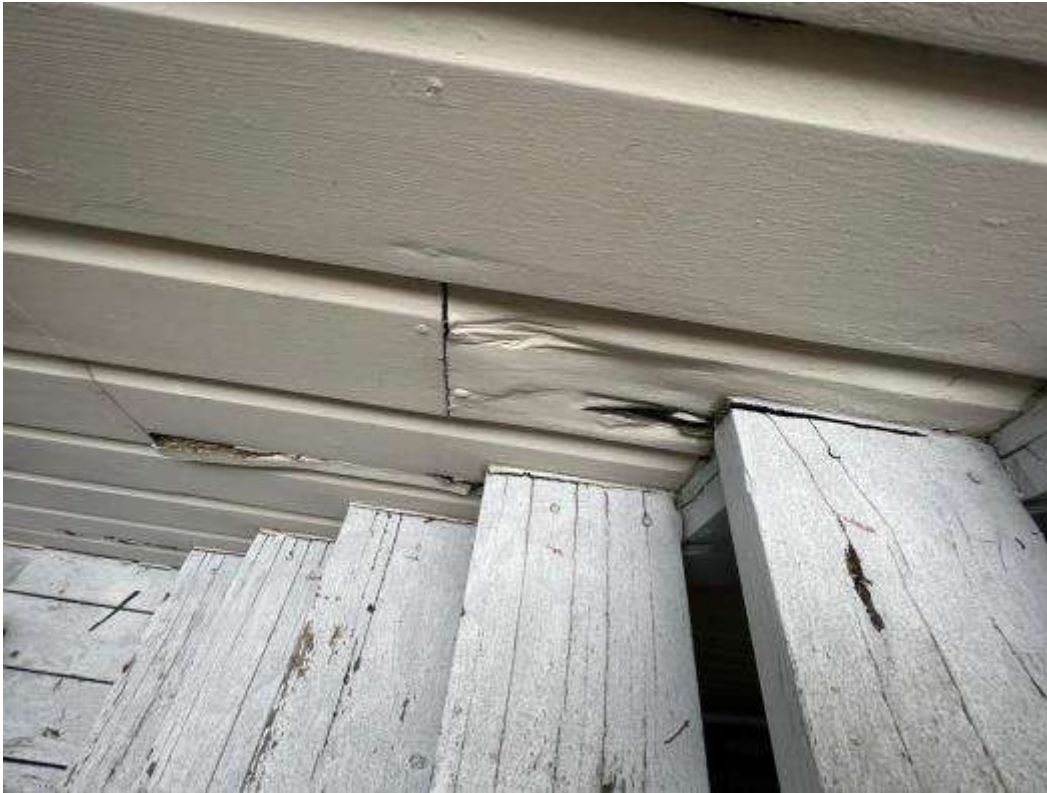
1325 Church St - 33

Relatively advanced dry rot on the neighbor's siding with little, if any, dry rot to the butt end of the treads.

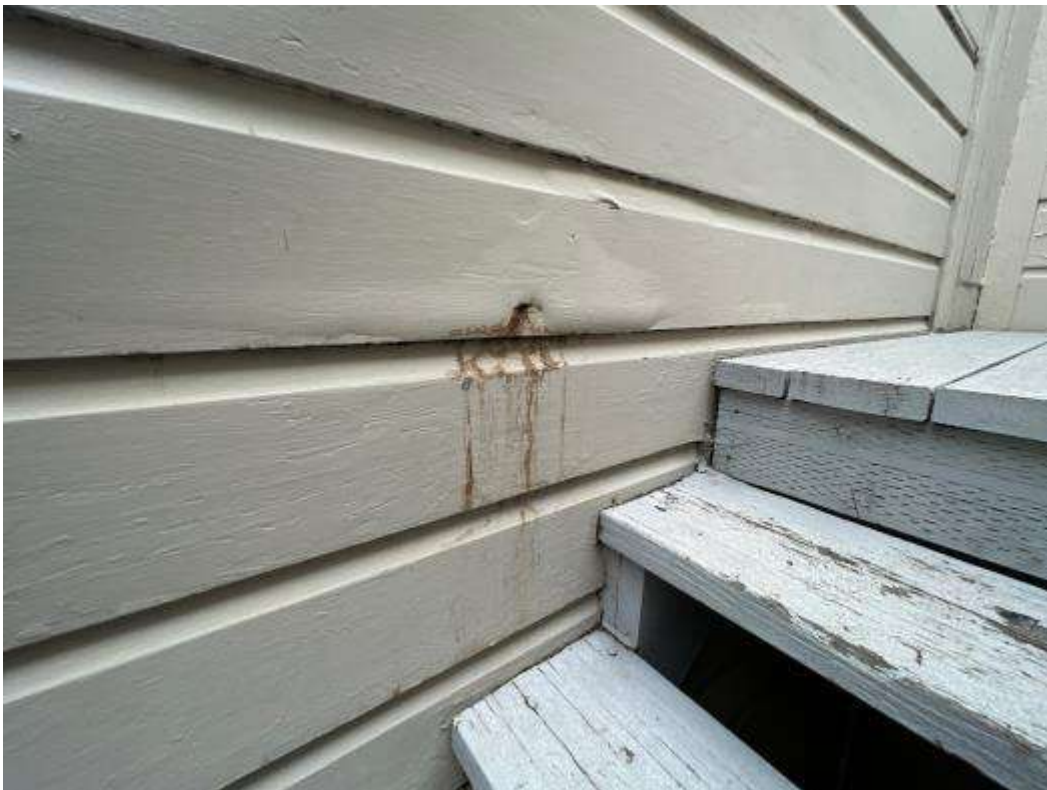
1325 Church St - 34

Water damage to neighbor's siding from interior leak.

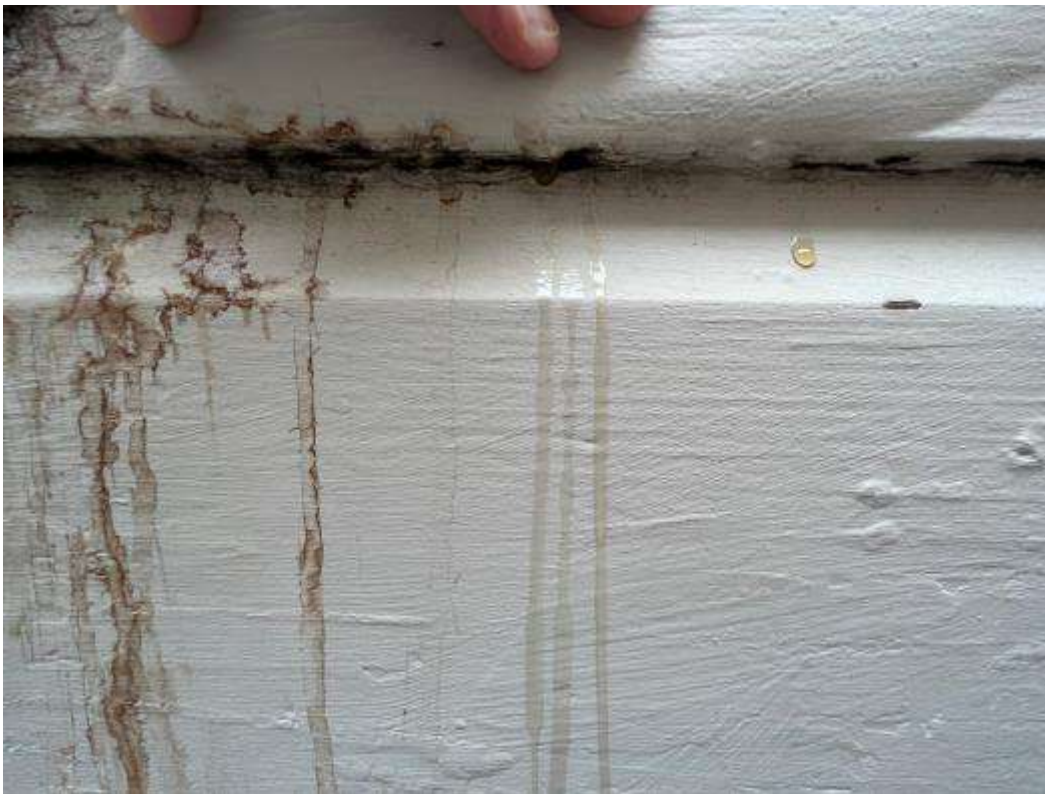
1325 Church St - 39

Water has pooled between wood and paint.
