From: [Rosenberg, Julie \(BOA\)](#)
To: [Longaway, Alec \(BOA\)](#); [Mejia, Xiomara \(BOA\)](#)
Cc: [BoardofAppeals \(PAB\)](#)
Subject: FW: Code interpretation of SFBC section 106A.1 (Appeal No. 23-046 @ 1331-1333 Church ST.)
Date: Monday, January 8, 2024 4:13:05 PM

In particular, the question is whether this code section requires that two permits be obtained for the exterior stair repair at 1331-1333 Church Street. Building permit application # 202306291194 was issued to the property owner of 1331-1333 Church. The owners of the adjacent property (1325-1327 Church Street), assert that there are some fasteners that penetrate their property line wall. As such, they believe that a second permit for the repairs is required to be issued under their address. Other than the fasteners (and I am uncertain as to the number of fasteners), the stair structure is on the 1331-1333 Church Street side of the property line. The stairs serve only 1331-1333 Church Street.

FIRE EGRESS STAIRS REPAIR

The substance or effect of the decision or order appealed from is the **ISSUANCE** on September 19, 2023 to Ken Chin, of an Alteration Permit (repair the damaged framing in-kind in the fire egress stai

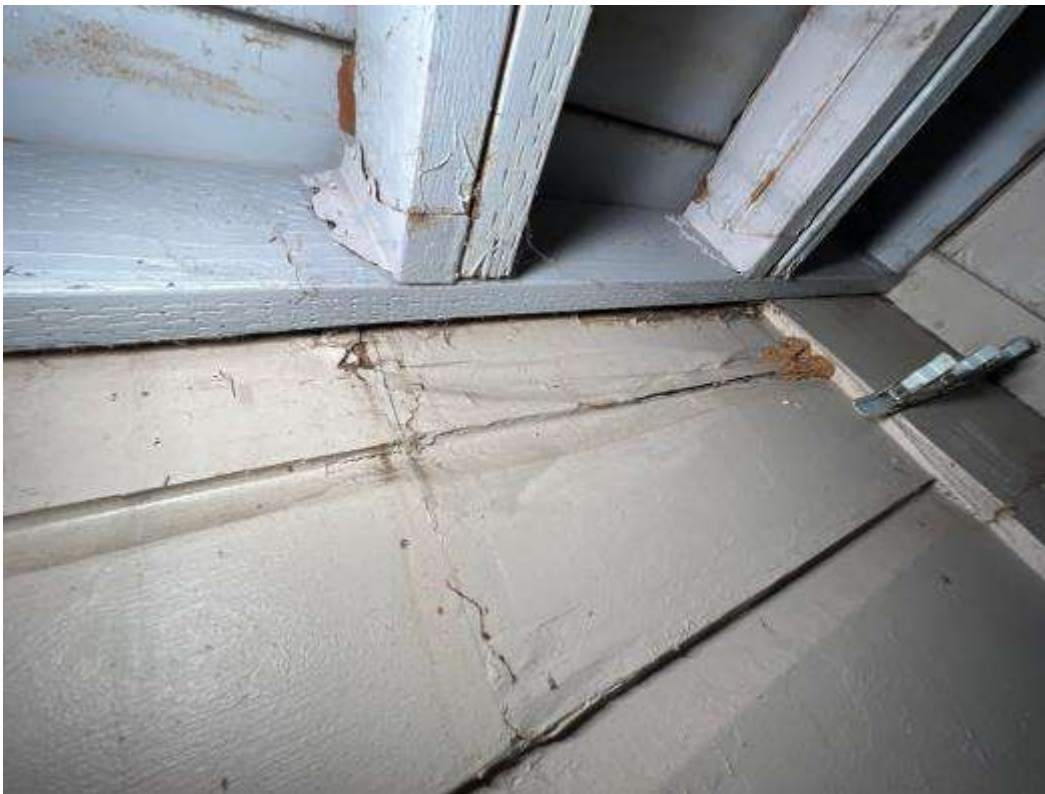
1325 Church St - 23

Dry rot and signs of termites on neighbor's siding.

No visible dry rot on 2x6 joist for Insured's 1st landing.

Note: the joist is pressure treated compared to most of the other stair's framing indicating it was probably replaced when the previous owner replaced the dry rotted section of stairs before selling the property to the Insured.

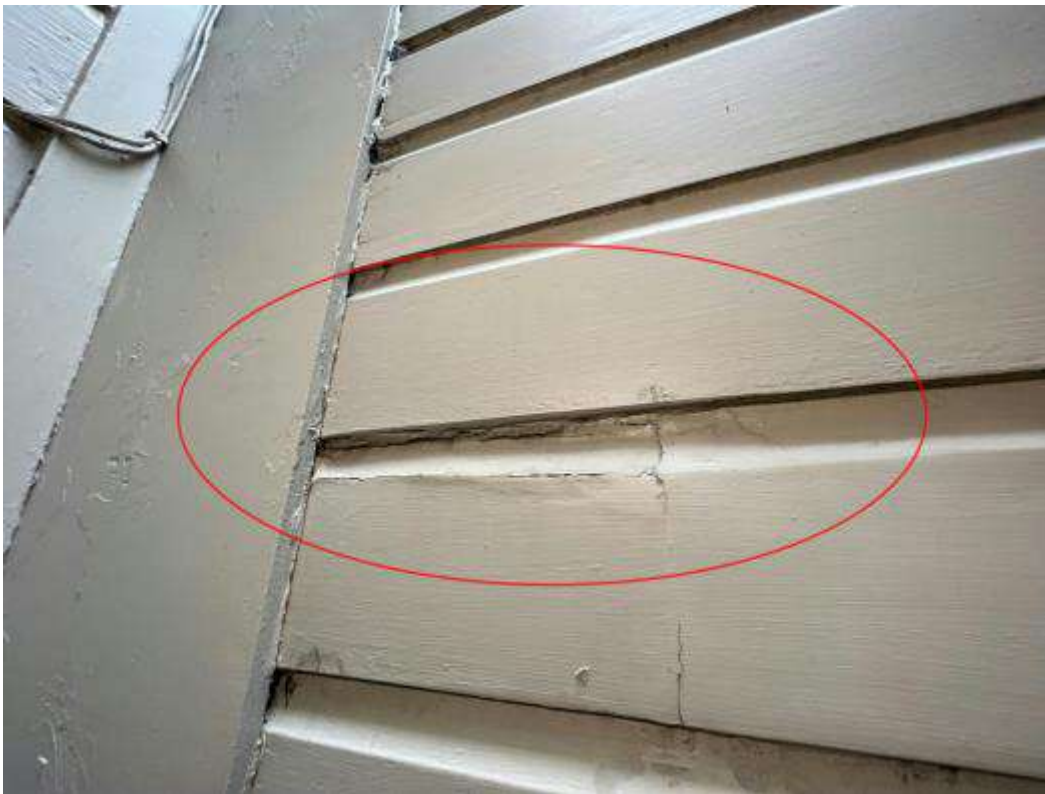
1325 Church St - 25

Dry rot on the neighbor's siding at least 3 feet from the Insured's stairs.

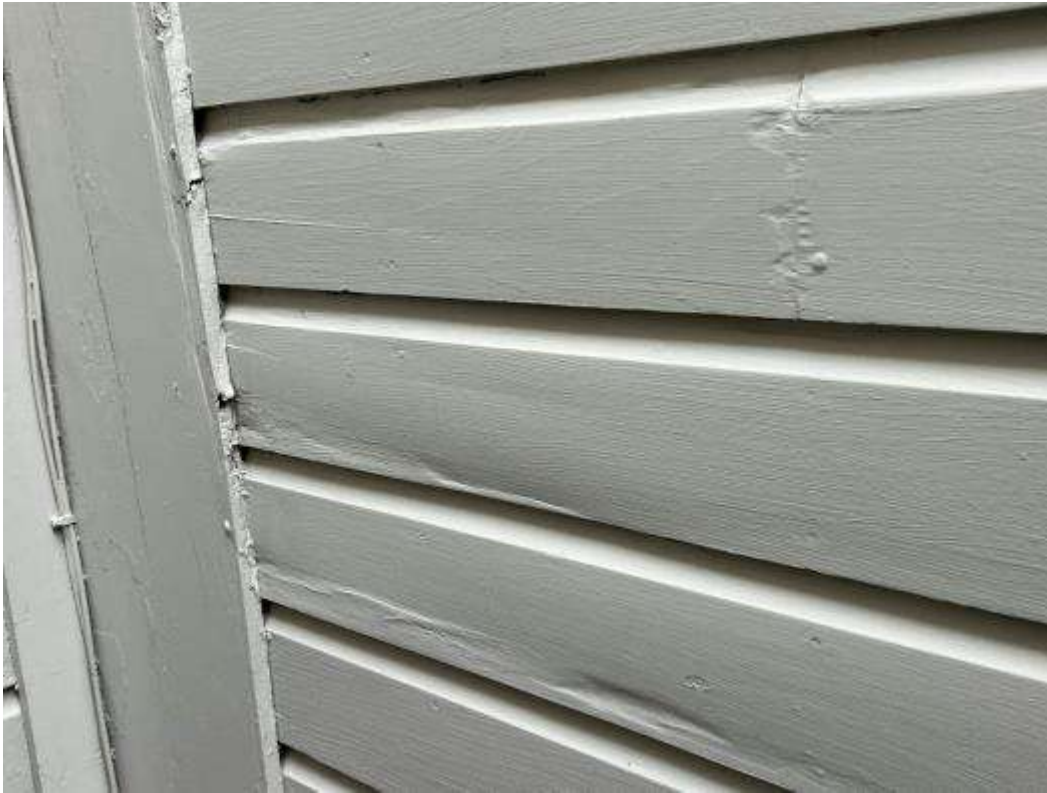
1325 Church St - 27

Dry rot on the neighbor's siding at least 2 feet away from the Insured's stairs.

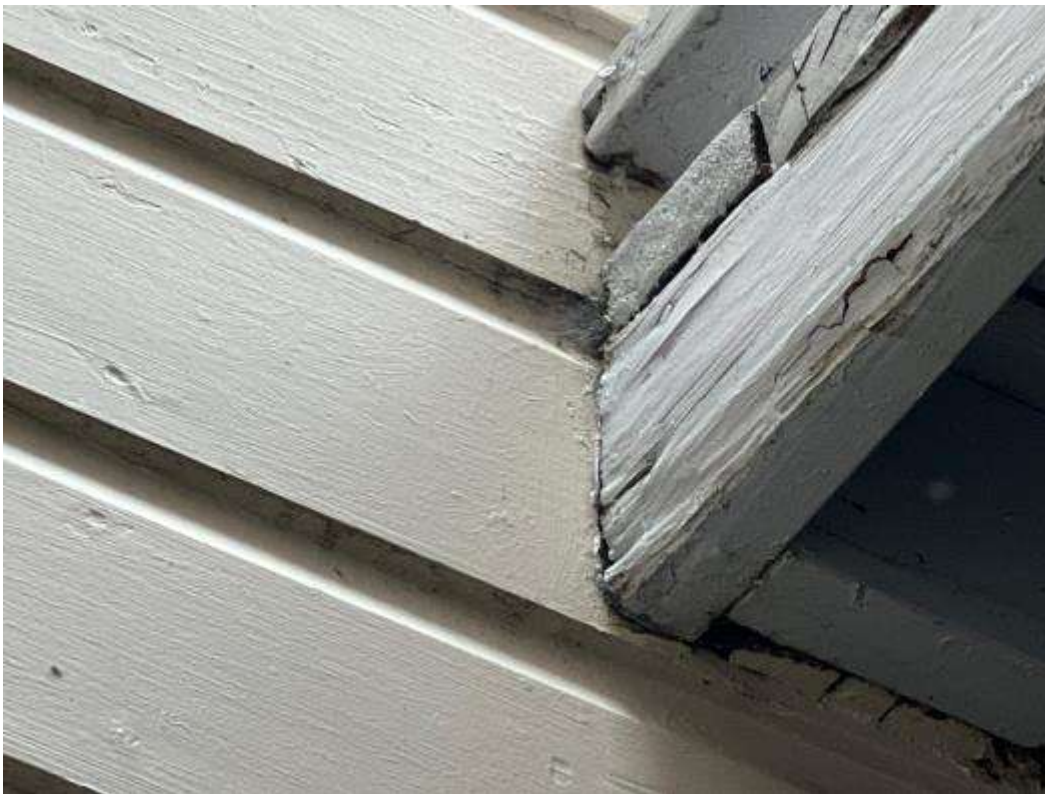
1325 Church St - 29

Dry rot to 2x6 joist for 2nd landing but no dry rot to neighbor's siding.

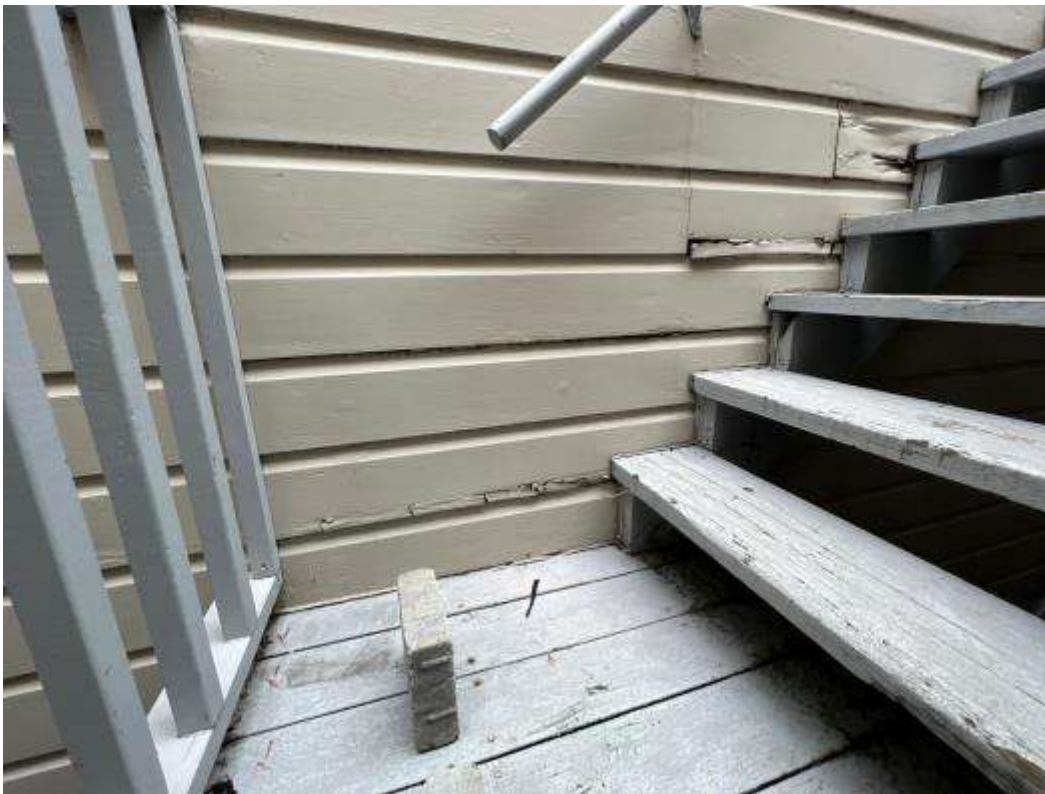
1325 Church St - 31

Relatively advanced dry rot on the neighbor's siding next to the treads of the stairs between the 2nd and 3rd landing with little, if any, dry rot to the butt end of the treads and stringer where they contact the neighbor's siding.

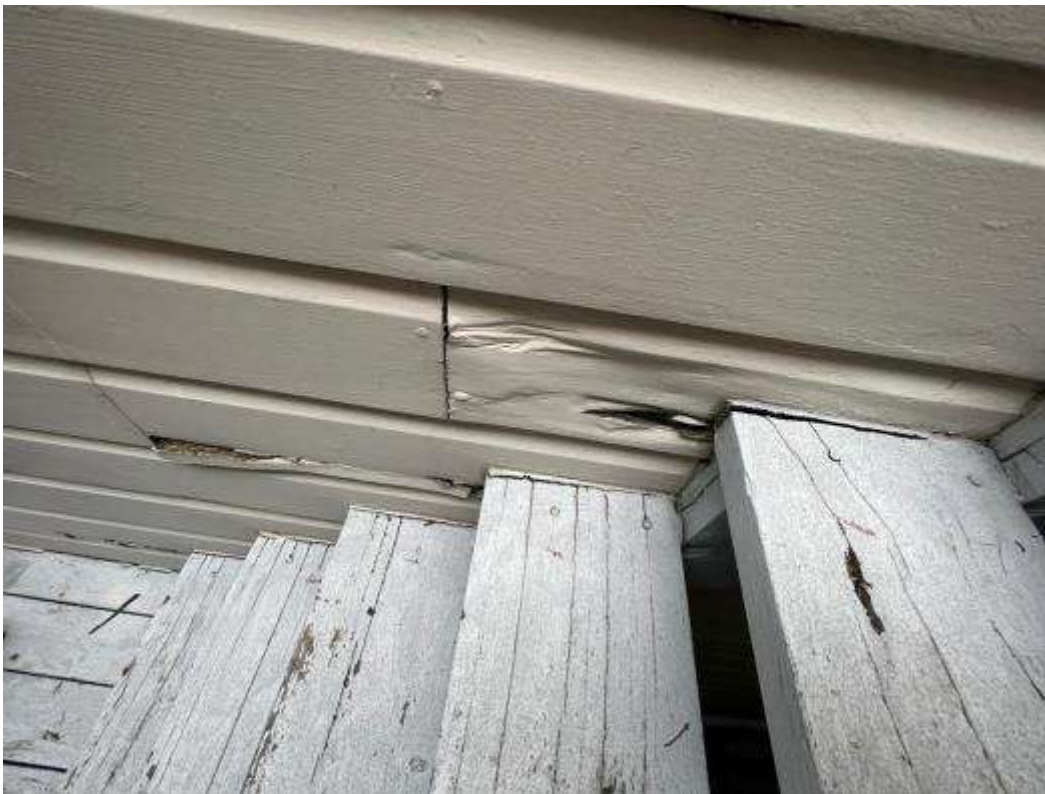
1325 Church St - 33

Relatively advanced dry rot on the neighbor's siding with little, if any, dry rot to the butt end of the treads.

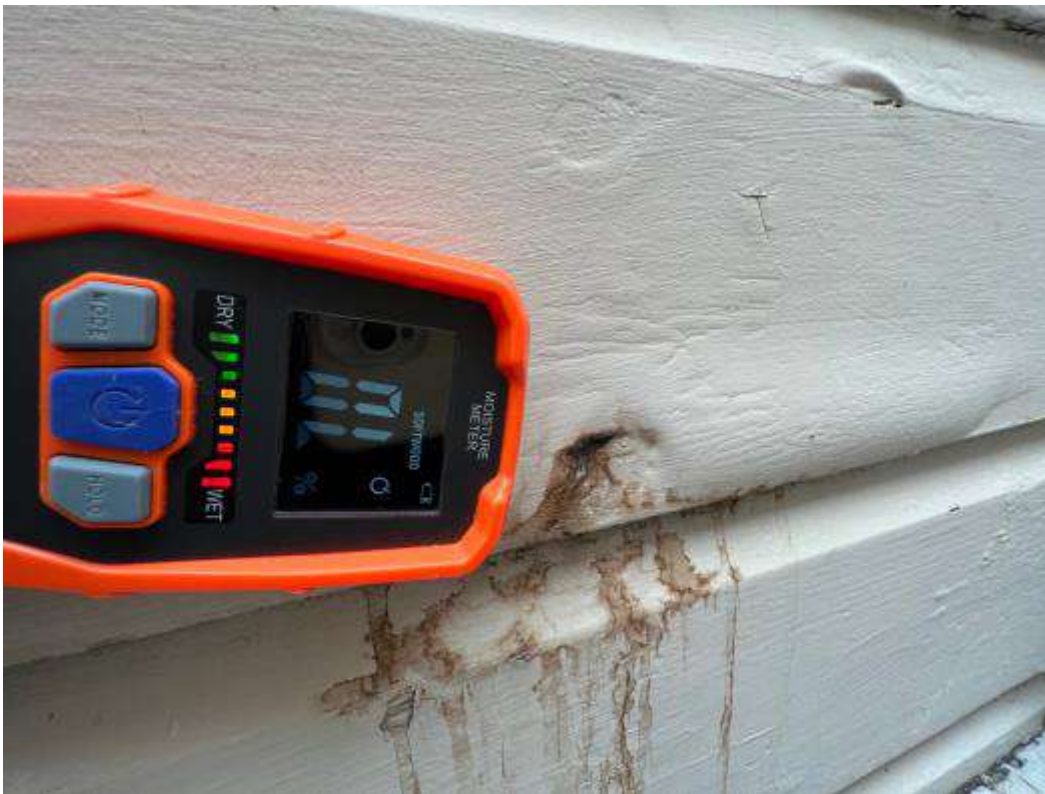
1325 Church St - 37

Wood is wet. Moisture reading is over limits.

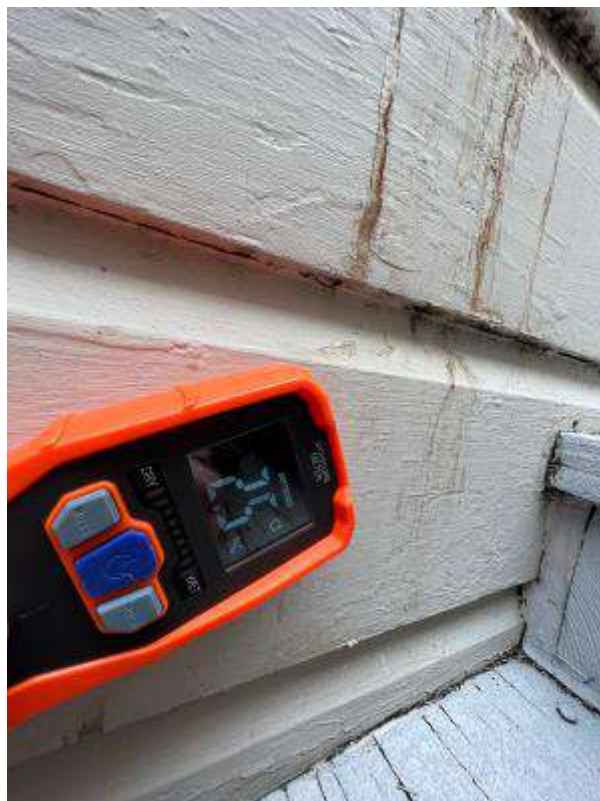
1325 Church St - 38

Board below water damage is dry.

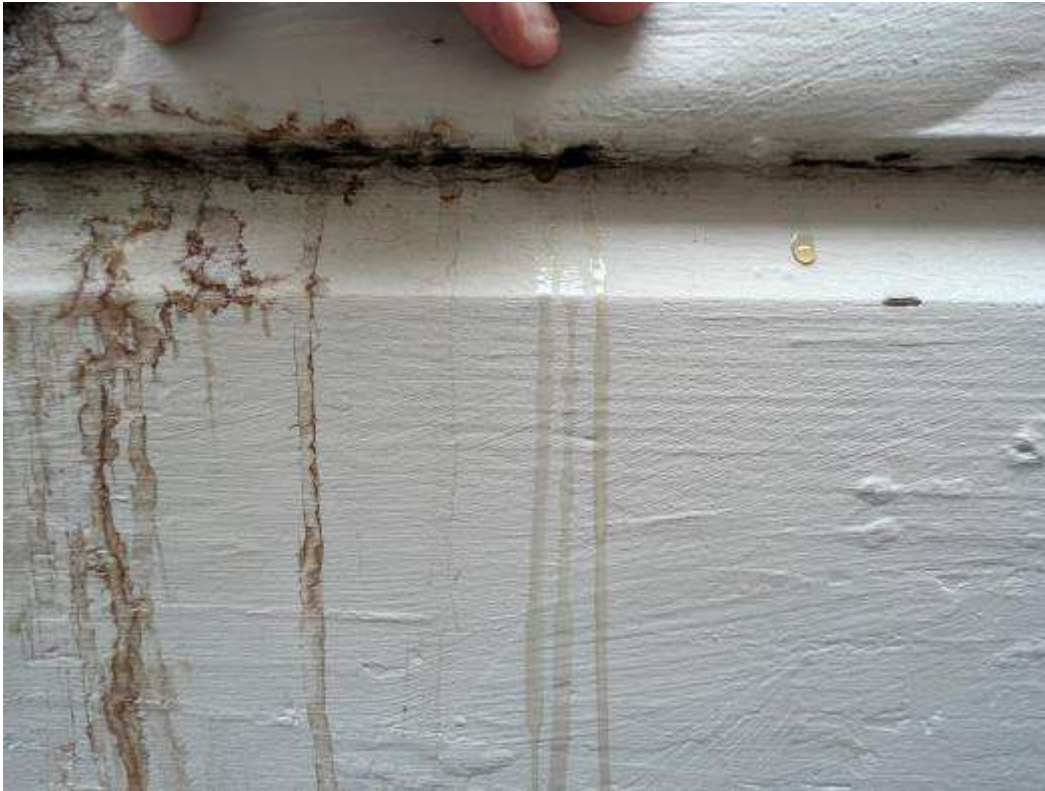
1325 Church St - 39

Water has pooled between wood and paint.

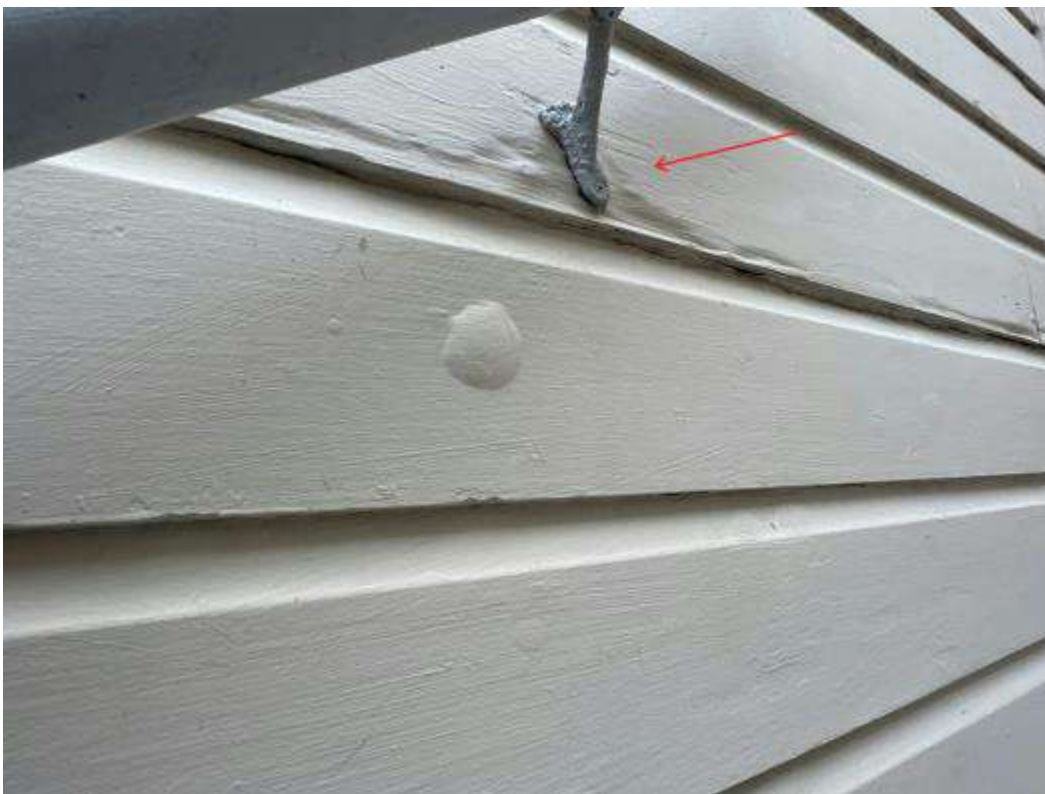
1325 Church St - 41

Arrow points to the bottom of the board above bubble, which has several feet of what appears to be old dry rot that was painted over at some point.

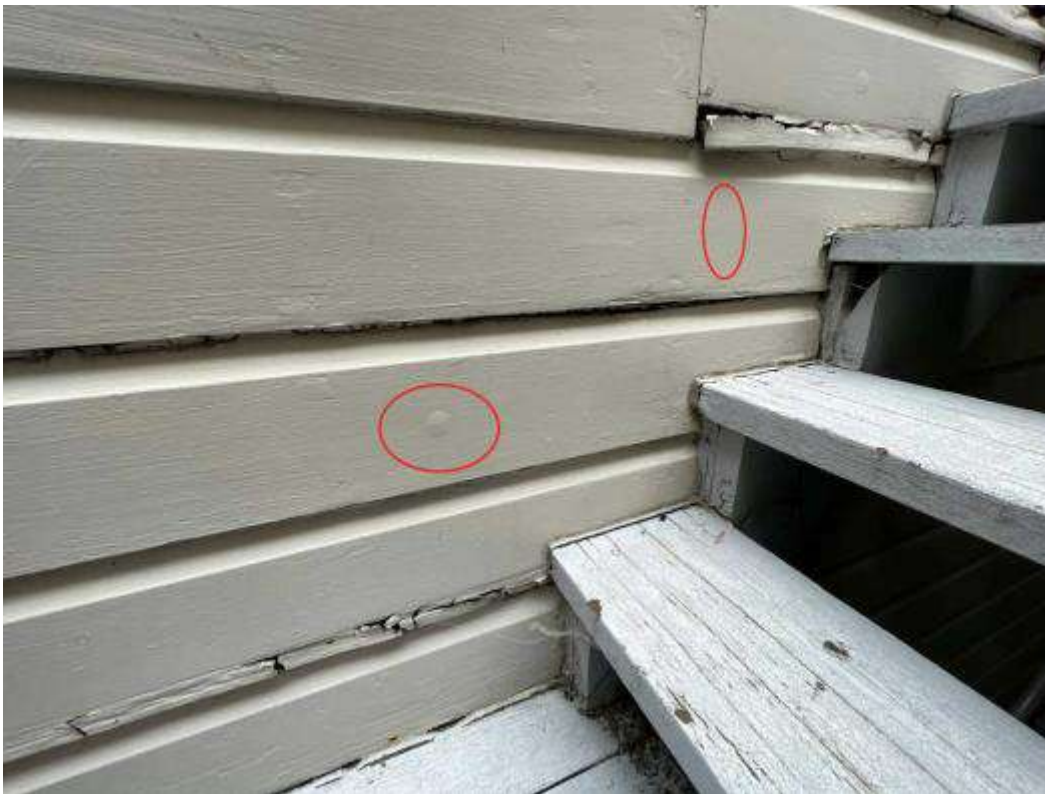
1325 Church St - 43

Areas circled in red had high moisture readings. The rest of the area in the photo was dry.

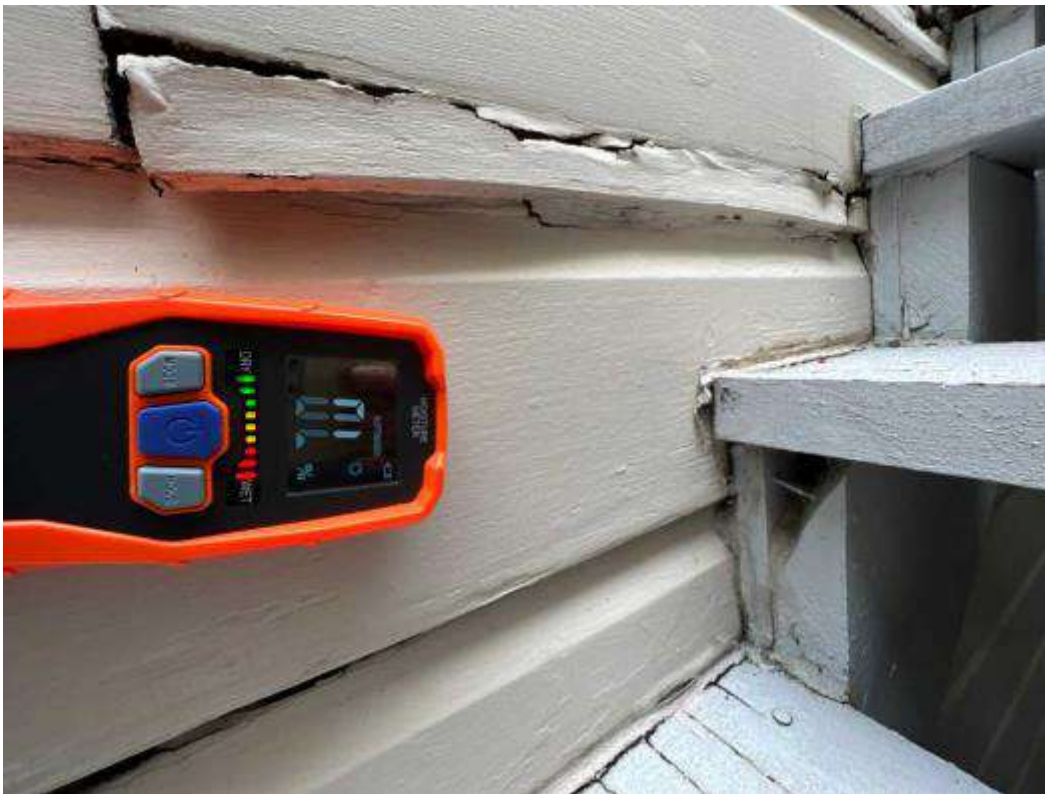
1325 Church St - 45

Wood is wet just below the advanced dry rot but dry in the rest of the photo.

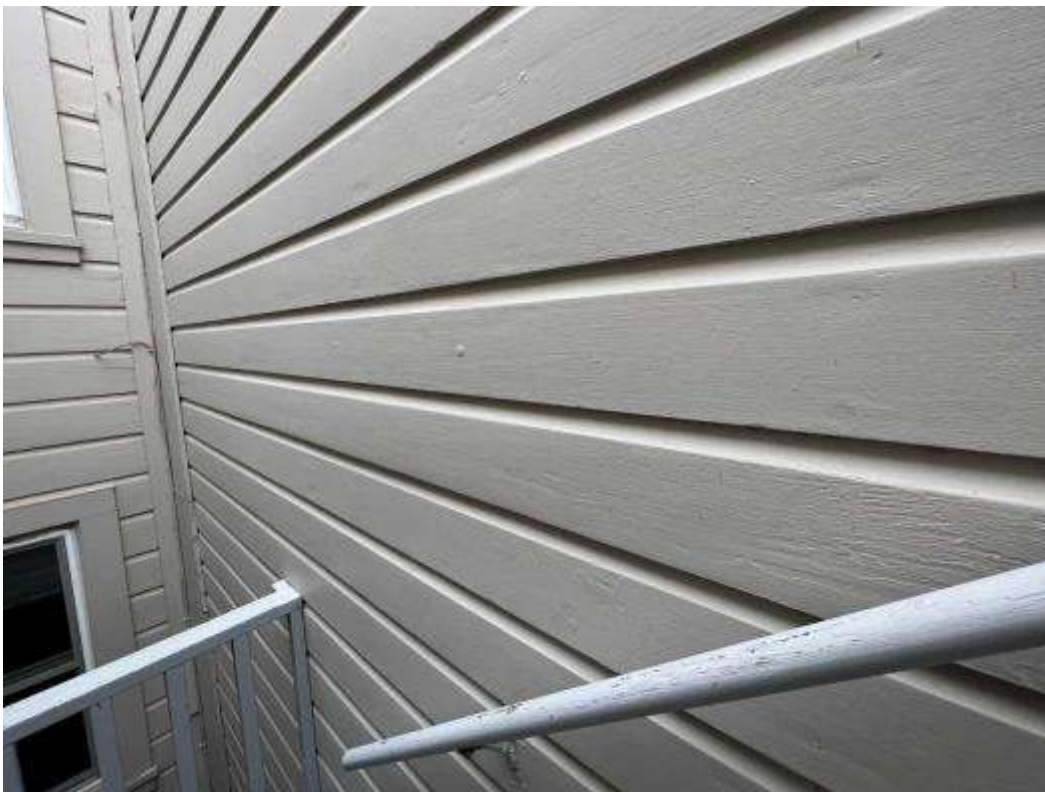
1325 Church St - 46

The wood around this bubble was dry. No dry rot on the neighbor's siding above this point.
